**WHEEL CREEK
GEOMORPHIC ASSESSMENT
YEAR 3
FINAL REPORT**

**WHEEL CREEK
GEOMORPHIC ASSESSMENT
YEAR 3 FINAL REPORT**

Harford County
Department of Public Works
Division of Highways and Water Resources
15 North Bond Street
Bel Air, Maryland 21014

Versar, Inc.
9200 Rumsey Road, Suite 100
Columbia, Maryland 21045

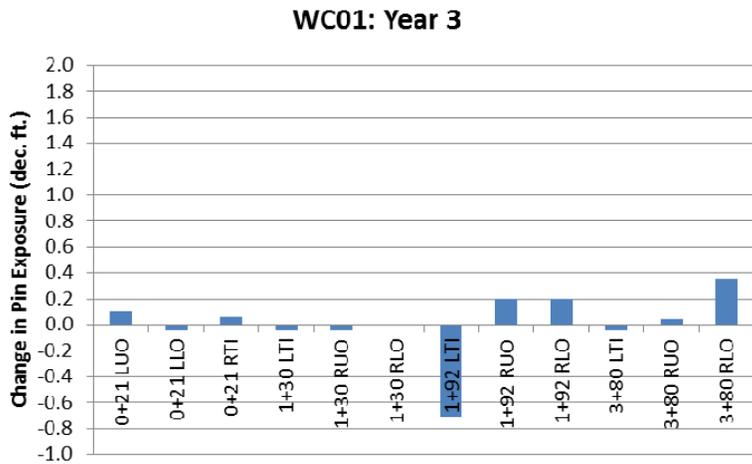
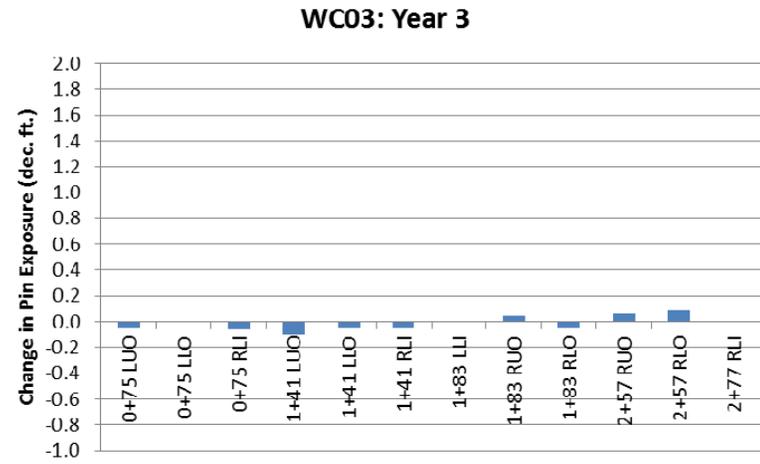
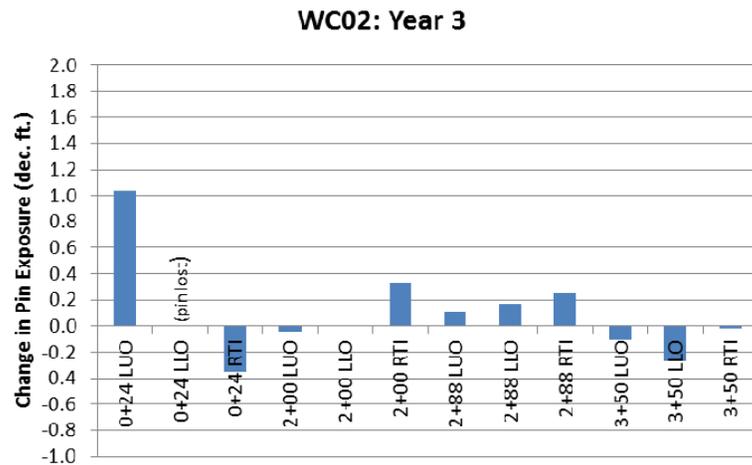
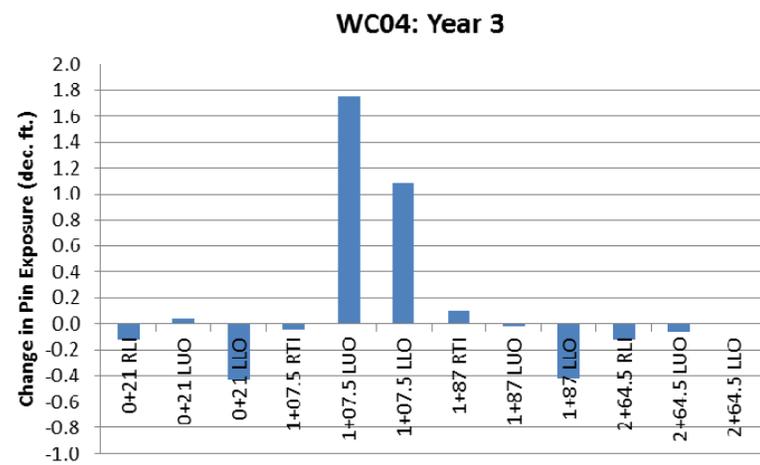
Figure 3-1. Cumulative change in Wheel Creek bankpin exposure by reach between mid-November 2012, and mid-October 2013. The pin lost at WC02 Station 0+24 LLO between Year 1 and Year 2 was not recovered in Year 3.

Measured erosion rates in reach WC01 ranged from 0.00 to 0.38 ft/year with the highest erosion occurring along the outer meander bend at profile station 3+80. Both pins installed within the meander bend at profile station 3+80 were hammered further into the bank after the completion of Year 3 measurements to prevent them from falling out of the bank. Deposition rates at WC01 ranged from -0.05 to -0.77 ft/yr with the most deposition occurring along the base of the inner meander bend at profile station 1+92. Erosion rates ranged from 0.00 to 1.13 ft/yr at WC02, while deposition rates ranged from -0.02 to -0.38 ft/yr. The upper left bank at profile station 0+24 continues to experience significant undercutting, and the lower left bank pin was still not able to be found. Erosion rates at site WC03 ranged from 0.00 to 0.09 ft/yr with the highest erosion occurring at profile station 2+57. Deposition rates at WC03 ranged from -0.05 to -0.11 ft/yr. At reach WC04, measured erosion rates ranged from 0.00 to 1.90 ft/yr, with the highest erosion rate occurring on the upper portion of the left bank at profile station 1+07.5. It should be noted that actual erosion rates may differ from measured erosion rates for the 1+07.5

left bank pins; both of which fell after the bank experienced a significant amount of erosion. Depositional rates in this reach ranged from -0.02 to -0.47 ft/yr.

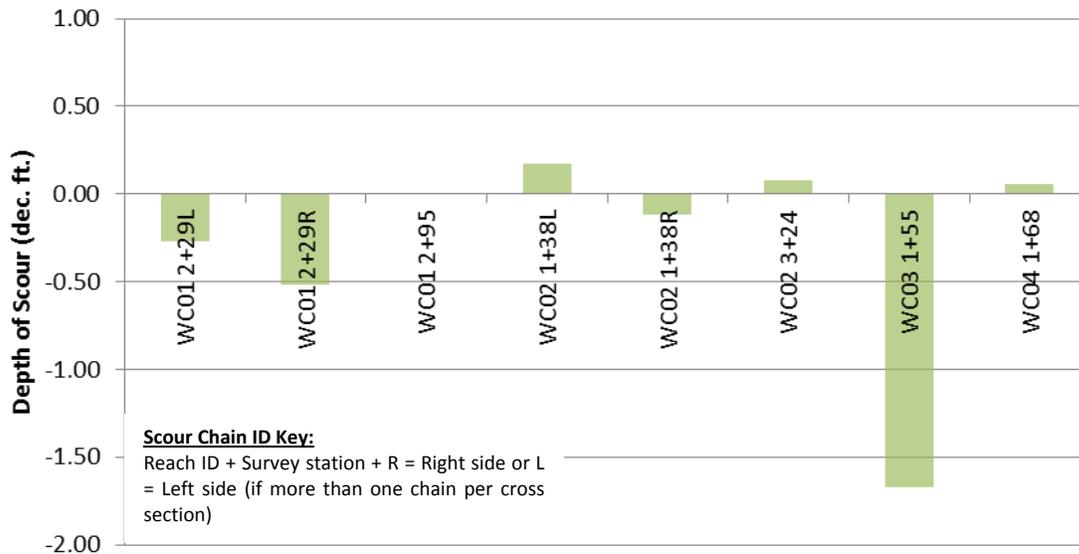
Figure 3-2. Bed scour in Wheel Creek between mid-November, 2012 and mid-October 2013 as measured through scour chain analysis at each reach. The scour chain at station 2+95 in WC01 was not able to be located for measurement.

During the period of mid-November 2012 to mid-October 2013, cumulative bed scour occurred within two reaches (WC02 and WC04). The largest amount of scour, 0.17 feet, was measured at station 1+38 in reach WC02. Cumulative deposition occurred at all other chains, with the most deposition occurring in reach WC03. Station 1+55 (WC03) had 1.67 feet of deposition, the most observed at any chain.

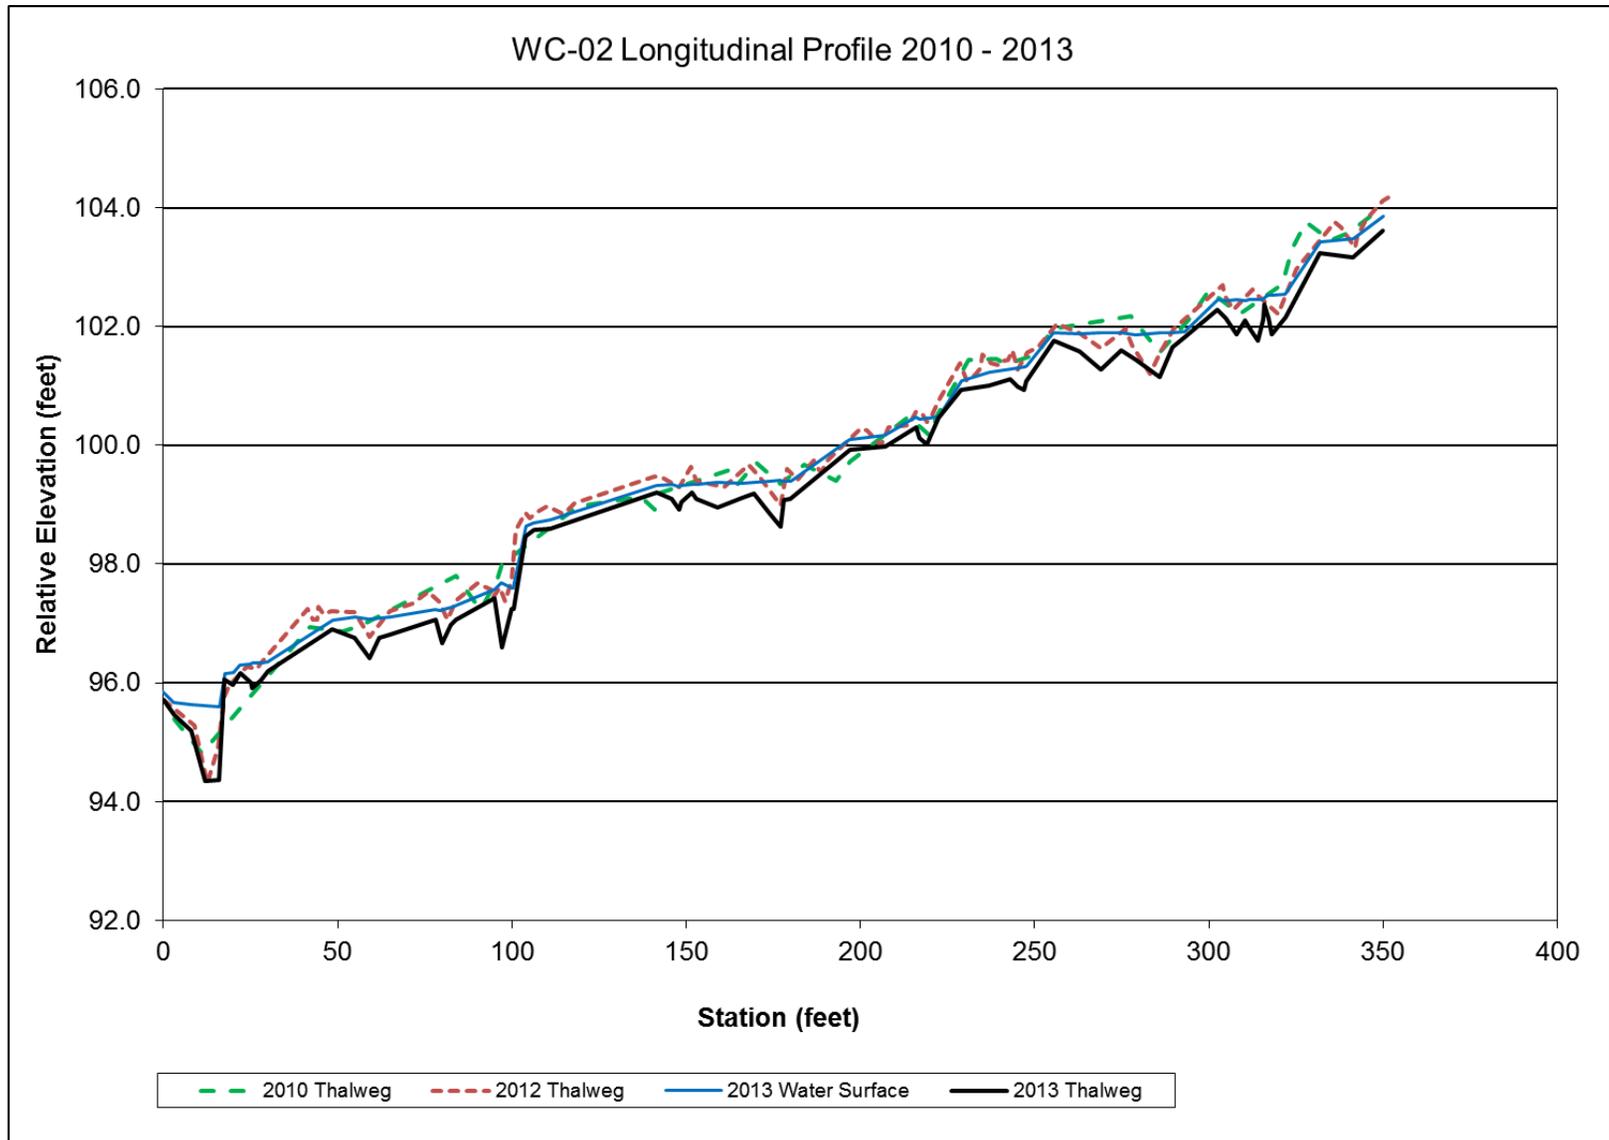
Figure C-2. WC-02 Chart

Significant changes in profile were not observed at WC02 over the three years of study (Figure C-2). Reach length remained constant and stream slope measurements were fairly consistent overall. Feature proportions within the reach have fluctuated from year to year. While the percentage of glides increased from 0% to 16.7% between Years 1 and 2, the percentage of pools has declined each year. During the third year 39.3% of the surveyed reach was classified as pools and glides, the lowest percentage since monitoring began. In contrast, riffles and runs made up 60.7% of the surveyed reach which was the greatest percentage of all three years (Table C-1).

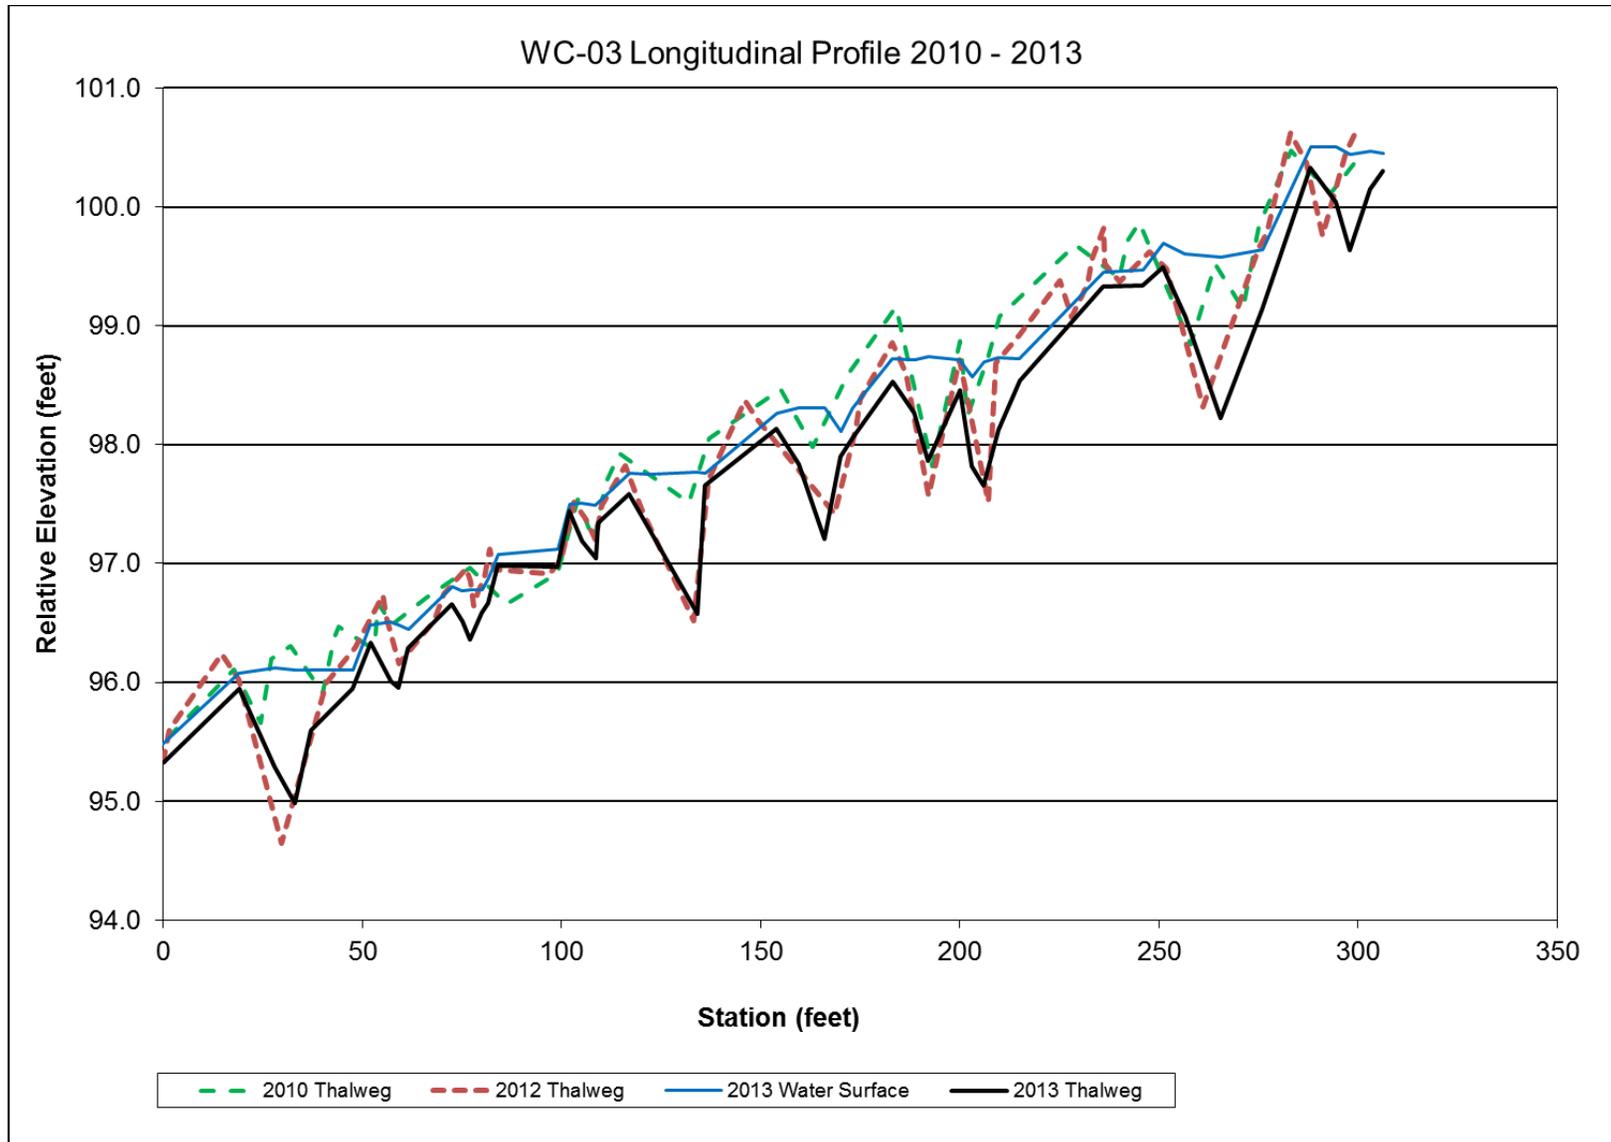
Figure C-3. WC-03 Chart

Pool and glide features have previously dominated reach WC03, as 65.6% and 67.5% of the reach was made up of pools and glides during Years 1 and 2, respectively. During Year 3, however, riffles and runs made up more than half (53.1%) of the reach (Table C-1). Changes in longitudinal profile were noted between the three years' of study, most notably the deepening of most pools reachwide between the first two years (Figure C-3). Pool depth has stayed fairly consistent between Years 2 and 3.

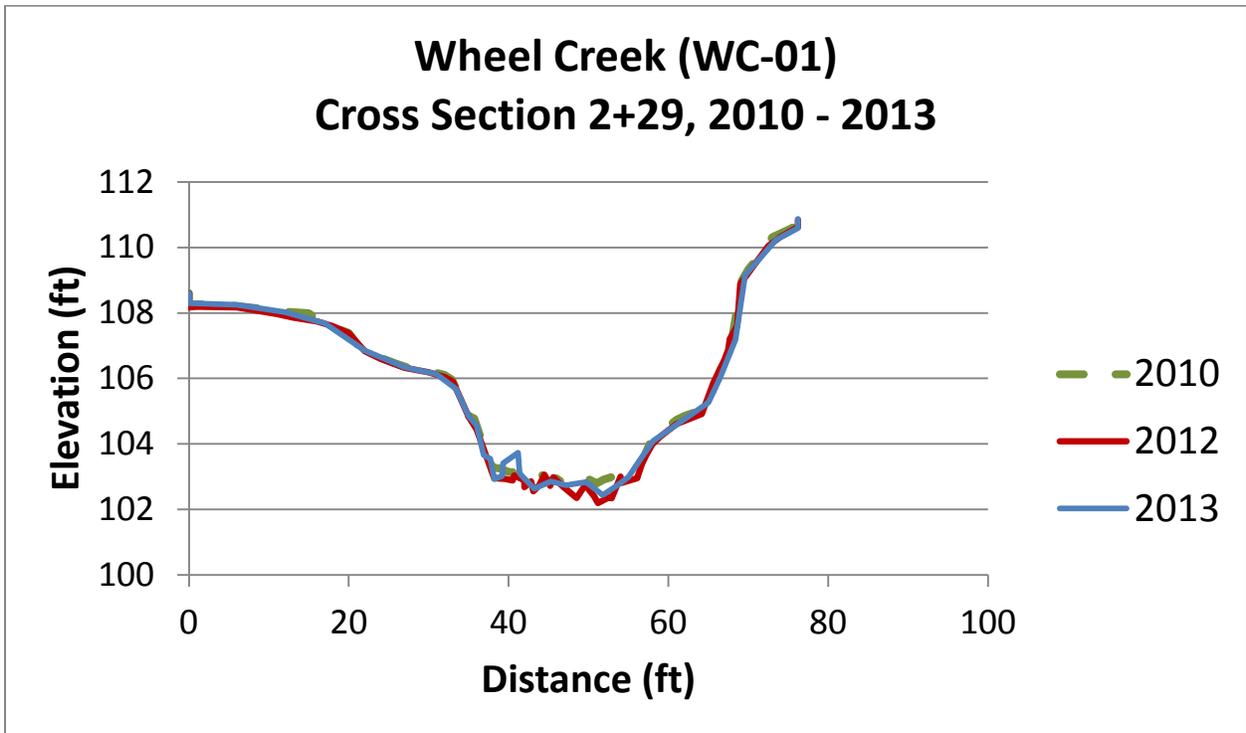
Figure C-5. WC01 Cross Section 1

Changes in the cross-sections were also observed at WC01 between the three years of survey (Figures C-5, C-6). Bed scour was observed at Cross-section 1 (Crossover Riffle at Station 2+29) especially near the right bank between Years 1 and 2, while deposition is apparent near the left bank between Years 2 and 3. Significant bank erosion and undercutting along the left bank (almost 6 feet) was observed at Cross-Section 2 (Meander Bend at Station 2+95) during both second and third years' monitoring. This has resulted in increases, from Year 1, of bankfull cross-sectional area and top of bank cross-sectional area at this station. Between Years 1 and 2, a side-bar formed on the right bank, burying the scour chain at this cross-section. In addition, the thalweg pattern changed between Years 1 and 2 so that it is no longer perpendicular to the permanently monumented cross-section markers at this location.

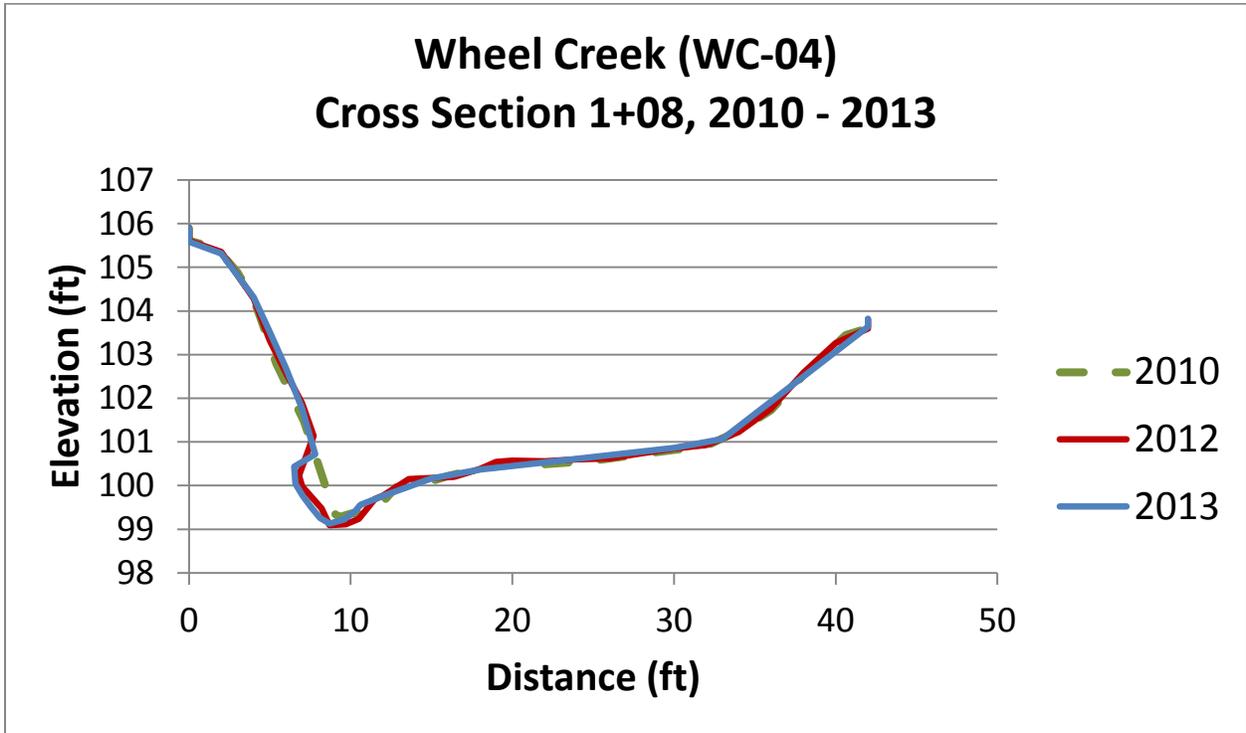
Figure C-11. WC04 Cross Section 1

The cross-sections within this reach also remained relatively unchanged between the three years of study, with the exception of some lower bank erosion observed at Cross-section 1 (Meander at Station 1+08) between Year 1 and Years 2 and 3 (Figures C-11 and C-12). This station was identified as a riffle located just above the top of a pool during the initial year of monitoring, but was within part of the pool when surveyed in Years 2 and 3. The channel was actively widening and cutting into the bank at this station during the Year 3 survey, resulting in changes in cross-sectional dimensions (Table C-2).
