**2009 Illicit Discharge Inspection Program
Summary Report
Harford County, Maryland**

Harford County
Department of Public Works
Division of Highways and Water Resources
212 South Bond Street, 3rd Floor
Bel Air, Maryland 21014

EA Engineering, Science, and Technology, Inc.
15 Loveton Circle
Sparks, Maryland 21152

May 2010

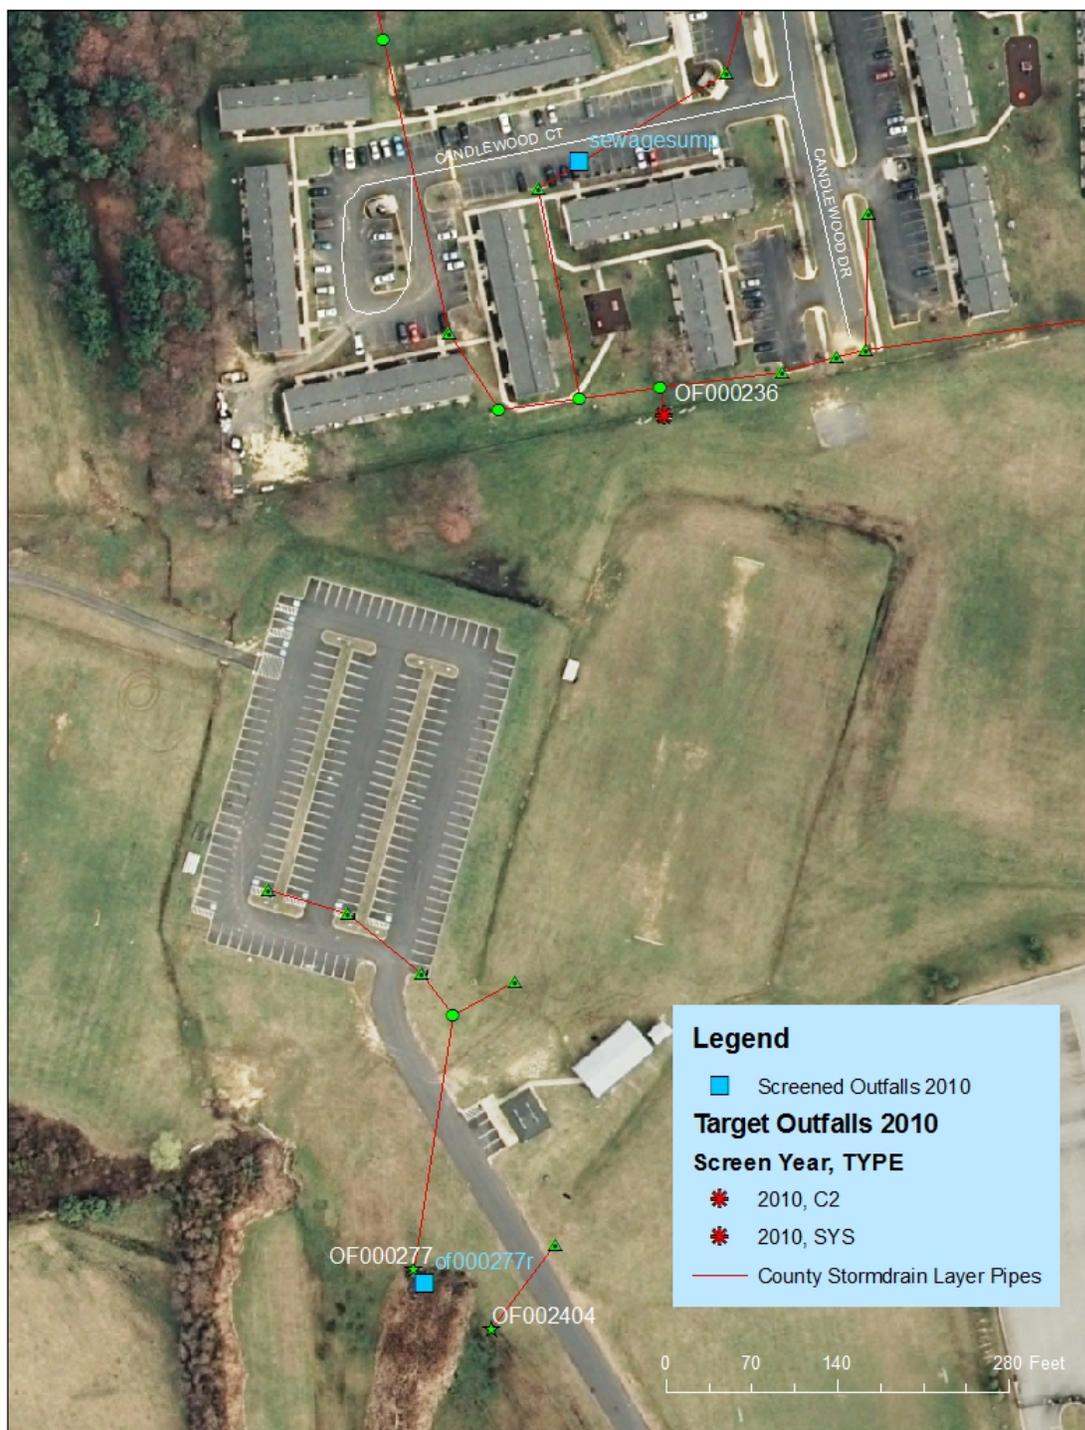
On December 10, 2010, County staff accompanied Versar staff to the site of the possible sanitary sewage illicit connection at the Windsor Valley Apartments property. While there, a sump pump discharged water to the parking area of Candlewood Court. Versar tested a sample of the water and found that the detergents concentration in the sample was 2.17 mg/l, which indicated that the discharge was washwater or perhaps connected to the evident sanitary sewer problem. County staff conferred with the management of the apartment community to communicate the urgency of rectifying the problem. County personnel informed them they must immediately address the problem and could not delay. County personnel also contacted the Harford County Health Department which is responsible for regulating private sanitary systems and for performing the follow-up investigation. The Windsor Valley Apartments is a private sanitary sewer system. It is not a part of the Harford County Sewer System. It is owned, operated and maintained by the property owner.

Figure 3-1. Windsor Valley Apartments illicit discharge. The point “sewagesump” refers to a sample taken from sump effluent discharged to the street on December 10, 2010.

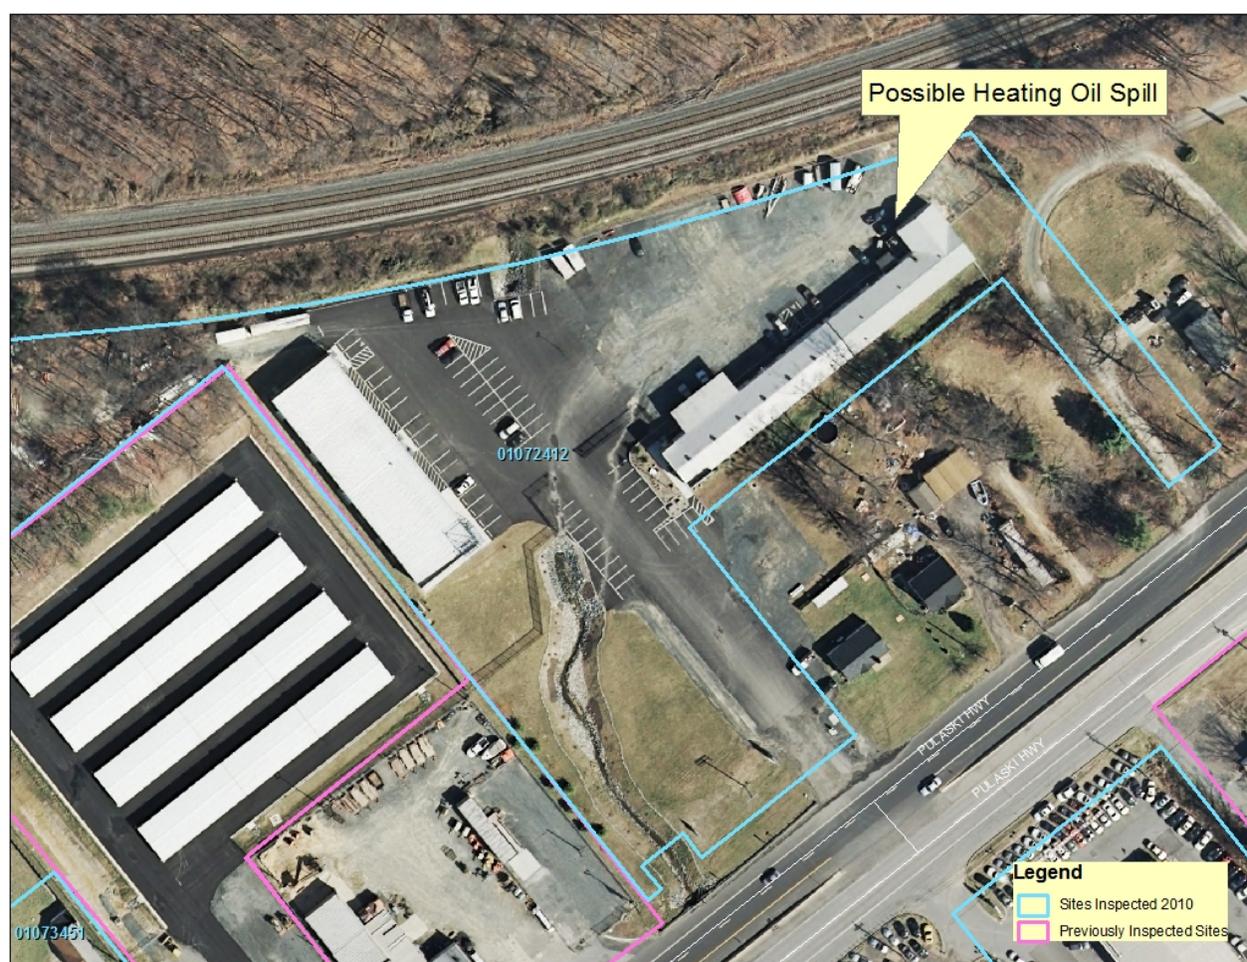
During facility inspections, a Versar field team discovered recent pollution on a parcel located at 2710 Pulaski Highway (Imark Builders) on December 15, 2010. The pollution source appeared to be a recent oil spill near a heating oil tank. Versar contacted Harford County to report the problem on December 16, 2010. An aerial map of the 2710 Pulaski Highway property is shown in Figure 3-2. Harford County personnel performed a site inspection on December 22, 2010. They were unable to contact the business owner. The MDE Oil Control Program was contacted by County personnel. They took over the follow-up investigation and clean-up of the site.

Figure 3-2. Pollution source found at 2710 Pulaski Highway (parcel 01072412).

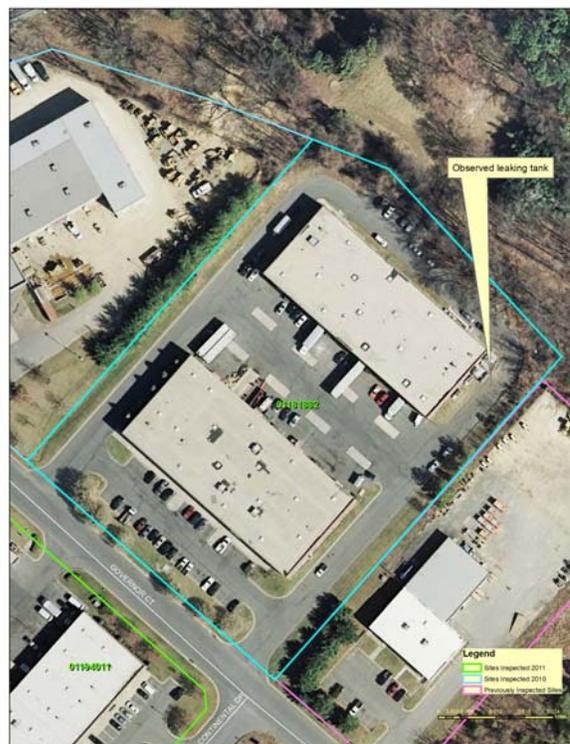
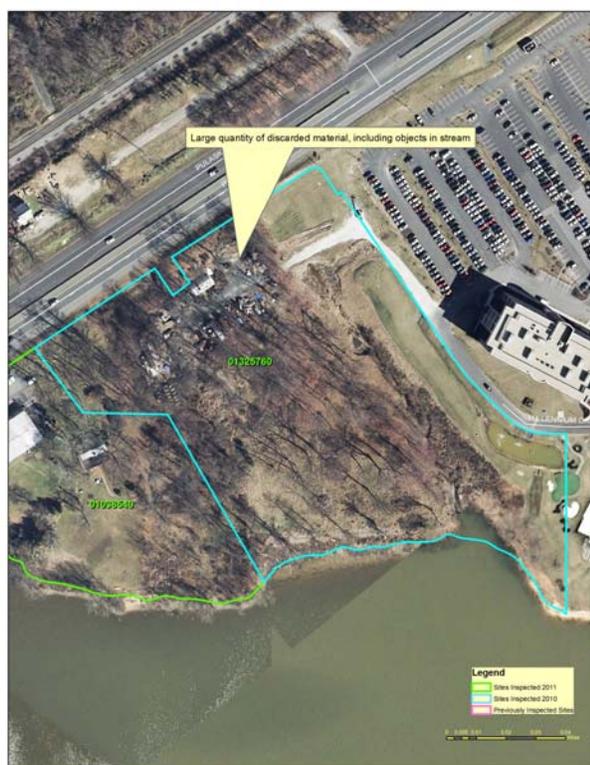
3.2.1 DuClaw Brewery, 1305 Governor Court, Abingdon, MD

Versar inspected the parcel on December 13, 2011. The parcel contained several businesses, but the entire parcel was evaluated. Field staff noted that a storage tank that appeared to be affiliated with DuClaw Brewery was leaking a substance that was tentatively identified as product (beer). Versar reported the hotspot to Harford County via e-mail on December 14, 2011. A secondary issue noted on the site was that the storm drain system did not have an outlet. Harford County visited the site on December 15, 2011 and spoke with business staff, who stated that the leaking tank was actually a garbage compactor. The County will follow up with the owner to determine whether the compactor is being used and whether it can be scrapped.

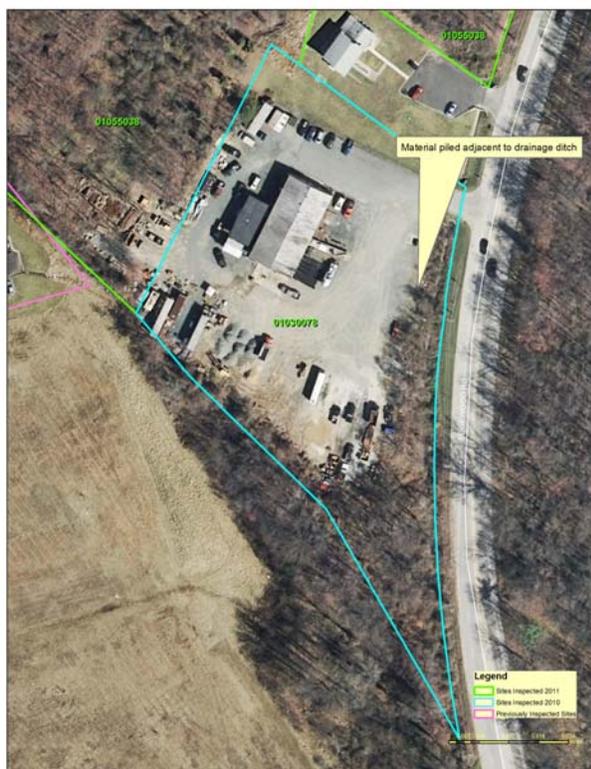
3.2.3 Stella May Contracting, 1512 Edgewood Road, Edgewood, MD

Versar inspected this business on December 29, 2011. Among the several issues identified on the parcel (uncovered outdoor fueling areas; stone, gravel, and other construction materials stored in open; open dumpsters), field staff noted that there were materials stored adjacent to a drainage ditch that runs between the parcel and Edgewood Road. This business had been classified as a “potential” hotspot immediately after inspection, but was later reclassified as “confirmed” upon data sheet and photograph review. Versar sent a report to Harford County via e-mail on May 1, 2012.
