Appendix E2. a – Restoration Plans and TMDLs (Impervious Area Assessment)

Impervious Area Assessment

Harford County, MD Department of Public Works
 Watershed Protection and Restoration
 Watershed Restoration Status (MS4 Permit 11-DP-3310)

Stormwater and stream restoration - inspections FY2020

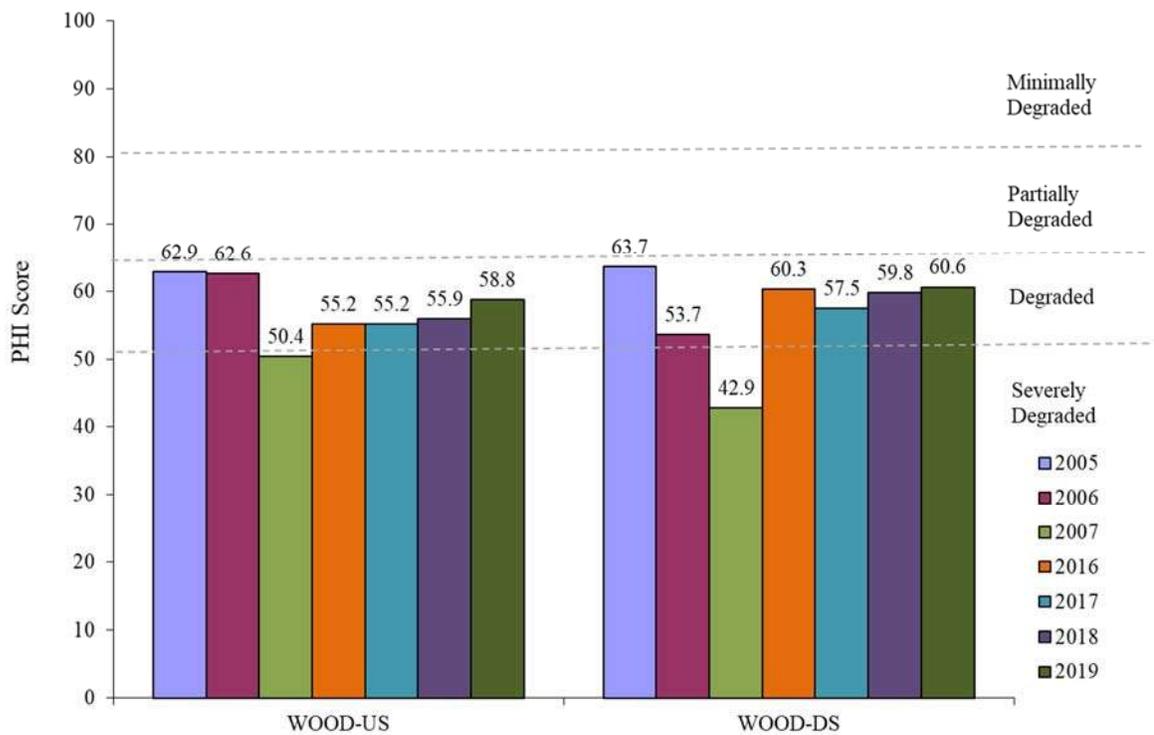
Figure 3 Comparison with Pre-Construction (2005-2007) and Post-Construction (2016-2019) PHI Scores

A comparison of post-construction PHI results from 2016 to 2019, to pre-construction data from 2005 – 2007 is presented below in Figure 3. Regarding the PHI scores, both sites remain relatively stable when compared with pre-construction conditions, with most years within the ‘Degraded’ category. However, habitat scores continued to improve slightly between the 2018 and 2019 surveys. It is likely that the PHI scores will improve once the vegetation becomes established, improving shading and woody input to the stream channel, however this process will take several more years. Both sites have shown improvements in regard to habitat conditions when comparing the post-construction assessment results with the 2007 pre-construction data (Figure 3). Habitat data sheets can be found in Appendix B

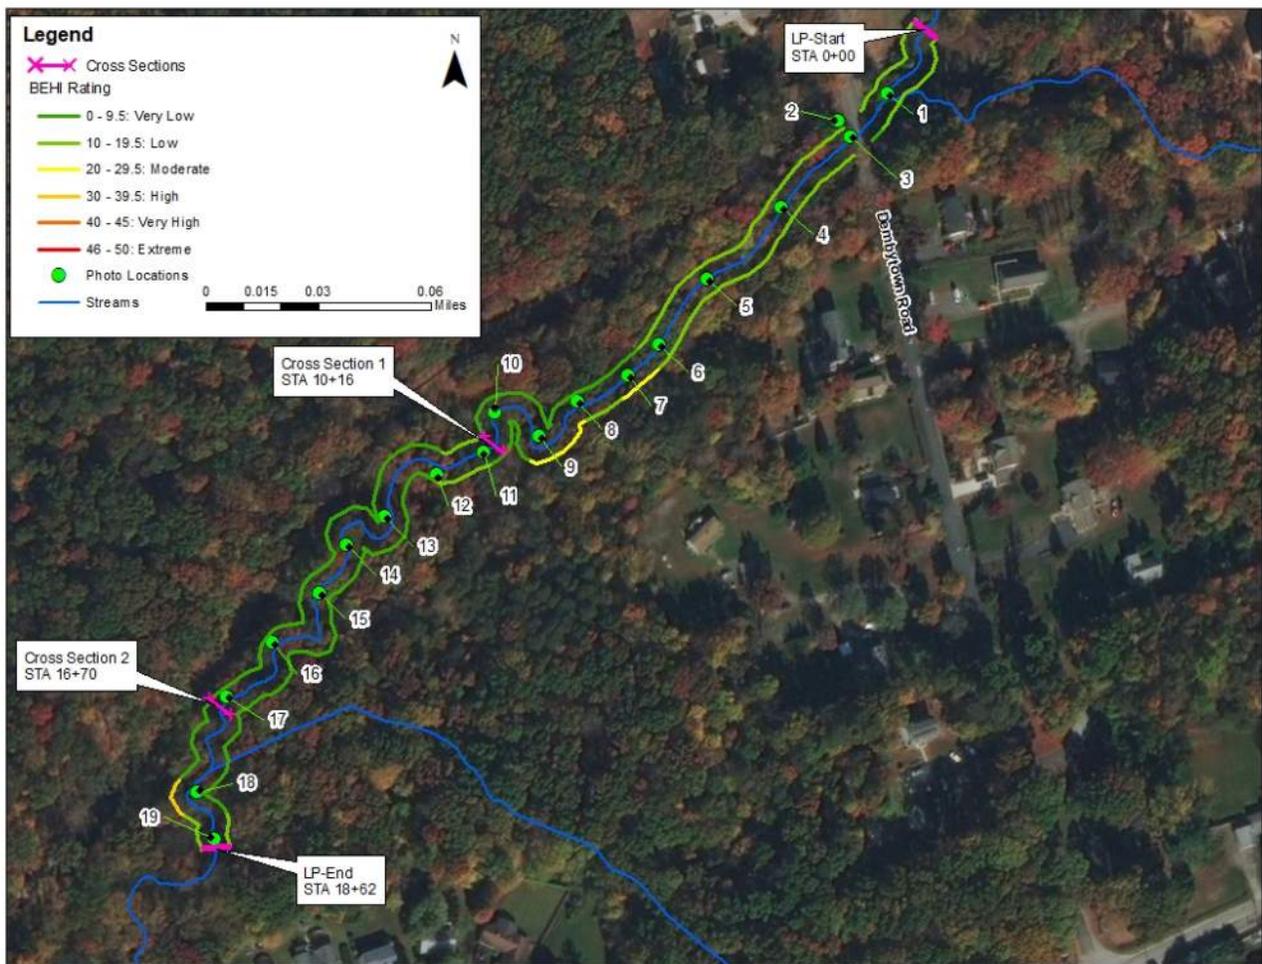
Figure 4 – BEHI analysis

The BEHI analysis demonstrates that the study area is not highly susceptible to lateral erosion. A BEHI score of 'Moderate or Better' is required and the majority of the site resulted in a rating of 'Low' or 'Very Low'. Figure 4 shows a map of the BEHI scores along the entire restoration length. Two short reaches in the middle of the restoration rated 'Moderate,' primarily due to the lack of a top of bank (the stream flowed against the edge of the valley). In addition, one short reach near the downstream extent of the restoration rated 'High' due to a newly fallen tree creating a raw bank without vegetation. This isolated section is very short compared to the overall length of restoration and overtime the bank will likely self-heal and vegetation will grow in and reduce the erosion potential. Overall this restoration site is laterally stable, thus resulting in 'Low' or 'Very Low' BEHI Ratings.

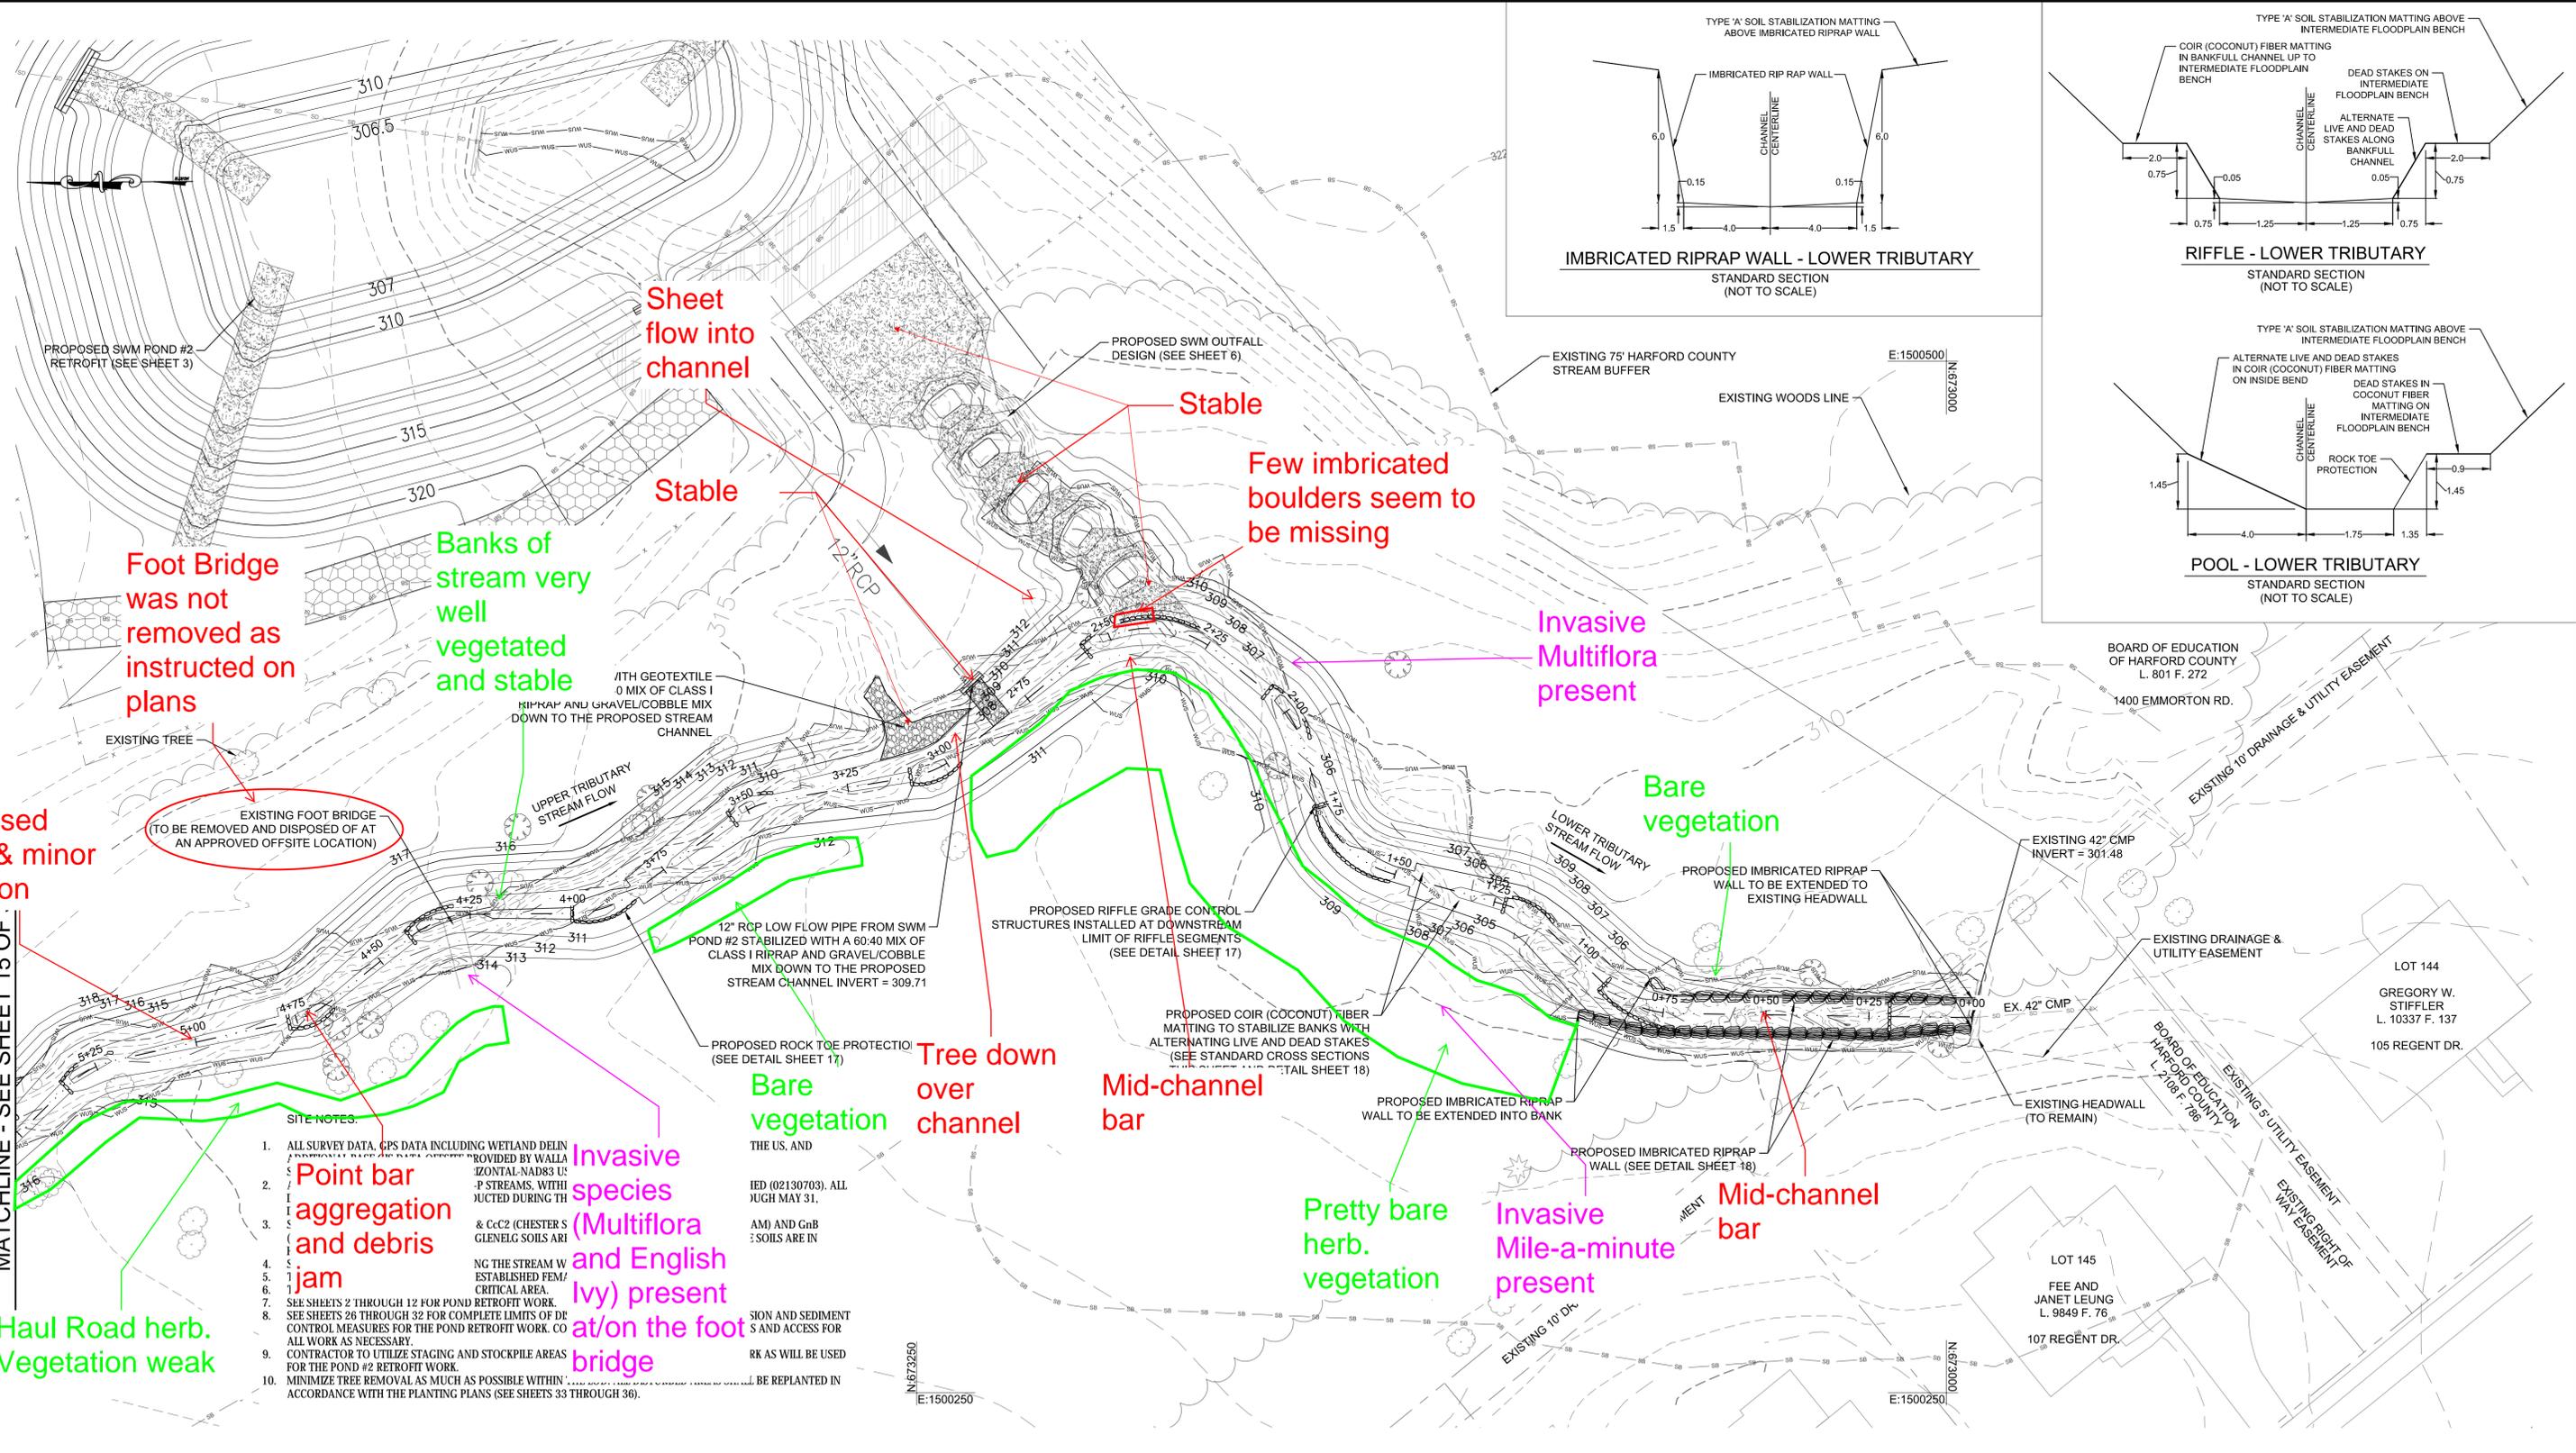
Foot Bridge was not removed as instructed on plans

Banks of stream very well vegetated and stable

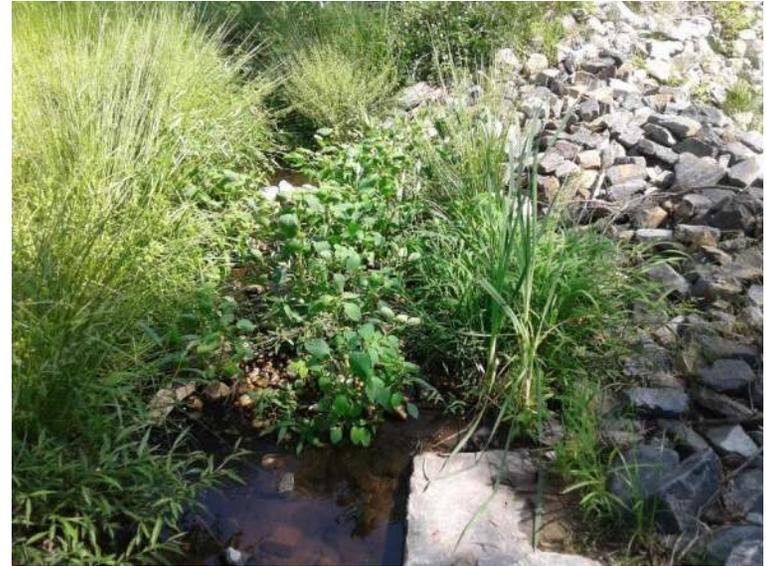
Photo 2 - Bar forming and imbricated boulders missing at station 2+45
– Moderate Concern

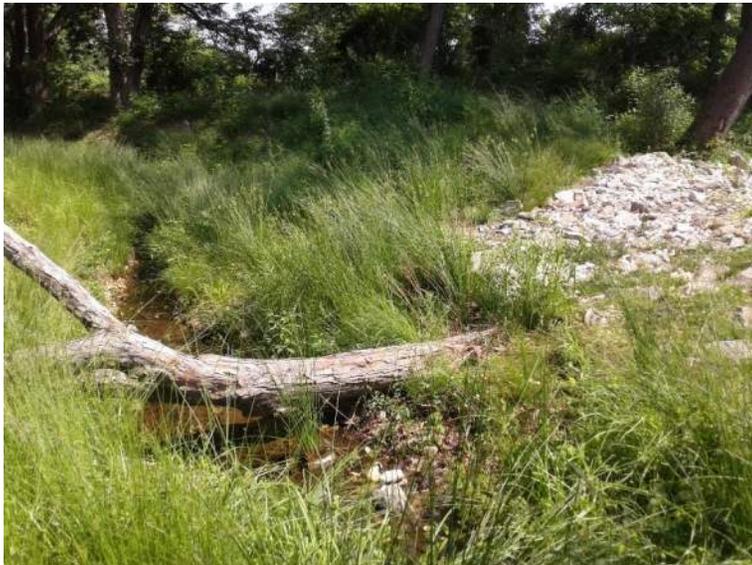
Photo 3 - Tree down across channel at station 3+00 – Minor Concern
