HARFORD COUNTY DPW

LOWER BYNUM RUN SMALL WATERSHED ASSESSMENT REPORT APPENDICES

DECEMBER 13, 2019

HARFORD COUNTY DEPARTMENT OF
PUBLIC WORKS

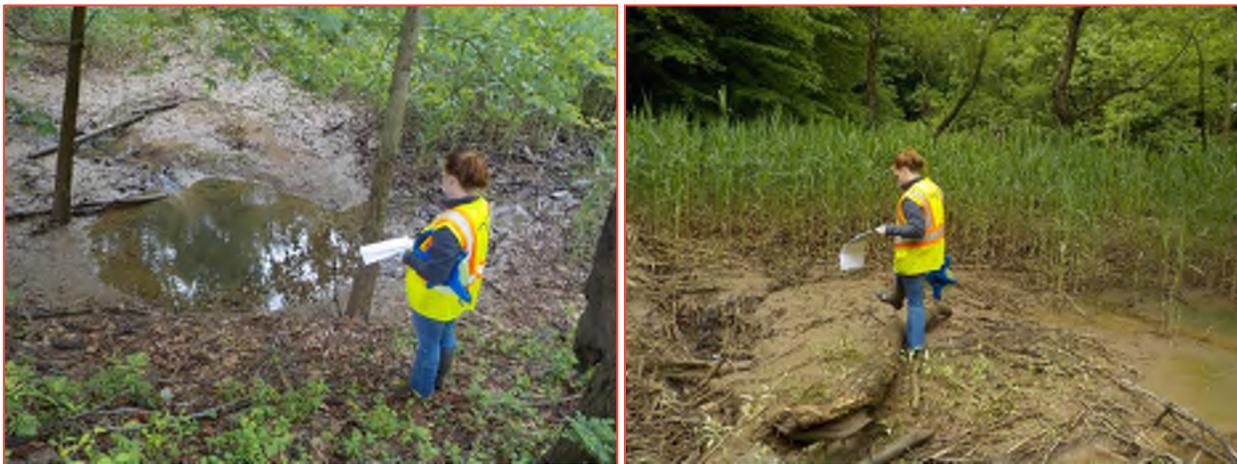
Existing SWM000058 is located at the southern end of Balmoral Drive, behind residences including 1 McGregor Way. It is within the MSB-5 subwatershed. The facility consists of a dry pond that drains into a riser control structure and discharges to a natural channel. Flow enters the facility from the east via a CMP orifice that drains into a forebay. The CMP was buried under water and sediment. A natural channel conveys flows from the south into the pond. The dry pond has major sediment build up but appears to still function.

Figure A-12. Eastern CMP inflow point and forebay (left); The channel that conveys flow to the pond (right)

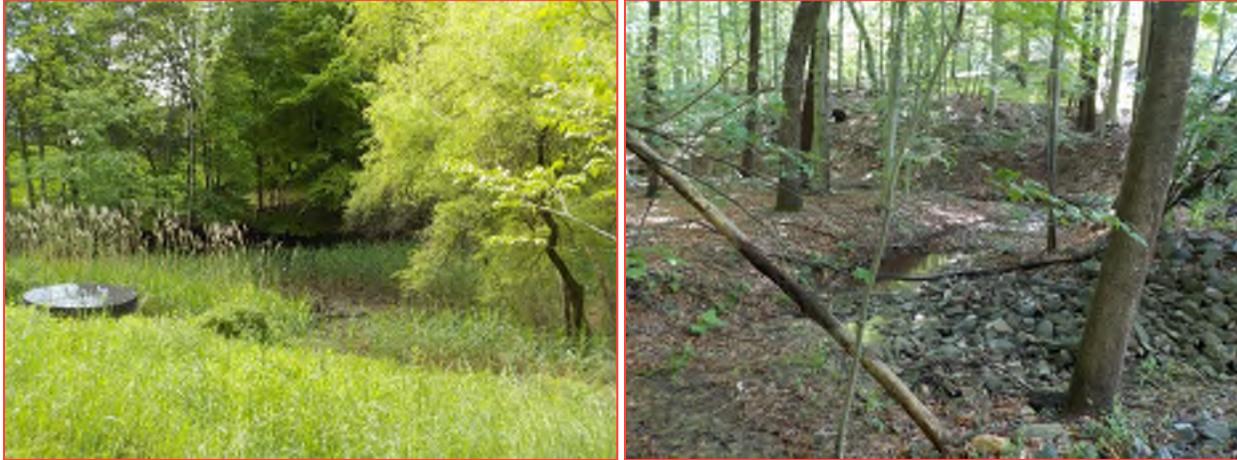
12-inch CMP dewatering device with trash rack. The pipe is buried under 3 feet of sediment and the trash rack was not located. Erosion has formed a 3-foot deep hole behind the riser. Flows discharge out of a 42-inch CMP principal spillway and into an unnamed tributary to Bynum Run. Downstream of the outfall there is moderate erosion (1 to 3 feet cuts) of the natural channel. The overall condition of the channel extending to approximately 100 feet downstream is good.

Figure A-13. Facing south towards facility and riser (left); Facing downstream at the outfall channel (right)

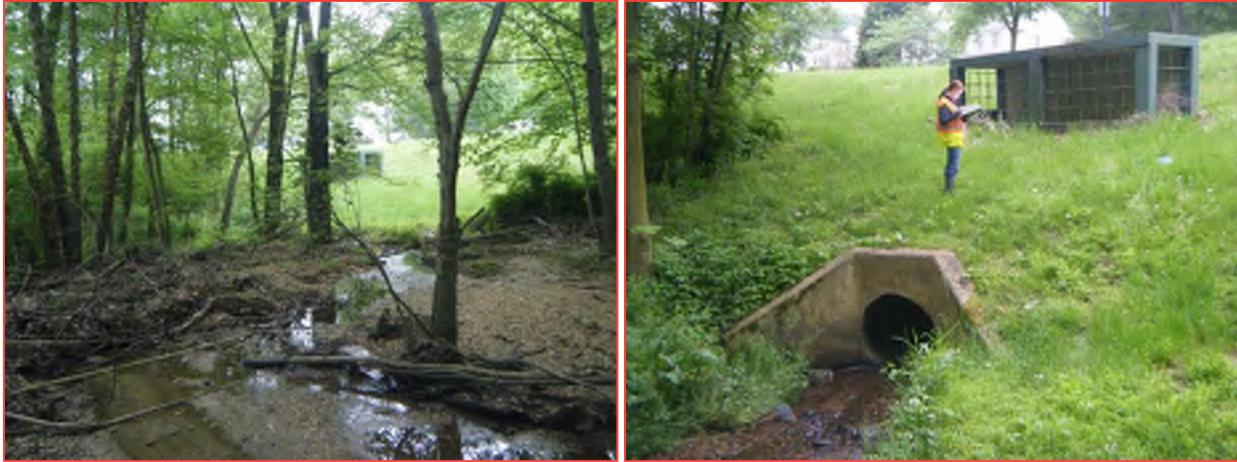
Existing SWM000163 is surrounded by residences and is adjacent to 1407 Fountain Glen Drive. It is accessible from the roadway, but vegetation is overgrown in the pond. The facility is within the MSB-6 subwatershed. It consists of two pipe inflows and a stream inflow that convey flows to a dry pond. The pond drains through a riser control structure and back into a natural channel. A 24-inch RCP conveys flows from residences from the southeast into a forebay on the northern part of the facility. The pipe is half-full of sediment. Another 24-inch RCP conveys flows from residences from the northwest into a forebay on the northern part of the facility. A small berm separates the northern part of the facility from the pond in the southern part. A natural channel conveys flows from the north. The stream is by-passing the facility, leaving little flow for the facility to treat. A portion of the roadway acts as an emergency spillway.

Figure A-27. Stream that bypasses the facility (left); Riser structure (right)

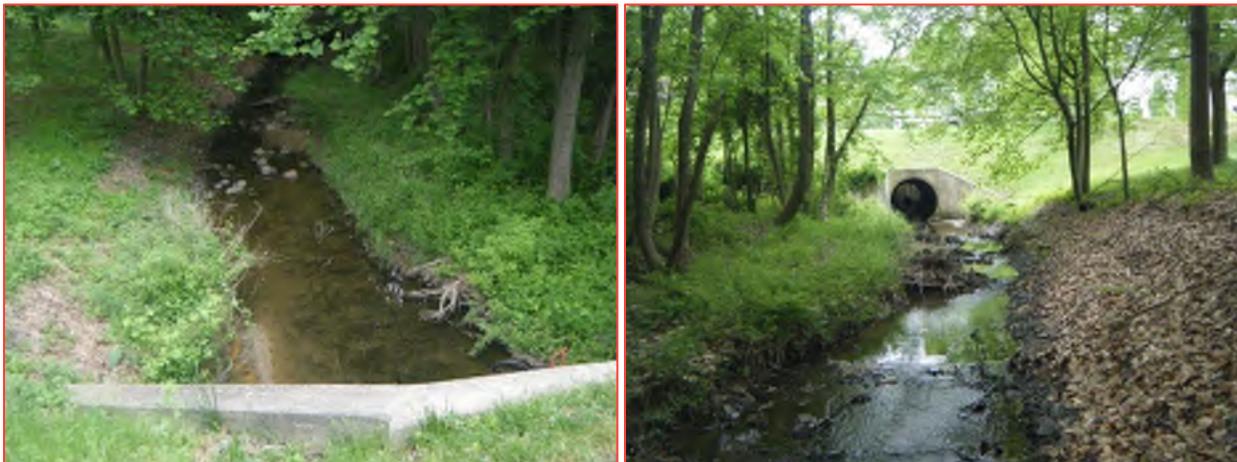
There was no rainfall observed in the area on the day of the site visit (5/23/19). There was no rainfall in the area on the two days prior to the site visit. A non-traditional, concrete riser sits at the southwestern tip of the facility. Flows enter the riser through a 36-inch RCP orifice and discharge through an 8-foot RCP principal spillway. A plunge pool exists at the outfall where flows enter an unnamed tributary to Bynum Run. The riprap/gabion section of the outfall is in good condition, and downstream of the outfall only has minor erosion.

Figure A-28. Downstream view of outfall (left); Upstream view of outfall (right)

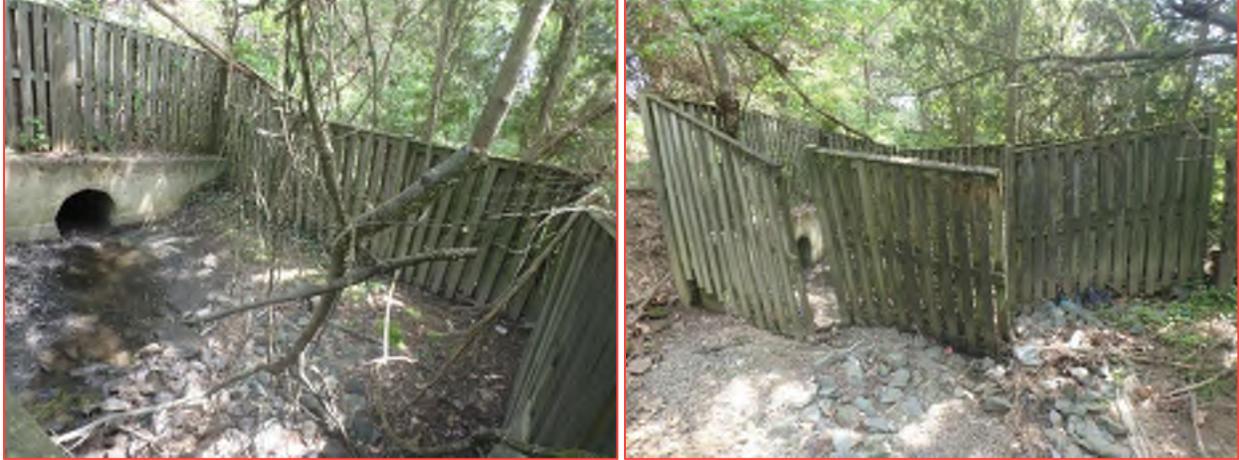
Figure A-33. Facing east towards outfall and wooden privacy fence (left); Damaged part of the fence downstream of the outfall (right)

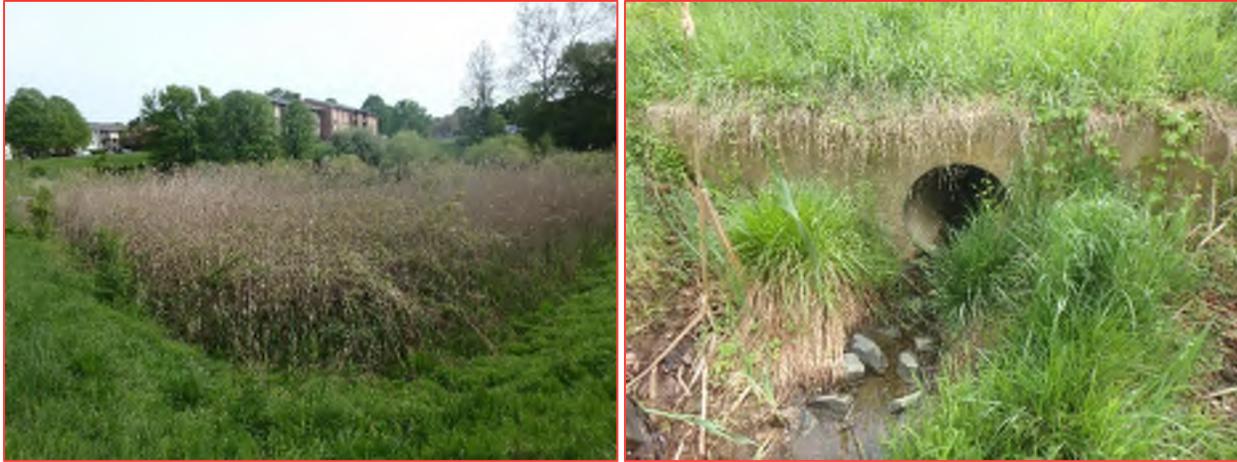
Existing SWM000203(1) is located behind the Seasons at Bel Air Apartments, 1001 Todd Road, near Royston Place. The facility is within the MSB-6 subwatershed. One 30-inch corrugated metal pipe with a concrete headwall conveys flow from a storm sewer system to the northwest. An additional 30-inch CMP with headwall conveys flows from the storm sewer system to the northwest. The inner pipe shows deterioration including rusting and loss of material. The facility discharges through a concrete riser structure with a 30-inch CMP principal spillway to a drainage channel discharging to Bynum Run to the southwest. The riser contains a low-flow orifice which was visibly flowing during the field visit. The facility is classified as a dry pond. Less than half a foot of standing water was observed within the facility.

Figure A-35. Facing northeast towards facility (left); Damaged 30-inch CMP inflow pipe (right)

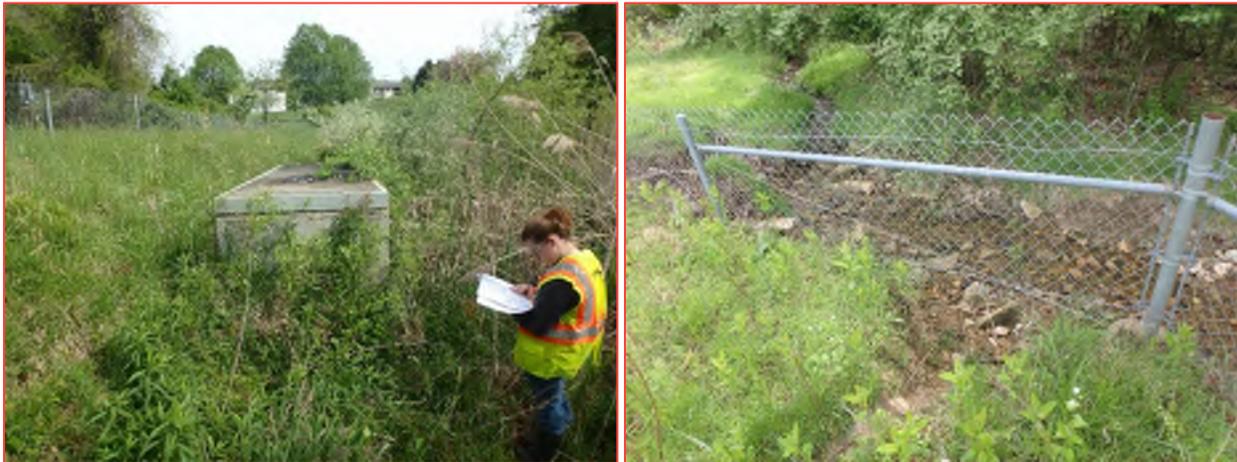
Figure A-36. Riser structure and embankment behind it (left); Erosion from stream under facility's outer fence (right)

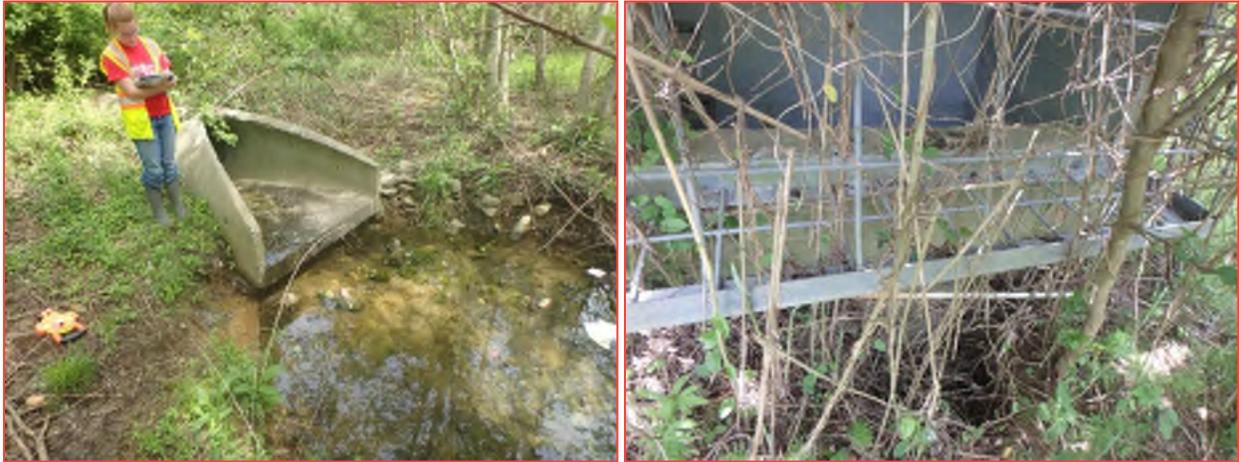
Figure A-37. 30-inch RCP at northern end (left); Riser structure with overgrown plants (right)

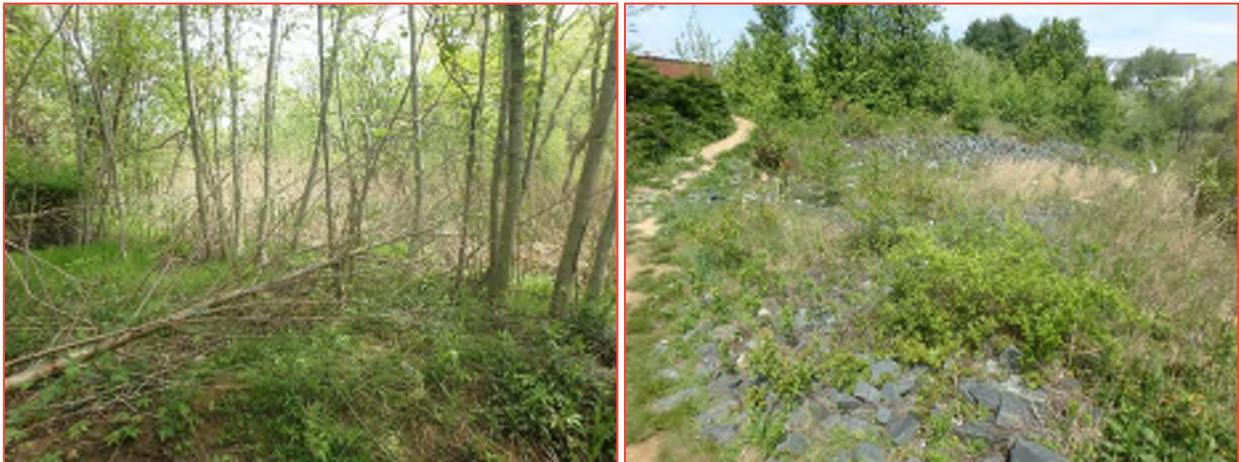
Figure A-38. Overgrown plants in facility (left); Emergency spillway (right)

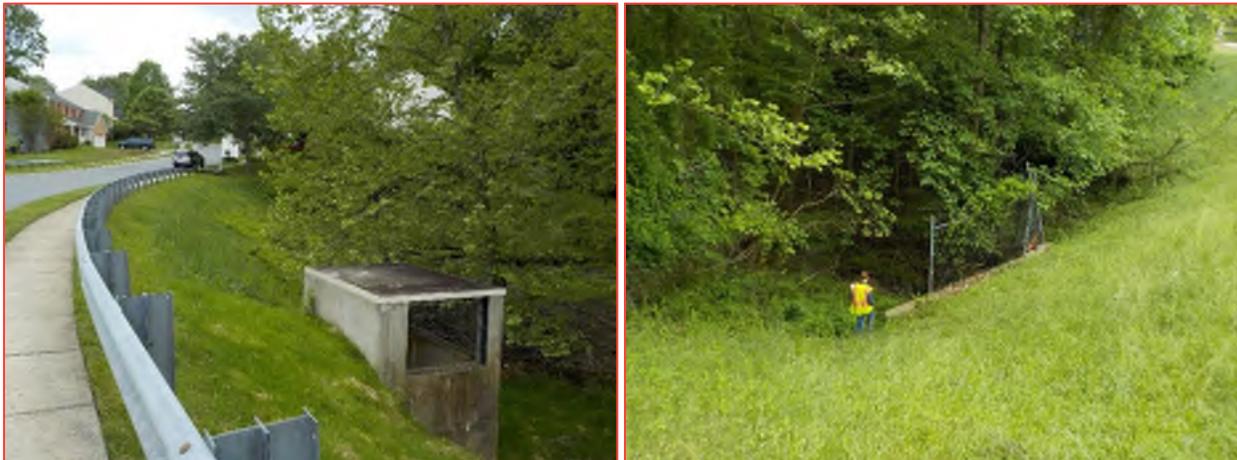
There was no rainfall observed in the area on the day of the site visit (5/14/19). There were 1.45 inches of rainfall in the area on the two days prior to the site visit. The concrete riser structure sits at the southern border of the facility, next to David Drive. Flows enter the riser through an 18-inch vertical CMP with trash rack. There is a small chain link fence around the orifice. Sediment and sticks were covering the orifice. Flows discharge through a 66-inch CMP that conveys flows under David Drive and into an unnamed tributary to Bynum Run. Large amounts of sediment are transported downstream through the riser. The immediate outfall area extending to approximately 100 feet downstream is in good condition. Downstream channel past 100 feet has 2 to 3-foot cuts and 6 to 7-foot bank erosion.

Figure A-55. Slope from David Drive to riser structure (left); Slope from David Drive to outfall (right)

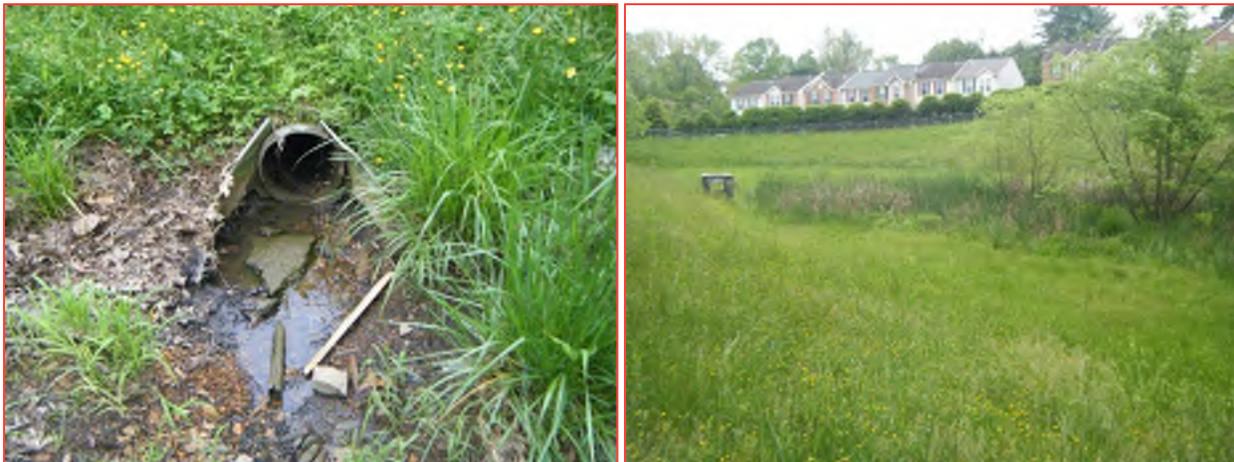
Figure B-13. Rusted 18-inch inflow pipe (left): Facility view from emergency spillway (right)

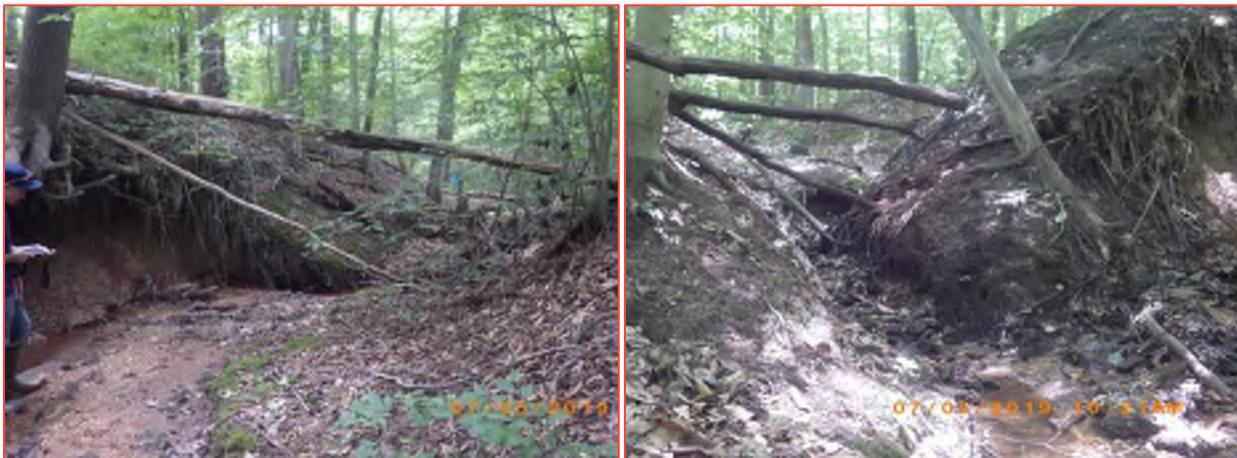
Figure C-1: Left bank severely eroded (left); Left and right banks are severely eroded and channel is dry (right).

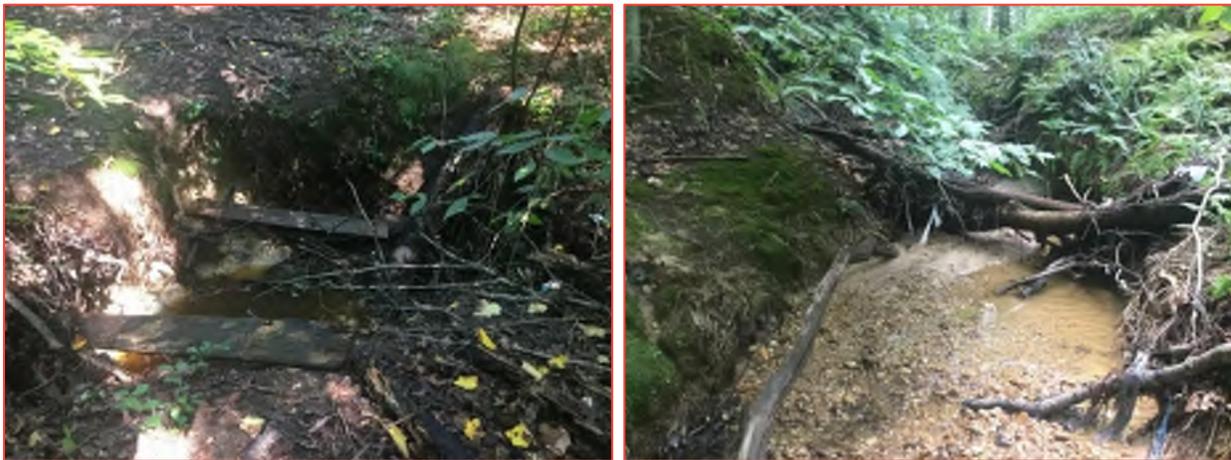
Figure C-6: Start of severe left bank and moderate right bank erosion within MSB-2B (left); Deposition and debris jams (right)

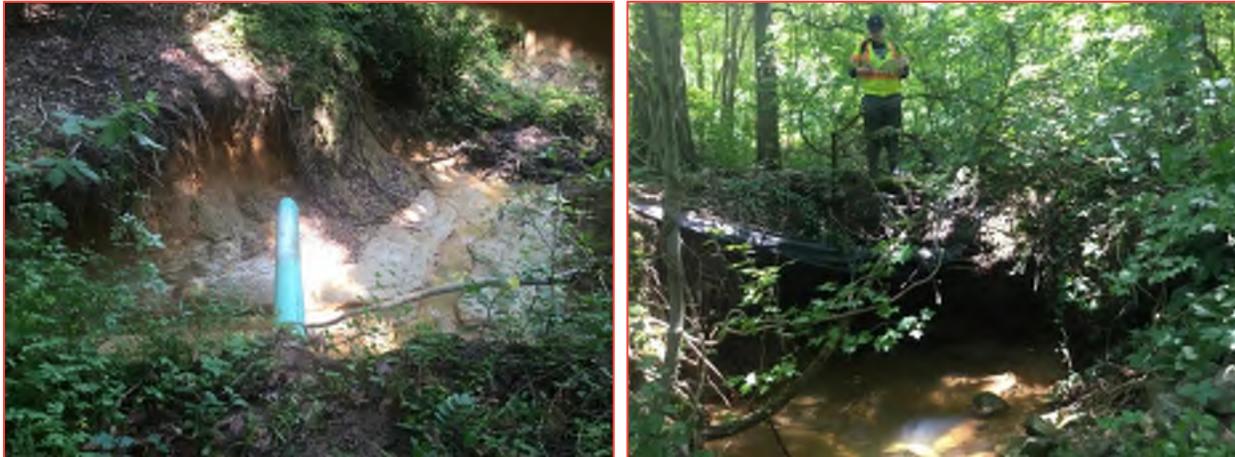
Figure C-7: Severe erosion around overflow pipe, Outfall 18 (left); Headcut at the intersection of the channel of Outfall 23 with the main stem (right).

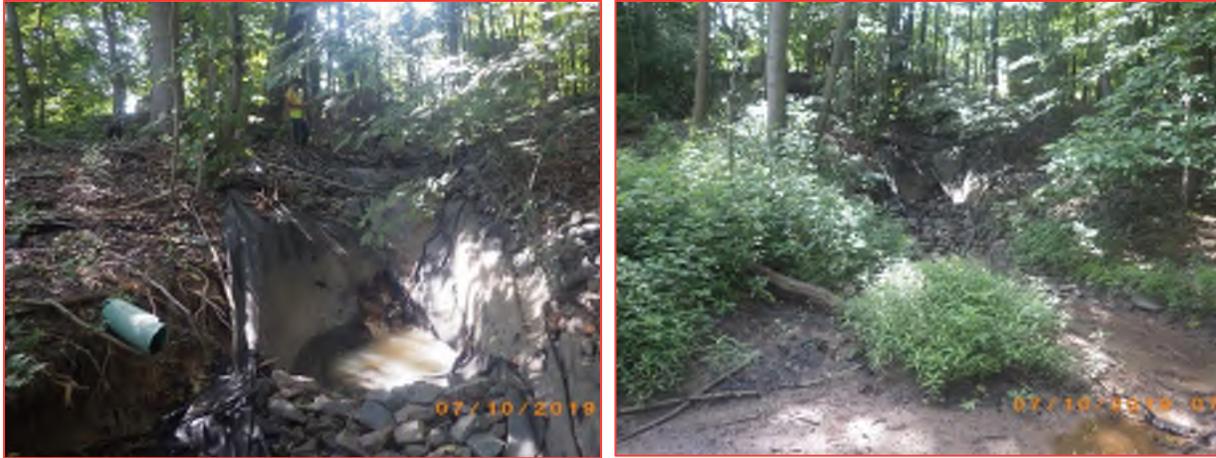
Figure C-11: Headcut and exposed geotextile (left). Outfall 17 confluence with stream (right).

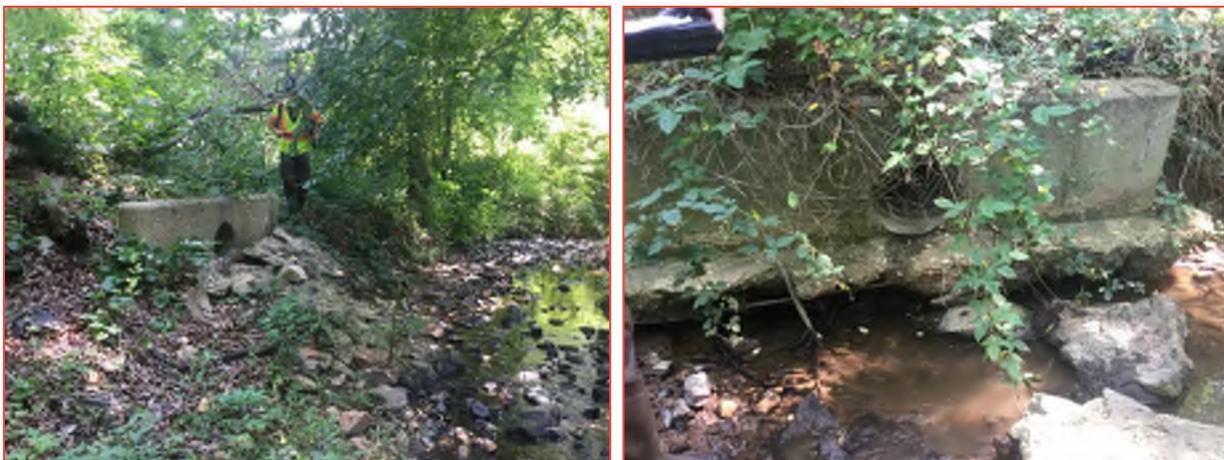
Figure C-13: Outfalls proposed for maintenance, OF-66 (left); and Outfall 68 (right)

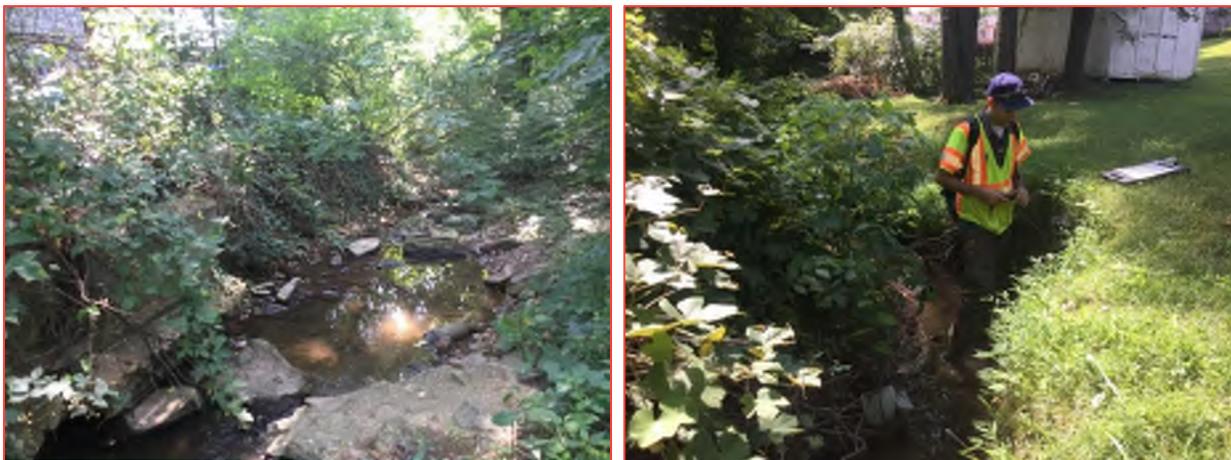
Figure C-15: Minor erosion on left bank (left) and moderate erosion on right bank (right).

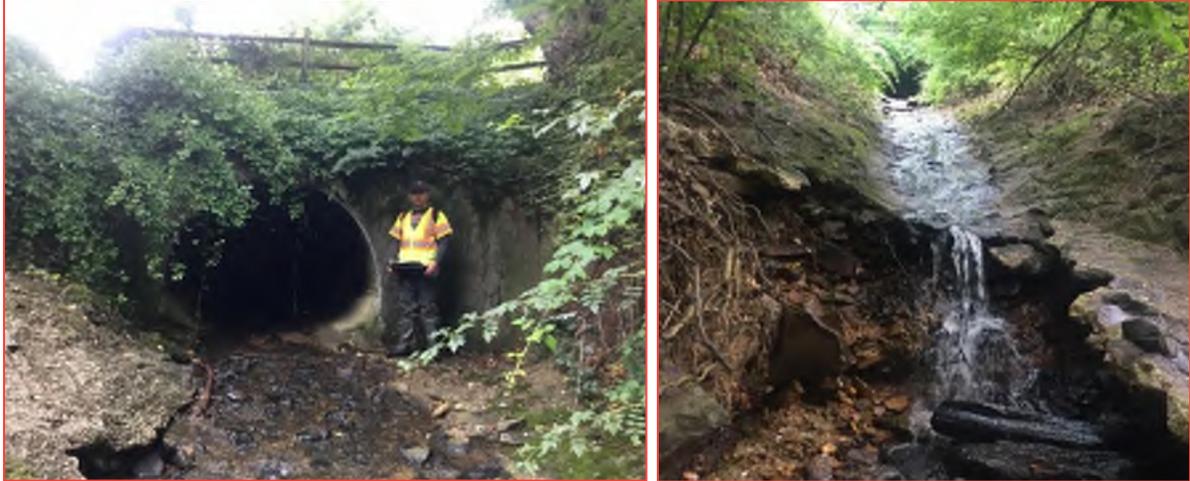
Figure C-16: Looking upstream at Outfall 71 (left); Looking upstream to Outfall 71, failed outfall protection (right).

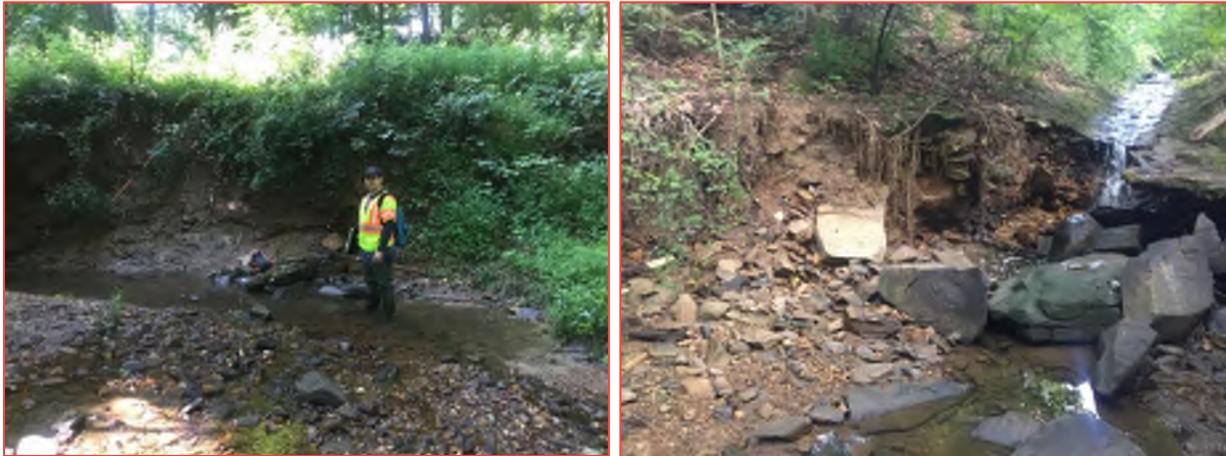
Figure C-17: Moderate erosion on the right bank downstream of the confluence (left); Moderate bank erosion on right bank further downstream (right)

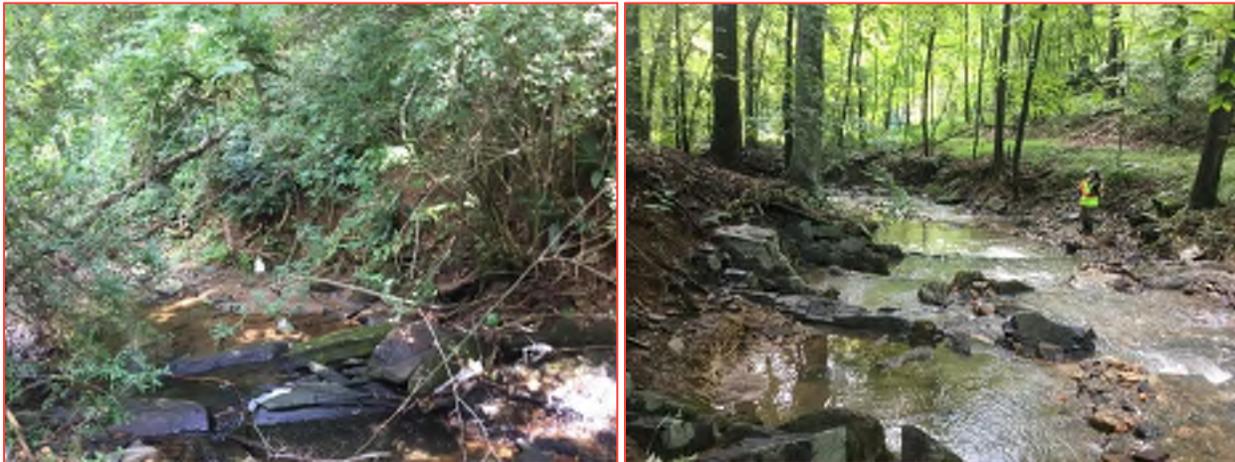
Figure C-21: Severe erosion on the right bank (left); Moderate erosion on the right bank further downstream (right).

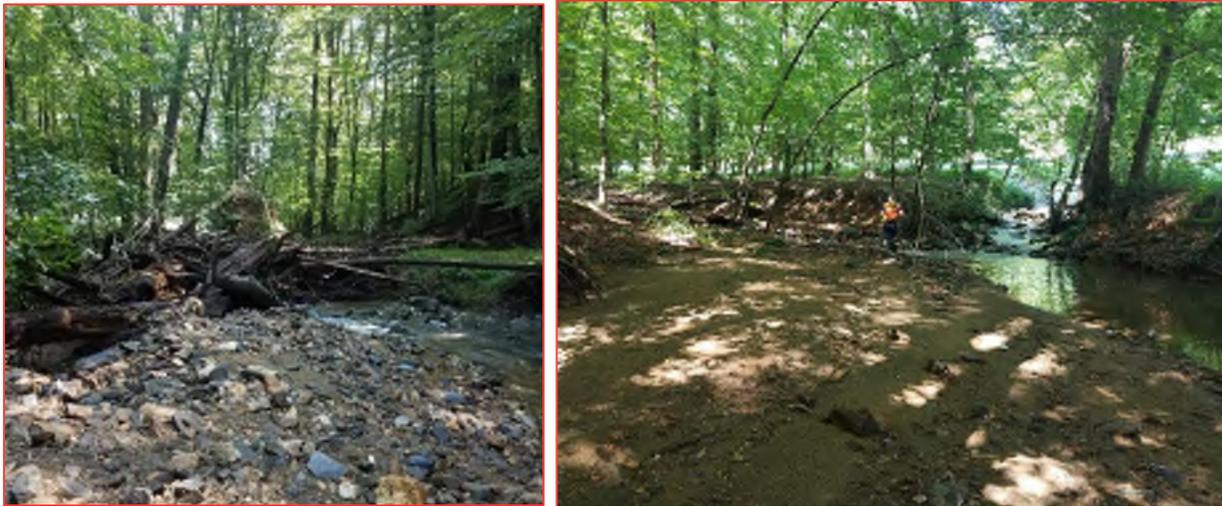
Figure C-25: Upstream view of the debris jam (left); Wide channels and significant erosion at confluence. (right)

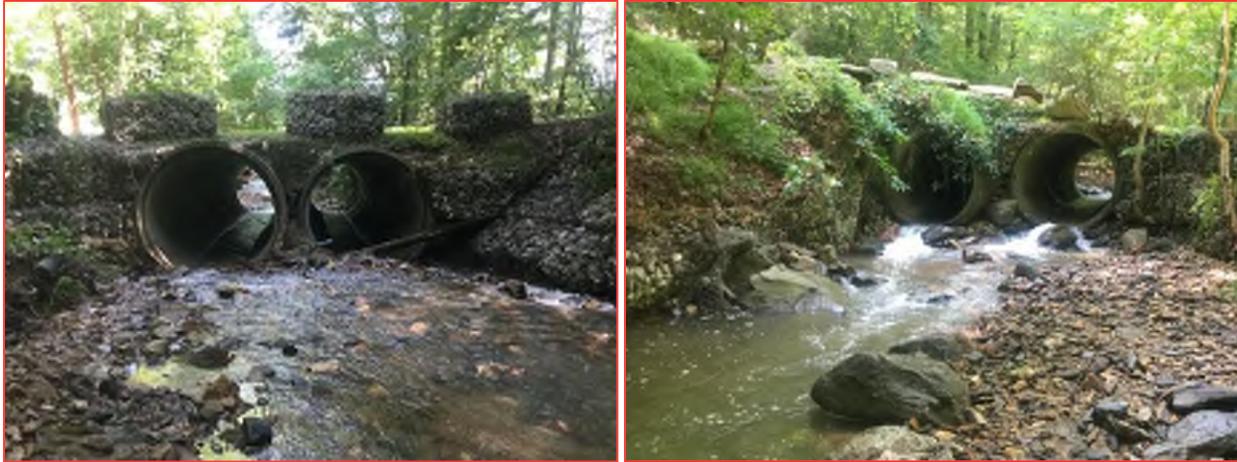
Figure C-26: Upstream (left) and downstream (right) of driveway culvert, illustrating the failing gabion baskets.

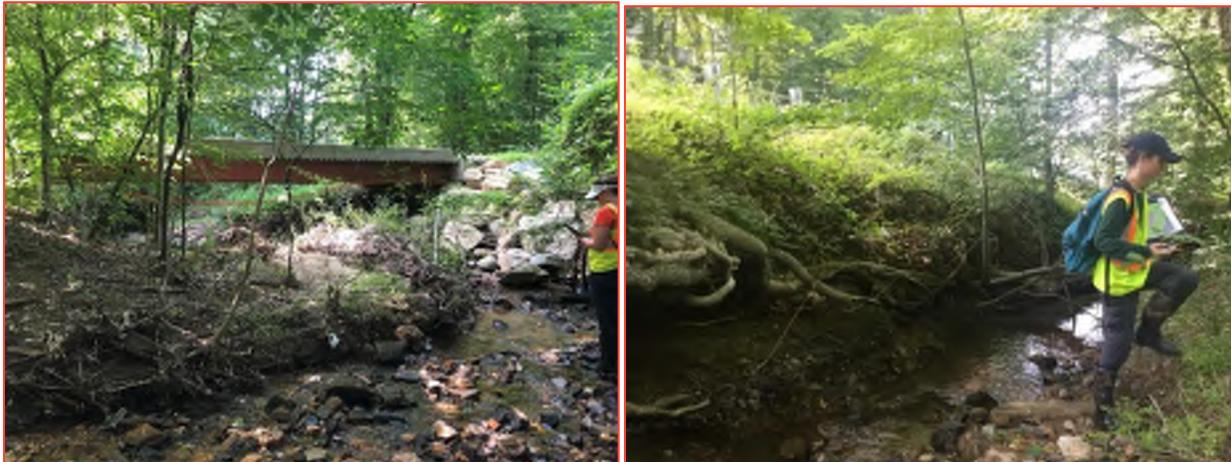
Figure C-31: Upstream view of the bridge (left); Severe erosion on the left bank (right)

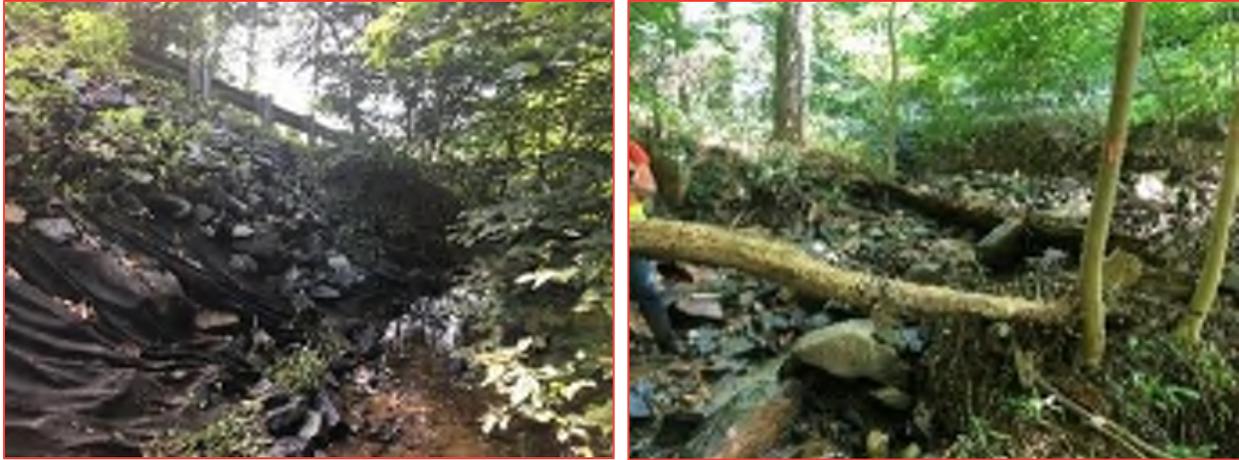
Figure C-32: Eroding banks within close proximity to the road creating a threat to infrastructure (left); Downstream view of the debris jam (right)

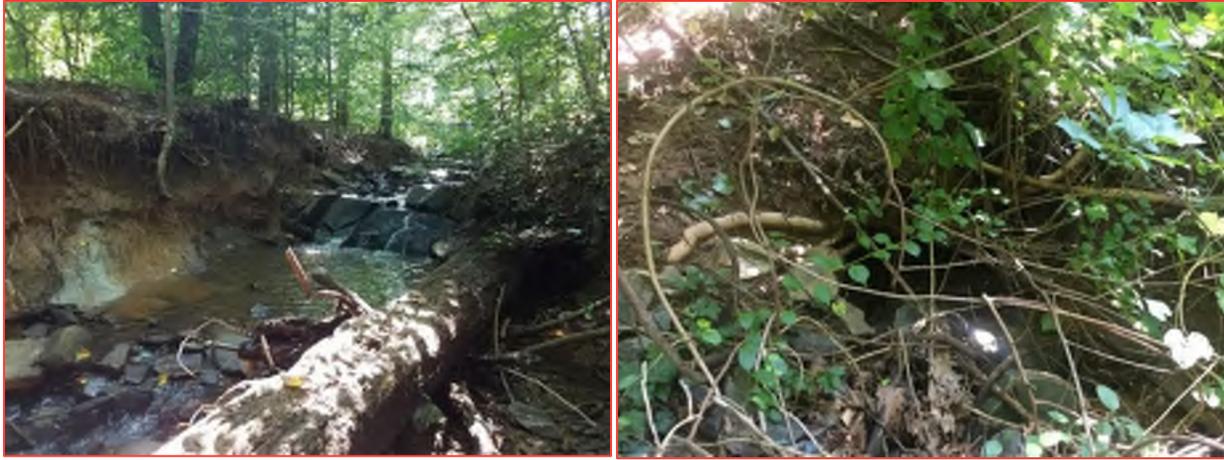
Figure C-35: Moderate erosion on right bank with exposed bedrock in the stream channel (left); Hole assumed to be OF-44 (right).

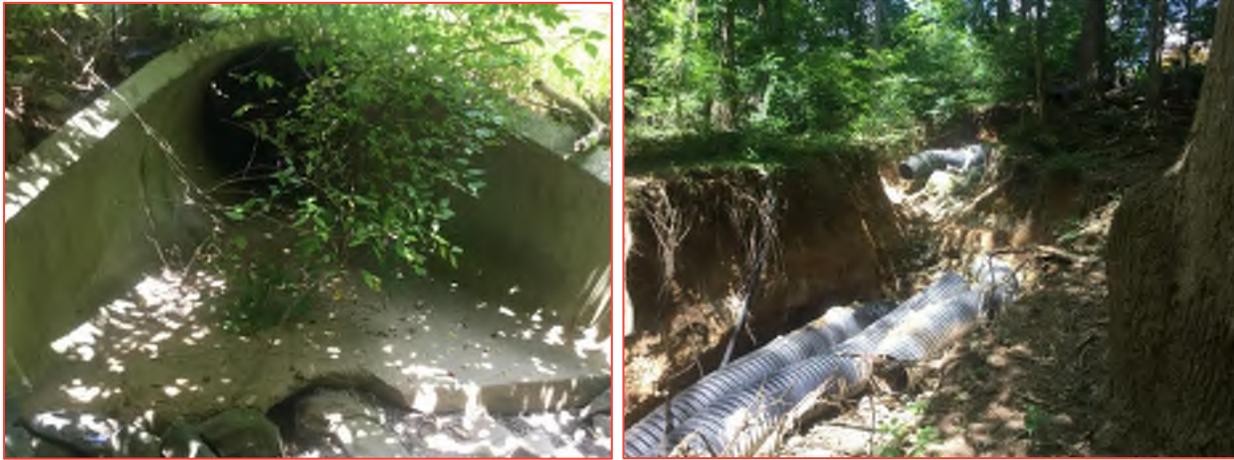
Figure C-37: Outfall 51 (left); Outfall 51's eroding channel with broken HDPE pipe scattered throughout (right).

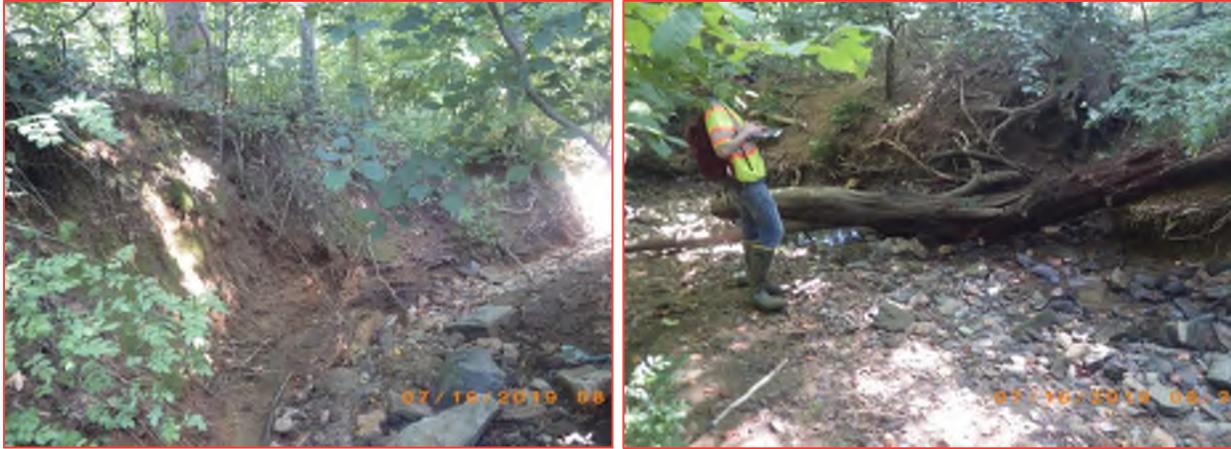
Figure C-51: Average 5-foot high exposed banks from Outfall 35 (left); Outfall 35 confluence with stream channel (right).

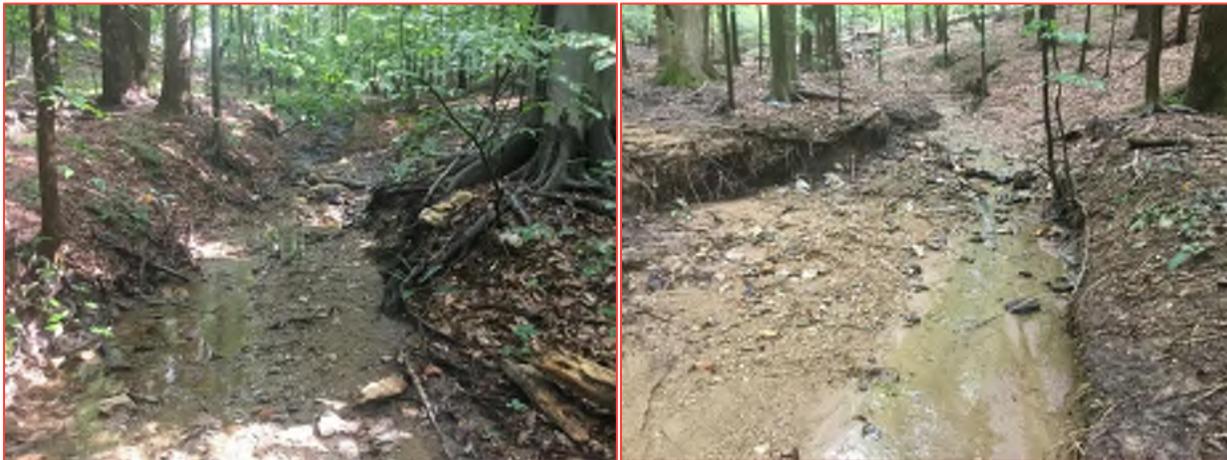
Figure C-56: Moderate erosion with 2-foot banks (left) and 1-foot banks (right)

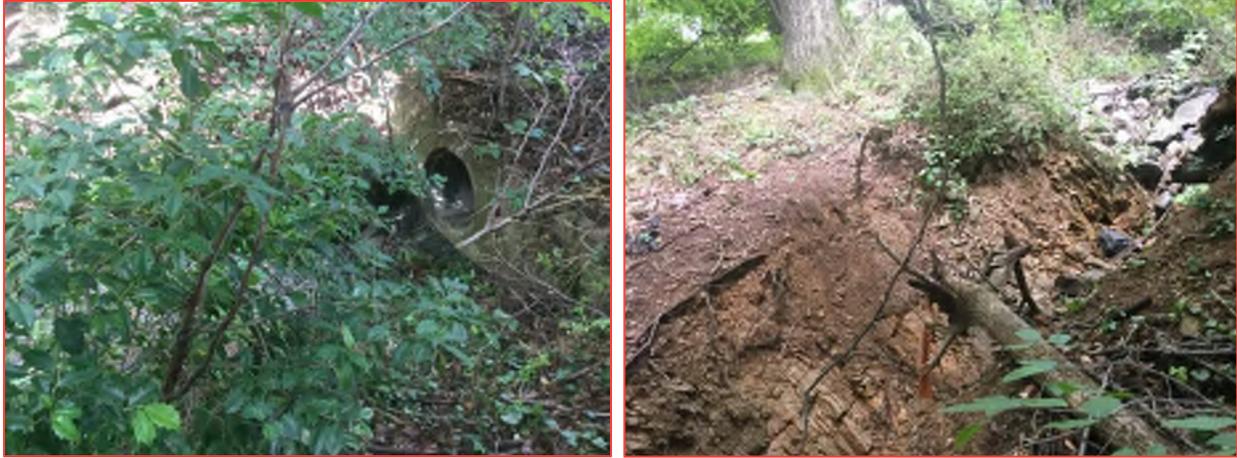
Figure C-57: Outfall 116 structure (left) and channel stabilization of 6-foot tall exposed banks with exposed bedrock (right).

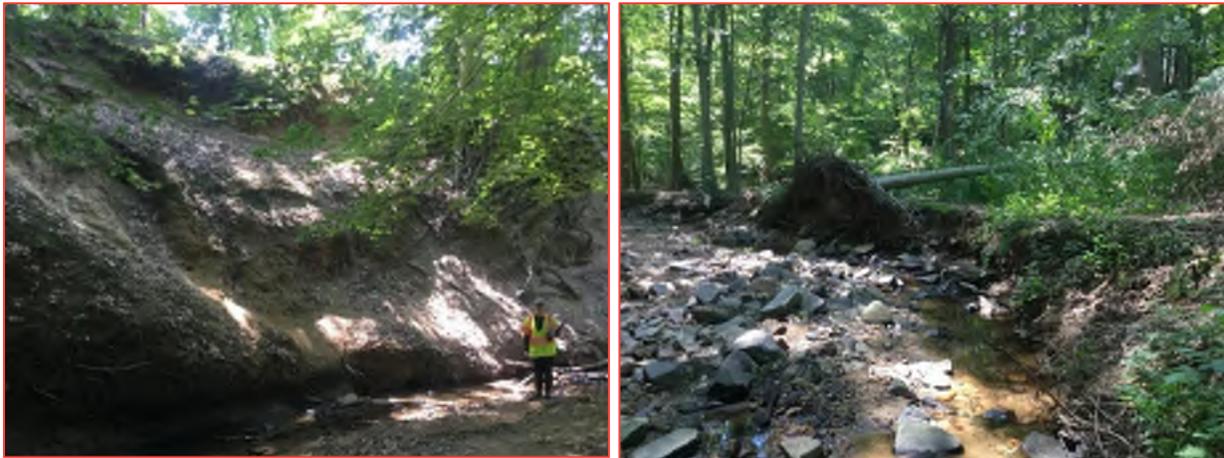
Figure C-61: Left bank severe erosion section with 15-foot average exposed bank height (left); Moderate severity erosion with 3-foot average exposed bank height at downstream limits of project MSB-5B (right).

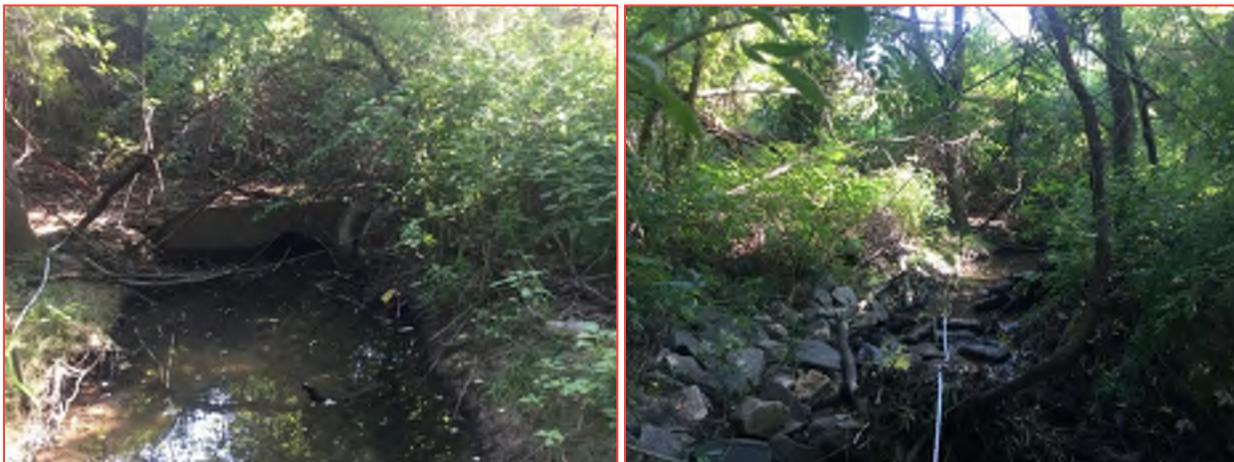
Figure C-63: Upstream view of outfall 125 structure and immediate channel protection (left); Downstream view of outfall 125 channel with debris jam in foreground and background (right).

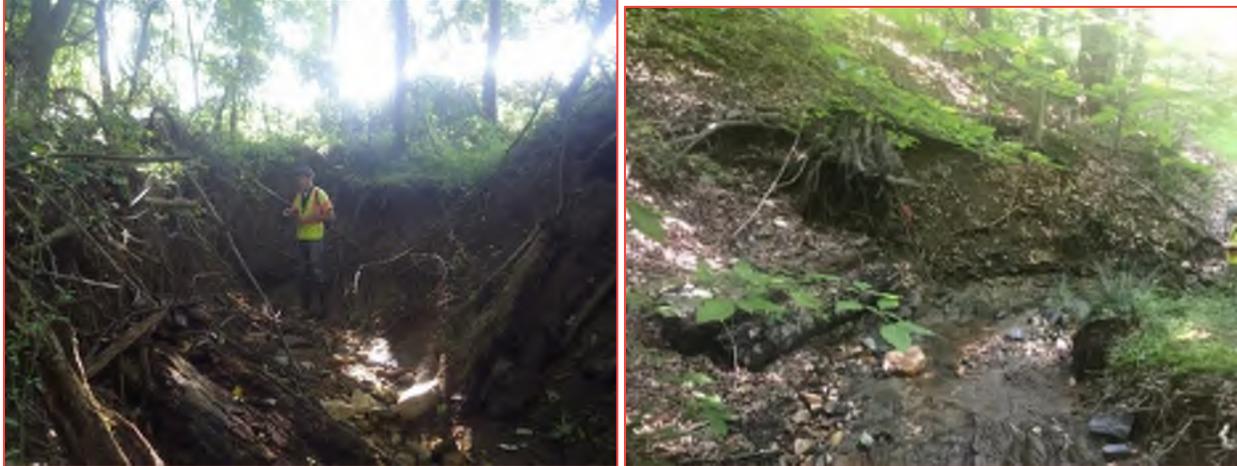
Figure C-66: Left and right bank erosion with an average exposed height of 5 feet (left); Section of average exposed banks of 3 feet on the left bank (right)

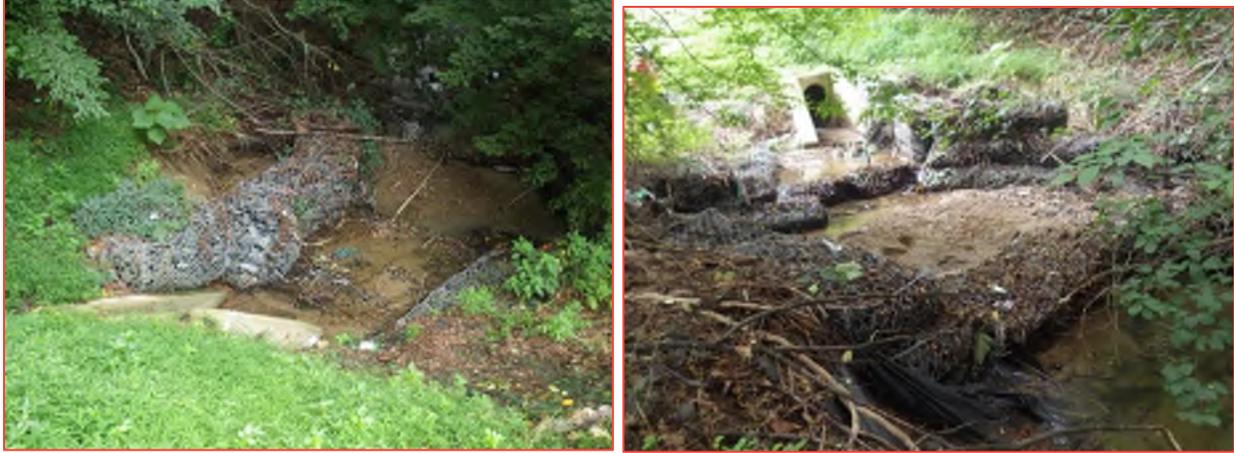
Figure C-68: Downstream view of outfall 100 with erosion behind the left bank gabion baskets (left); Outfall 100 gabion basket channel protection (right).

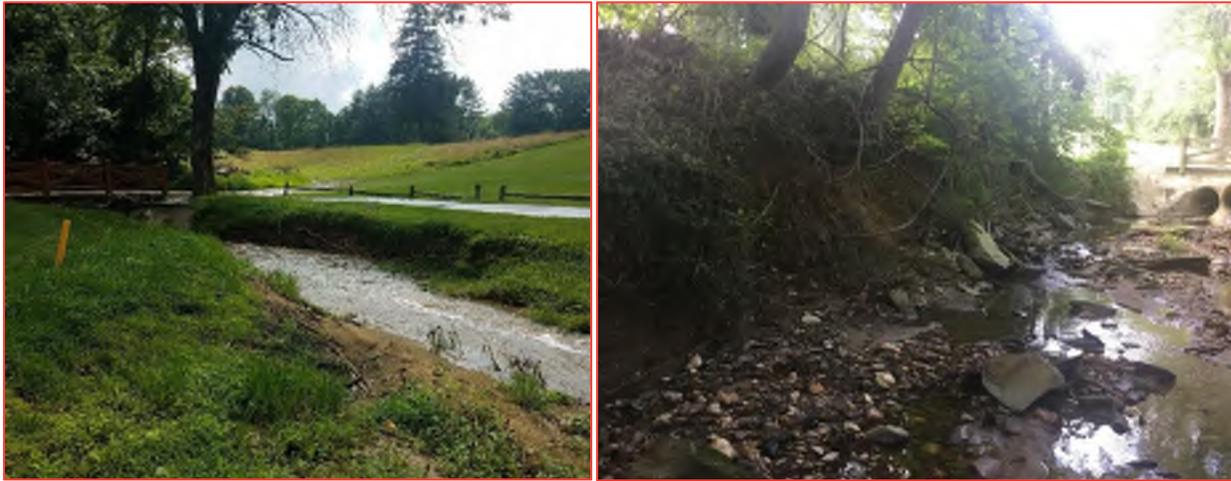
Figure C-70: Downstream view towards the channel golf cart crossing with inadequate buffer and erosion (left); five-foot exposed bank height downstream of golf cart crossing (right).

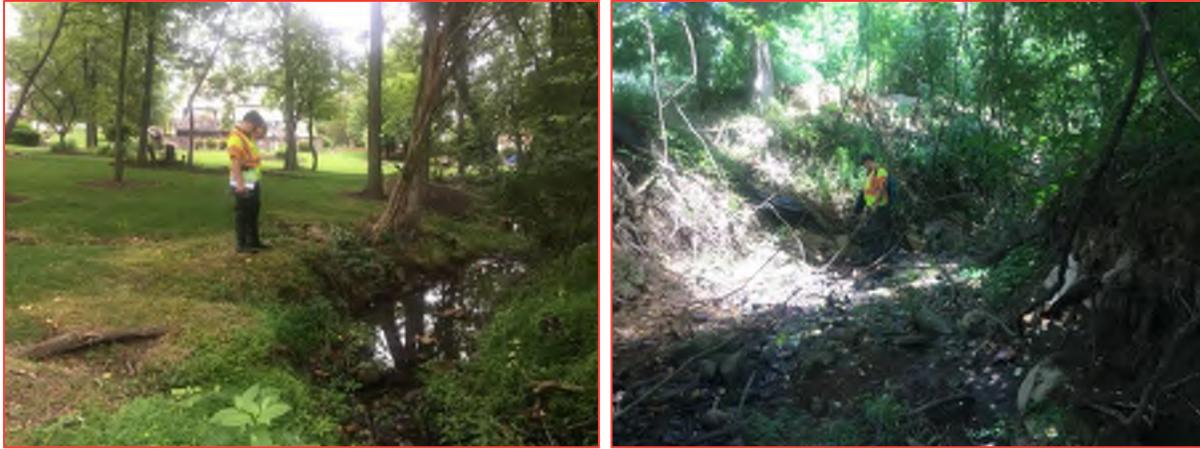
Figure C-76: Left bank moderate severity with an average of 3 feet exposed banks (left); Severe Severity Erosion on the right and left banks at 7 feet exposed bank heights (right)

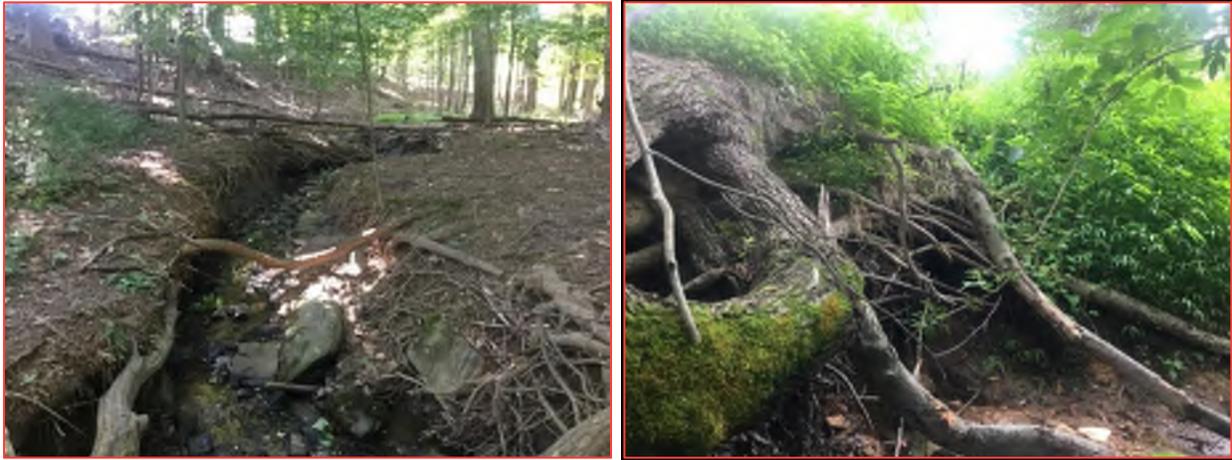
Figure C-77: Moderate eroded banks with an average exposed bank height of 4 feet in the second tributary (left); Erosion downstream of Outfall 79 at the confluence with the main stem (right)
