HARFORD COUNTY DPW

LOWER BYNUM RUN SMALL WATERSHED ASSESSMENT REPORT APPENDICES

DECEMBER 13, 2019

HARFORD COUNTY DEPARTMENT OF
PUBLIC WORKS

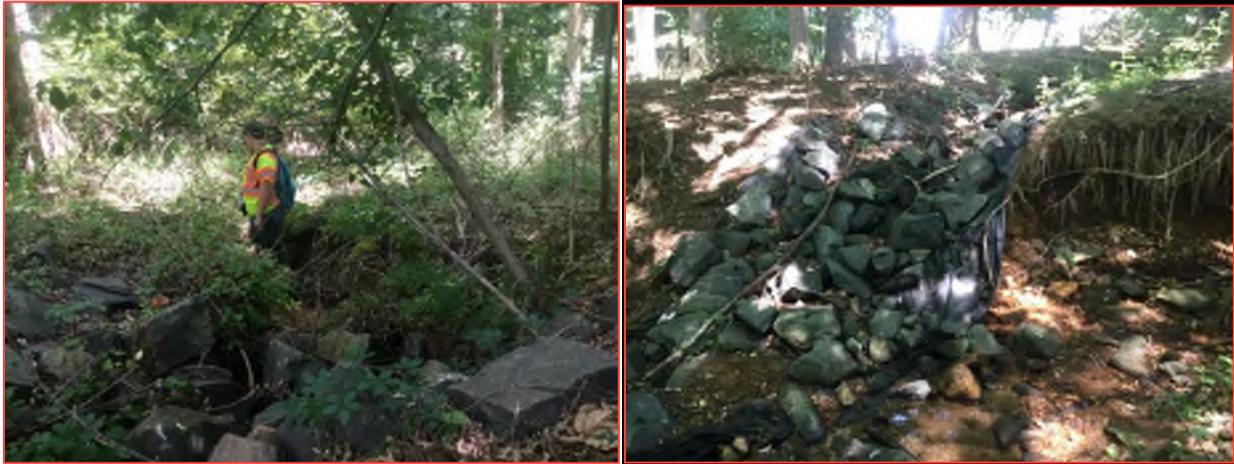
Figure C-78: 3 feet exposed banks downstream of basin outlet protection for Outfall 175 (left); Outfall 82 riprap channel protection extending to the stream channel with adjacent erosion (right)

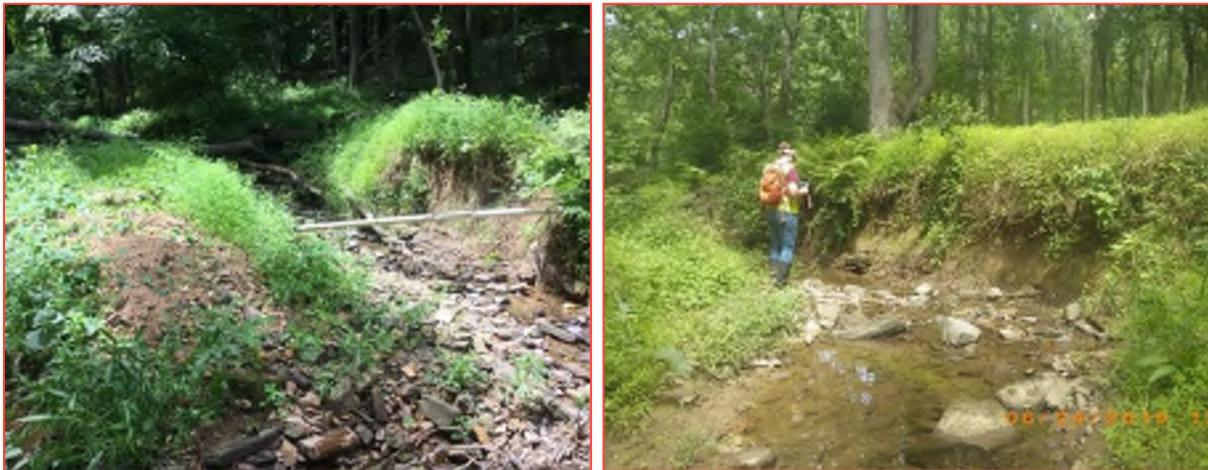
Figure C-84: 3-foot vertical exposed heights on the left and right banks and exposed pipe. (left); Right bank erosion with a height of 6 foot banks (right)

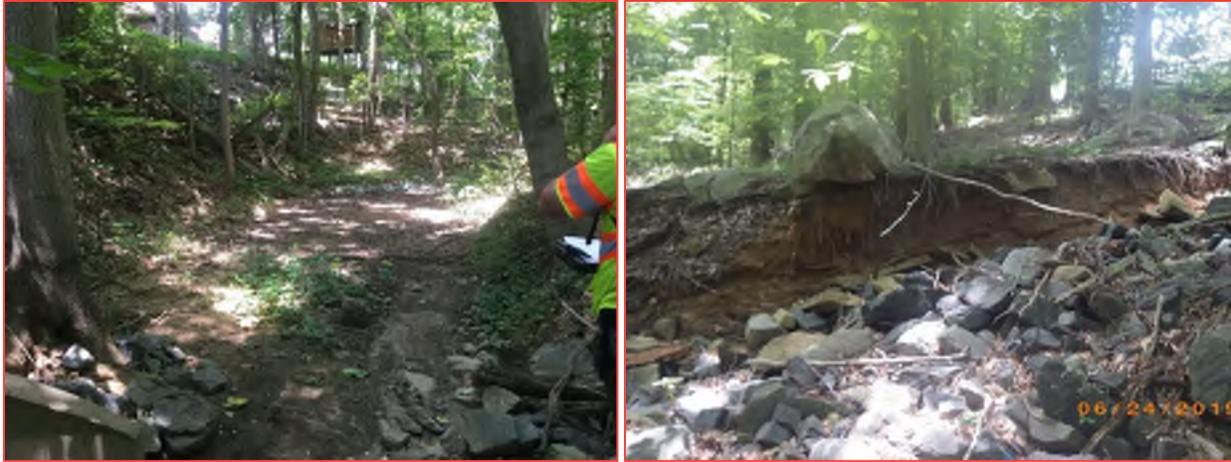
Figure C-88: Sediment basin (left); Severe erosion downstream of outfall 80 (right).

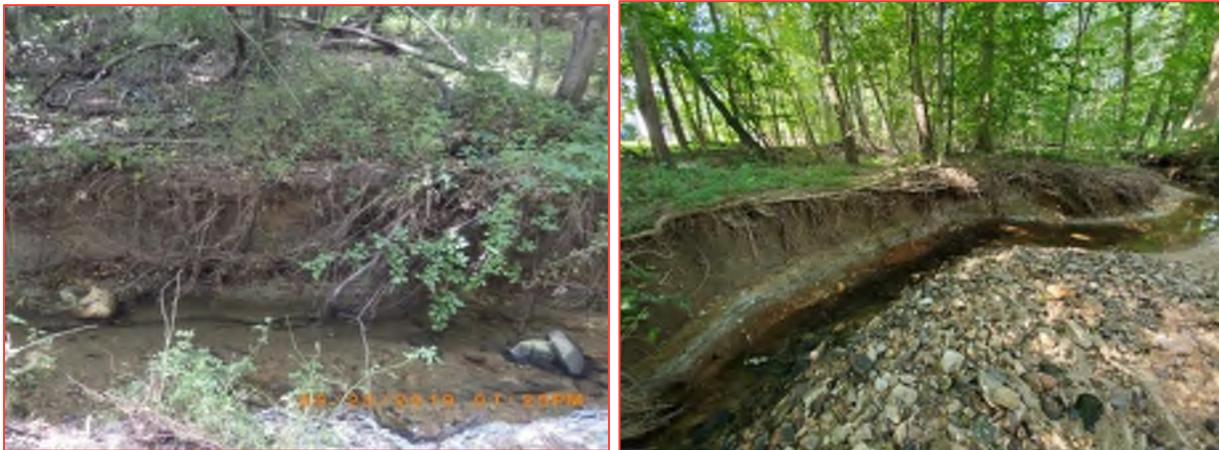
Figure C-92: Severe erosion along the right bank (left); Low severity along the left bank (right)

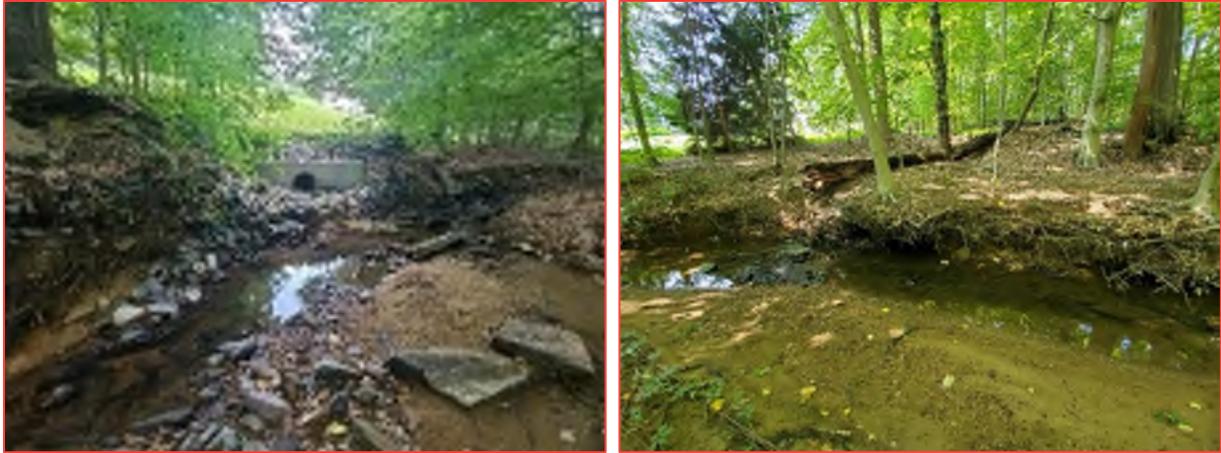
Figure C-93: Outfall 184 from SWM facility (left); Left bank low severity erosion (right)

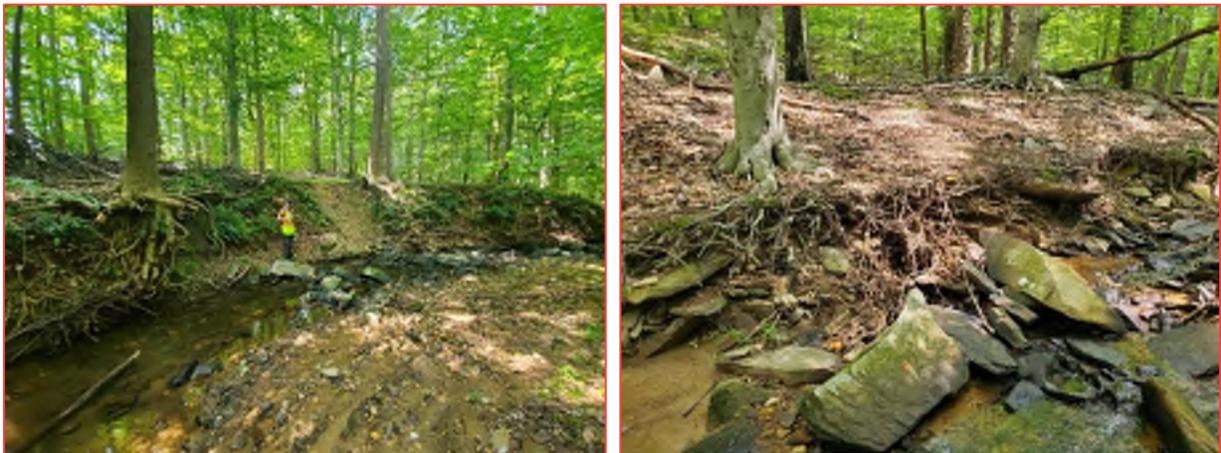
Figure C-94: Left bank severe erosion (left); Right bank minor erosion (right).
