Upper Bynum Run Watershed Assessment Report

This report is a summary of the Upper Bynum Run Watershed. This report meets all the requirements of the 319 Grant application.

December 14, 2018

Stantec Consulting Services, Inc
810 Gleneagles Court, Suite 300
Baltimore, MD 21286

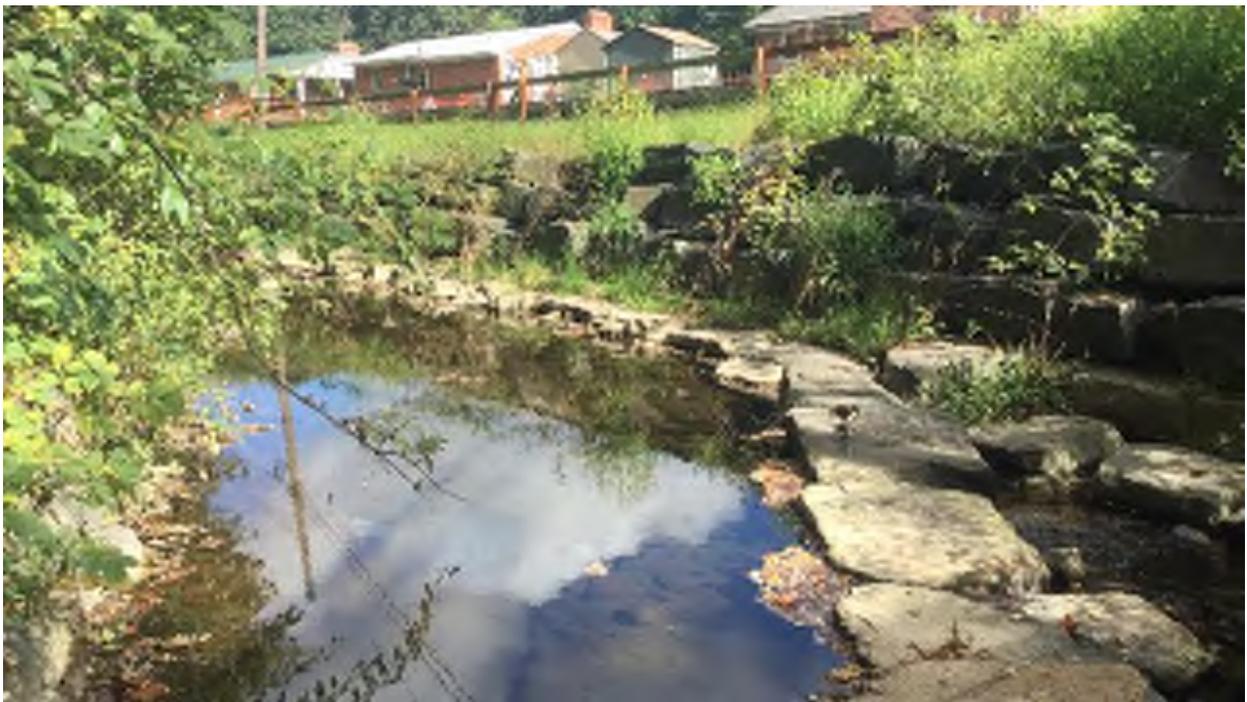
Photo 1 - Beaver dam at stream assessment Point 43 at downstream end of sub area 5

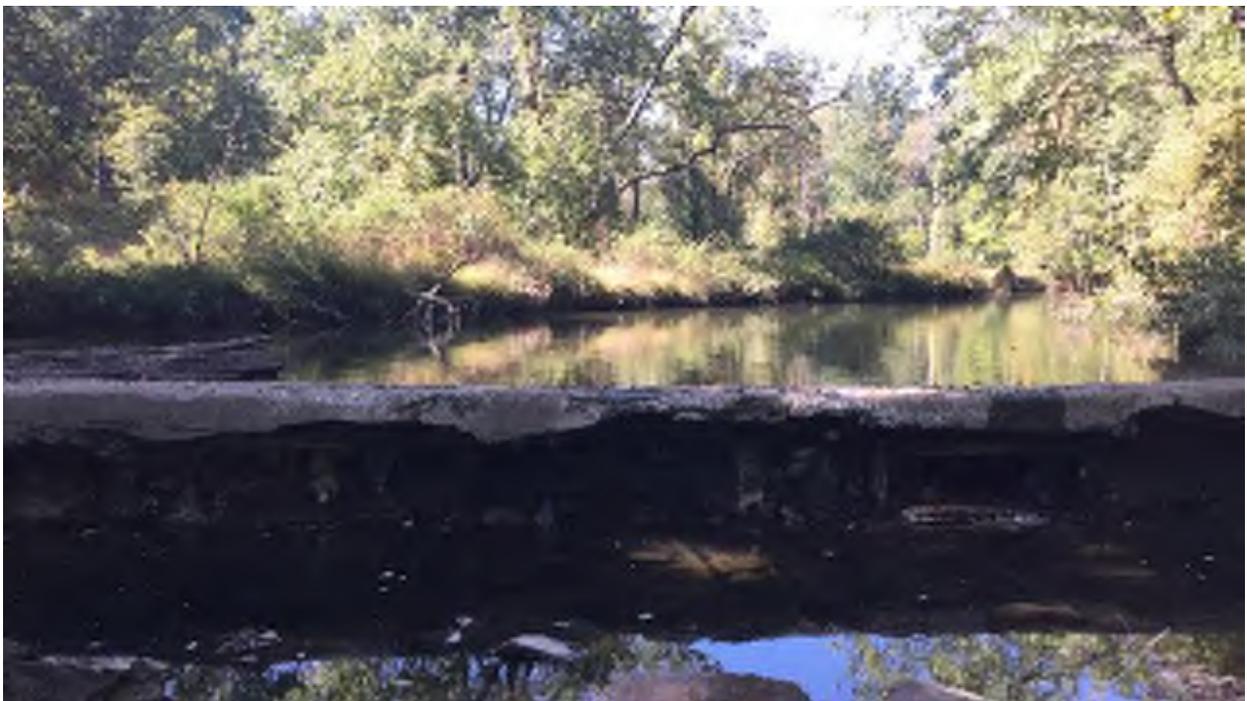
Photo 3- Backwater pool at stream assessment Point 118 created by downstream Mill Dam

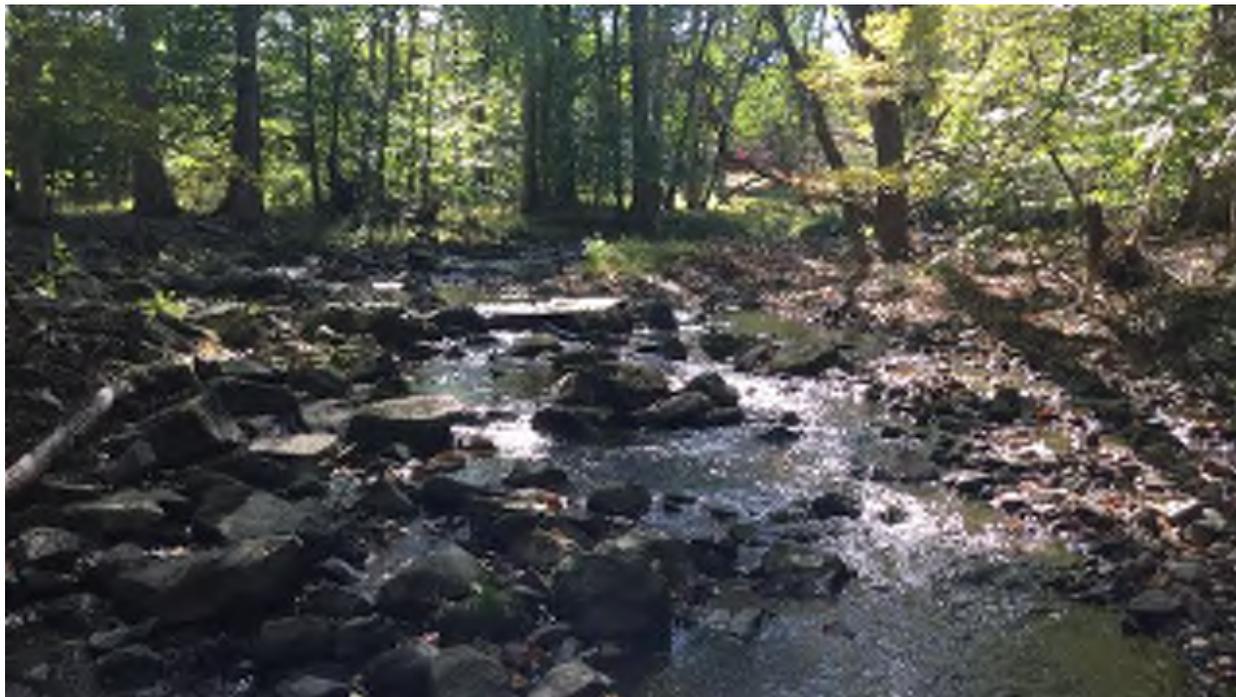
Photo 4 - Mill dam in poor condition blocking flow at stream assessment Point 123

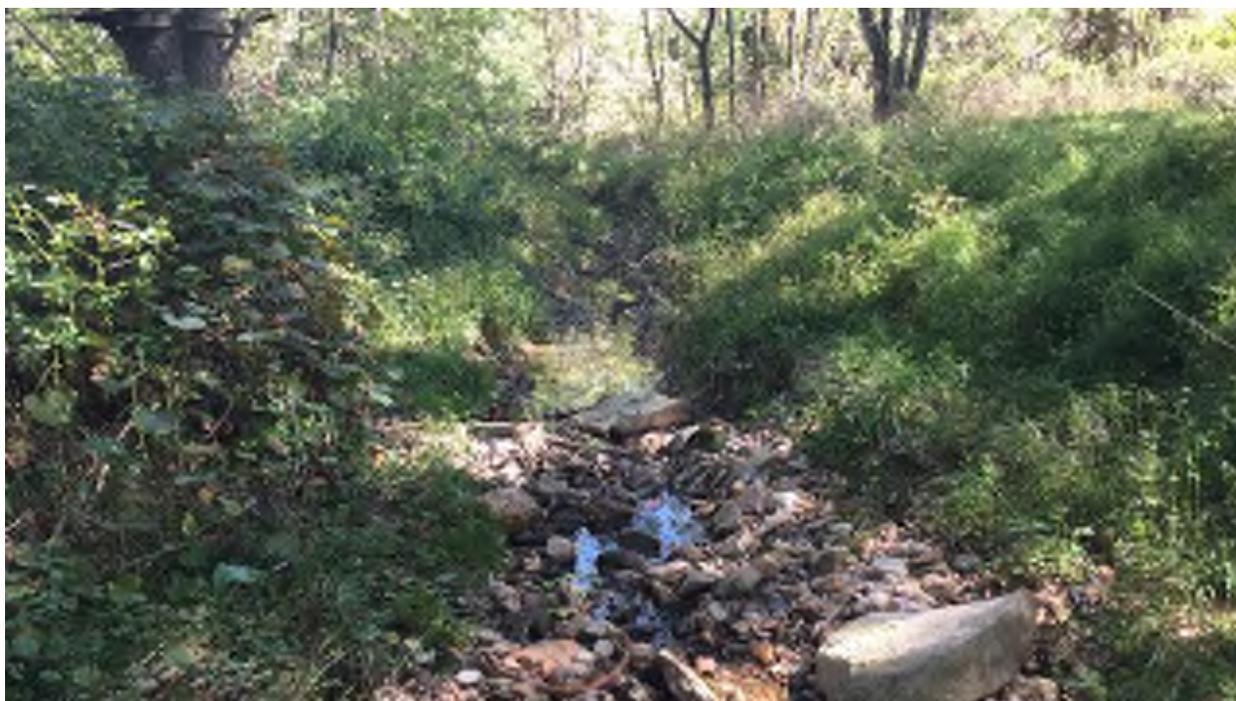
Photo 5 - Upper Bynum Run main-stem in healthy condition at stream assessment Point 20

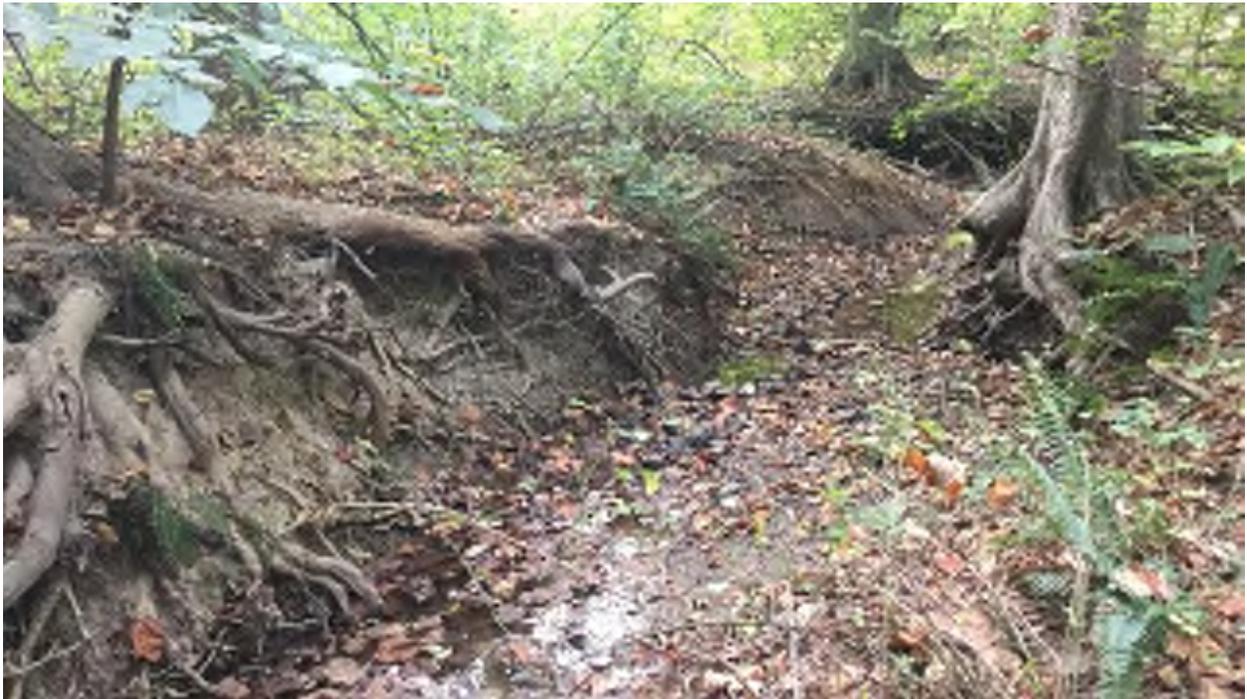
Photo 6 - Unnamed tributary in fair condition in subarea N1 at stream assessment Point 155

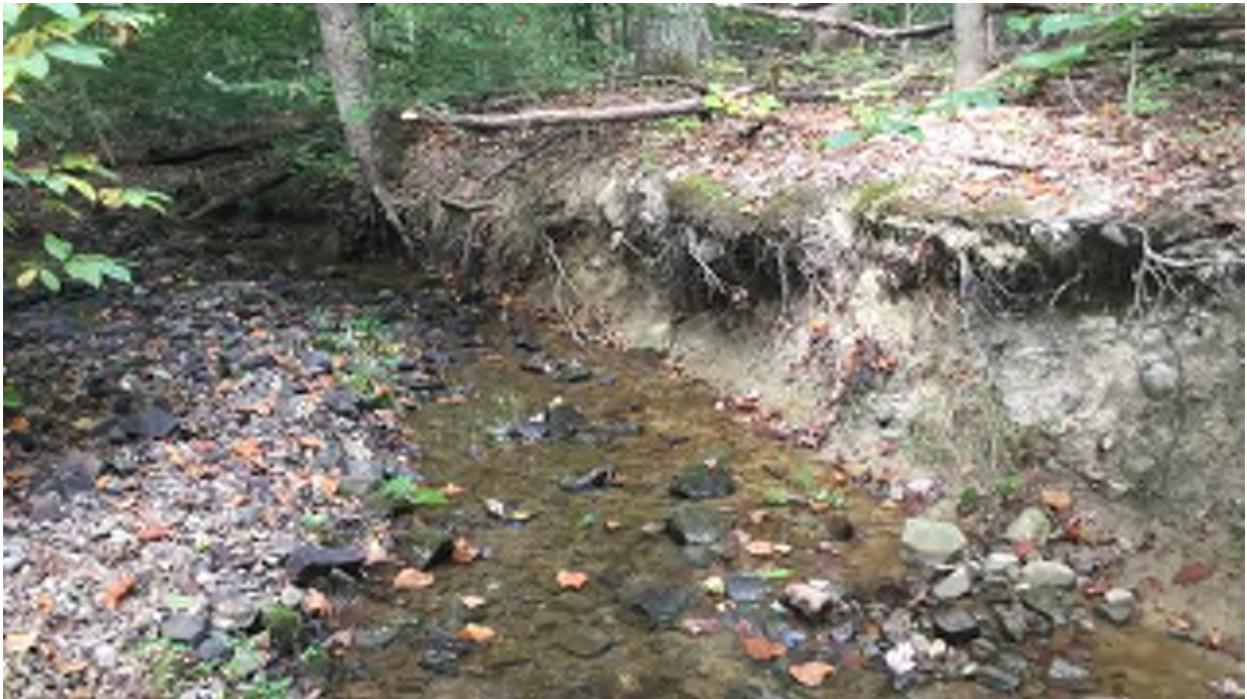
Photo 7 - Eroded channel section in subarea N2, at stream assessment Point 170

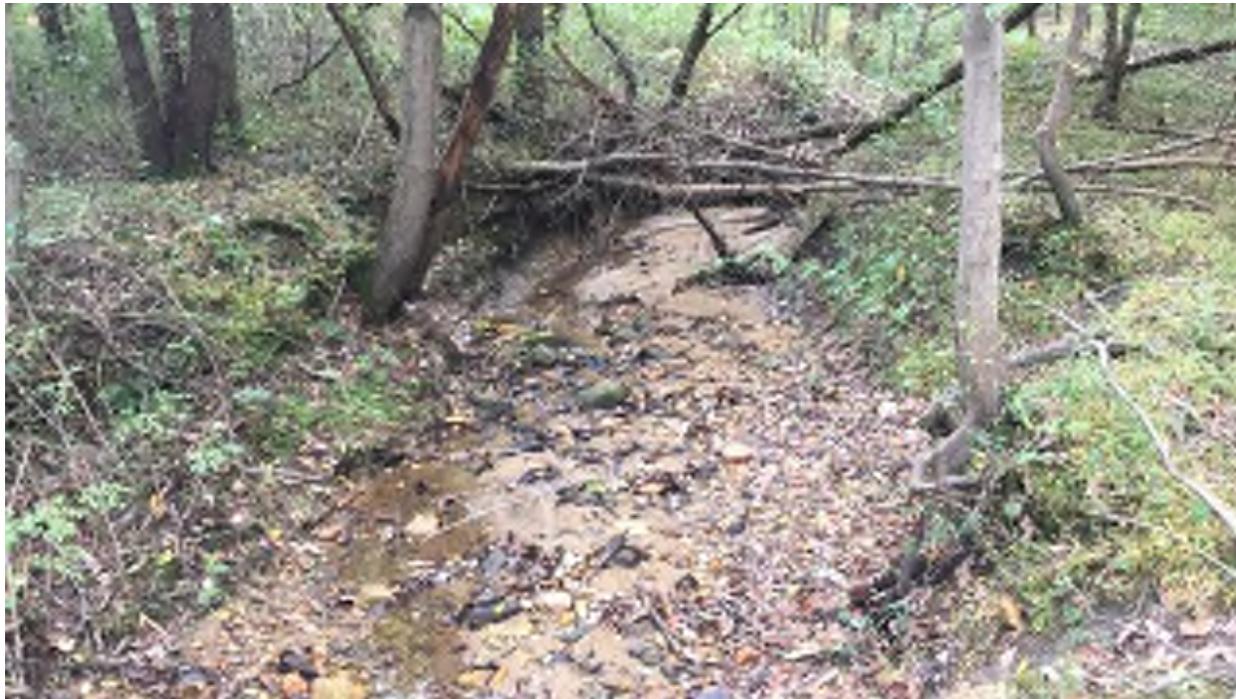
Photo 9 - Stream assessment Point 181 shows debris in the stream channel

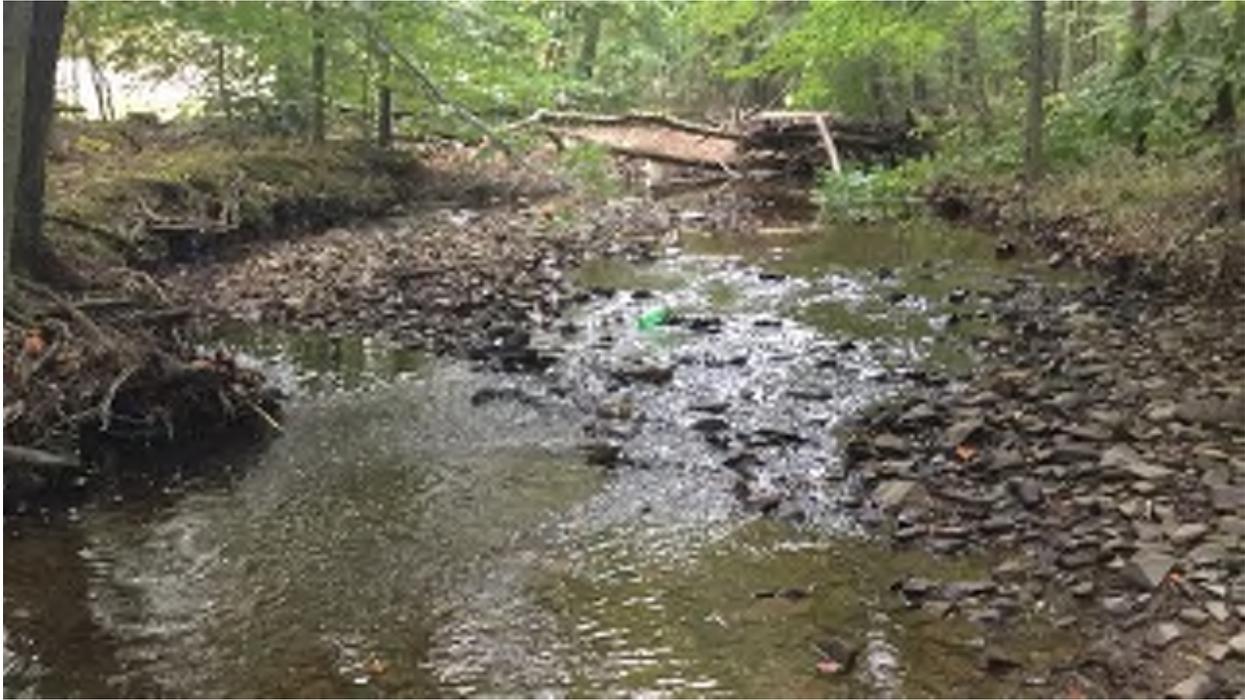
Photo 10 - Unnamed tributary in poor condition at stream assessment Point 244 in subarea S1

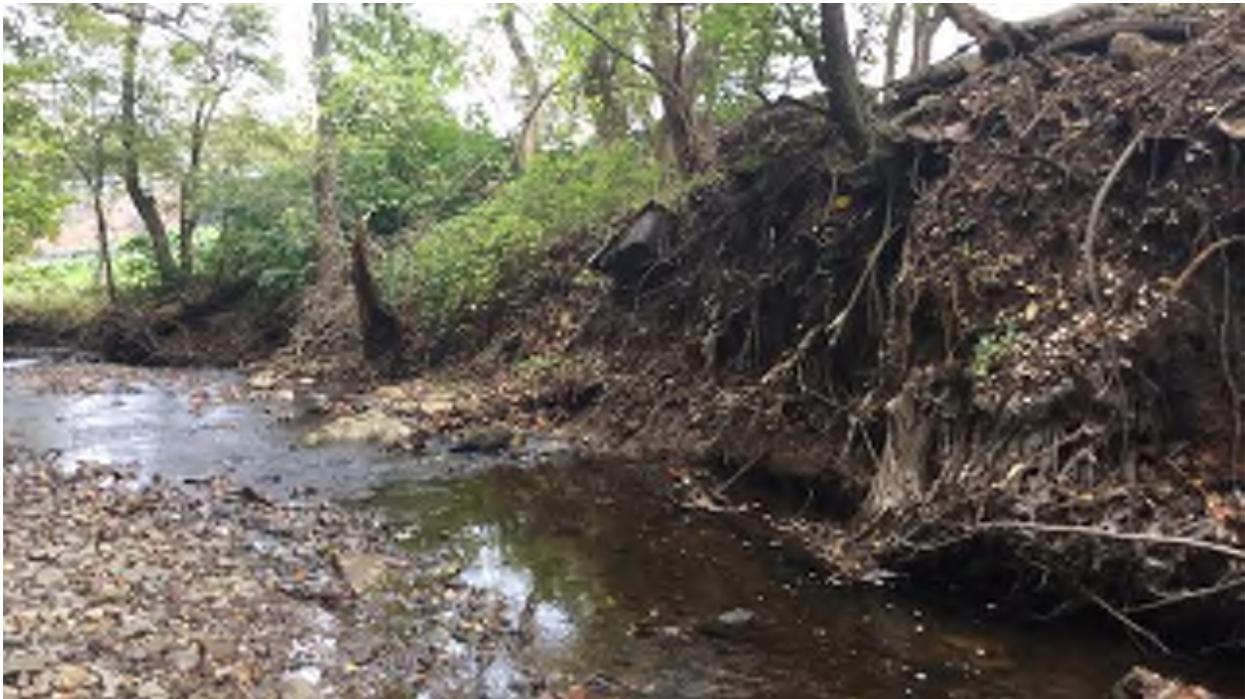
Photo 11 - Stream assessment Point 264 - Upper Bynum Run channel in stable condition

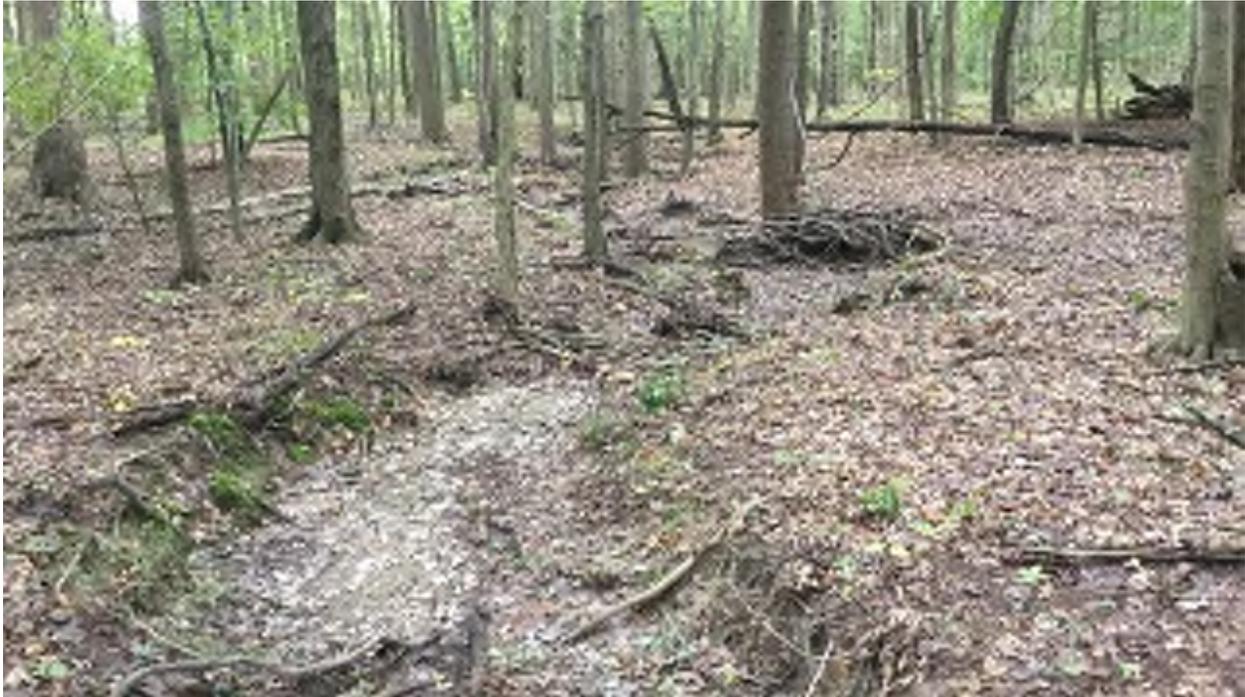
Photo 12 - Severe stream bank erosion observed at stream assessment Point 267 in subarea 3

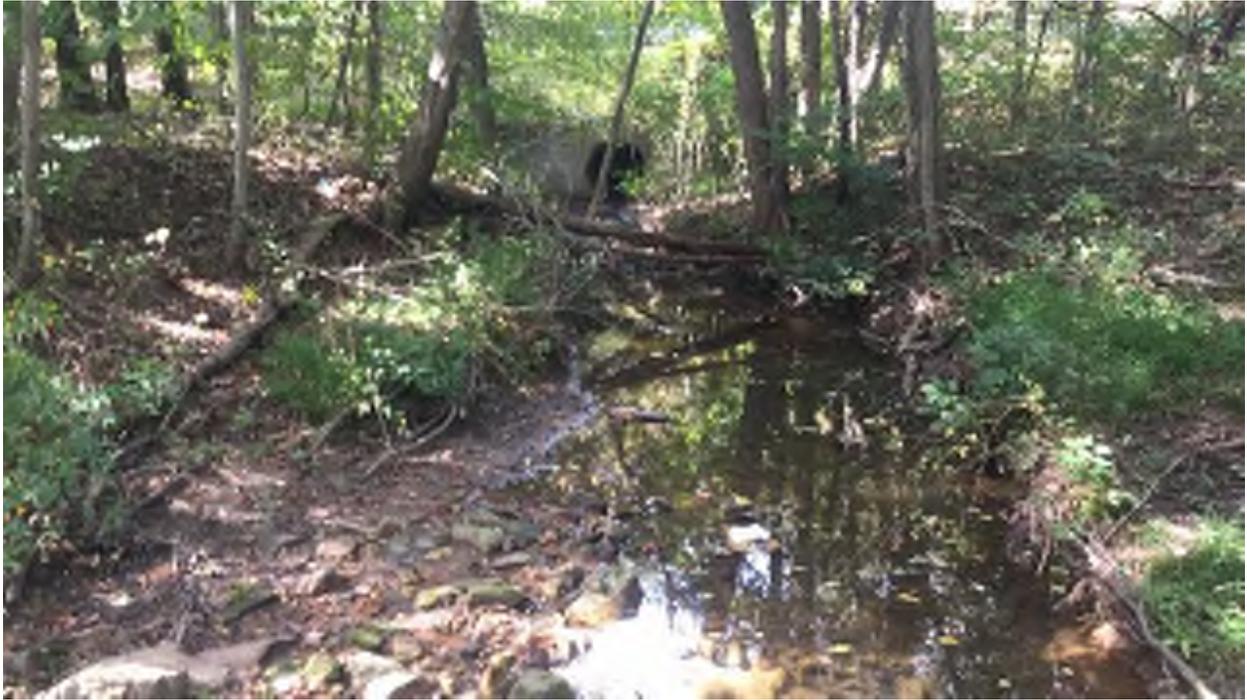
Photo 19 - Downstream of culvert crossing at assessment Point 426 in subarea 5

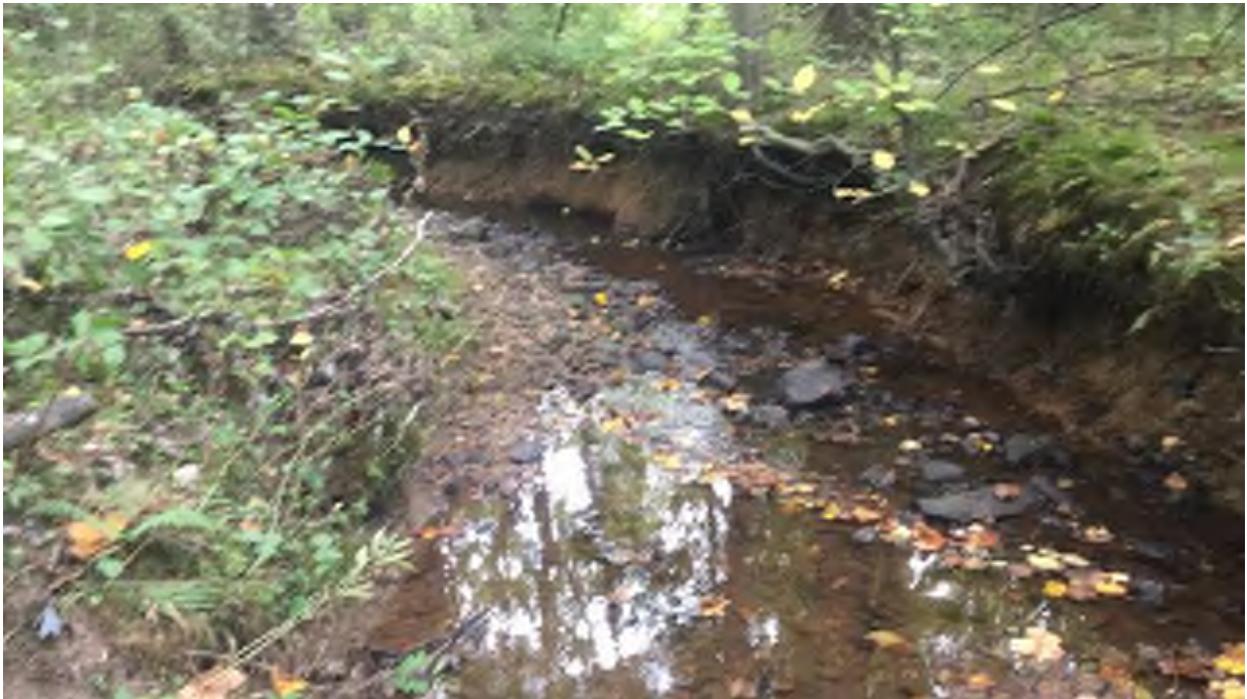
Photo 20 - Erosion observed on stream meander in subarea 5 at assessment Point 431

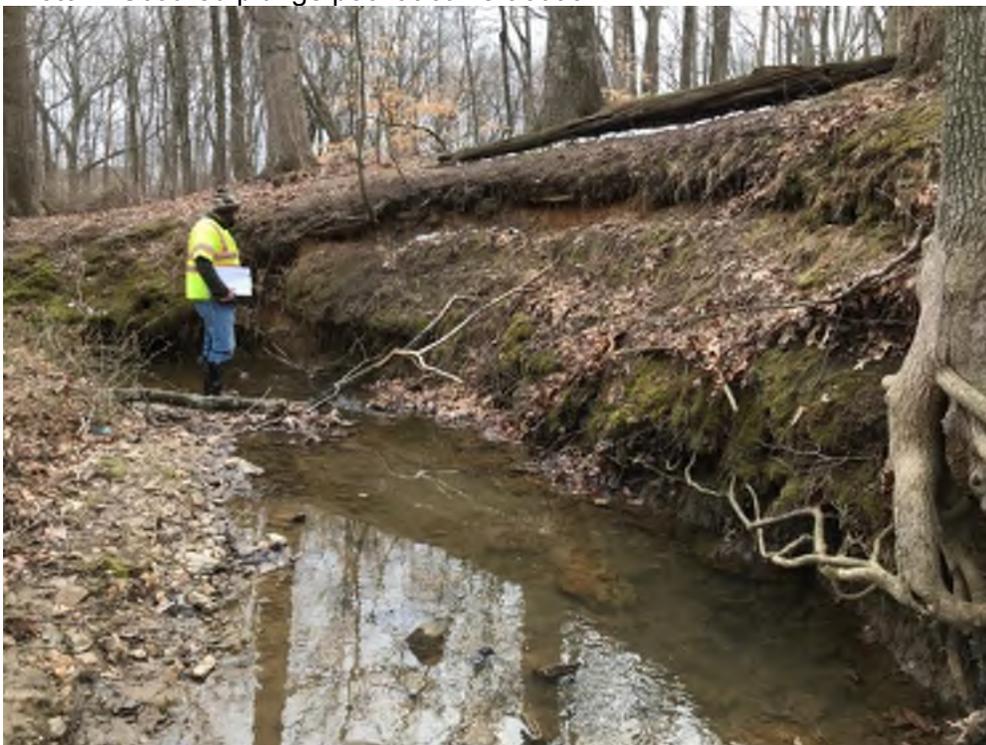
Photo 5: Tall bank indicating signs of failure.

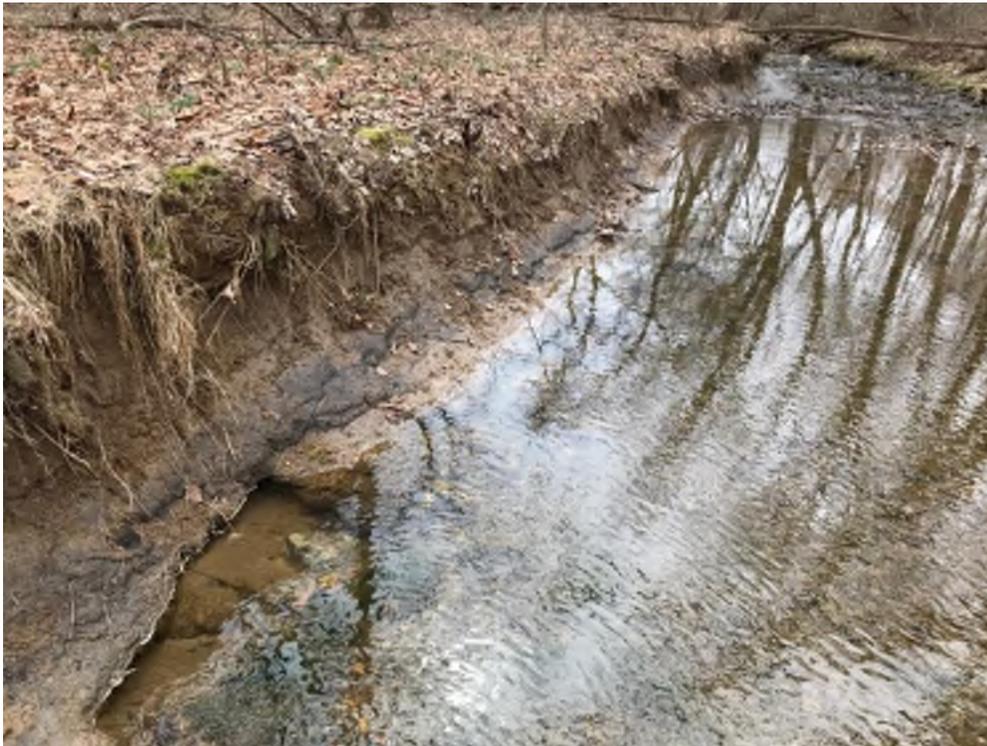
Photo 6: Incised stream channel along a straightaway.

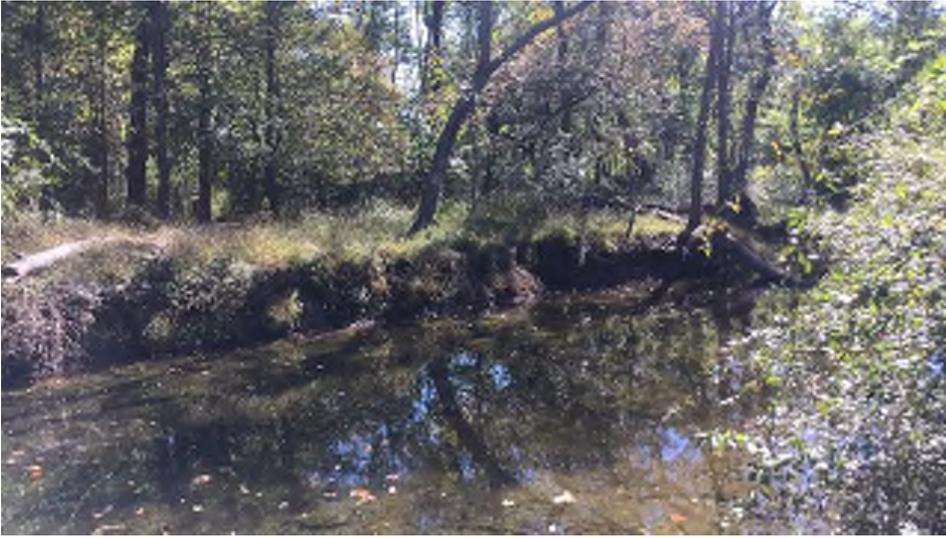
Photo 14: Backwater pool with heavy aggradation caused from low head dam downstream.

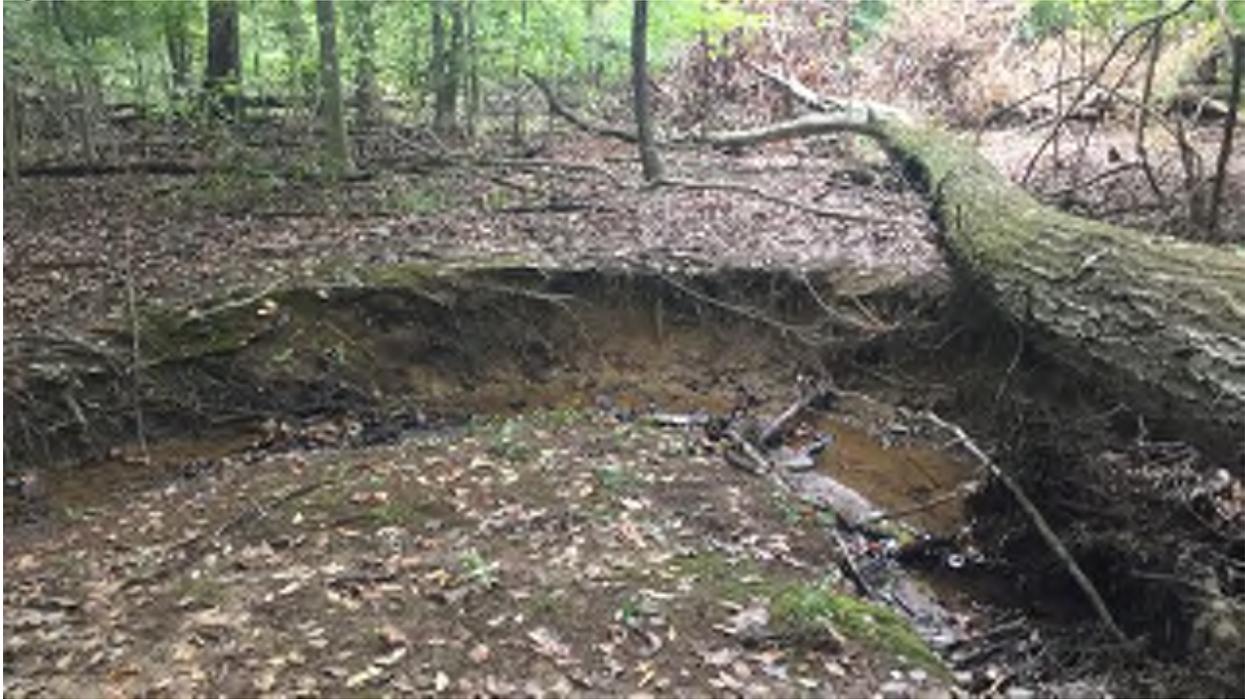
Photo 15: Outside bend actively eroding.

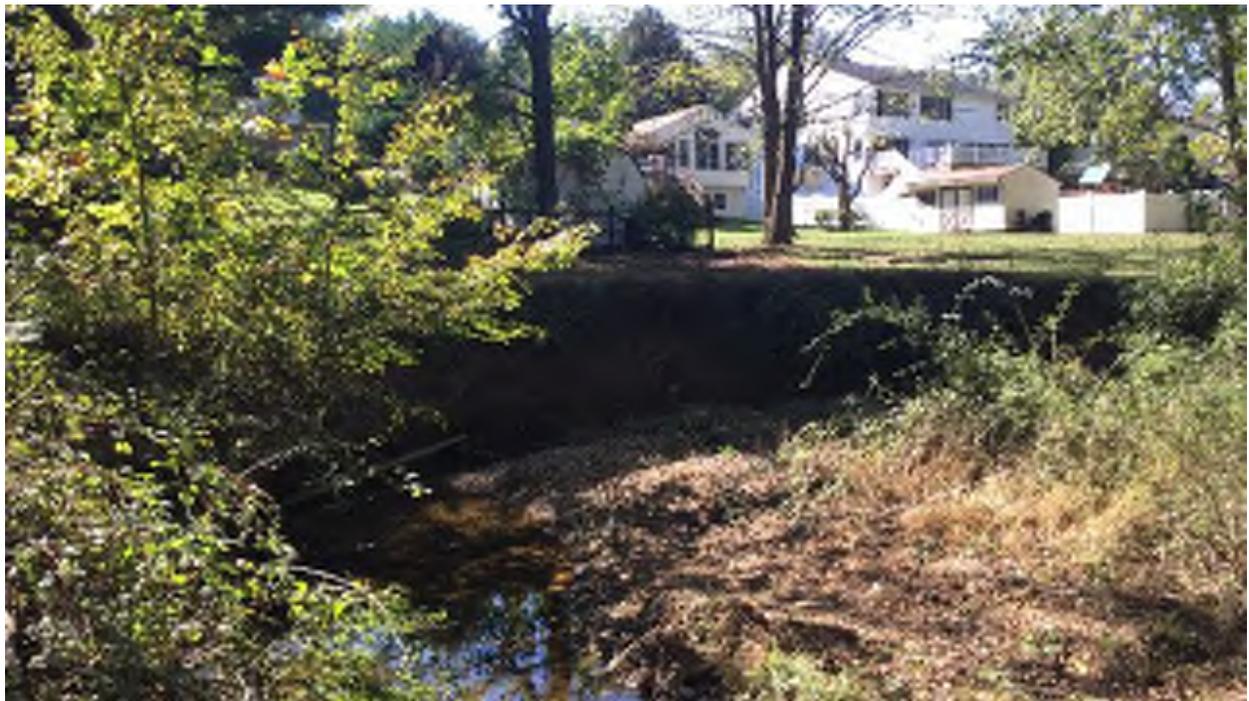
Photo 29: Very high and steep outside bend.

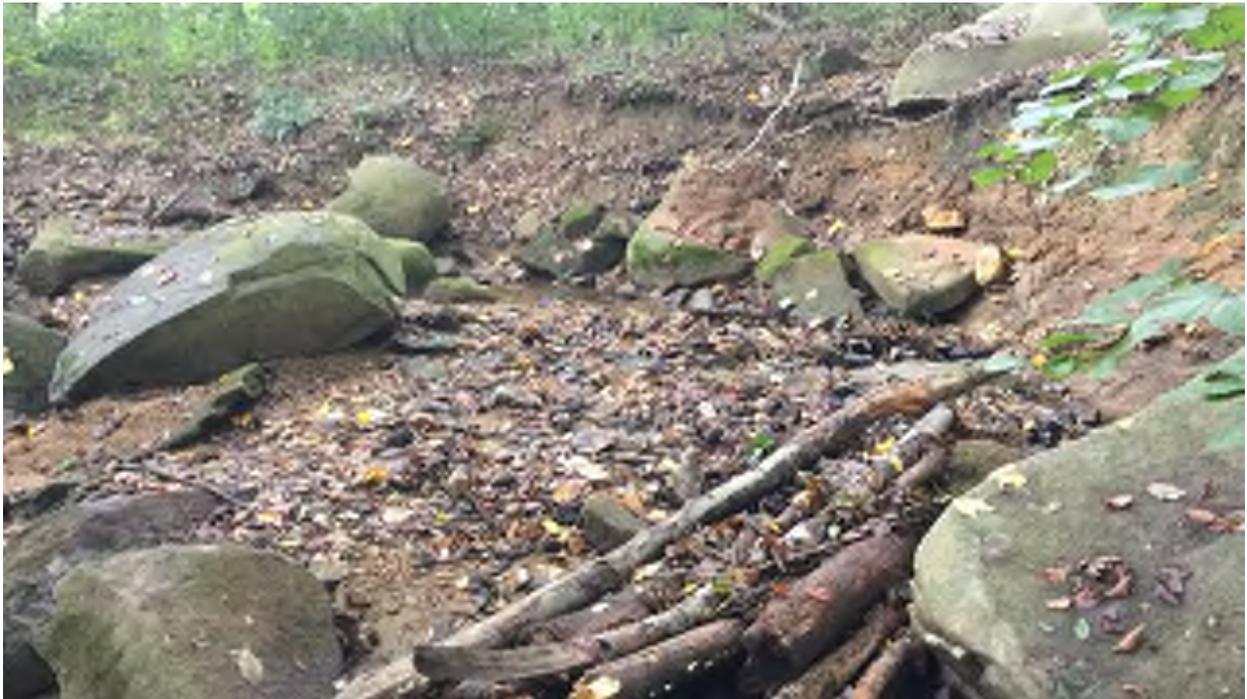
Photo 32: Outside bank erosion with pointbar aggradation.
