Appendix F2 – Assessment of Controls (Stormwater Management Assessment)

Wexford Annual Physical Assessment 2021

November 2022

KCI Technologies, Inc.

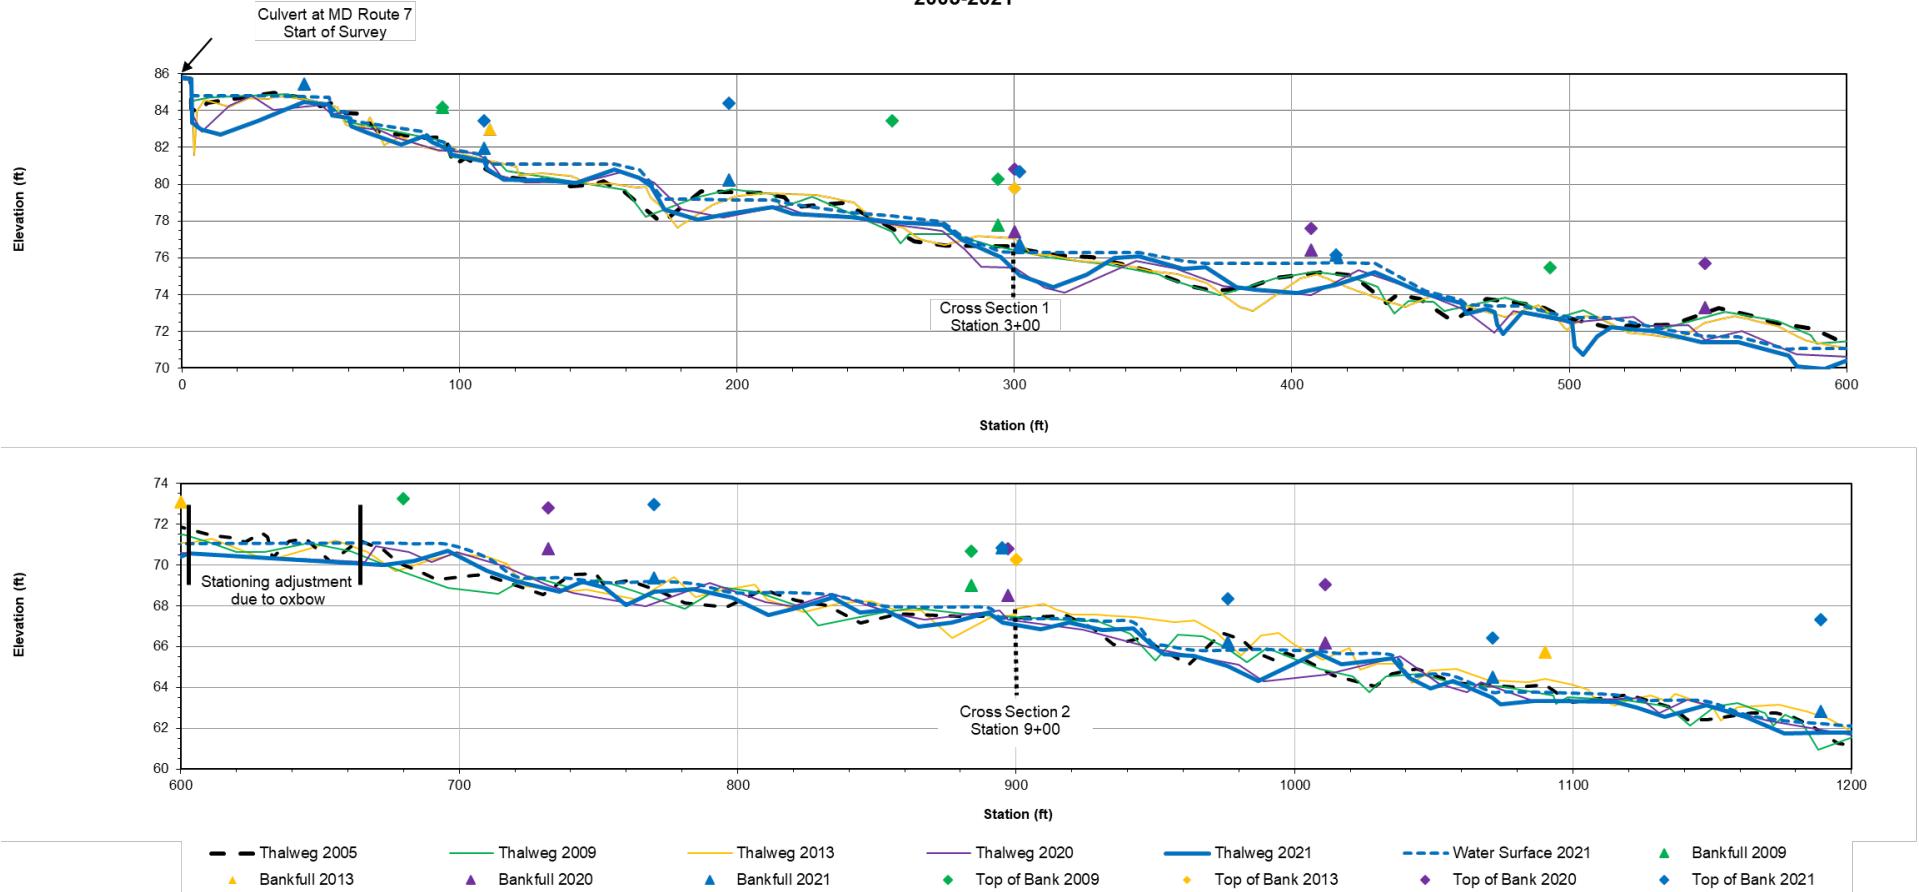
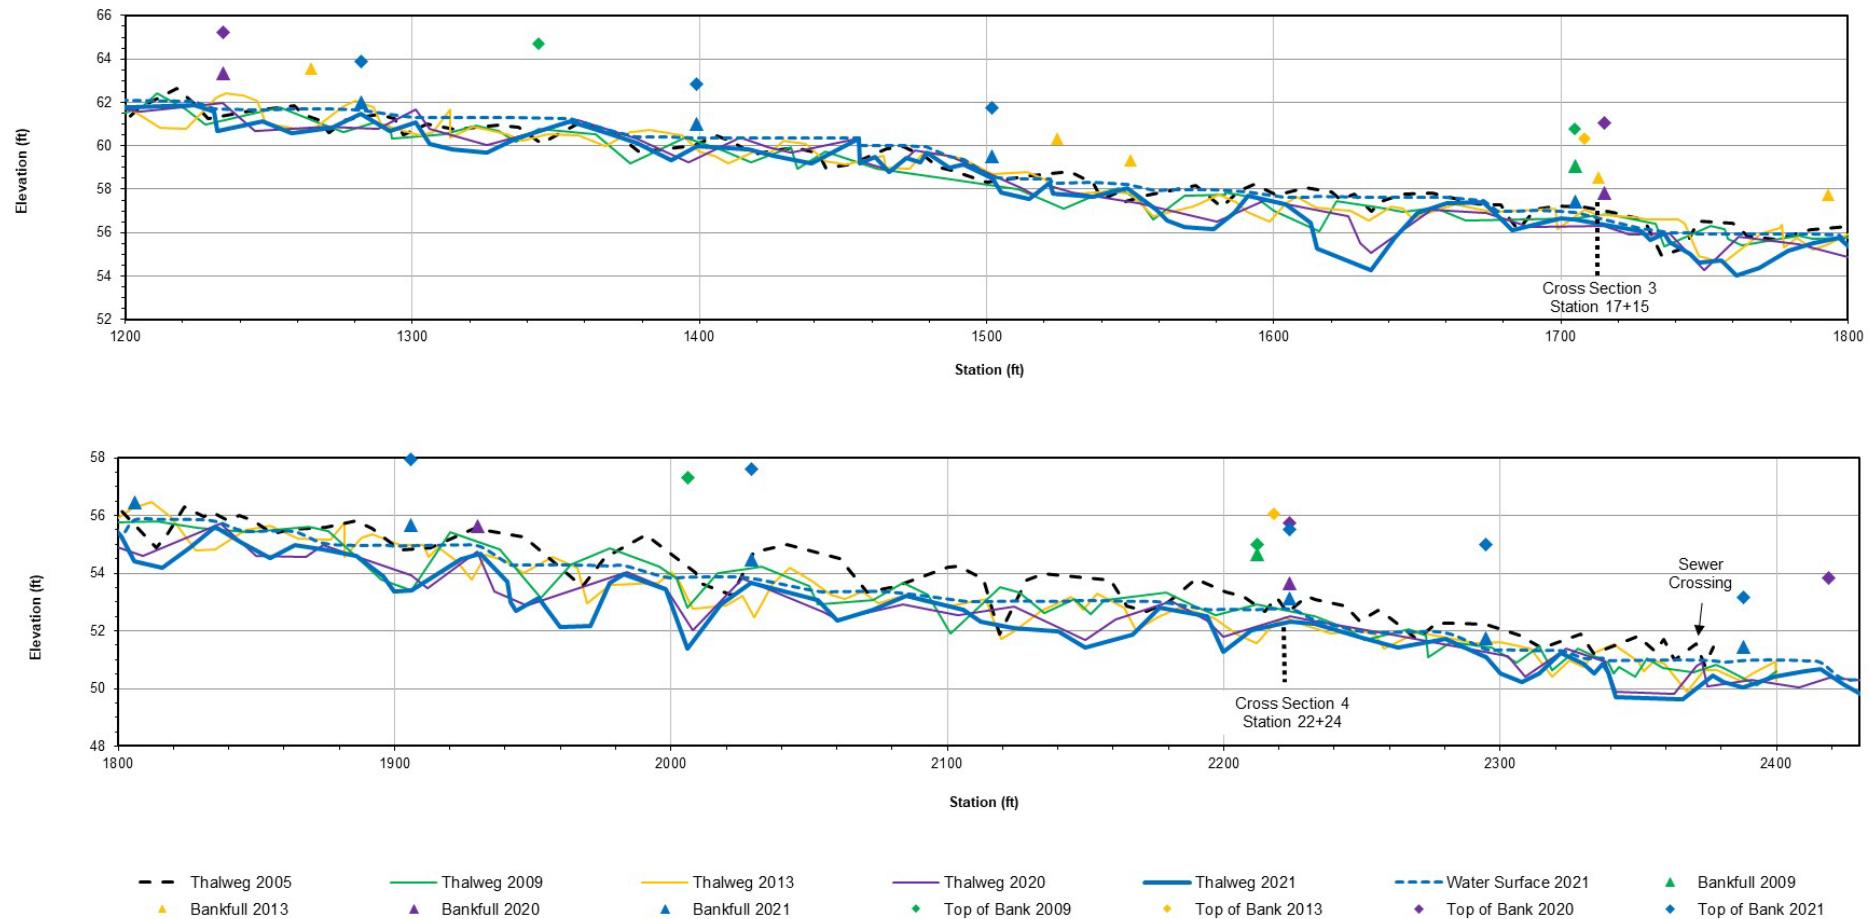
Figure 2 - Longitudinal Profile Overlays 2005-2021

In addition to the slope comparisons, the profile surveyed during 2021 was plotted and superimposed on the plots of prior year profiles surveyed from 2005 through 2021 (Figure 2). In an effort to better graphically present the data, years 2005, 2009, 2013, 2020, and 2021 are plotted to better distinguish changes. Bed features exhibited evidence of the continually shifting and dynamic nature of this system, including deposition in some pools and bars, deepening of

other pools, and shifting locations of riffle crests. In 2020, an oxbow cutoff was created around STA 5+25 (Figure 3, Figure 4). This cutoff bypassed a 70 foot meander bend. KCI surveyed the new channel and adjusted the stationing throughout the rest of the survey to account for the change. Stationing between STA 5+25 and 8+00 was difficult to match with previous surveys due to this change in channel length and stationing. In 2021 the cutoff remained and has further developed into the main channel.

Throughout the current survey there is a trend of slight bed erosion, especially between station 13+00 and 22+00 where the most fluctuations can be seen between 2020 and 2021. The bed erosion is most notable within pool deepening rather than within riffle sections. The average slope of the entire study reach is 1.50%, however there is variability in portions of the channel that are both less than and greater than the average with a decrease in slope moving from upstream to downstream. From station 0+00 to 6+00 the slope is 2.6%. Slope in the middle section of the reach, 6+00 to 18+00, is 1.4% and the lower portion, 18+00 to 24+00, is 0.6%. As the slope decreases towards the bottom of the reach there is less energy and lower flow velocities which is likely contributing to the yearly changes in aggrading and eroding in the bottom portion of the survey. The channel appears unable to transport the sediment load contributed from upstream sources, which results in large mid-channel and lateral bar formation comprised of loose sand and gravel, which overwhelms the channel and causes frequent shifts in bedform. These depositional features increase near-bank stresses resulting in erosion of the bank and bed. The stream banks and bed near the sewer encasement at station 23+75 continue to degrade and the area should continue to be monitored (Photo on pg. 29 and 30 of Appendix A). The most notable changes in channel bed between 2020 and 2021 are:

- Plunge pool lengthened by 27 feet at the MD 7 culvert, STA 0+07 to 0+44
- Pool length shortened by 8 feet at STA 4+73
- Two foot deep pool created at STA 5+02 to 5+15
- Filling in of pool at STA 2+53
- 70 foot Oxbow cutoff remained around STA 5+25
- Bed erosion of 0.2 feet from STA 5+81 to 5+95
- Riffle crest created at STA 10+08
- Decreasing of riffle crest by 0.3 feet at STA 13+00
- Pool lengthened by 13 feet and deepened by 0.8 feet at STA 16+15
- Pool lengthened by 17 feet at STA 17+61
- Pool depth increase of 0.4 feet at STA 18+16
- Pool depth increase of 1.0 foot at STA 19+60
- Pool depth increase of 0.6 feet at STA 20+06
- Pool depth increase of 0.5 feet at STA 22+00
- Pool length increase of 8 feet at STA 22+95

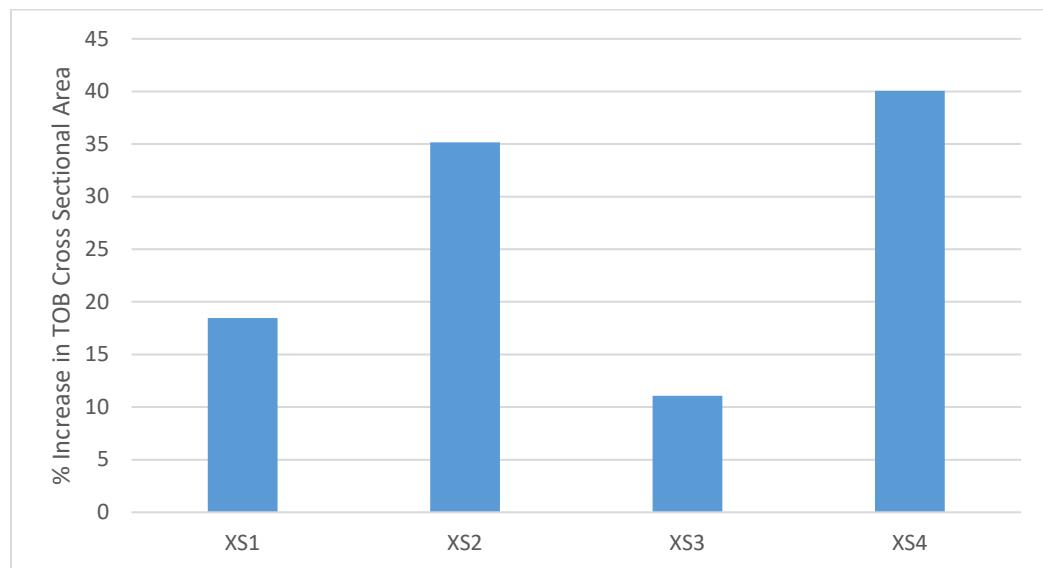
Figure 5 - Percent increase in top of low bank cross-sectional area from 2005-2021

Cross-section surveys from seventeen years of monitoring were analyzed at each of the four permanent monitoring locations to compare bankfull width, mean depth, width/depth ratio, and overall cross-sectional area. Since field determination of bankfull elevation in incised systems is difficult to identify and repeat over time, top of low bank elevation was used to track changes in the cross-sectional dimensions listed below. To compare the stability of reaches over time, the percent increase in top of bank cross-sectional area from 2005 through 2021 is shown in Figure 5. The greatest changes in top of bank cross-sectional area occurred at Cross-section 2 and Cross-section 4, which are located at stations 9+00 and 22+24.

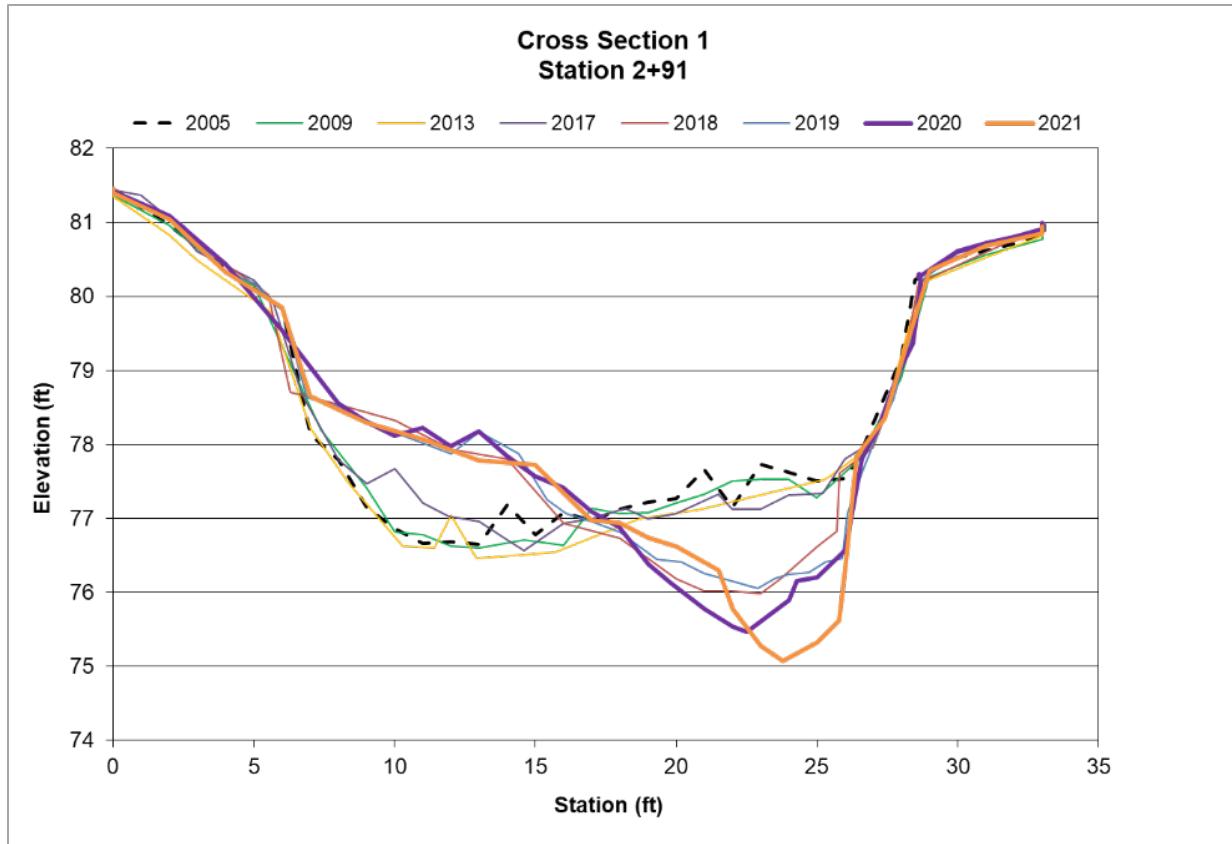
Figure 6 - Cross-section 1 Overlay 2005-2021

Cross-section 1 had previously been the most stable, but saw significant bed erosion between 2017 and 2018. Currently, only a small deepening of the thalweg occurred between 2020 and 2021 of approximately 2 inches and the thalweg shifted one foot towards the right bank over the same period. Between 2017 and 2018, significant deposition on the left side of the channel along with bed incision on the right side were visible in the survey (Table 3, Figure 6). Photos facing downstream between 2017 and 2021 below (Figure 7) help visualize how much this cross-section has changed in a matter of a few years. In 2017, cross-section 1 was characterized as a shallow riffle with a uniform bottom. In 2021, the riffle has migrated upstream and the cross section located at a pool that has increased considerably in mean depth and has moved to the right side of the channel. About 0.75 feet of large cobble has been deposited on the left side of the channel while about 1.75 feet of erosion has scoured out the right side of the channel since 2017. (Figure 7). A large pool developed directly downstream of the cross-section in 2018. Between 2018 and 2019 this pool began filling in, but deepened about 5" in the 2020 survey and has remained near that depth in 2021. The bankfull width has decreased since 2019 along with the bankfull area and top of bank area both having decreased between 2020 and 2021.

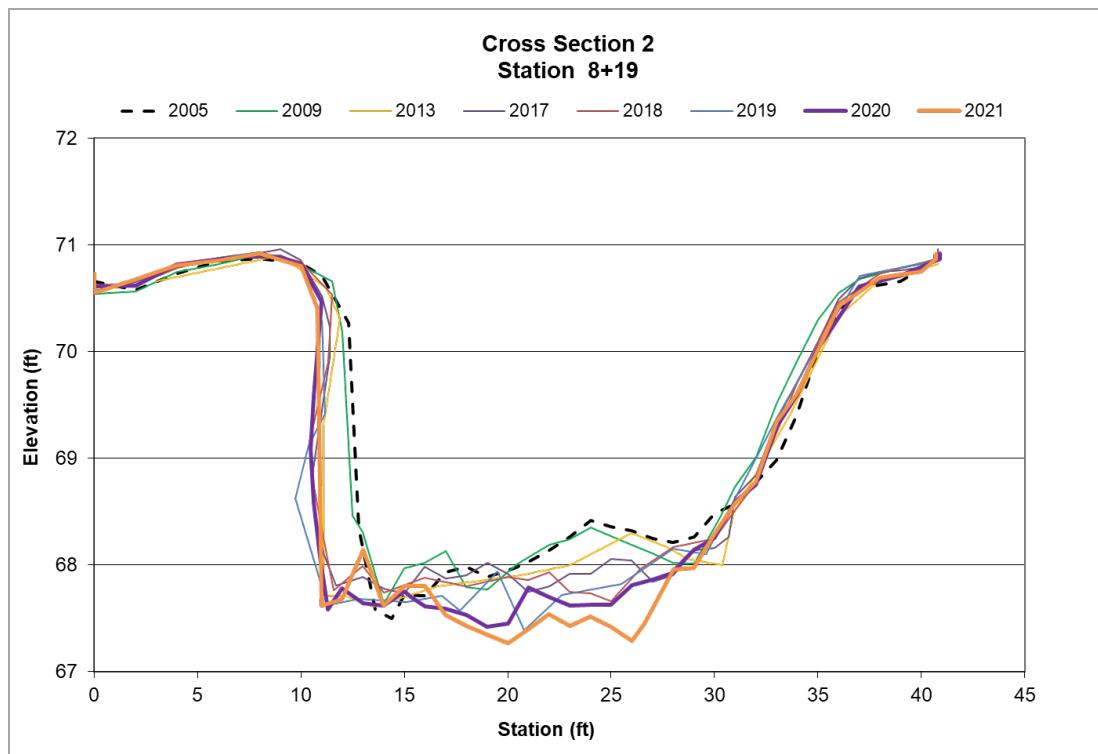
Figure 8 - Cross-section 2 Overlay 2005-2021

In the vicinity of Cross-section 2, approximately 1.1 feet of bed erosion occurred between 2005 and 2021. Additionally, approximately 3.1 feet of bank erosion has occurred on the left bank. The left bank and bed erosion have caused an increase in the bankfull area by 10.0 ft² and an increase in the top of bank area of 21.5 ft² (Table 4, Figure 8). The greatest increase in the left bank erosion occurred between 2009 and 2013. Between 2020 and 2021 there was no increase in bank erosion, however, there was 3-6" of bed erosion along the thalweg.

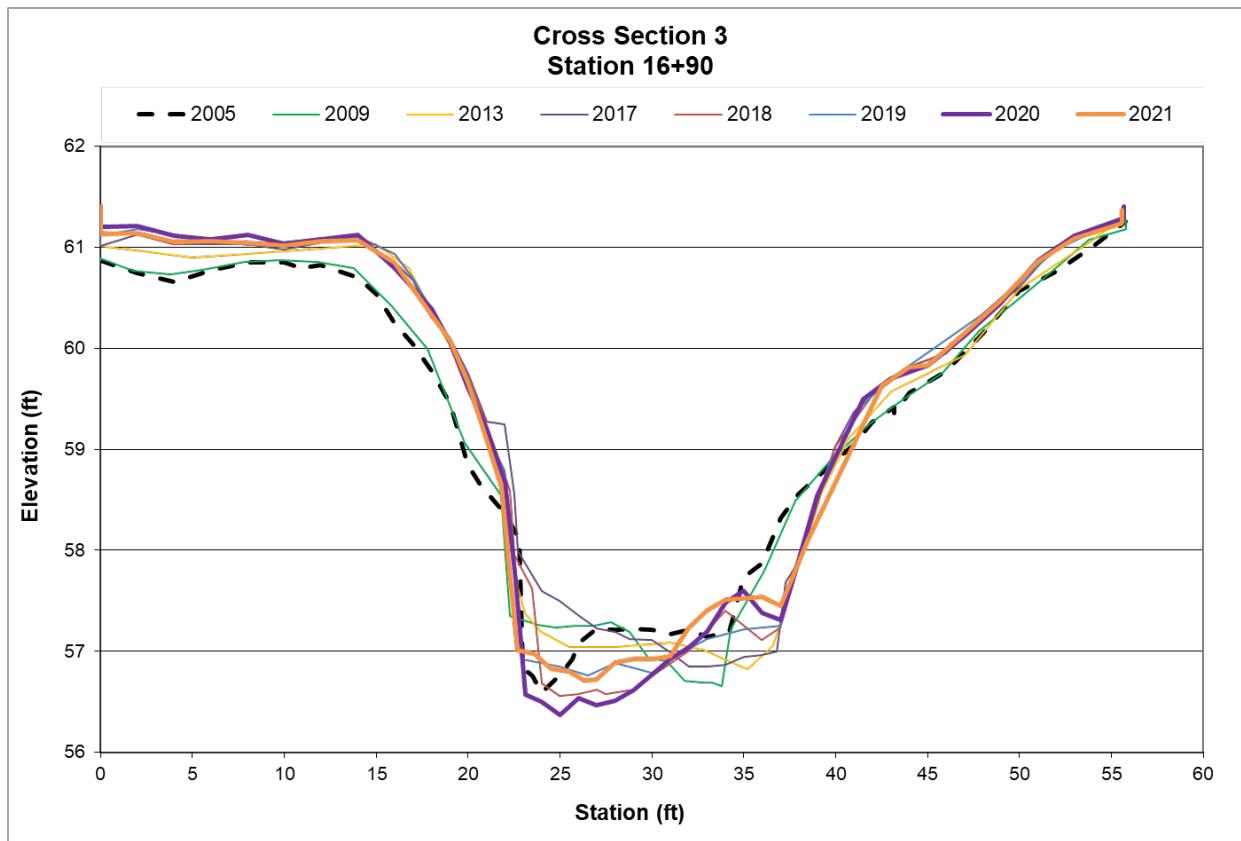
Figure 9 - Cross-section 3 Overlay 2005-2021

Cross-section 3 was moderately stable with signs of both aggradation and erosion prior to 2018 when considerable bed erosion occurred between 2017 and 2018 along the left side of the channel. The most evident change is the shift of the thalweg from the right side of the channel to the left (Table 5, Figure 9). Photos facing downstream between 2017 and 2021 below (Figure 10) help visualize how much this cross-section has changed in a matter of a few years. Between 2017 and 2018, approximately 1 foot of bed erosion occurred on the left side of the channel while 0.6 feet of deposition occurred on the right side of the channel. The bed was mostly stable between 2018 and 2019 with a small amount of aggradation on the left side of the channel. Between 2019 and 2020 approximately 4 inches of bed erosion occurred along the left bank while the depositional bar on the right side of the bed increased. Approximately 3-4" of bed aggradation occurred in the thalweg between 2020 and 2021 along with a slight widening of the depositional bar along the right bank. The banks have remained very stable between 2017 and 2021.

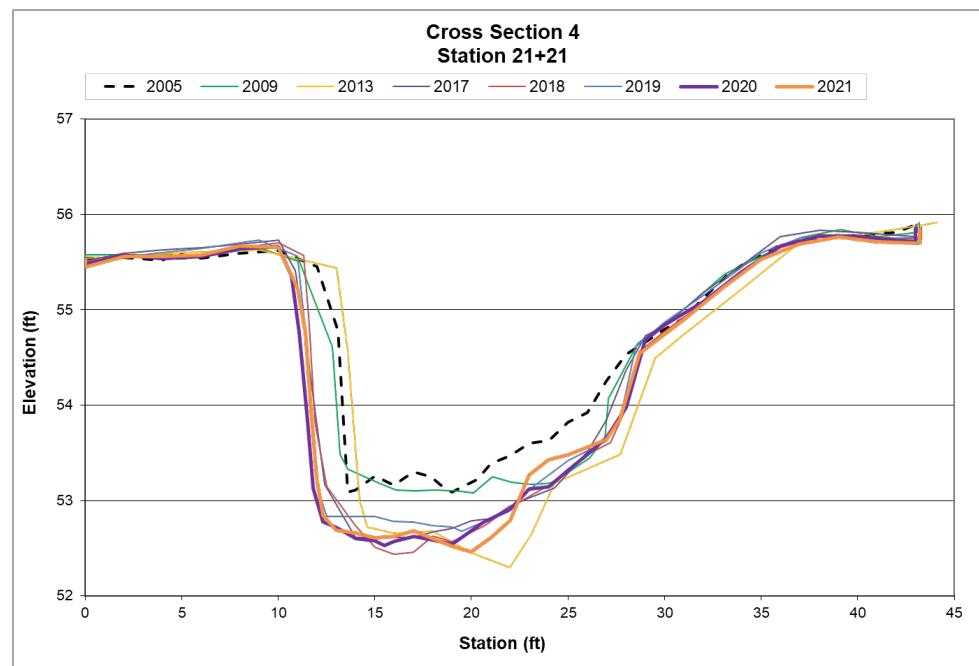
Figure 11 - Cross-section 4 Overlay 2005-2021

Cross-section 4 previously experienced the most change from 2005 to 2017; however it appears to have since stabilized through 2021 (Table 6, Figure 11). Similar to the other cross-sections, the greatest bed erosion took place between 2009 and 2013. Between the 2013 and 2021 surveys, there was 1.5 feet of left bank erosion and approximately 0.45 feet of bed aggradation. While the channel bed material contains more cobble material in the upstream portions of the channel, the bed material of Cross-section 4 consists of mostly depositional sand and gravel, which is easily transported during high flows. This cross section has remained mostly stable between the 2017 and 2021 surveys, with only minor bed and bank erosion.
