# Sam's Branch Tributary Watershed Assessment and Baseline Stream Monitoring

*Final Report*

*August 2012*

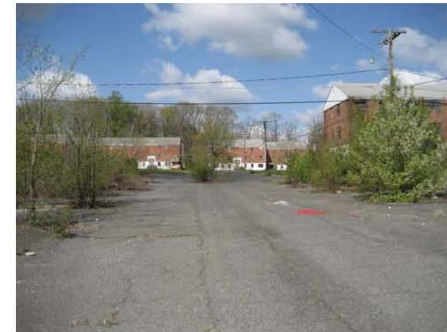
*Existing pavement on Hawthorne Drive*

Issues:

- Abandoned/unused impervious surfaces in poor condition

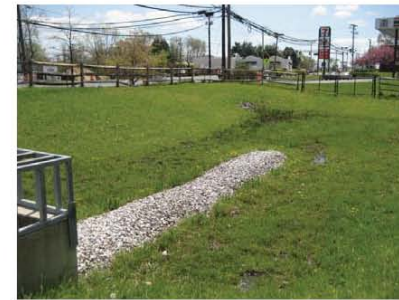
*Outflow riser with de-watering device*

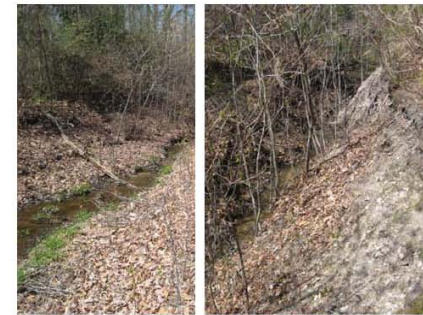
*Eroded outfall channel*

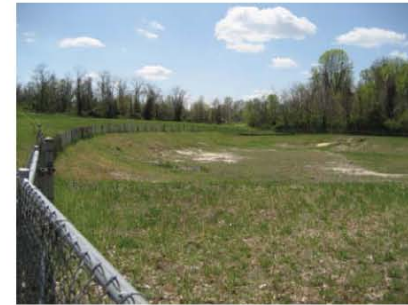
At Basin #3, a lack of vegetation, bare and eroded soils, trash deposition and lack of maximized water quality benefit were noted. Retrofit strategies include stabilization of bare and eroded soil, and native vegetation installation, construction of a water quality forebay, and a modified mowing program for any portion that remains grassy. Expected benefits include improved trash management and water quality, as well as, enhanced habitat and aesthetic appeal.

*Partial view of eroded areas*

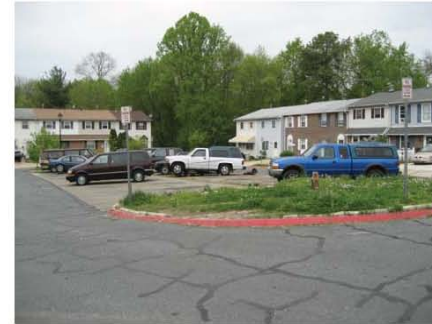
*Parking in center of cul-de-sac on Sequoia Dr.*

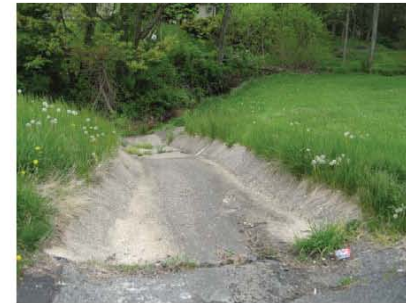
*One of two existing channels from road into Sam's Branch*

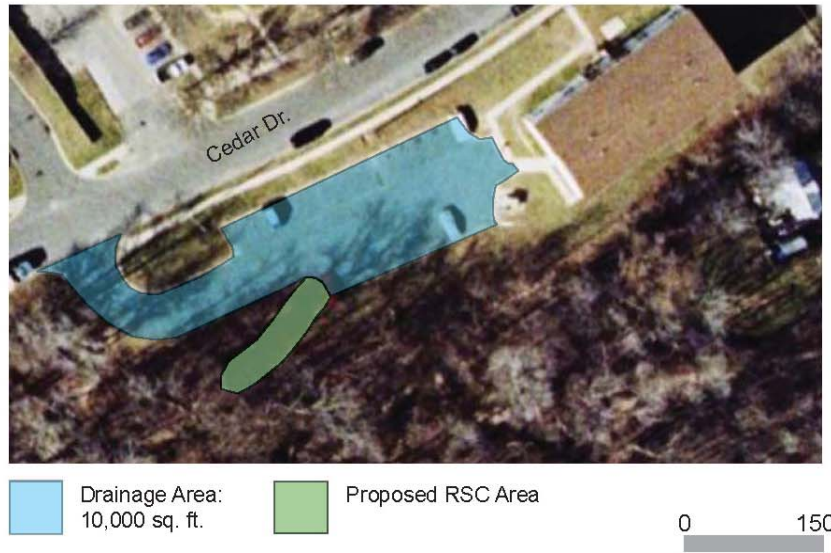
*Riprap channel at southwest corner of parking lot*

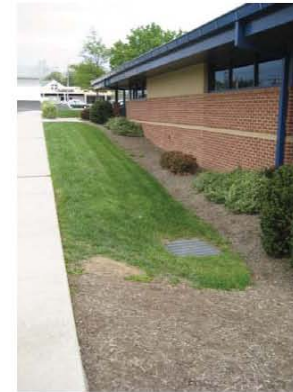
*Existing swale and downspouts*

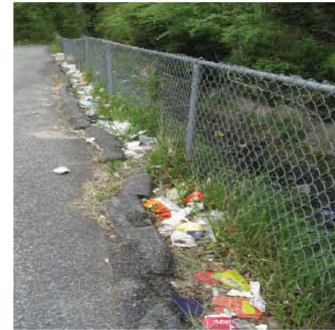
*Trash accumulation along fence*

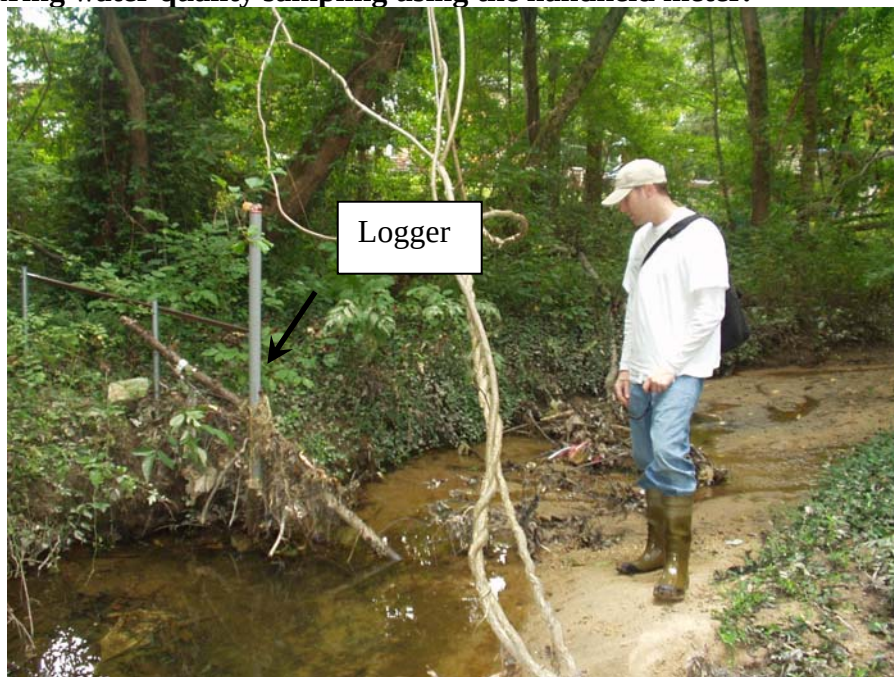
**Figure 8-2. Photo from the Reach 4 stage logger. The photo shows the Reach 4 cross section with some debris build-up after the August 28, 2009 event (September 09, 2009).**

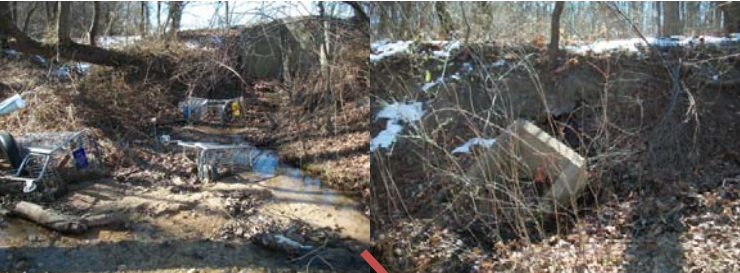
Trash and Debris in Stream, Failed Headwall

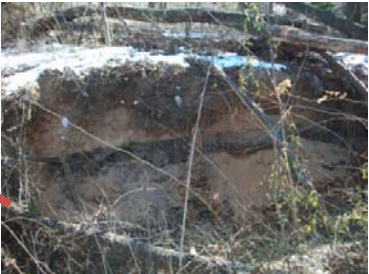
Severe Bank Erosion

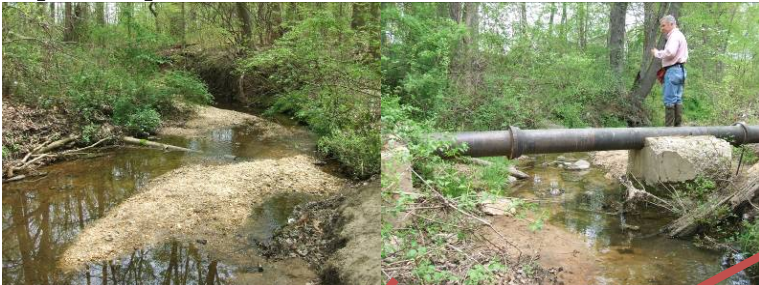
Exposed Pipes in Stream

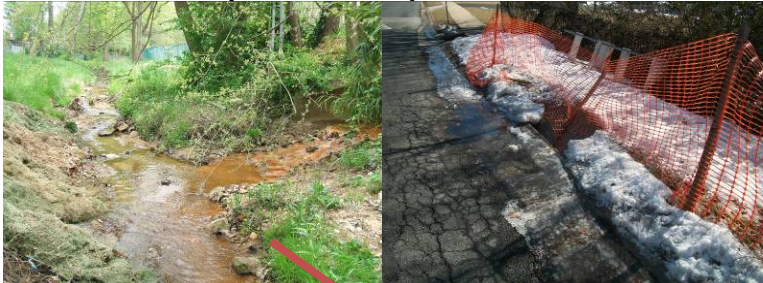
Poor Water Quality from tributary; Erosion near Hornbeam Road

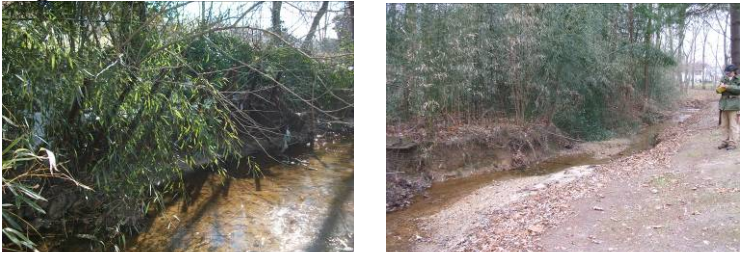
Invasive species (bamboo) and bank erosion/stream channel migration

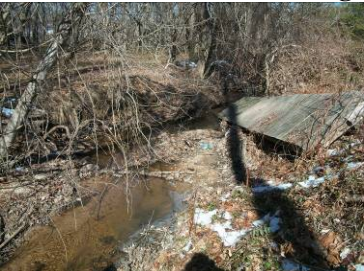
Failed homeowner footbridge:

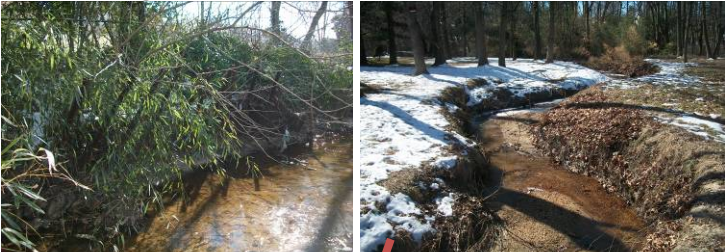
Invasive species (bamboo) and bank erosion/stream channel migration

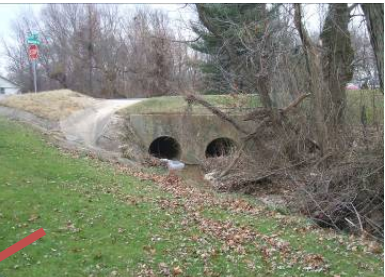
Poor Riparian Buffer and concrete swale at Perry Avenue

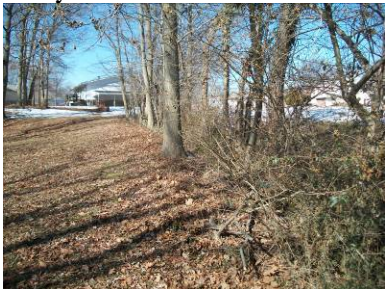
Stormwater outfall channel at Perry Avenue:
