TO: Michele Dobson, Harford County Department of Public Works

FROM: Michael Pieper, KCI Technologies, Inc.
Megan Crunkleton, KCI Technologies, Inc.

DATE: September 14, 2012

SUBJECT: Box Hill South Stream Monitoring 2012
KCI Job Order No. 16122305

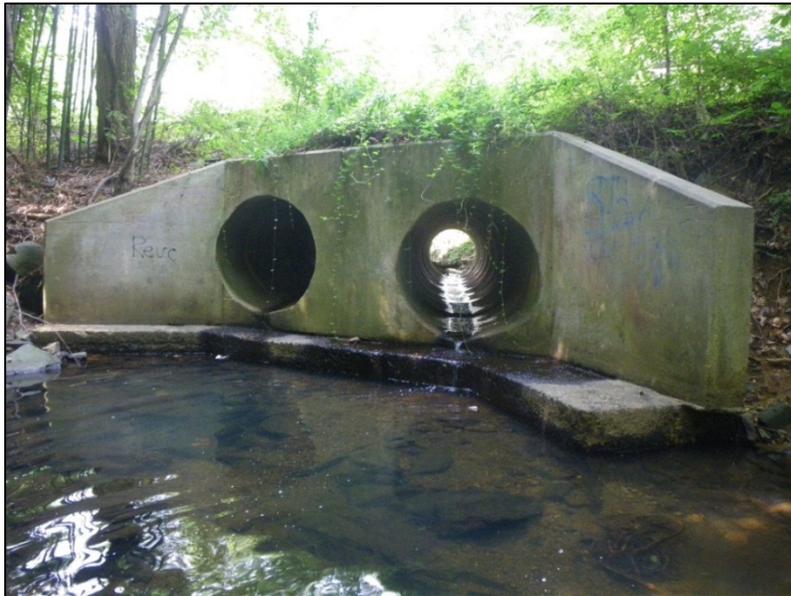
Figure 2 – Fish blockage at Laurel Bush Road

The bioassessment results for 2012 indicated a 'Poor' biological community for fish. The sample was dominated by pollution-tolerant taxa, making up 99.6 percent of the sample. The addition of one intolerant species (rosyside dace) shows that biological conditions in the restored channel may be improving. However, the current species composition may be limited due to a fish blockage at the downstream end of the culvert at Laurel Bush Road (Figure 2). This blockage is 1.5 feet in height and is a double barrel concrete culvert road crossing. Multiple intolerant northern hogsuckers (*Hypentelium nigricans*) were observed in the large pool downstream of the blockage at the time of sampling.
