Wexford 2009: Annual Physical Assessment

Harford County Department
of Public Works

Wexford 2010 Annual Physical Assessment

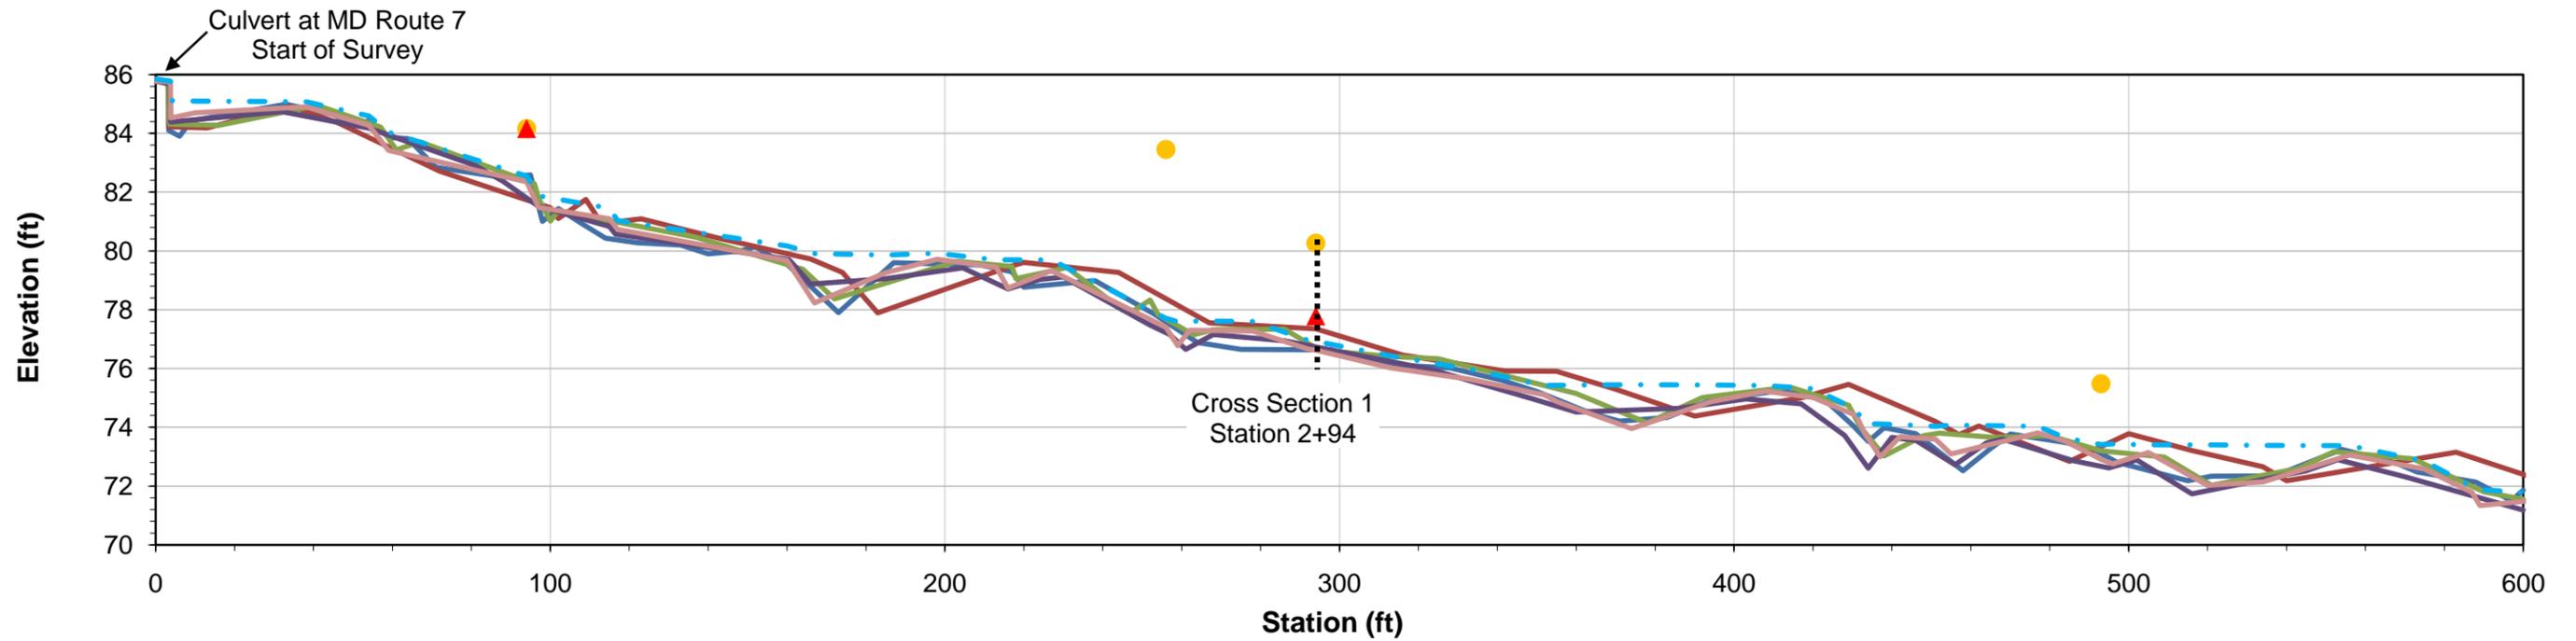
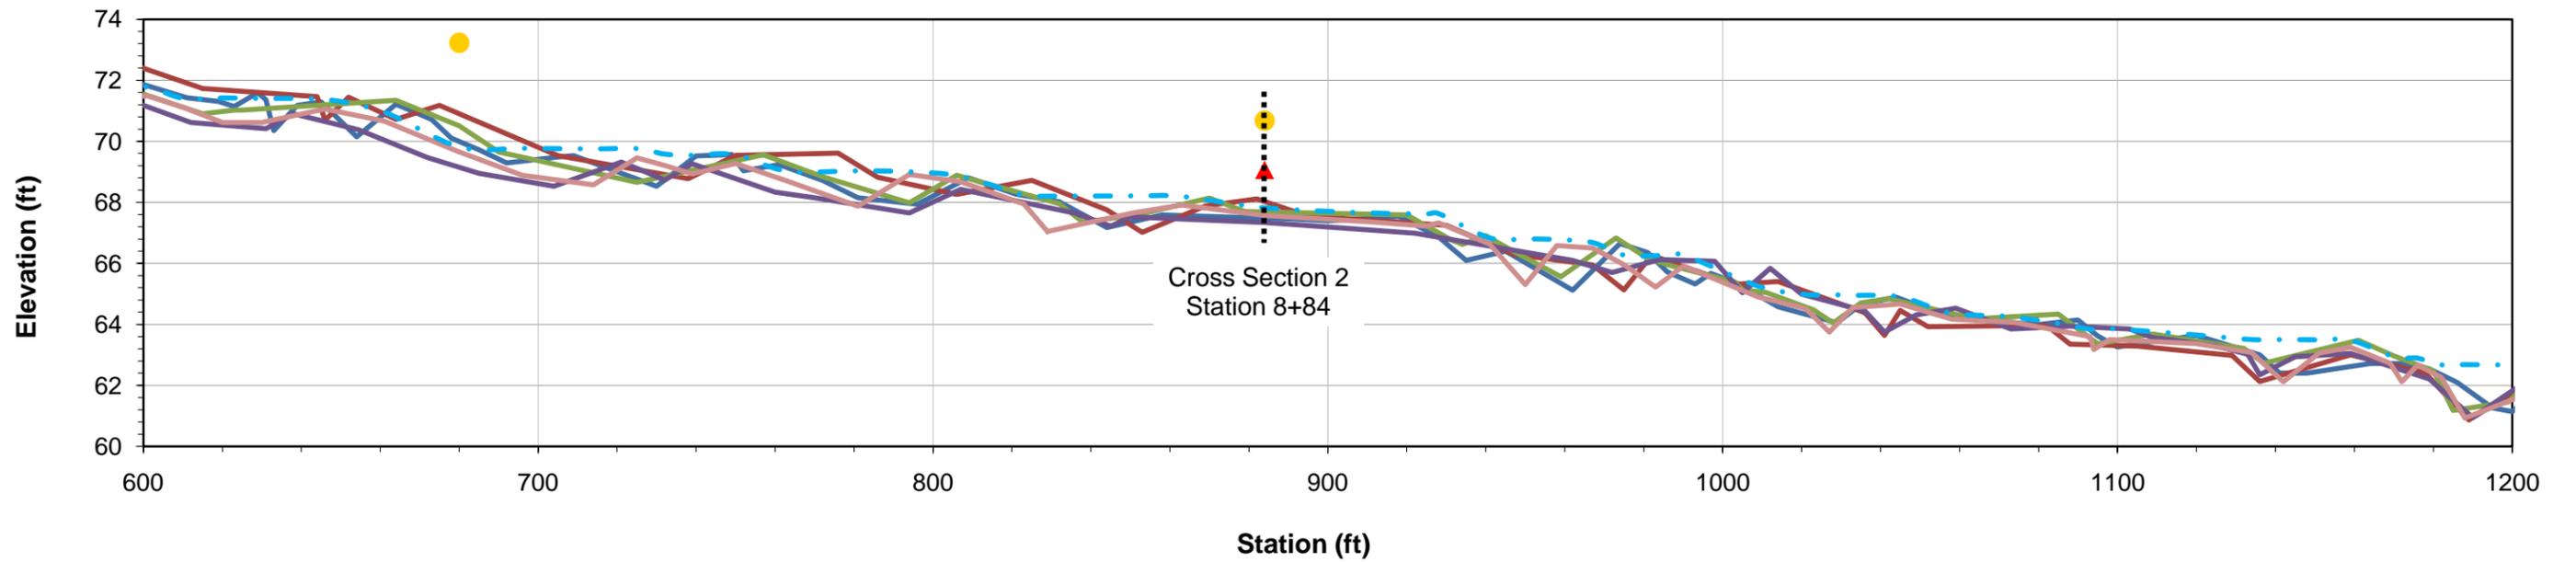
Longitudinal Profile Station 0+00 to 12+00

— Thalweg 2005
 — Thalweg 2006
 — Thalweg 2007
 — Thalweg 2008
 — Thalweg 2009
 - · - Water Surface 2009
 ● Top of Bank 2009
 ▲ Bankfull 2009

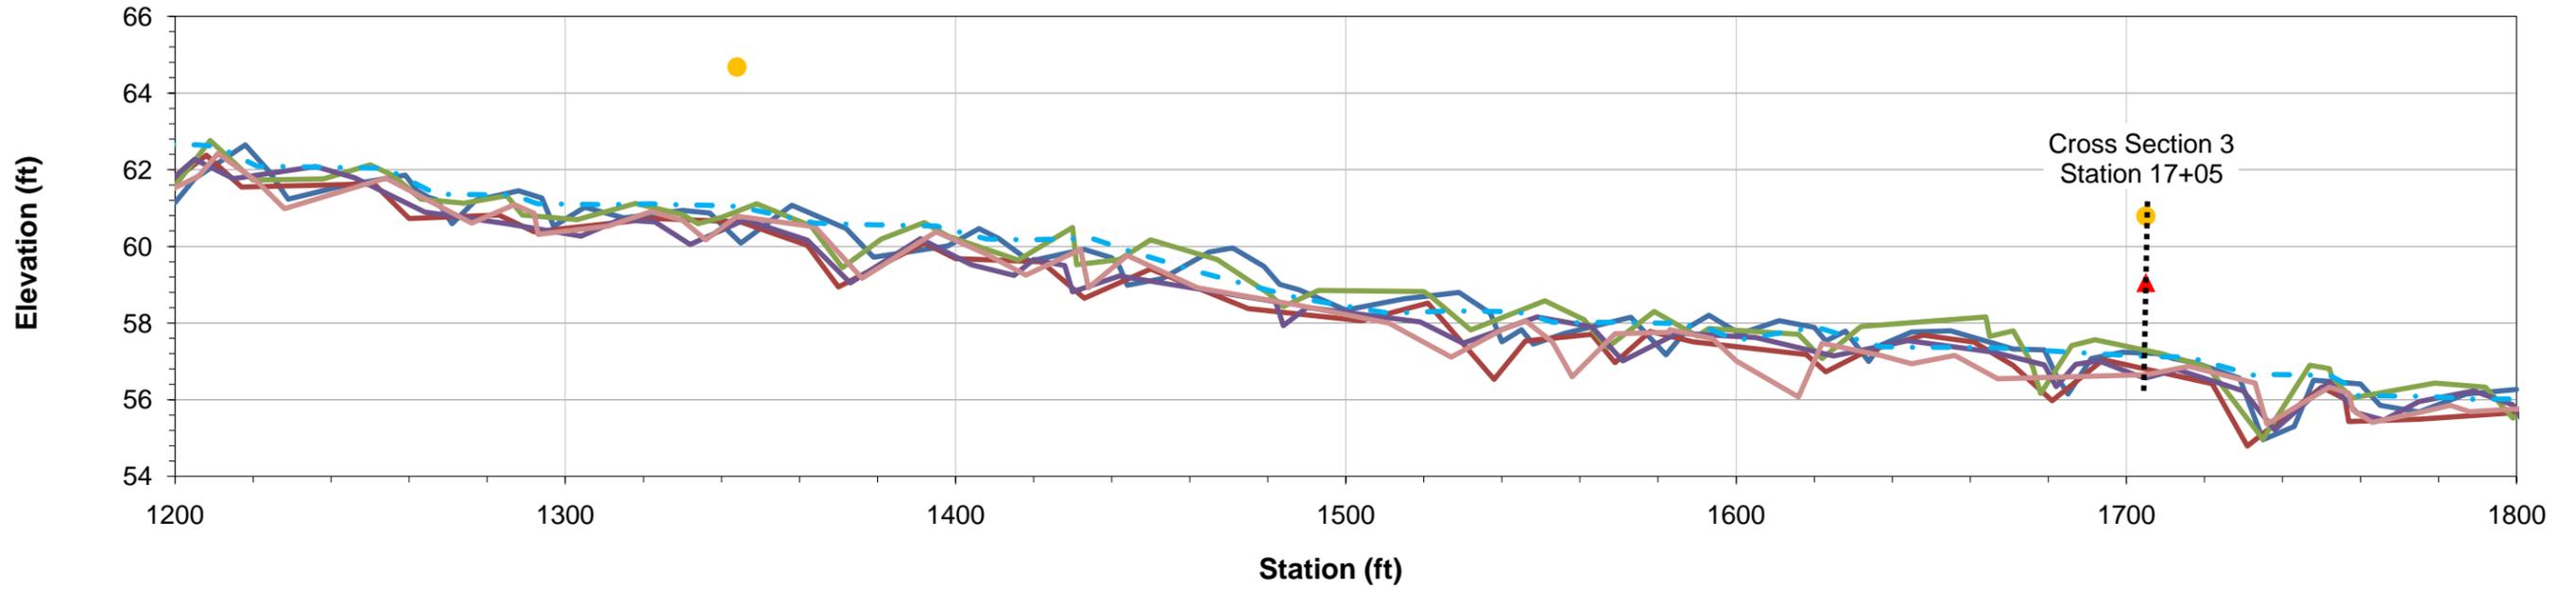
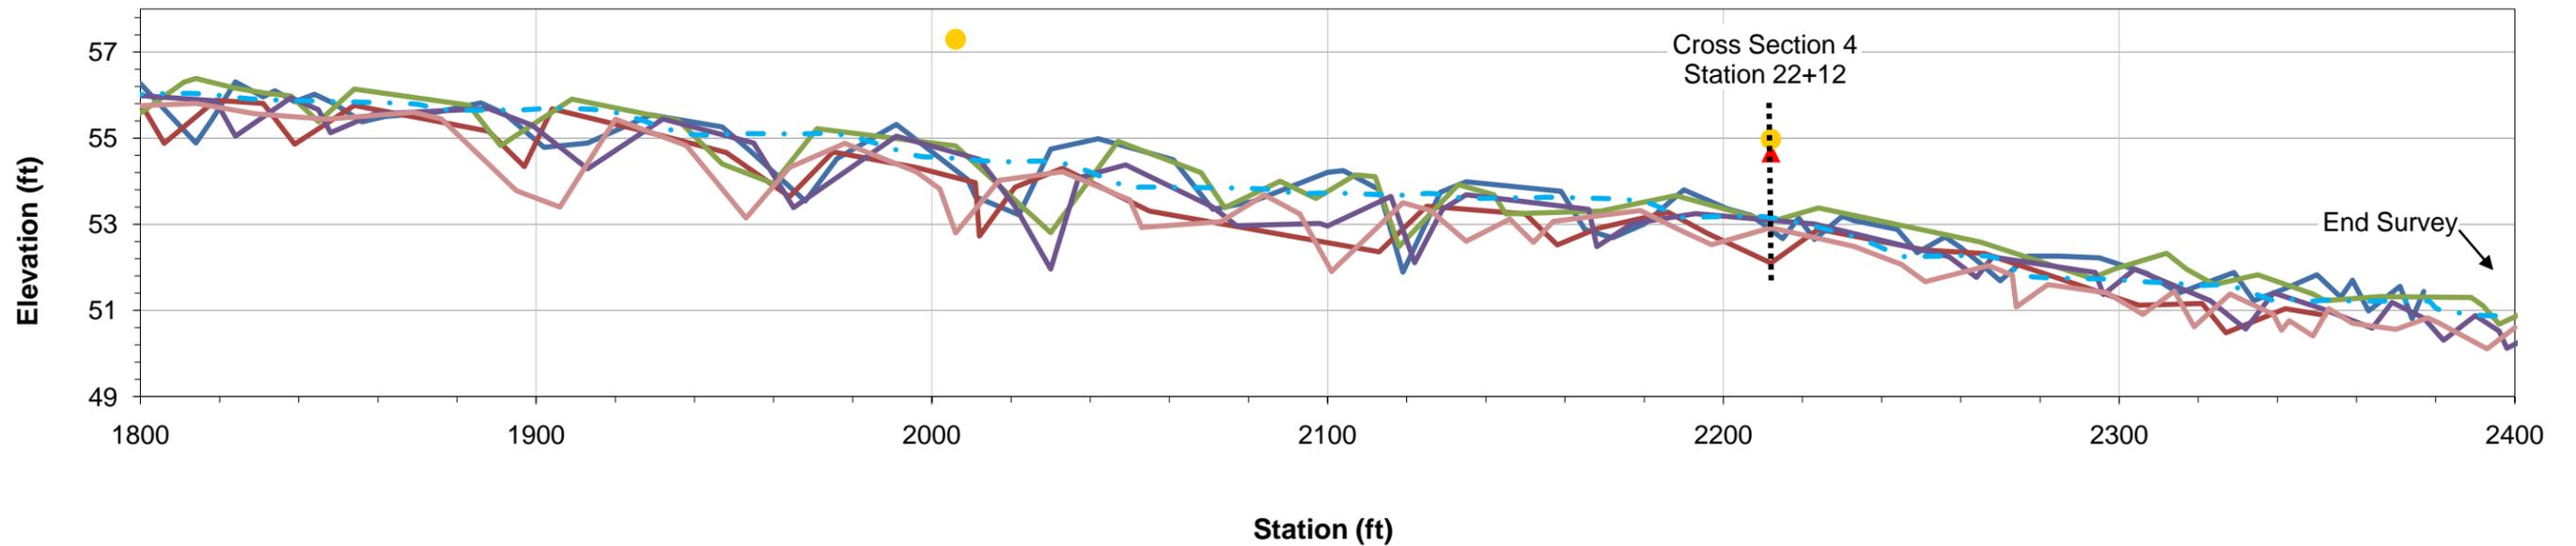
Longitudinal Profile Station 12+00 to 18+00

— Thalweg 2005 — Thalweg 2006 — Thalweg 2007 — Thalweg 2008 — Thalweg 2009 - · - Water Surface 2009 ● Top of Bank 2009 ▲ Bankfull 2009

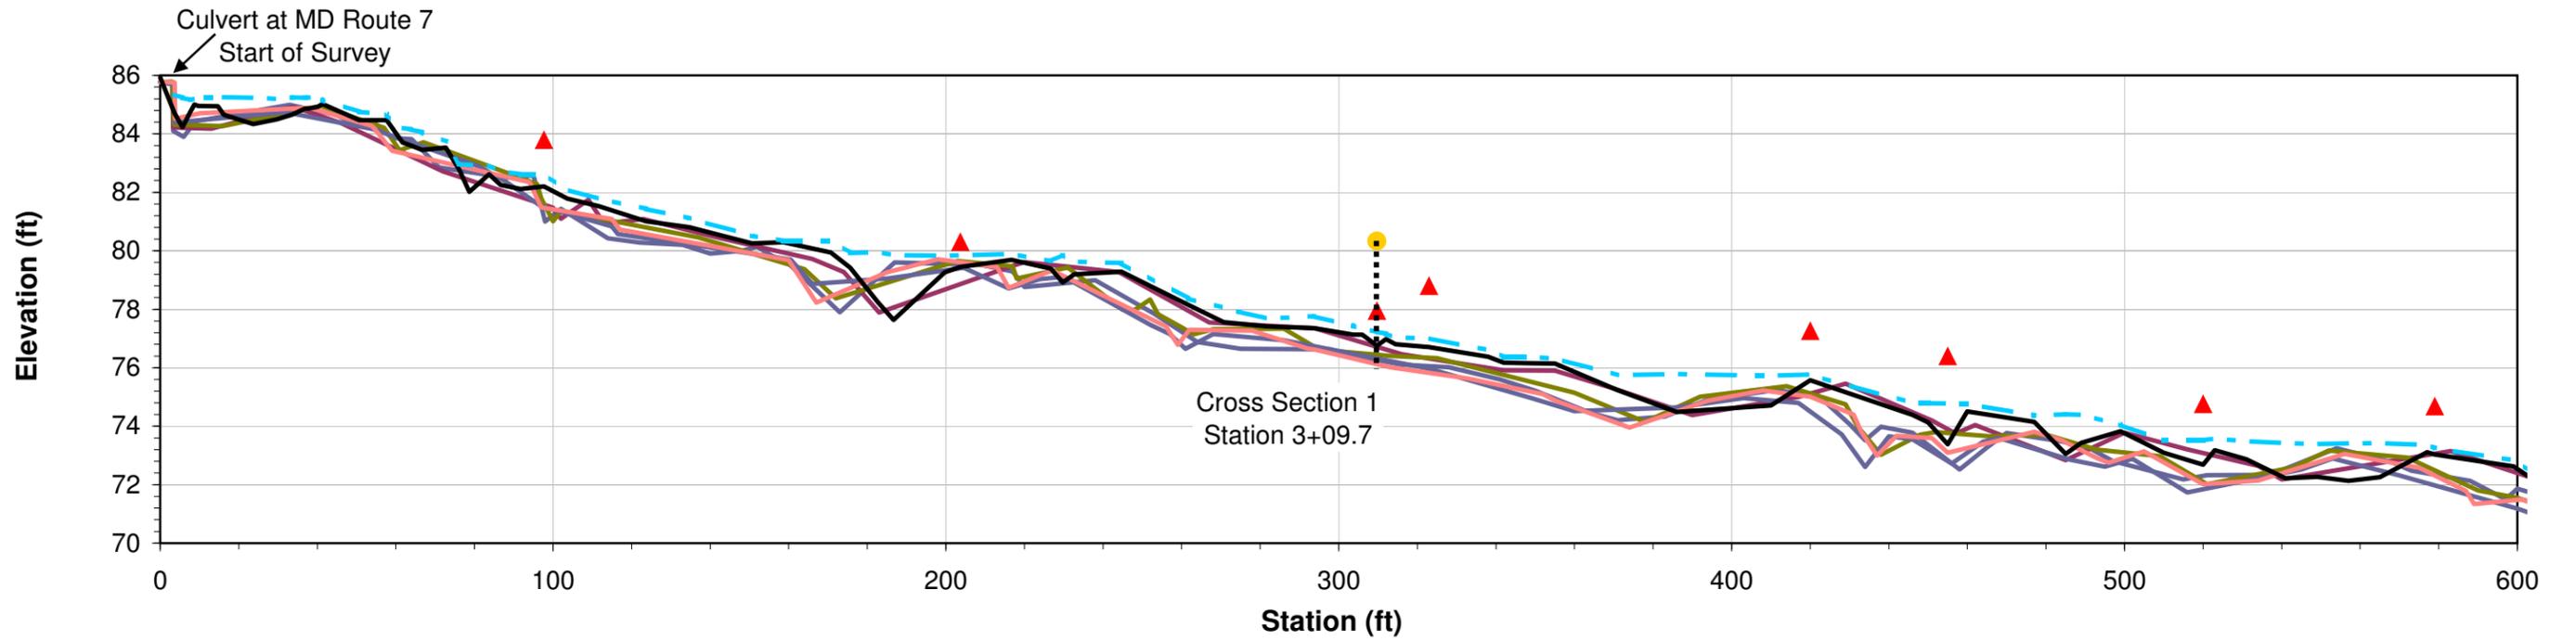
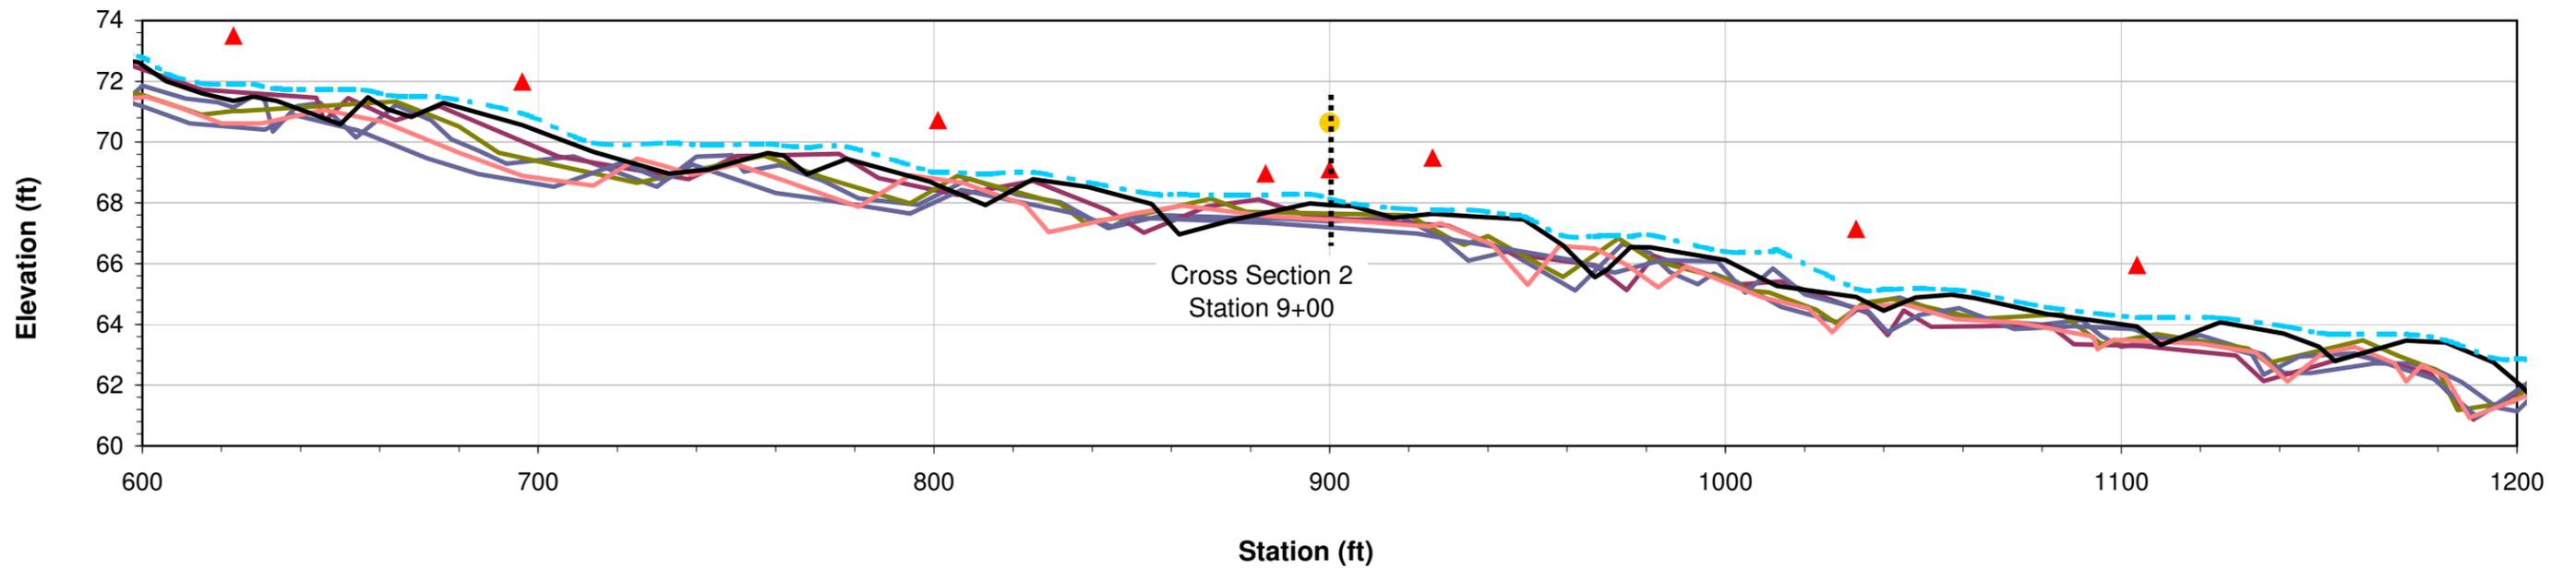
Longitudinal Profile Station 0+00 to 12+00

The profile and cross section data collected for 2010 were superimposed over the data collected for years 2005 to 2009. The 2010 data is generally consistent with data collected in previous years, and no discernible change in the stream's overall condition is evident from the data. The stream remains degraded, and there are some notable changes in stream bed elevations, but on average the stream does not appear to be degrading further. In addition, the cross section data shows that there is little change in the stream bank locations, indicating that the stream does not appear to be widening further, at least in the short term of five years. However, there does appear to be some change in the stream bed elevations at the cross section locations, indicating shifting of sediment as it is transported downstream.

— Thalweg 2005
 — Thalweg 2006
 — Thalweg 2007
 — Thalweg 2008
 — Thalweg 2009
 — Thalweg 2010
 - - Water Surface 2010
 ● Top of Bank 2010
 ▲ Bankfull 2010

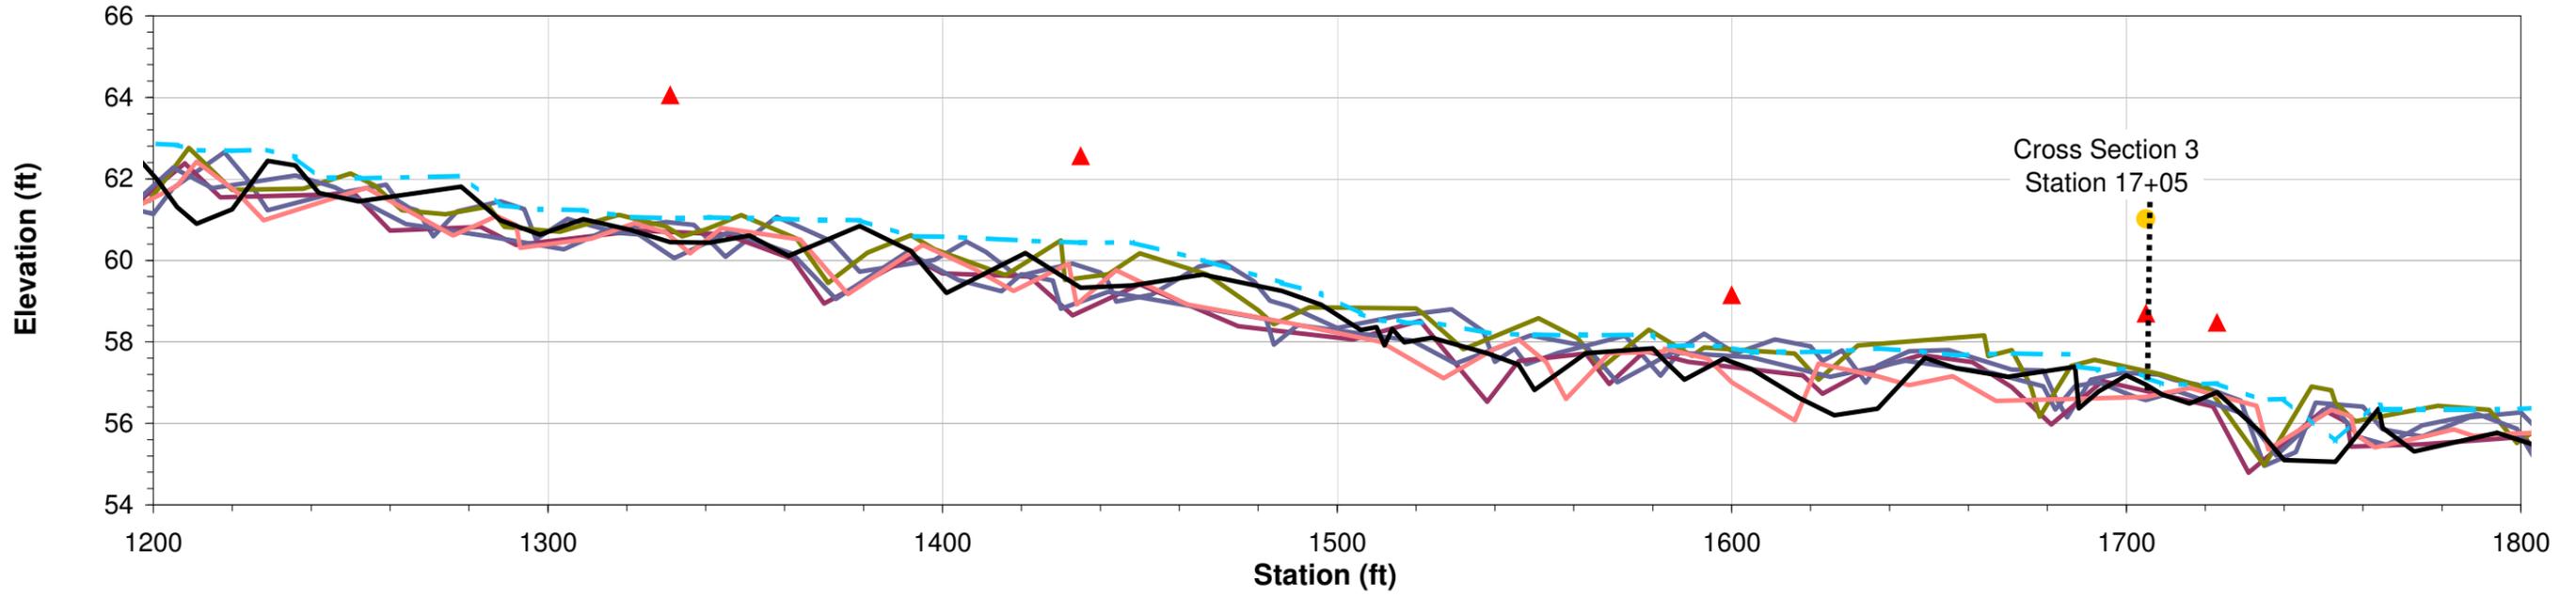
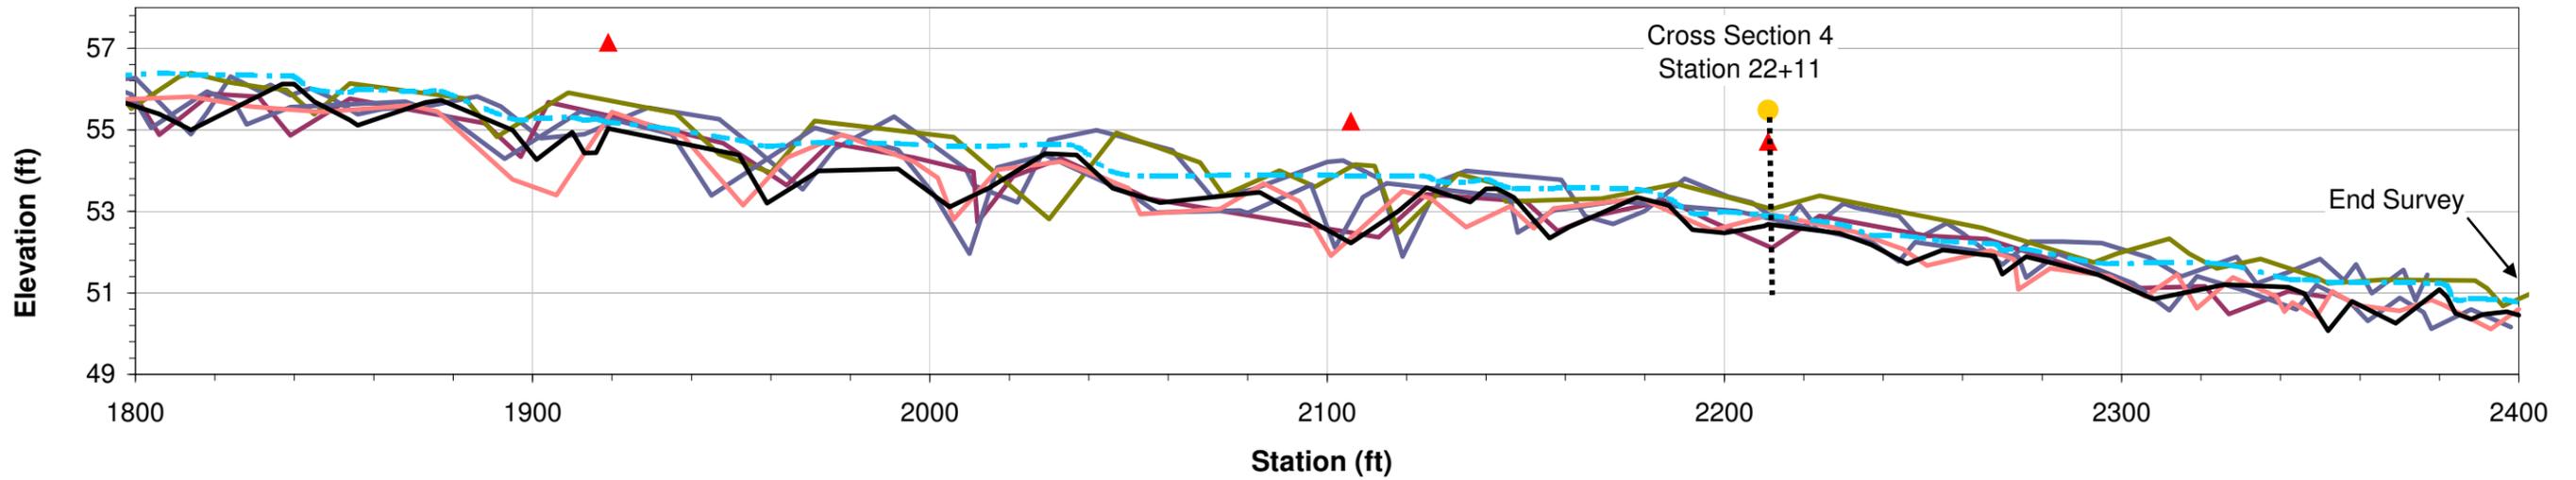
Longitudinal Profile Station 12+00 to 24+00

— Thalweg 2005 — Thalweg 2006 — Thalweg 2007 — Thalweg 2008 — Thalweg 2009 — Thalweg 2010 — - - - Water Surface 2010 ● Top of Bank 2010 ▲ Bankfull 2010

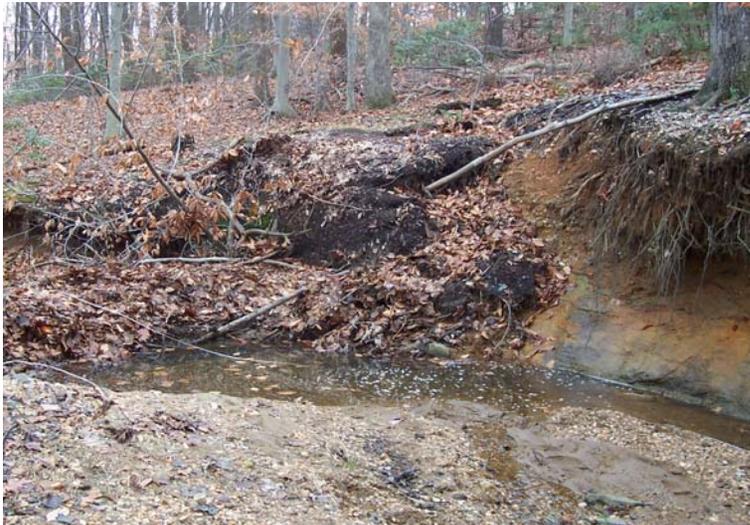
Erosion at station 4+73

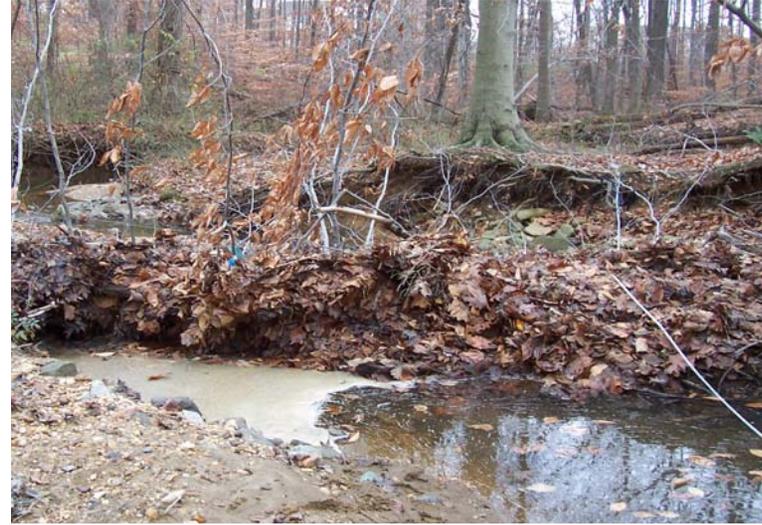
Mass wasting at station 4+84

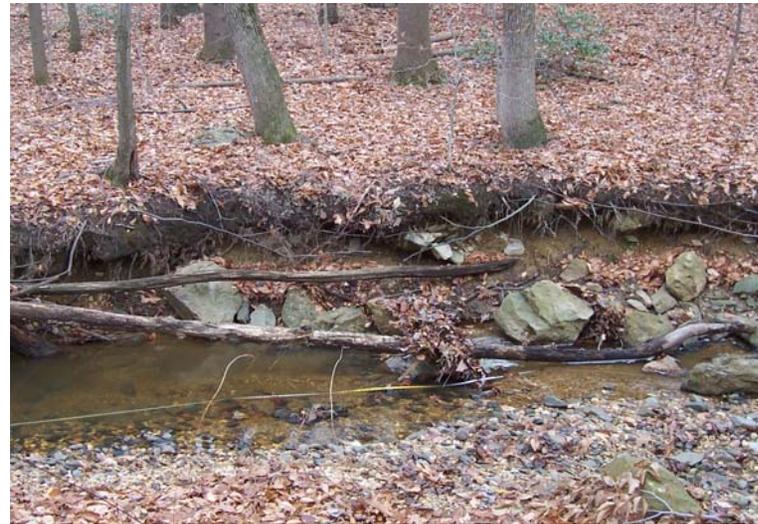
Log across stream at station 7+78

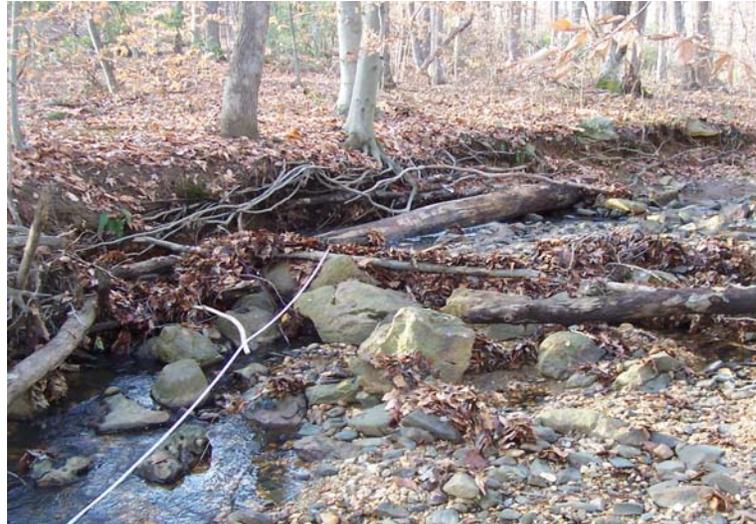
Debris jam at station 10+14

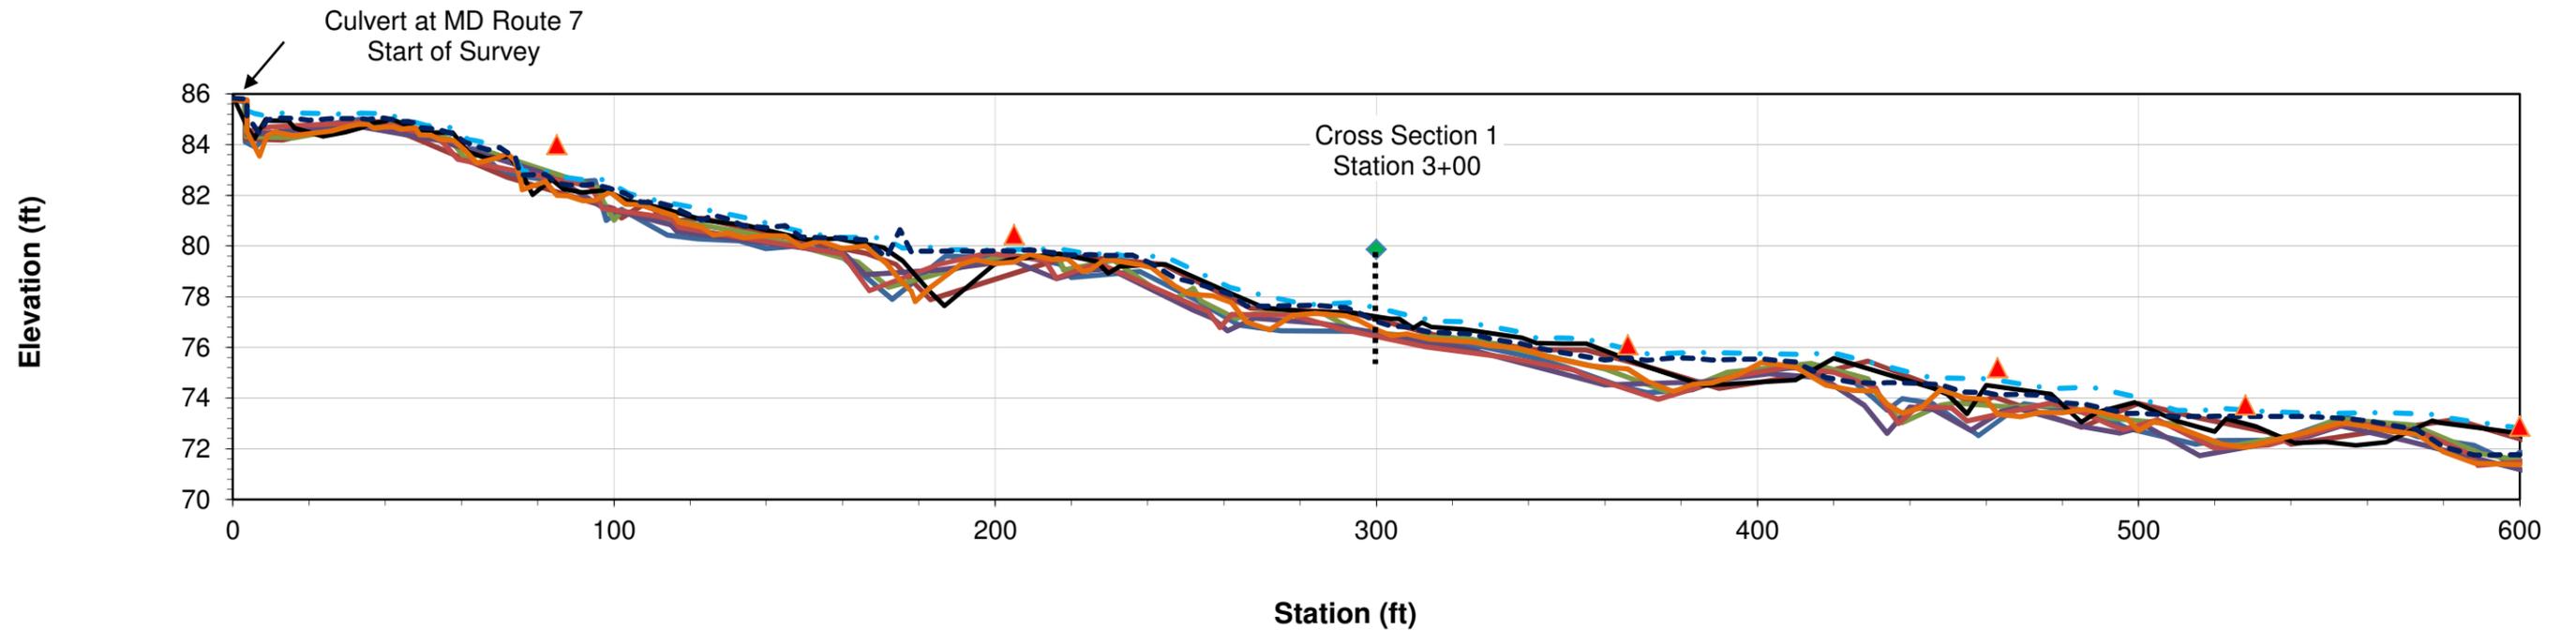
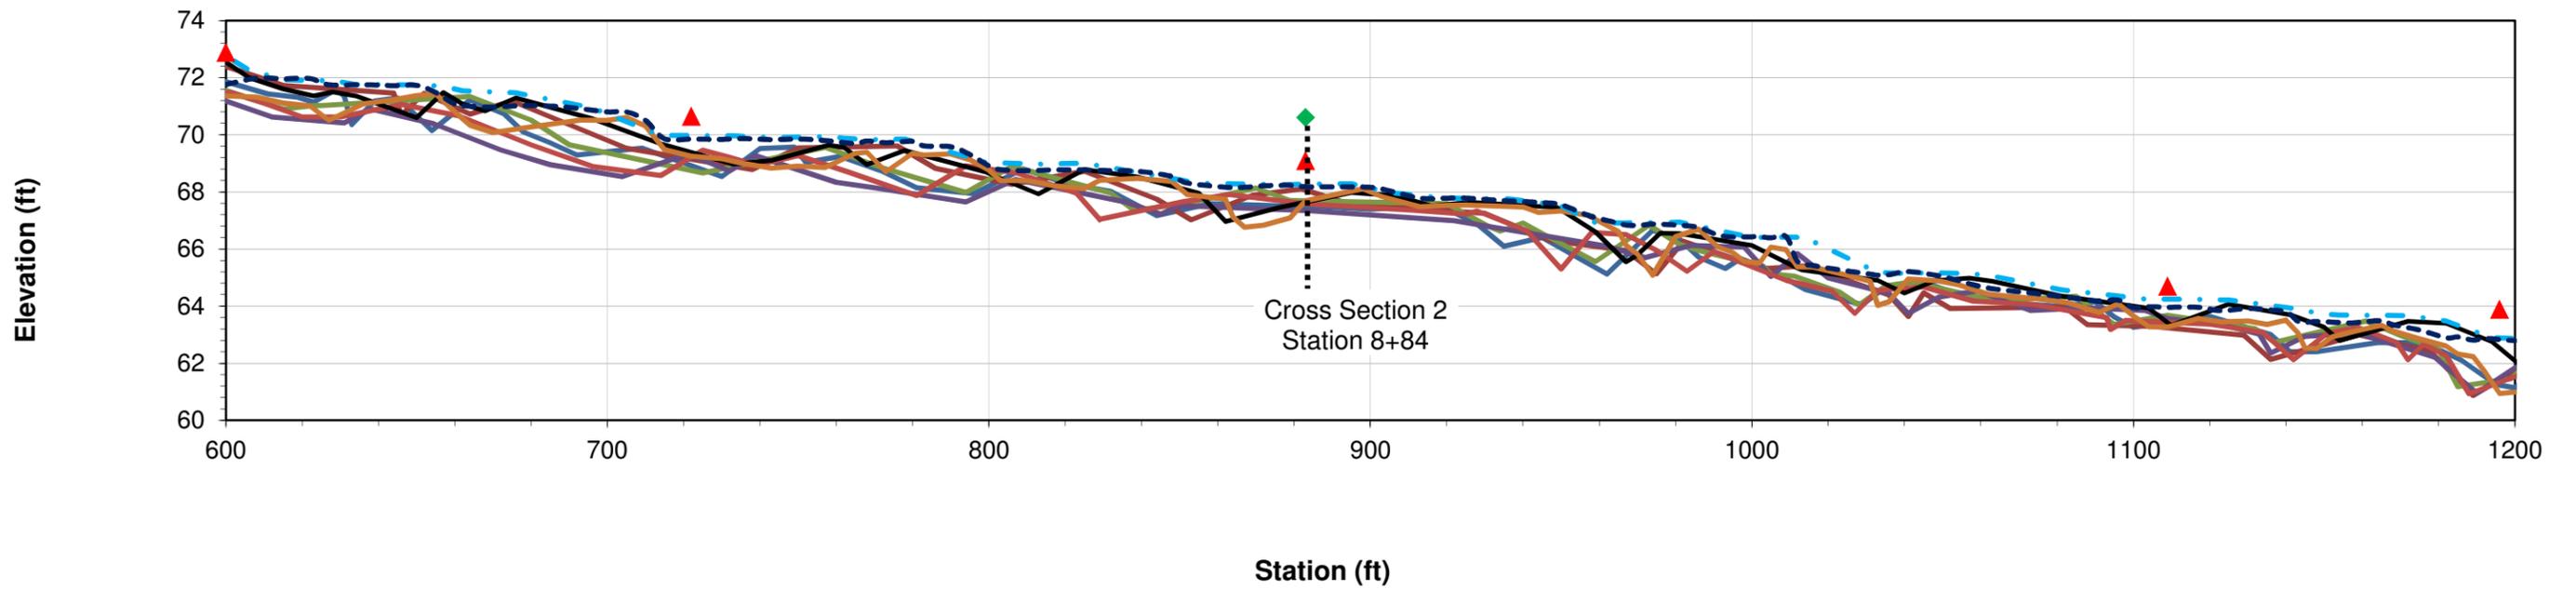
Longitudinal Profile Station 0+00 to 12+00

The profile and cross section data collected for 2011 were superimposed over the data collected for years 2005 to 2010. The 2011 data is generally consistent with data collected in previous years, and no discernible change in the stream's overall condition is evident from the data. The stream remains degraded, and there are some notable changes in stream bed elevations, but on average the stream does not appear to be degrading further. In addition, the cross section data shows that there is little change in the stream bank locations, indicating that the stream does not appear to be widening further, at least in the short term of five years. However, there does appear to be some change in the stream bed elevations at the cross section locations, indicating shifting of sediment as it is transported downstream. One notable change is located at cross section 4, where the stream has down cut 0.3 feet (3.6 inches) since the 2010 assessment.

- Thalweg 2005
- Thalweg 2006
- Thalweg 2007
- Thalweg 2008
- Thalweg 2009
- Thalweg 2010
- Thalweg 2011
- . - . Water Surface 2010
- - - Water Surface 2011
- ▲ Bankfull 2011
- ◆ Top of Bank 2011

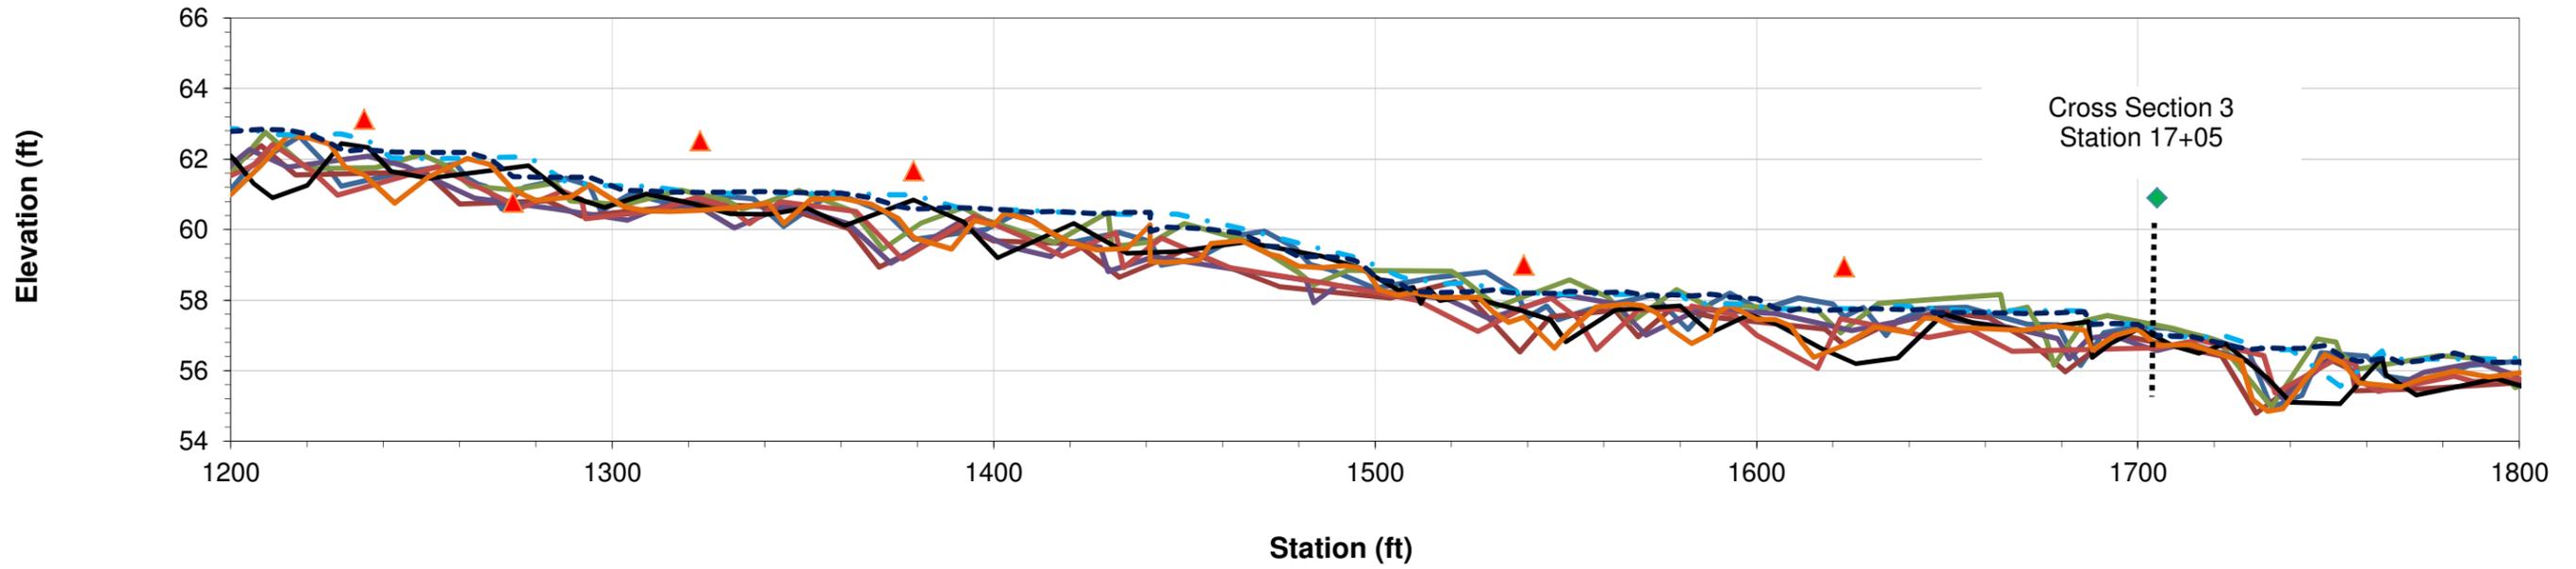
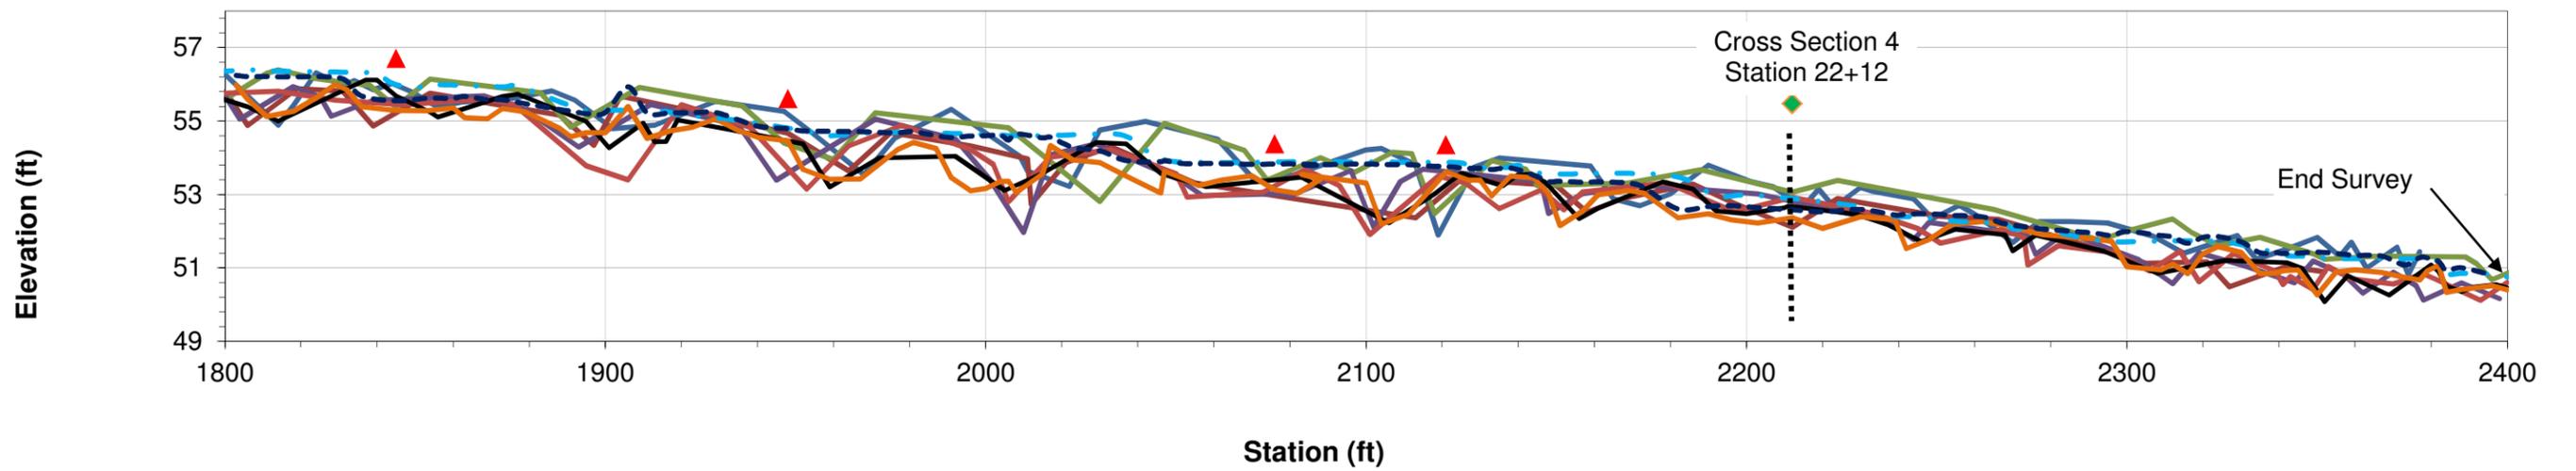
Longitudinal Profile Station 12+00 to 24+00

- Thalweg 2005
- Thalweg 2006
- Thalweg 2007
- Thalweg 2008
- Thalweg 2009
- Thalweg 2010
- . - Water Surface 2010
- - - Water Surface 2011
- ▲ Bankfull 2011
- ◆ Top of Bank 2011

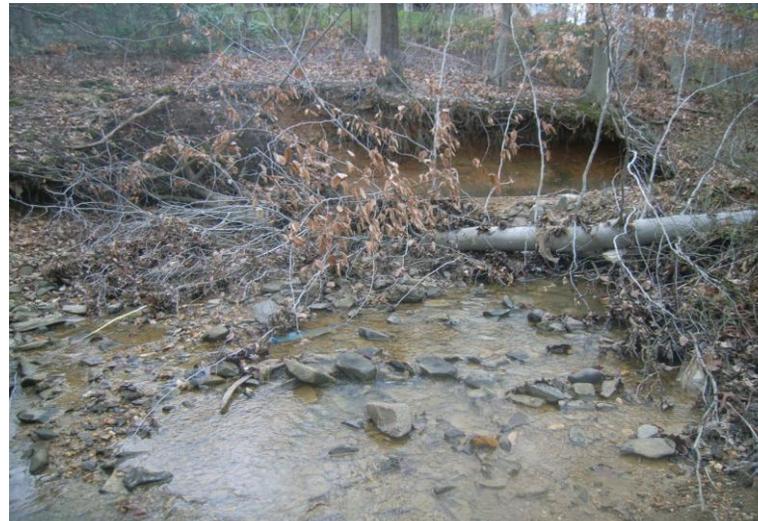
Downstream view at 3+60 showing downed tree
