**WHEEL CREEK
GEOMORPHIC ASSESSMENT
YEAR 3
FINAL REPORT**

**WHEEL CREEK
GEOMORPHIC ASSESSMENT
YEAR 3 FINAL REPORT**

Harford County
Department of Public Works
Division of Highways and Water Resources
15 North Bond Street
Bel Air, Maryland 21014

Versar, Inc.
9200 Rumsey Road, Suite 100
Columbia, Maryland 21045

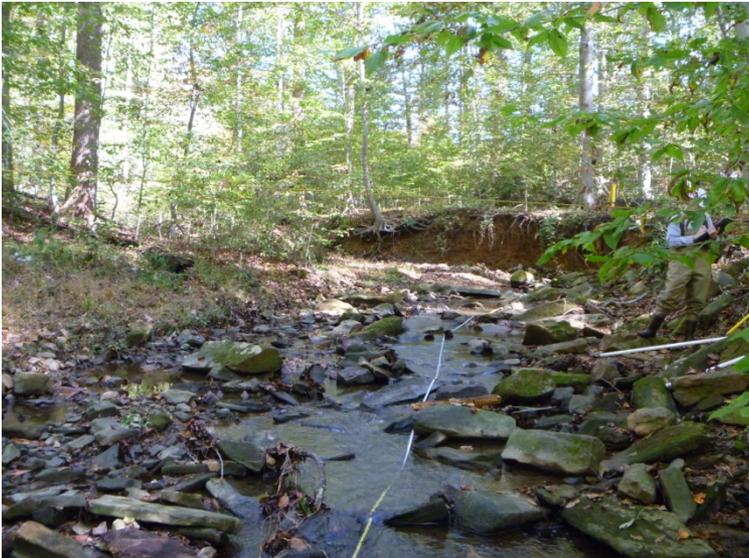
WC01 – XS-1 facing upstream

Changes in the cross-sections were also observed at WC01 between the three years of survey (Figures C-5, C-6). Bed scour was observed at Cross-section 1 (Crossover Riffle at Station 2+29) especially near the right bank between Years 1 and 2, while deposition is apparent near the left bank between Years 2 and 3. Significant bank erosion and undercutting along the left bank (almost 6 feet) was observed at Cross-Section 2 (Meander Bend at Station 2+95) during both second and third years' monitoring. This has resulted in increases, from Year 1, of bankfull cross-sectional area and top of bank cross-sectional area at this station. Between Years 1 and 2, a side-bar formed on the right bank, burying the scour chain at this cross-section. In addition, the thalweg pattern changed between Years 1 and 2 so that it is no longer perpendicular to the permanently monumented cross-section markers at this location.

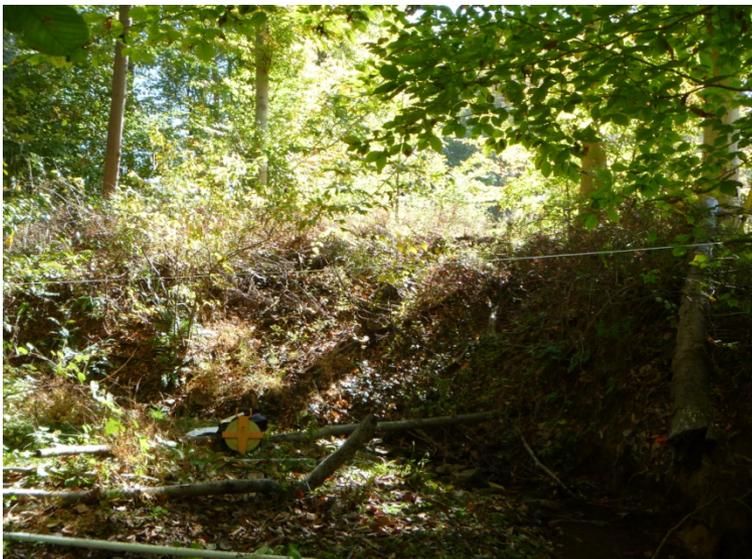
WC04 – XS-1 facing upstream

The cross-sections within this reach also remained relatively unchanged between the three years of study, with the exception of some lower bank erosion observed at Cross-section 1 (Meander at Station 1+08) between Year 1 and Years 2 and 3 (Figures C-11 and C-12). This station was identified as a riffle located just above the top of a pool during the initial year of monitoring, but was within part of the pool when surveyed in Years 2 and 3. The channel was actively widening and cutting into the bank at this station during the Year 3 survey, resulting in changes in cross-sectional dimensions (Table C-2).

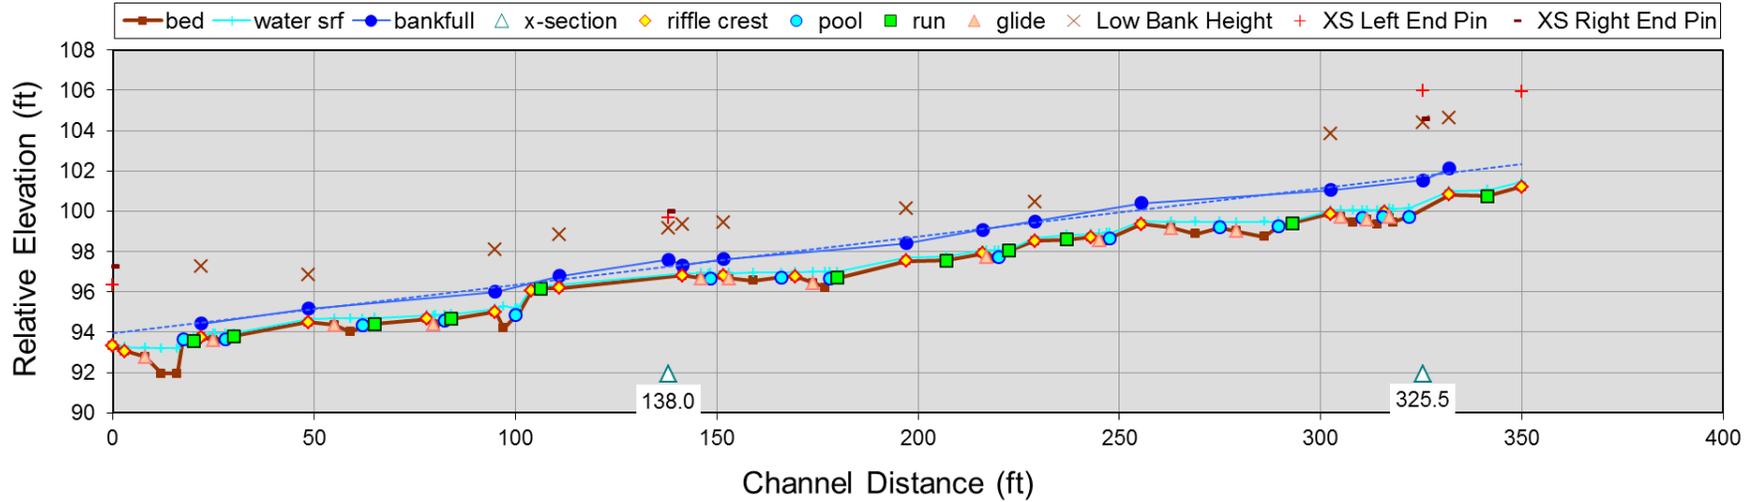
Wheel Creek WC-02 2013

Significant changes in profile were not observed at WC02 over the three years of study (Figure C-2). Reach length remained constant and stream slope measurements were fairly consistent overall. Feature proportions within the reach have fluctuated from year to year. While the percentage of glides increased from 0% to 16.7% between Years 1 and 2, the percentage of pools has declined each year. During the third year 39.3% of the surveyed reach was classified as pools and glides, the lowest percentage since monitoring began. In contrast, riffles and runs made up 60.7% of the surveyed reach which was the greatest percentage of all three years (Table C-1).

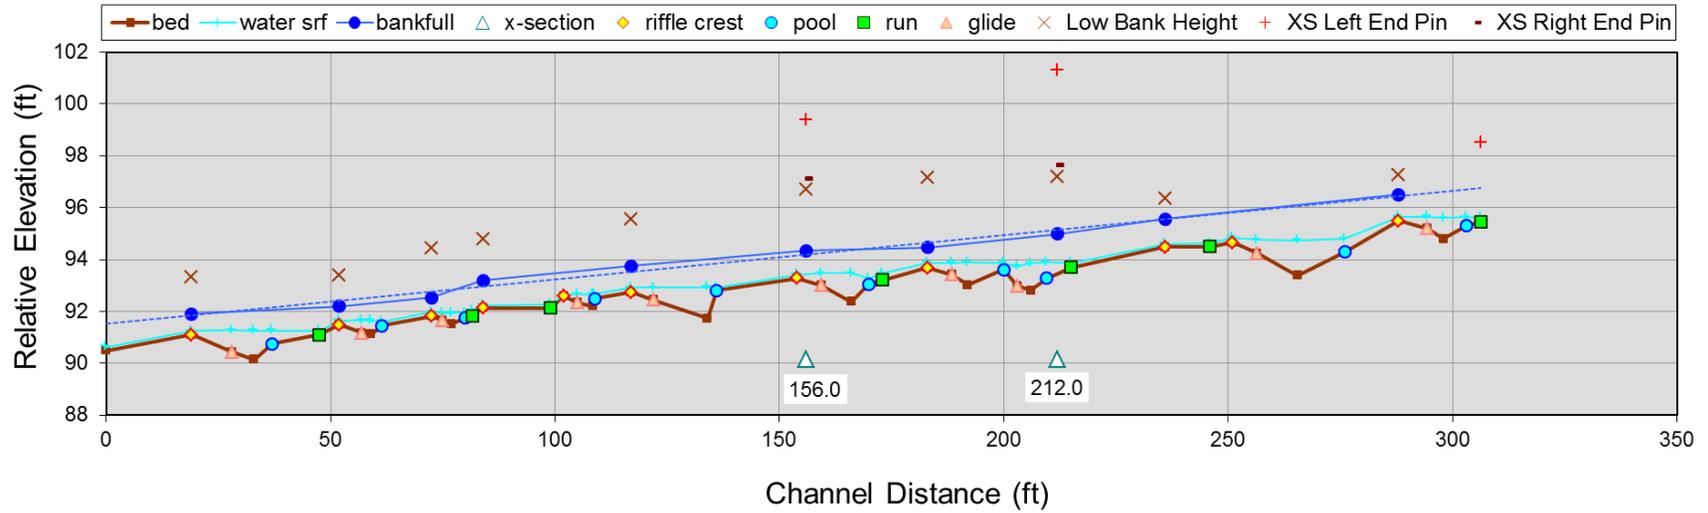
Wheel Creek WC-03 2013

Pool and glide features have previously dominated reach WC03, as 65.6% and 67.5% of the reach was made up of pools and glides during Years 1 and 2, respectively. During Year 3, however, riffles and runs made up more than half (53.1%) of the reach (Table C-1). Changes in longitudinal profile were noted between the three years' of study, most notably the deepening of most pools reachwide between the first two years (Figure C-3). Pool depth has stayed fairly consistent between Years 2 and 3.

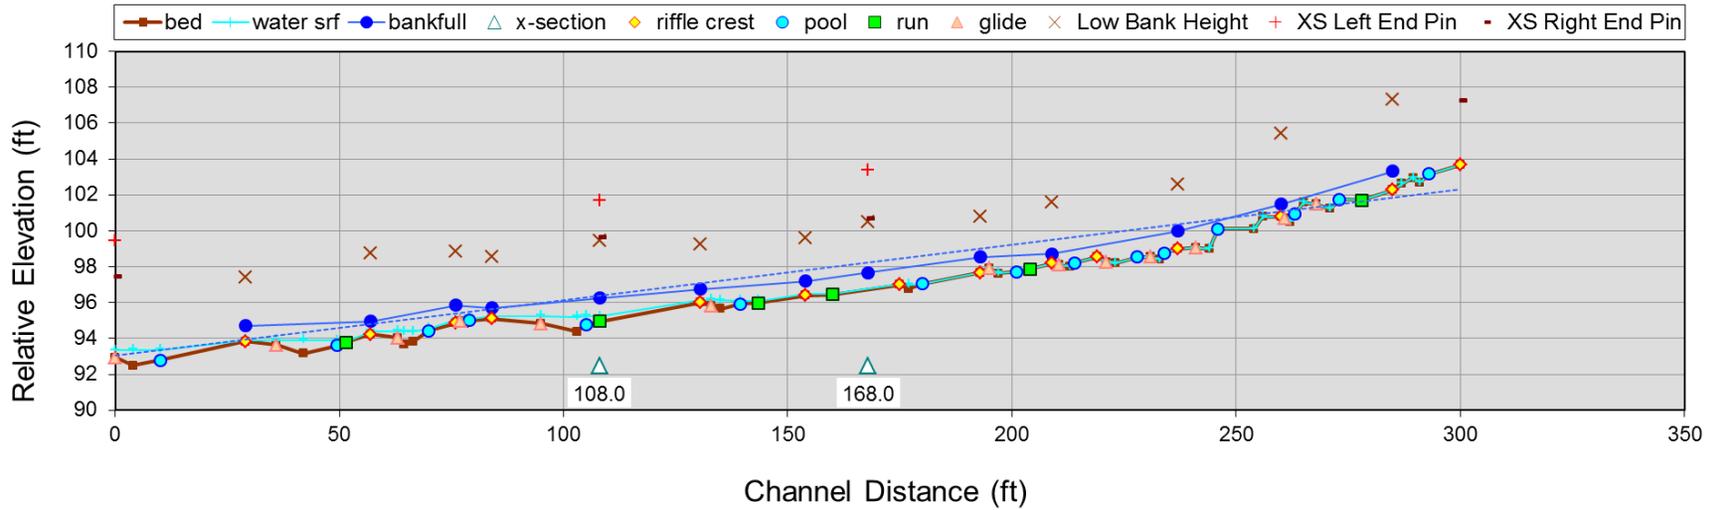
Wheel Creek WC-04 2013

No significant changes were observed in the profile of the downstream portion of the reach at site WC04 between the three years' of study. However, during Years 2 and 3 survey, the stream channel was dry from above the pool feature at Station 1+80 to the top of the reach at Station 3+00 and beyond. Around this same station and above, channel aggradation can be seen when comparing the profiles of the initial year and Years 2 and 3 surveys (Figure C-4), which may explain the decrease in water depth between these surveys. This aggradation can be explained by a slight decrease in stream power caused by the net stream bank erosion that has occurred throughout the study period in the upper portion of this reach (Table C-4; WC04 Station 2+64.5), which is explained in detail below. Reach length, slope, and proportion of features within the reach remained relatively unchanged (Table C-1).

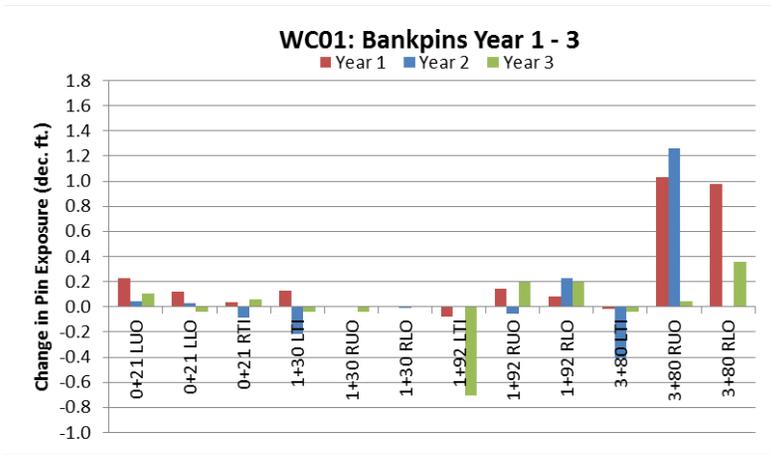
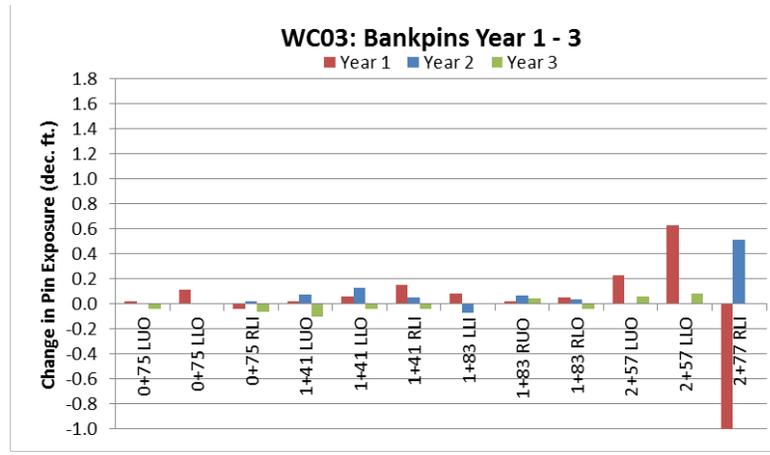
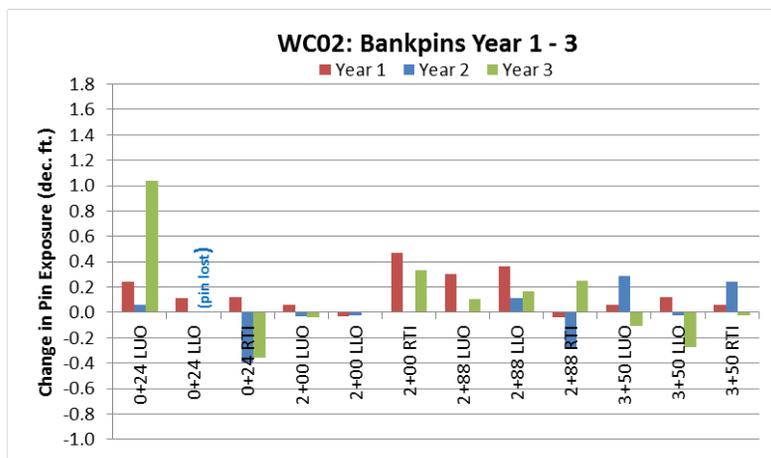
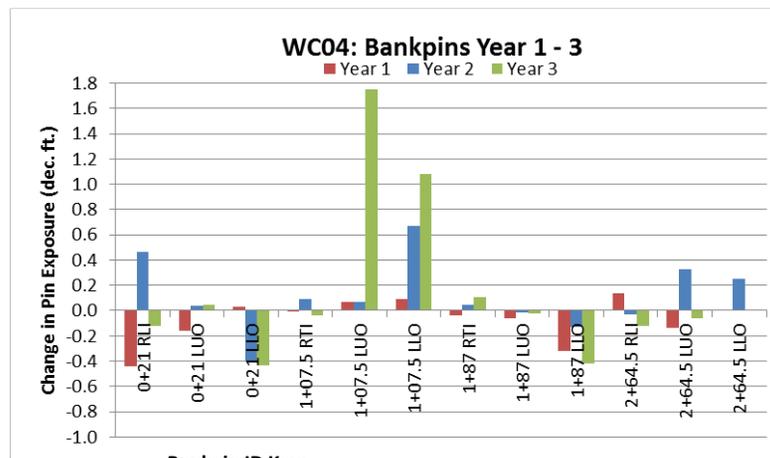
Figure C-13. Cumulative changes in Bank Pin Exposure Year 1-3. Between Year 1 and Year 2, a pin was lost at WC02 station 2+24 LLO, and was not recovered in Year 3.
