HARFORD COUNTY DPW

LOWER BYNUM RUN SMALL WATERSHED ASSESSMENT REPORT APPENDICES

DECEMBER 13, 2019

HARFORD COUNTY DEPARTMENT OF
PUBLIC WORKS

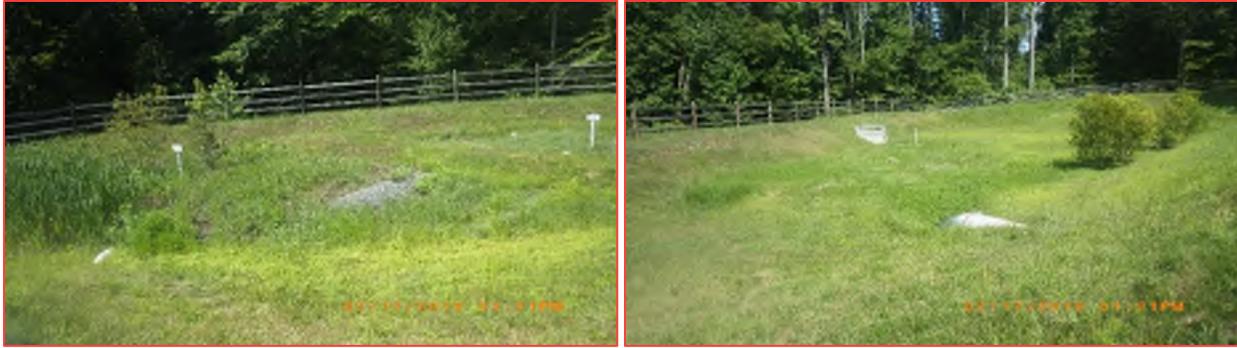
Existing HA14BMP000933 is located behind residences on the north end of Cogswell Court. There is unobstructed access from Cogswell Court to an 18-foot swing gate. It is within the MSB-2 subwatershed. It consists of a sediment forebay on the eastern part of the facility that conveys flows to a dry pond. The dry pond drains through a riser control structure and into a natural channel. A 24-foot grass emergency spillway exists on the northeast part of the facility. Flows from Cogswell Court are split before entering the facility at two inflow points. A 12-inch CMP pipe conveys flows into the forebay. There is wetland vegetation in the forebay, and it is in good condition. A 24-inch CMP conveys flows directly into the dry pond. The facility appears to be relatively new, and all structures are in excellent condition.

Figure A-1. Forebay from access gate (left); 24-inch CMP inflow point and riser structure from access gate (right)

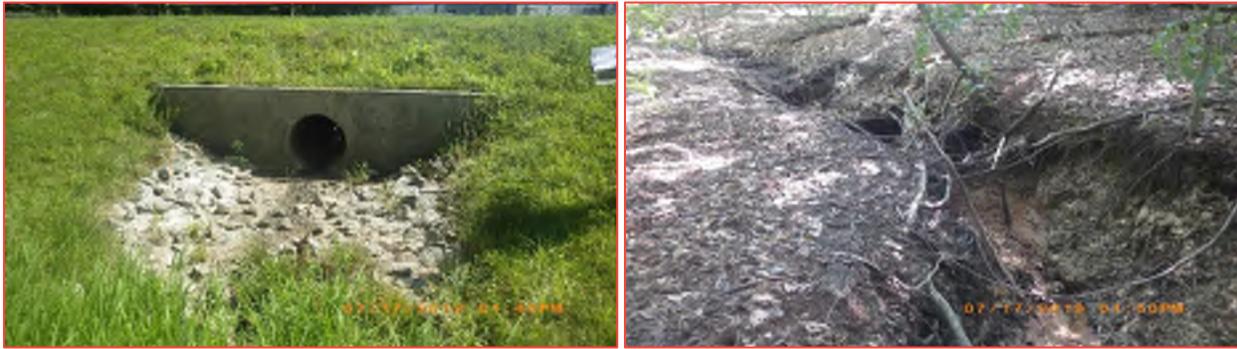
There was 0.41 inch of rainfall observed in the area on the day of the site visit (7/17/19). There was 0.02 inch of rainfall in the area on the two days prior to the site visit. A concrete riser structure sits on the northern border of the facility. Flows enters through a 6-inch PVC low flow orifice with trash rack and discharges through a 30-inch CMP principal spillway. The outfall is in excellent condition. The outfall channel is in good condition up until 50 feet upstream of confluence with a natural channel. There is a 4-foot headcut and minor erosion at this point in the channel.

Figure A-2. Facing upstream at outfall and outfall protection (left); Facing upstream at headcut and erosion in outfall channel (right)

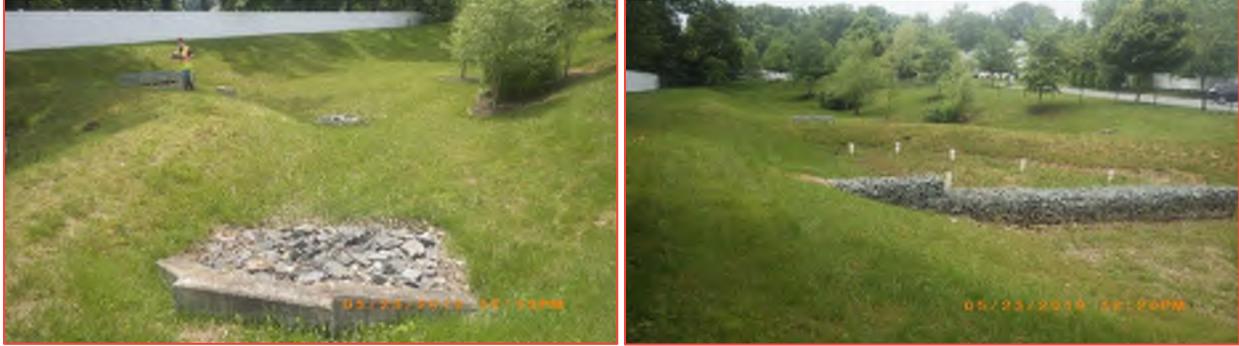
There was 0.1 inch of rainfall observed in the area on the day of the site visit (5/23/19). There was no rainfall recorded in the area on the two days prior to the site visit. Low flow enters through a 12-inch HDPE pipe with an orifice plate constricting the flow diameter to 1.5 inches. The low-flow orifice is housed in a riser structure consisting of triangular prism trash rack. Flows discharge out the riser from a 24-inch RCP principal spillway and enter the municipal storm sewer system.

Figure A-3. Facing southwest towards facility at inflow pipe (left); facing west towards sand filter (right)

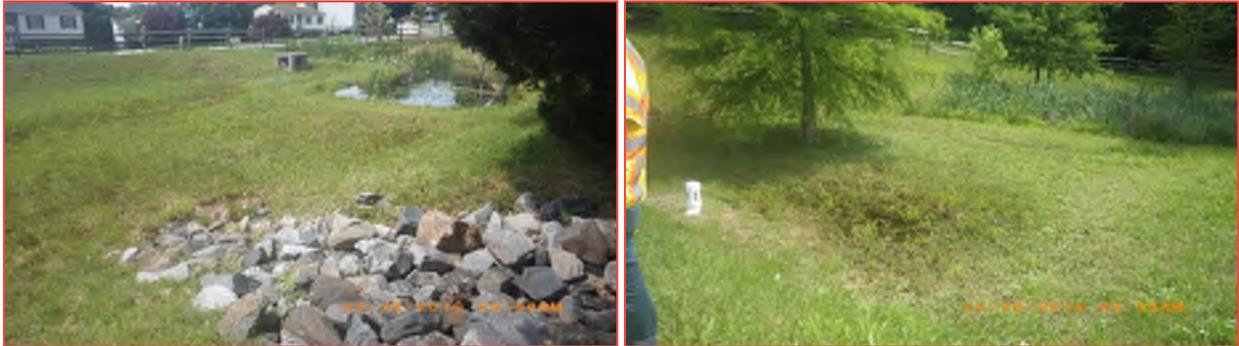
Existing SWM000029 is located off St. Mary’s Church Road on the side of New Covenant Presbyterian Church. It is accessible from the road and has an 18-foot swing gate. The facility is within the MSB-4 subwatershed. It consists of a dry pond that is routed through a riser and drains to the storm sewer system. A 24-inch corrugated HDPE pipe conveys flow from a northern parking lot into a wetland on the eastern side of the facility. A 6-inch PVC riser conveys flow from the eastern wetland area to the main dry pond in the center of the facility. Flows from the roof, field, and playground areas are conveyed into the facility and the inflow is protected by riprap. A French drain at the base of the western parking lot collects runoff and conveys it via a 12-inch CMP into the facility’s western wetland area. Water in the wetland covers the 12-inch CMP, its 6-inch PVC control structure, and is nearly overflowing its eastern berm. There are lily pads and cattails in the wetland, and trees on the edges have been partially submerged. The submerged 6-inch PVC control structure conveys flow into the dry pond. A 14-foot wide grass emergency spillway exists on the east part of the southern border of the facility.

Figure A-4. Facing west at the dry pond and wetland area from the inflow point (left); Eastern wetland region of the facility (right)

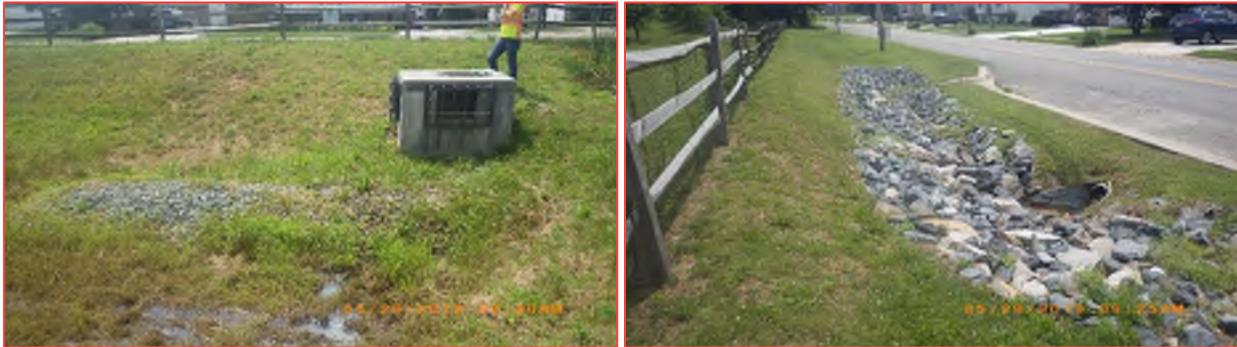
There was no rainfall observed in the area on the day of the site visit (5/29/19). There were 0.09 inch of rainfall in the area on the two days prior to the site visit. The concrete riser structure sits just outside the western wetland in the facility. Low flow enters through a 6-inch PVC pipe. Flow is discharged from the facility through a 12-inch CMP principal spillway and immediately enters a 24-inch CMP at the outfall. Both the outfall and 24-inch CMP end sections have major rust damage. Riprap protection in good condition surrounds the outfall. Flow enters the 24-inch CMP, flows under St. Mary’s Church Road, and

enters the storm sewer system. An individual inside the church indicated that recent work on the BMP had been completed in the summer of 2018. Expenses to the church exceeded \$30,000.

Figure A-5. Facing south, towards St. Mary's Church Road, at the riser (left); Outfall (right)

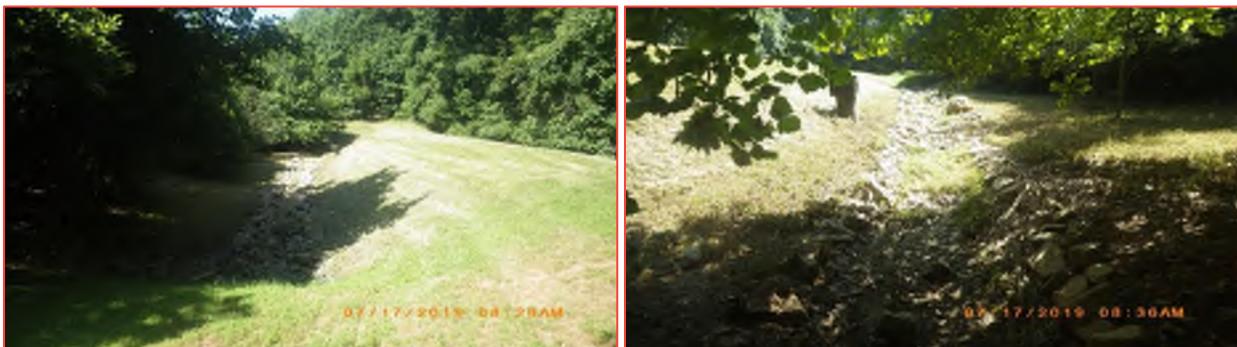
Existing SWM000039 is located behind residences off Bigmount Court. Access is difficult due to steep slopes and is only accessible from private property. The facility is within the MSB-4 subwatershed. The facility consists of a dry pond that drains through a riser to a channel. An 18-inch CMP discharges flows from residences on Bigmount Court into the northeast part of the facility. Flows enter a 5-foot wide riprap channel which conveys runoff to the riser. Another 18-inch CMP conveys flows from residences on Smallwood Drive into the southeast part of the facility. A riprap channel directly behind this CMP pipe acts as the third inflow point. There is minor riprap displacement around the southeast inflow points.

Figure A-6. Facing west towards facility at inflow pipe (left); Facing east toward facility at inflow channel (right)

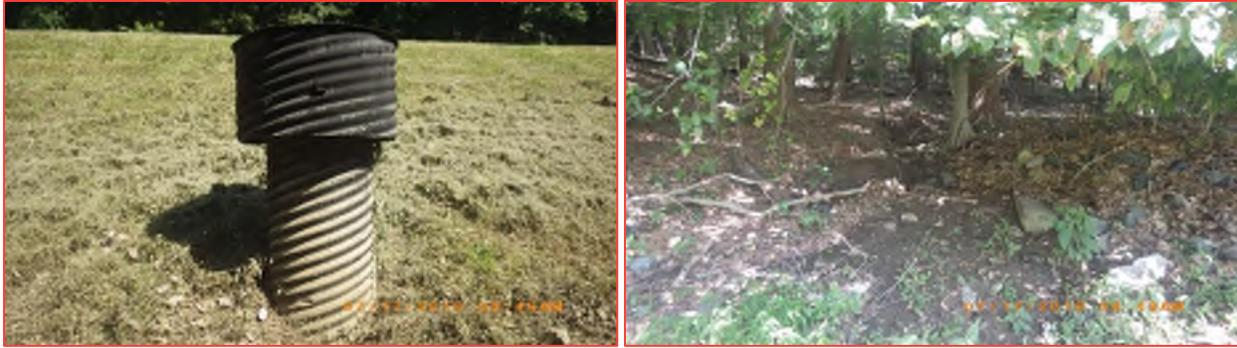
There was 0.41 inch of rainfall observed in the area on the day of the site visit (7/17/19). There were 0.02 inch of rainfall in the area on the two days prior to the site visit. A 38-inch diameter cylindrical CMP riser structure sits in the center of the northern border. Flows enter through a 5-inch CMP low flow orifice and discharge through an 18-inch CMP principal spillway. There is minor riprap displacement at the outfall. There is minor channel erosion extending up to approximately 100 feet downstream from the outfall.

Figure A-7. Riser structure and embankment (left); Facing downstream towards outfall protection and outfall channel (right)

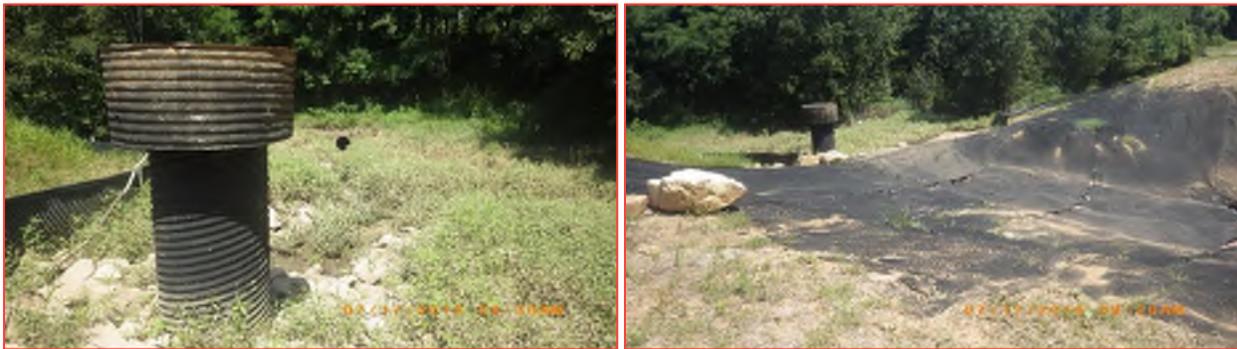
Existing SWM000040 is located south of residences off of Lindsay Court. There is very good access from the remnants of a construction access path west of the facility. The facility consists of a dry pond that drains through a riser control structure and into a channel. It is within the MSB-4 subwatershed. An 18-foot riprap emergency spillway sits in the southwest corner of the facility. The facility has four inflow points. A 30-inch CMP conveys flows from residences along Smallwood Drive and Boeing Court into the eastern part of the facility. Flows travel in a riprap channel to the riser structure. A silt fence runs along the south bank of this channel. A riprap channel acts as another inflow point in this area. It conveys flows from residences into the east part of the facility. A 24-inch CMP conveys flows from residences along Colpepper Road and Lindsay Court into the center of the facility. The fourth inflow point is a riprap channel entering the west part of the facility.

Figure A-8. 24-inch inflow pipe and riser structure (left); Facing north towards riser structure, breached embankment, and stabilizing matting (right)

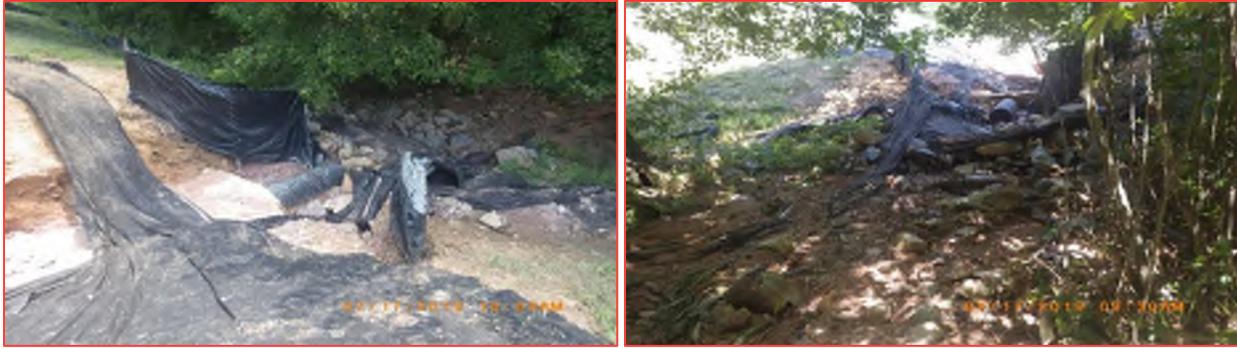
There was 0.41 inch of rainfall observed in the area on the day of the site visit (7/17/19). There were 0.02 inch of rainfall in the area on the two days prior to the site visit. A 57-inch diameter cylindrical CMP riser structure sits on the southern border of the facility. Flows enter through a 6-inch CMP low flow orifice and discharge out an 18-inch CMP principal spillway. There is a failed super silt fence a few feet east of the riser. The embankment behind the riser has been completely eroded; stabilizing matting and silt fences are failing. Dry mud is visible on the top of the riser structure. There is substantial debris in the outfall channel.

Figure A-9. Outfall and outfall protection (left); Facing upstream at outfall and outfall protection (right)

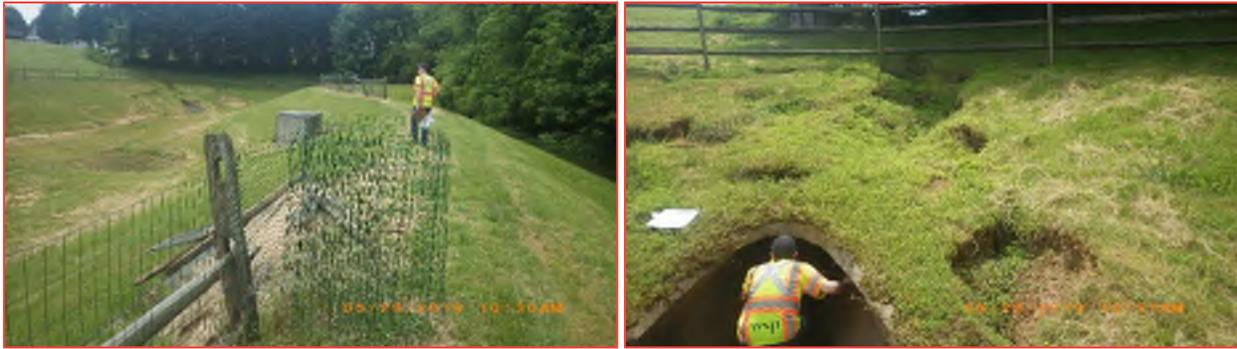
Existing SWM000041 is located off West Rhododendron Drive, behind residences including 2608 W. Rhododendron Drive. It is accessible from the roadway and has an 18-foot swing gate. A portion of the fence behind the riser was removed when the field team visited the site. The facility is in the MSB-4 subwatershed. It consists of a partial wet pond that is routed through a riser control structure and drains to a channel. A 32-inch RCP with concrete end section conveys flows from W. Rhododendron Drive into an 8-foot wide by 13-foot long plunge pool on the eastern part of the facility. The seal connecting the end section to the rest of the pipe is broken and there is major erosion surrounding the pipe at this damaged area. Another inflow is located at the southeastern tip of the facility. Flows from residences naturally enter the facility and flow down an 8-foot wide by 42-foot long riprap slope. A 36-inch RCP with end section conveys flows into the facility’s southern tip. There are numerous animal burrows and major erosion around the inflow. There is minor riprap displacement and minor erosion along the route the flows take from the inflow to the wet pond. The western part of the facility is covered with wet soil. Numerous 4-inch residential HDPE pipes were observed by the field team conveying flow into this area. They contribute a negligible amount of flow to the western part of the facility. An inflow exists on the western tip of the facility conveying flows onto a 16-foot wide by 71-foot long riprap slope. A 26-foot grass emergency spillway exists on the northern border of the western part of the facility.

Figure A-10. Facing west towards riser, embankment, and broken fence (left); Facing south towards erosion behind the 36-inch RCP inflow pipe (right)

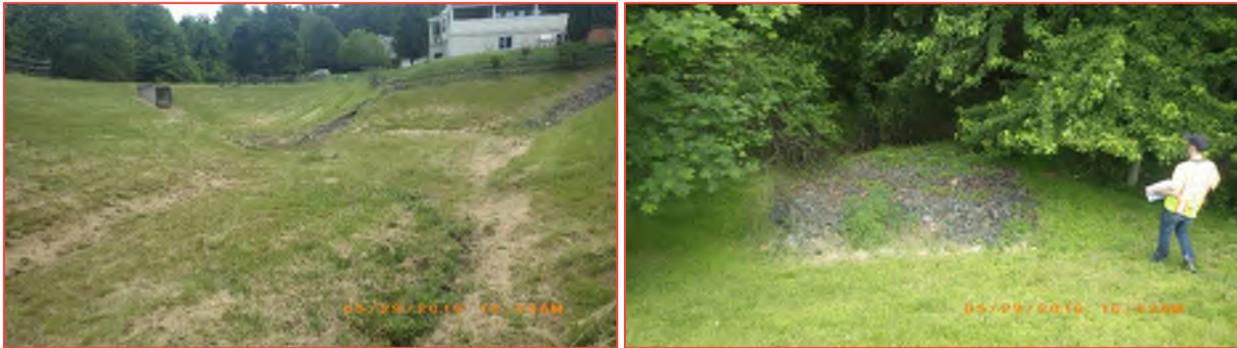
half of the facility. There are a few animal burrows and minor erosion around the riser structure. Low flow enters through a 4-inch PVC pipe. The low flow pipe sits 2 feet above the pond bottom. The low flow pipe is broken 27 feet from the riser. Flows discharge out the riser from a 36-inch CMP principal spillway. A 20-foot wide by 34-foot long riprap protection exists at the outfall where flows enter an unnamed tributary to Bynum Run. The immediate outfall area extending to 100 feet downstream has minor erosion. Flows pass under W. Rhododendron Drive about 200 feet downstream of the outfall via a 90-inch CMP.

Figure A-11. Facing east toward facility at 36-inch RCP inflow pipe (left); Outfall and outfall protection (right)

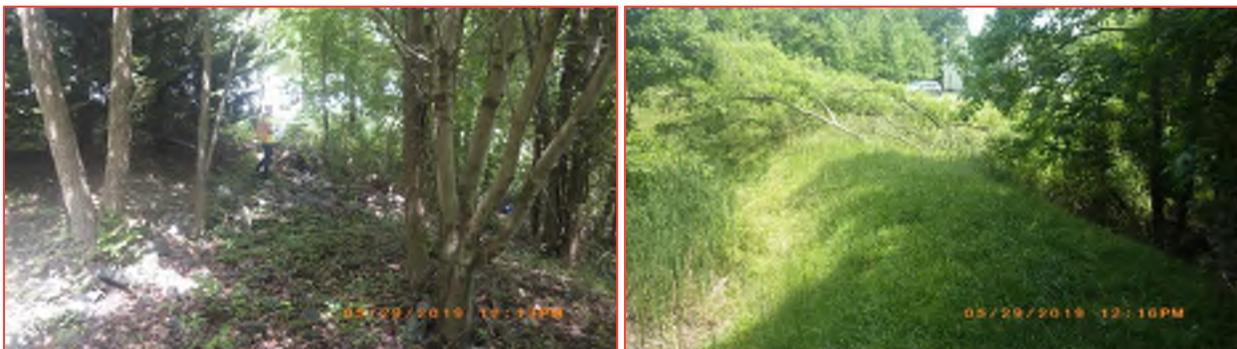
Existing SWM000084 is located west of Eastbend Court, behind residences including 3231 Eastbend Court. It is accessible from the road and is within the MSB-3 subwatershed. The facility consists of a dry pond and two natural streams that are routed through a riser control structure that drains to a natural channel. A 24-inch RCP with concrete end section conveys flows from residences to riprap on the northern part of the facility. Flows enter a forebay pretreatment pond. The pond has wetland vegetation and a 9-inch PVC control structure with mesh wrap. The two streams that feed into the dry pond have low flow rates. There is heavy wetland vegetation in the dry pond and the embankments surrounding the facility are covered with young trees (less than 10 years old).

Figure A-14. Facing east towards the 24-inch RCP inflow pipe (left); The embankment between the forebay and the riser control structure (right)

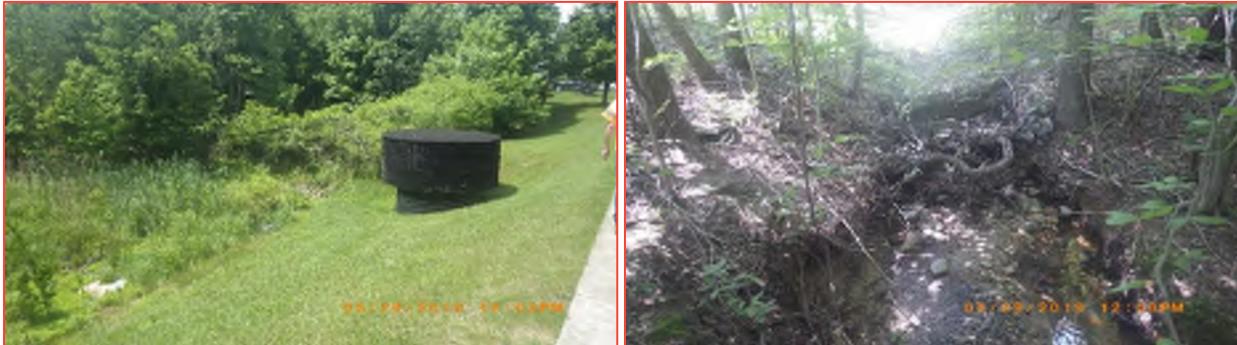
48-inch CMP principal spillway with end section. High flows are conveyed over a circular weir inside the riser. A 31-foot wide by 26-foot long riprap outlet protection exists at the outfall where flows enter an unnamed tributary of Bynum Run. Flows undercut a gabion structure 30 feet from the outfall, and geotextile is visible. There is major erosion in the outfall area and extends hundreds of feet downstream.

Figure A-15. Facing west towards the facility from Eastbend Court (left); Facing upstream towards the undercut gabion structure (right)

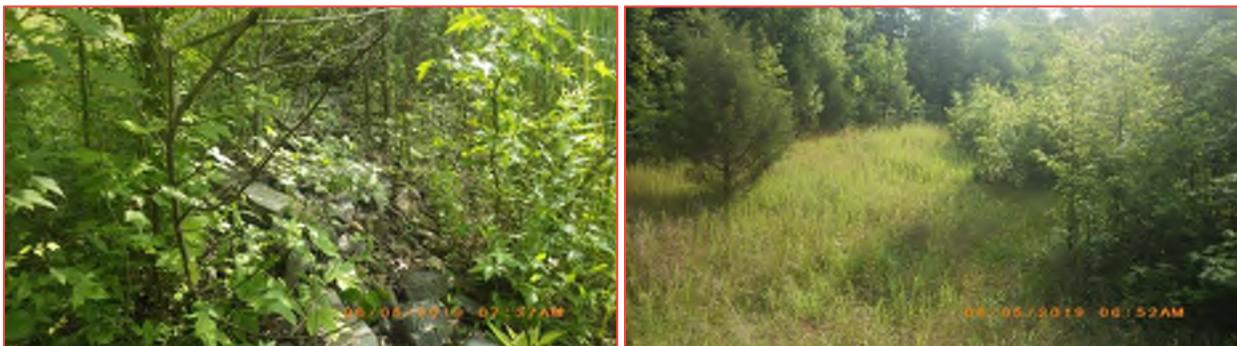
Existing SWM000085 is located off of Birch Brook Lane adjacent to the property located at 3120 Birch Brook Lane. It is accessible via a chain link swing gate located along the southeast edge of the facility. The facility is within the MSB-3 subwatershed. One 28-inch RCP into the facility conveys flows originating from the storm sewer system to the southwest. One 20-inch RCP into the facility conveys flows originating from the storm sewer system to the northeast. The facility is in-line with an existing stream that enters the site from the northwest. A concrete riser structure controls flows out of the facility and discharges through a 54-inch CMP principal spillway. The principal spillway outfall drains to a channel discharging to an unnamed tributary to Bynum Run to the south. Shallow standing water and wetland vegetation were observed within the facility.

Figure A-16. Channel protection for the 28-inch RCP inflow point at western part of the facility (left); View of facility from access gate (right)

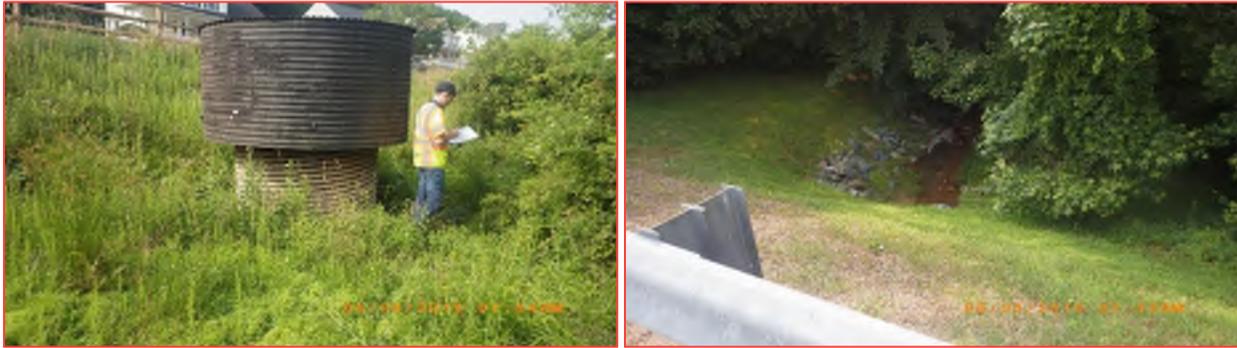
Rainfall totaling 0.05 inch had been observed in the area on the day of the site visit (6/5/19). No rainfall was observed during the two days prior to the field site visit. The pond is functioning as a dry pond in its current condition. Based on field observation, an 18-inch CMP conveys flows into the riser via a low-flow orifice. The size of the orifice could not be confirmed because the upstream end could not be located due

to heavy sediment buildup upstream of the riser. Overflow is conveyed through the inner lip of the 9-foot diameter circular CMP riser.

Figure A-17. Riser control structure and embankment (left); Outfall channel from Birch Brook Lane (right)

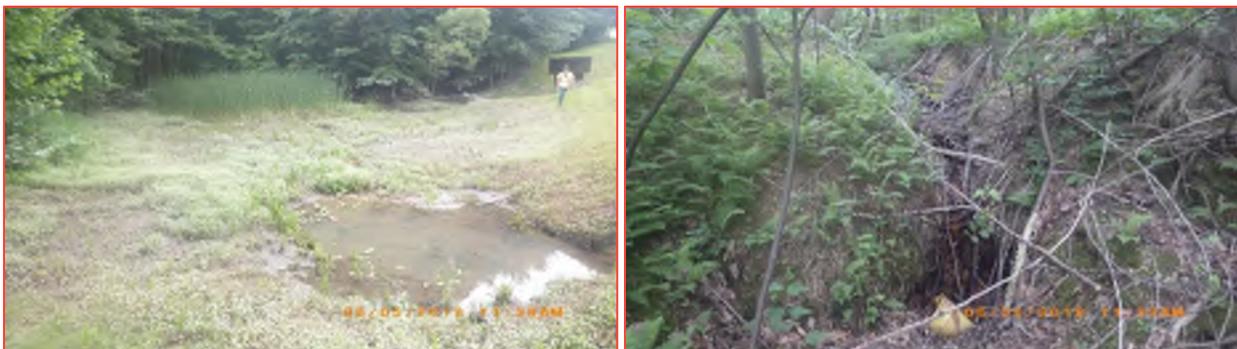
Existing SWM000089 is located off of Federal Lane adjacent to properties located at 1423 Crystal Ridge Court and 3717 Federal Lane. It is accessible from Federal Lane although a guardrail currently is present along the northern edge of the site. The facility is within the MSB-2 subwatershed. One 24-inch CMP into the facility conveys flows originating from the storm sewer system to the southwest. The facility is in-line with an existing stream that enters the site from the southeast. A concrete riser structure controls flows out of the facility and discharges through a 27-inch CMP principal spillway transitioning to a 42-inch CMP upstream of the outfall. The principal spillway outfall drains to a channel discharging to an unnamed tributary to Bynum Run to the north. Shallow standing water and wetland vegetation were observed within the facility.

Figure A-18. Facing south towards the facility from the 24-inch CMP inflow point (left); Facing upstream towards the channel that flows into the facility (right)

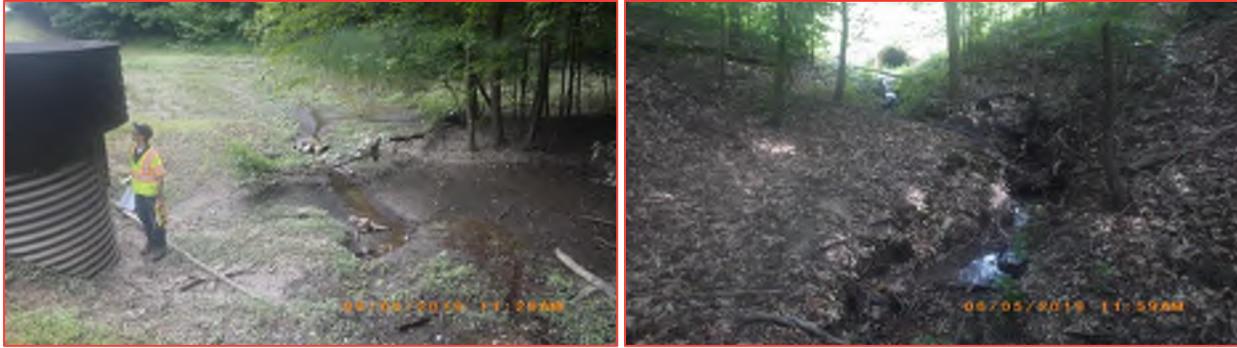
Rainfall totaling 0.05 inch had been observed in the area on the day of the site visit (6/5/19). No rainfall was observed during the two days prior to the field site visit. The pond is functioning as a dry pond in its current condition. Based on record drawings (and confirmed during field observation), an 8-inch CMP conveys flows into the riser via a low-flow orifice. Overflow is conveyed through the 8-foot diameter circular CMP riser.

Figure A-19. Riser structure (left); Facing upstream towards the outfall channel and embankment (right)

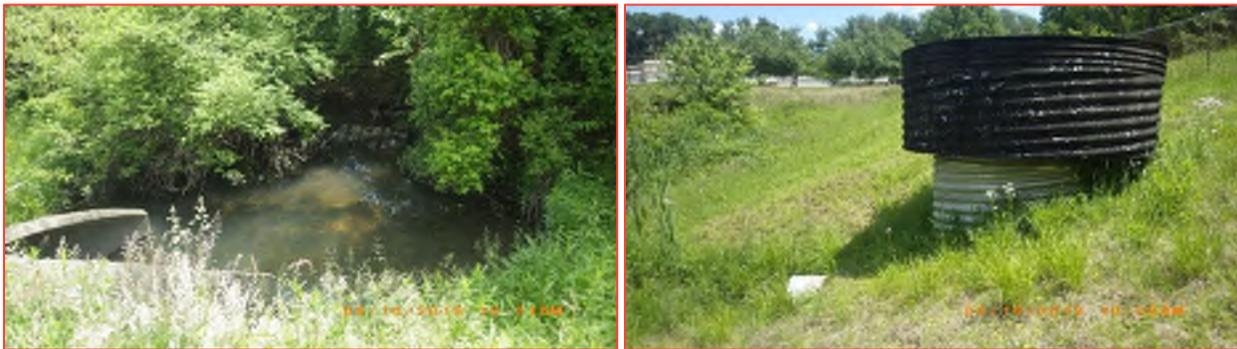
Existing SWM000123(1) is located across from the APGFCU credit union building, 2113 Laurel Bush Road. It is accessible from Laurel Bush Road. The facility is within the MSB-4 subwatershed. One 42-inch RCP with a concrete end section conveys flows into the facility from the storm sewer system to the northwest. One 24-inch RCP with concrete end section conveys flows into the facility from the storm sewer system to the northeast. There is also a riprap ditch in the southwest corner of the site conveying flows from a natural channel to the southwest. The riprap ditch has mild to moderate erosion and riprap displacement. A CMP riser structure controls flows out of the facility and discharges through a 66-inch CMP principal spillway. A gabion reinforced plunge pool at the outfall drains to a channel discharging to an unnamed tributary to Bynum Run to the east. Dense vegetation and saturated soils were observed within the facility.

Figure A-20. The 42-inch RCP inflow pipe and plunge pool (left); Riser control structure and low flow orifice (right)

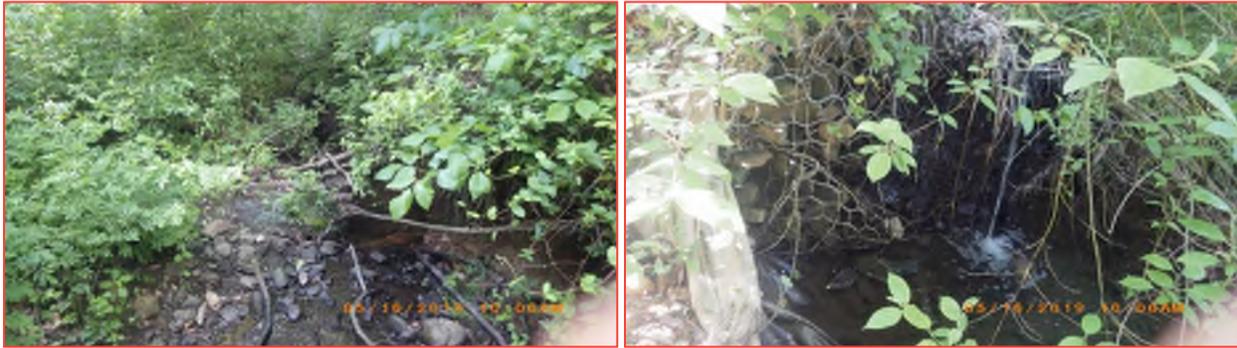
Rainfall totaling 0.02 inch had been observed in the area on the day of the site visit (5/16/19). The pond is functioning as a dry pond in its current condition. Based on record drawings (and confirmed during field work), a low-flow 24-inch CMP is installed at the pond bottom. Overflows enter the 84-inch diameter corrugated metal riser structure and are conveyed through a 66-inch CMP principal spillway. The immediate outfall area is in good condition; however, there is some debris jamming approximately 30

feet downstream of the spillway where a gabion basket structure is creating a 2-foot to 3-foot elevation drop.

Figure A-21. Facing downstream at the outfall channel and debris jam (left); The 2 foot to 3 foot elevation drop in outfall channel after gabion basket structure (right)

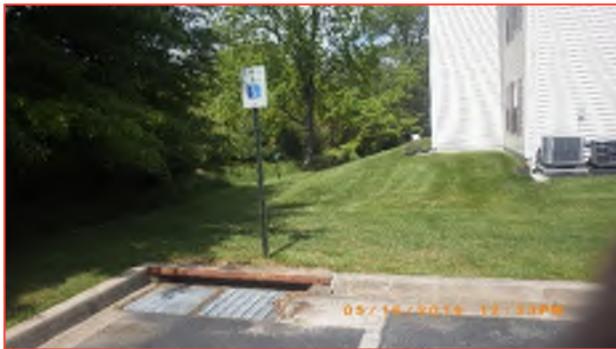
Existing SWM000124 was field investigated on 5/16/19, but no existing facility could be located. There is a facility located approximately 0.4 miles northeast in the vicinity of 201 Royal Oak Drive (SWM000312) which matches the as-built (Bright Oaks Courtyard).

Figure A-22. Supposed location of SWM000124

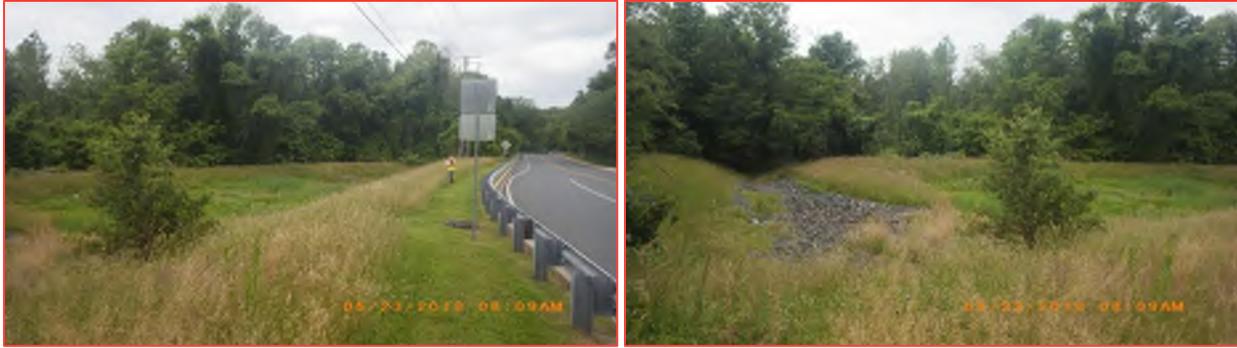
Existing SWM000125 is located at the intersection between Hookers Mill Road and Bynum Overlook Drive. It has no fence surrounding it and is well maintained. There is good access to the facility from the roadway. The facility is within the MSB-3 subwatershed. The facility consists of an infiltration basin that drains to a natural channel. The basin collects flows from residences on Bynum Overlook Drive. Flows enter the northeast part of the facility through a 36-inch RCP and into a riprap forebay. The inflow needs currently bypasses the infiltration basin. A 32-foot riprap emergency spillway exists on the eastern part of the facility. Two 8-inch PVC dewatering devices, spaced on the southern border of the basin, drain flows to Bynum Run confluent to James Run. The outfall is in good condition, and there is minor erosion where the outflow enters the natural channel extending to approximately 100 feet downstream of the outfall.

Figure A-23. Facing northwest, adjacent to Hookers Mill Road, at the facility (left); Channel protection of the 36-inch RCP inflow that bypasses the facility (right)

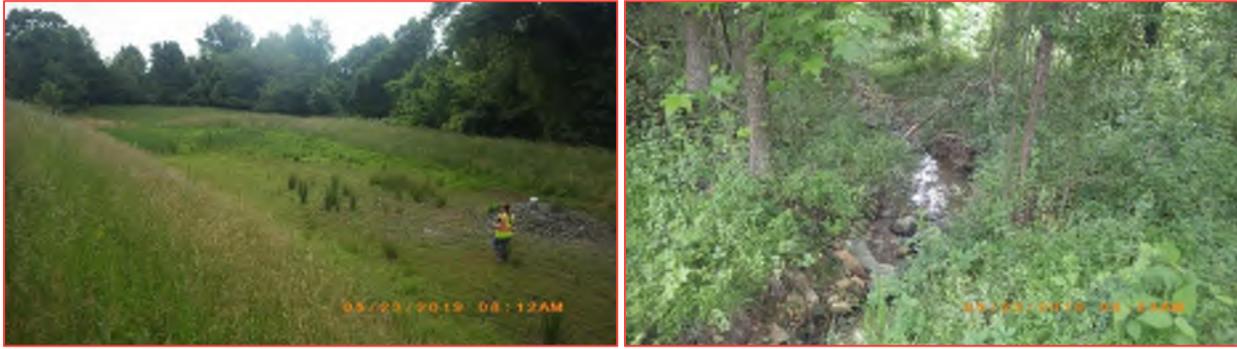
There was 0.47 inch of rainfall observed in the area on the day of the site visit (5/23/19). There was no rainfall in the area on the two days prior to the site visit.

Figure A-24. Facing southeast toward facility (left); Channel downstream of the facility (right)

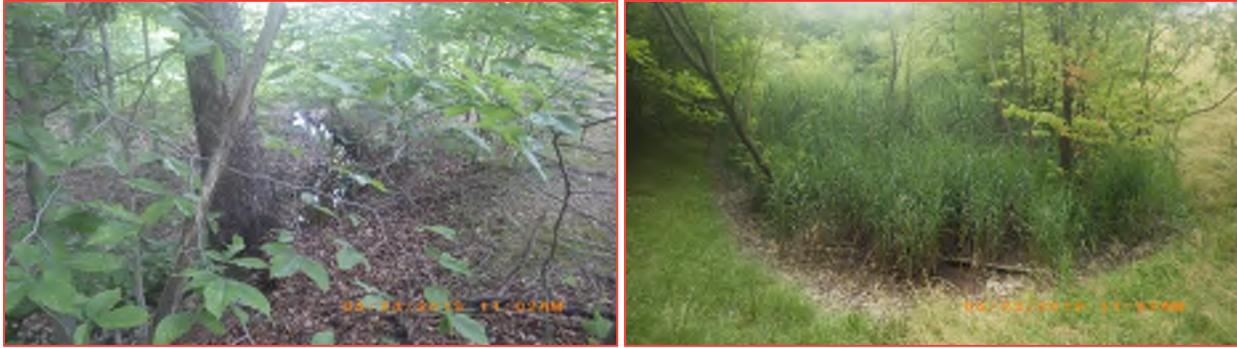
Existing SWM000126 is located off Deer Court, in between 911 Deer Court and 913 Deer Court. Access from the roadway is difficult due to steep embankments and heavy vegetation. The facility is within the MSB-3 subwatershed. It consists of a dry pond that collects flows from two pipes and a natural stream. The pond drains through a triple culvert that runs under Deer Court and returns flow into a natural stream. The stream providing inflows to the facility is in fair condition. It brings flows from the north to the facility and only has minor erosion. A 24-inch RCP conveys flows from residences from the east into a forebay on the east side of the facility. Another 24-inch RCP conveys flows from residences from the west into a forebay on the west side of the facility. In between these two inflows sits the triple culvert. There is standing water upstream of the culvert.

Figure A-25. Natural stream upstream of the facility (left); Forebay (right)

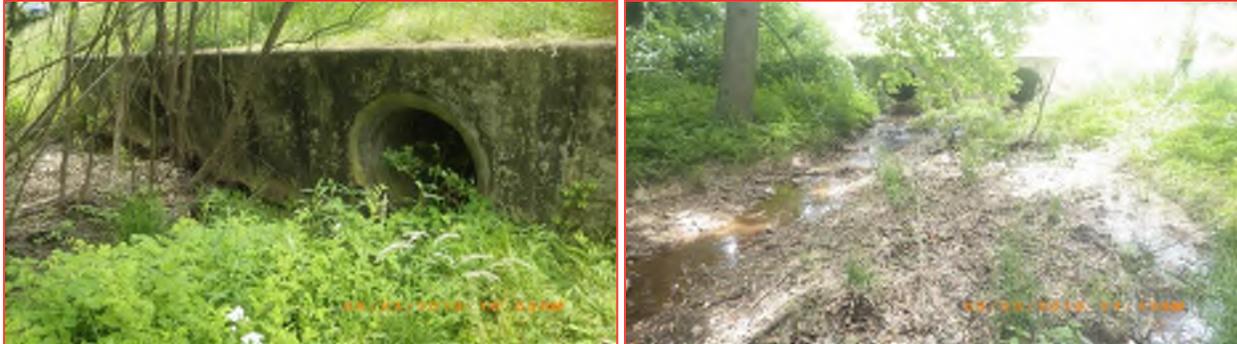
The triple culvert consists of two 48-inch RCPs and a 24-inch CMP that sits a little below and in between them. The 24-inch CMP’s inlet is buried under sediment. The outfall has minor riprap displacement and sediment build up is impacting the 24-inch CMP. The western RCP at the outfall did not have flowing water, but the eastern RCP did. Flows drain into an unnamed tributary to Bynum Run. The immediate outfall area extending to approximately 100 feet downstream is in fair condition.

Figure A-26. Upstream end of the triple culvert (left); Downstream end of the triple culvert (right)

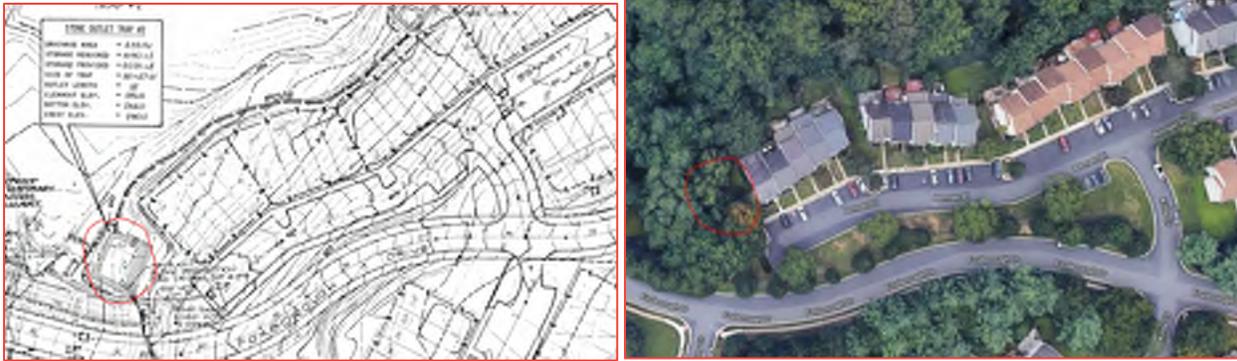
Existing SWM000166 could not be located during field investigations. GIS information indicates it is located along Foxborough Drive west of Bennett Place. The Foxborough Farms Section 3 Phase 2 record drawing calls out a structure in this vicinity called Stone Outlet Trap #2. The outfall channel adjacent to Bennett Place is eroded with the majority of the riprap displaced. The outfall’s location is within the MSB-5 subwatershed.

Figure A-29. Record drawings of the site (left); Satellite imagery of the site (right)

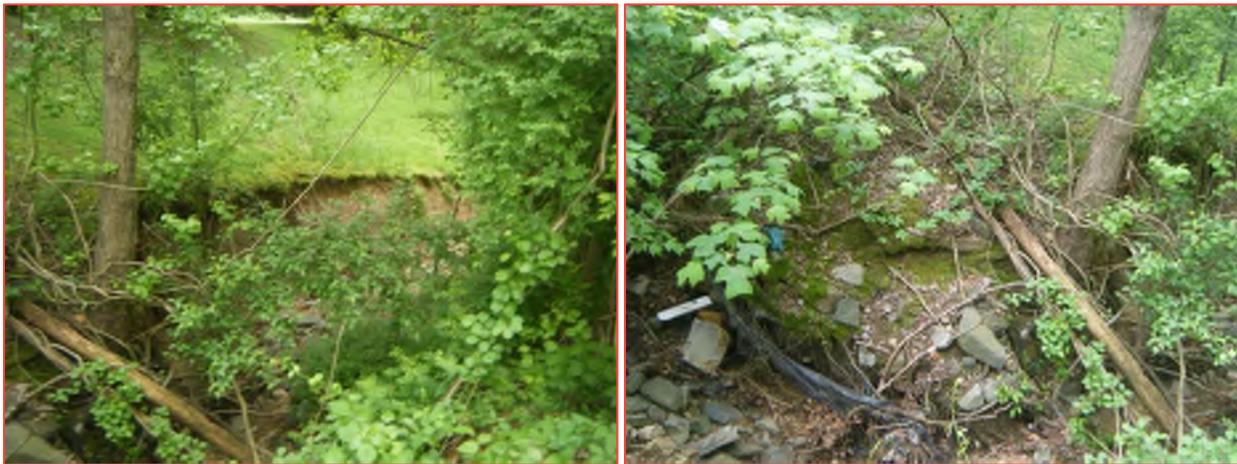
Figure A-30. Facing downstream at the outfall channel (left); Outfall protection (right)

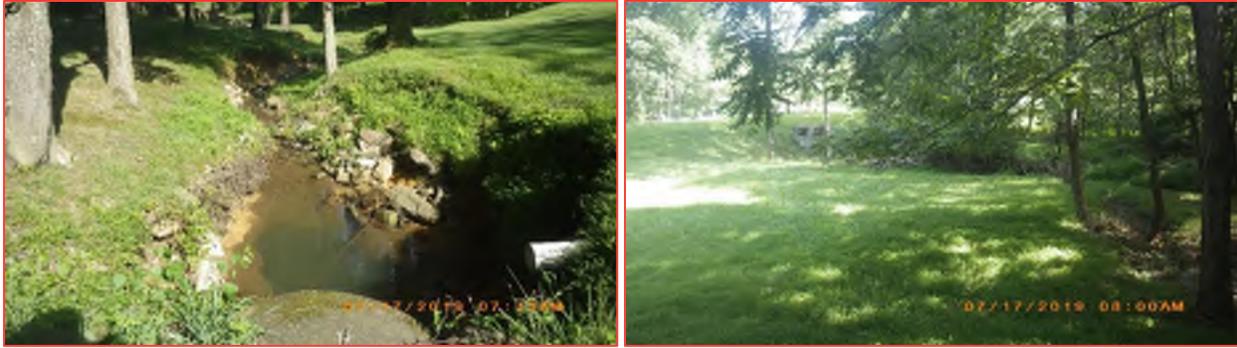
Existing SWM000198 is located behind residences on the west end of Royal Troon Court. There is unobstructed access from private properties around the facility. It is within the MSB-5 subwatershed. The facility consists of a dry pond that drains through a riser control structure to a natural channel. A 24-inch CMP conveys flows from residences on Royal Troon Court into the southern part of the facility. The pipe is half buried by sediment; there is a 24-inch headcut downstream out the inflow point. A 36-inch RCP conveys flows from residences on Muirfield Close into the northern part of the facility. A natural stream flows from east to west into the facility. A 48-foot grass emergency spillway exists on the southwest end of the facility.

Figure A-31. Facing downstream from the 36-inch RCP inflow pipe (left); Facing downstream towards the 24-inch CMP inflow channel (right)

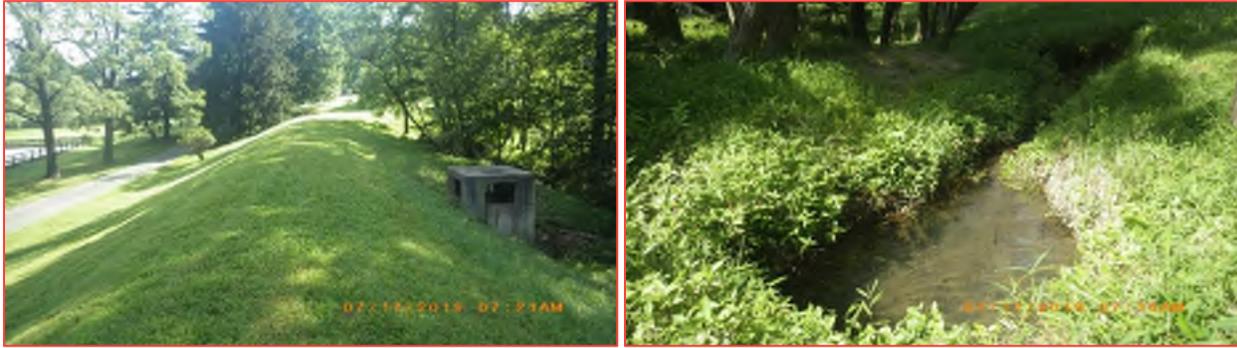
There was 0.41 inch of rainfall observed in the area on the day of the site visit (7/17/19). There were 0.02 inch of rainfall in the area on the two days prior to the site visit. A concrete riser structure sits on the northwest border of the facility. Flows enter through an 18-inch CMP. There is debris and sediment buildup at the pipe. Flows discharge through a 36-inch CMP principal spillway, enter an ex-SD manhole, and outfall through a 48-inch CMP. There is minor outfall sediment and outfall erosion. The channel extending 100 feet downstream is in good condition.

Figure A-32. Embankment and riser structure (left); Facing downstream at outfall (right)

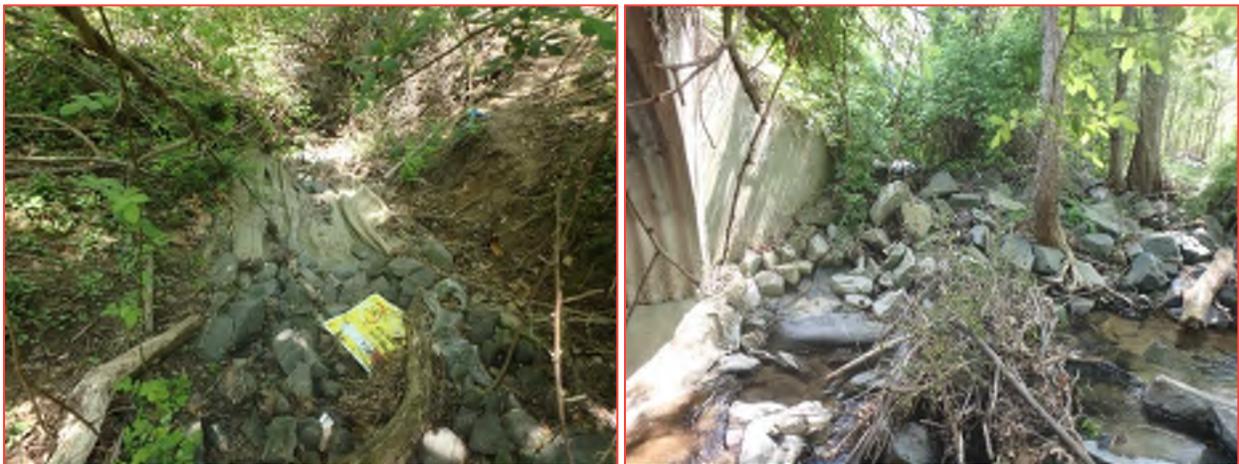
Rainfall totaling 0.02 inch had been observed in the area two days prior to site visit. A puddle of standing water was observed at the outfall but the riprap channel was dry.

Figure A-34. Facing north downstream of the outfall channel (left); Facing south at the confluence of the outfall channel and an unnamed tributary to Bynum Run (right)

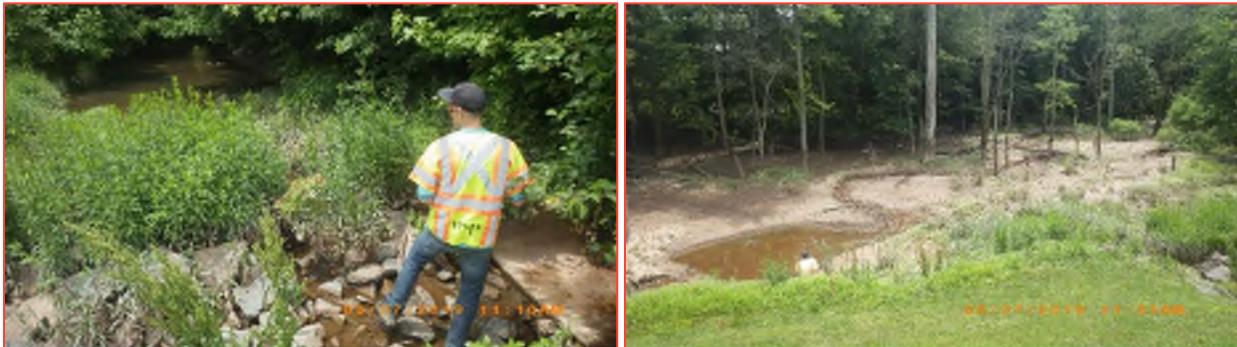
principal spillway drains to a channel discharging to Bynum Run to the northeast. Approximately 3 feet of accumulated silt was observed in the facility. The low flow pipe and headwall were not visible due to the material buildup.

Figure A-39. 30-inch RCP inflow pipe and forebay at northwest edge of facility (left); Facing south towards facility (right)

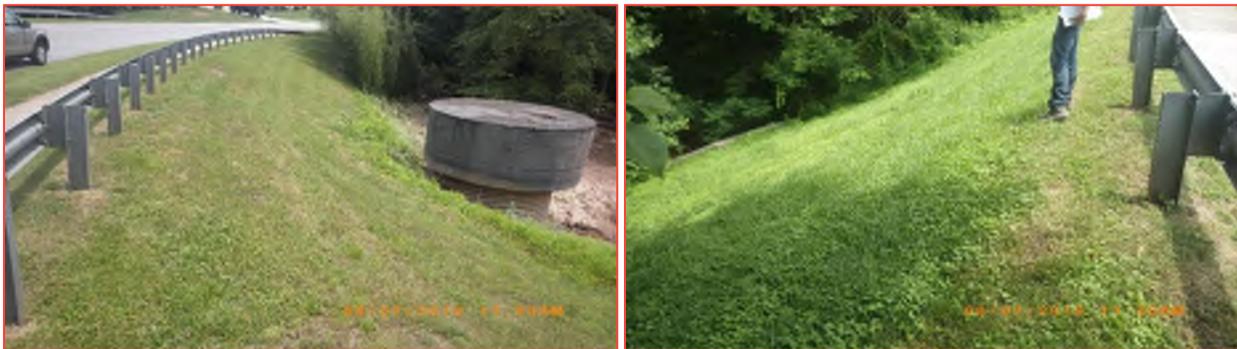
No precipitation had been observed in the area on the day of the site visit (6/7/19). Rainfall totaling 0.07 inch was observed during the two days prior to the field site visit. The pond is functioning as a dry pond in its current condition. Based on record drawings, a 36-inch BCCMP with concrete headwall conveys flows into the riser via a low-flow orifice. There is no emergency spillway.

Figure A-40. Slope between the riser structure and Hidden Stream Drive (left); Slope from Hidden Stream Drive down to the outfall (right)

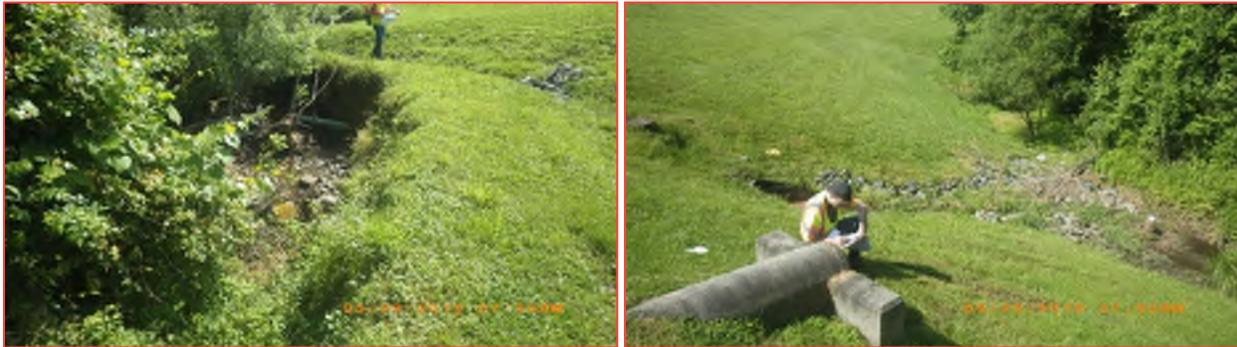
it into the southern water quality treatment bed. There are 4 inches of standing water in the water quality bed and there is major sediment build up. There is major erosion at the point where the water quality bed discharges flow into its natural stream. There is minor riprap displacement at the inflow. Both streams are in good condition upstream of the facility.

Figure A-41. Erosion in natural stream near the outfall of the southern water quality treatment bed's overflow pipe (left); 15-inch RCP inflow pipe, the northern CMP inflow pipe, and the northern water quality treatment bed

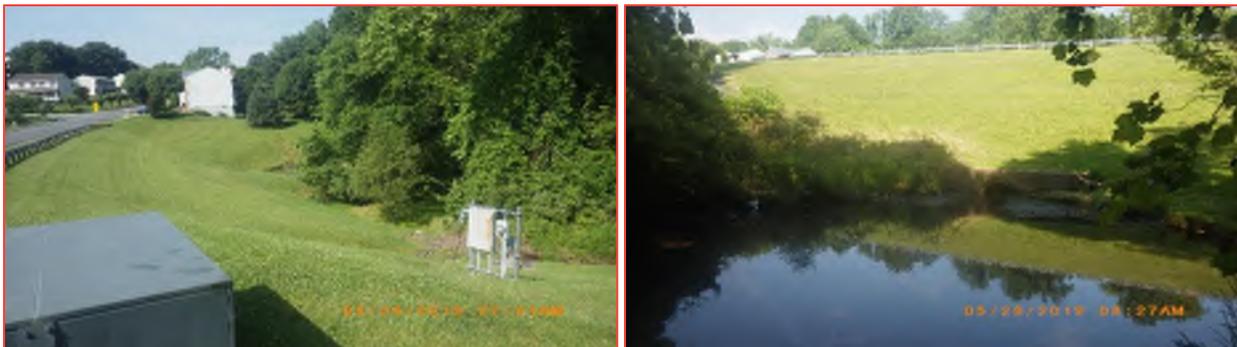
There was no rainfall observed in the area on the day of the site visit (5/29/19). There was 0.09 inch of rainfall in the area on the two days prior to the site visit. There is no riser structure. A 36-inch RCP with 17-foot headwall serves as the principal spillway. There is moderate erosion behind the headwall. A log blocked part of the pipe, causing major sediment buildup in front of it. Flow is conveyed under Hunters Run Drive, which serves as the embankment (61 feet), to the outfall on the other side. At the outfall, flow enters a silted pool that is approximately 3 feet deep. The slopes that lead down to the outfall from the roadway are reinforced with riprap in good condition. A 6-inch PVC pipe and a 3-inch corrugated HDPE pipe convey flow into the riprap on the northern slope. There is minor erosion downstream of the outfall where the flow enters an unnamed tributary of Bynum Run. The overall condition downstream of the outfall is good.

Figure A-42. Facing south toward the facility (left); Outfall, silted pool, and the embankment behind the outfall (right)

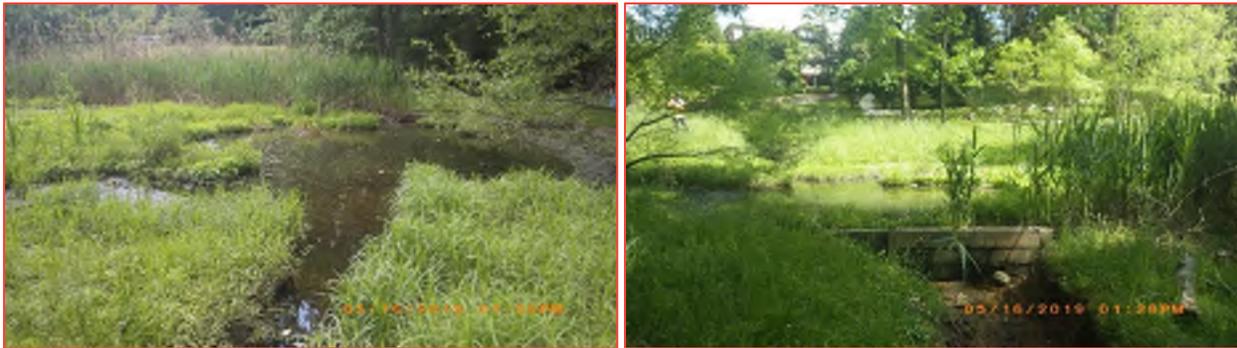
Existing SWM000259 is located off Glenangus Drive behind residences including 1500 Parkland Drive. It is accessible from Glenangus Drive. The facility is within the MSB-5 subwatershed. The facility consists of an infiltration basin that drains to a natural channel that is routed through a riser control structure. The infiltration basin is separated from the downstream natural channel by a timber weir. A 30-foot length PVC pipe at the floor of the facility drains low flows around the weir wall. In its current condition the infiltration basin has several feet of standing water (up to the top of the wood weir) and wetland vegetation, indicating the PVC low flow orifice may be clogged. The PVC pipe was not visible during field inspection. There is severe slope erosion along a portion of the slope leading from the infiltration basin toward the stream. The inflow pipes into the infiltration basin include one 18-inch BCCMP conveying flows from two dual grate inlets along Glenangus Drive and one 24-inch RCP with a concrete end section conveying flows from the residential area to the east. Damaged silt fence is visible around the 24-inch RCP outfall.

Figure A-43. Infiltration basin from behind the RCP inflow pipe (left); Infiltration basin from behind the timber weir (right)
