HARFORD COUNTY DPW

LOWER BYNUM RUN SMALL WATERSHED ASSESSMENT REPORT APPENDICES

DECEMBER 13, 2019

HARFORD COUNTY DEPARTMENT OF
PUBLIC WORKS

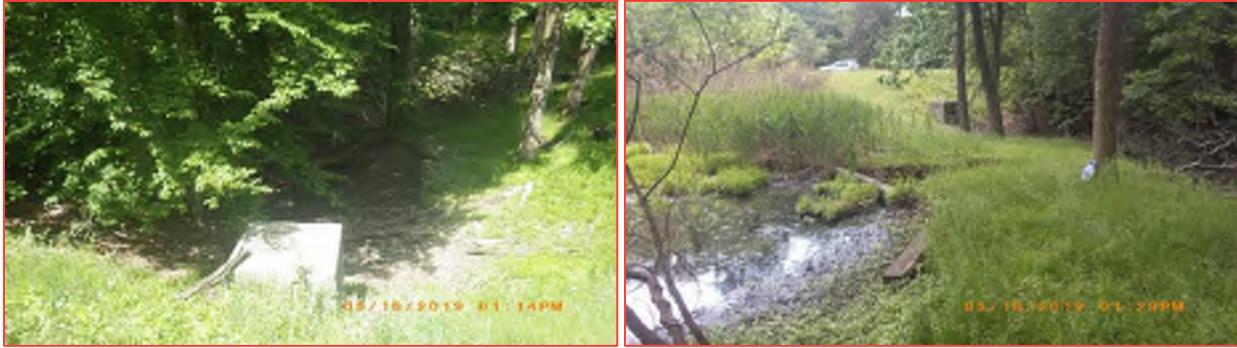
Rainfall totaling 0.02 inch had been observed in the area on the day of the site visit (5/16/19). The concrete riser structure sits at the toe of the embankment of Glenangus Drive. Flows enter through a 24-inch RCCP pipe orifice and discharge through a 24-inch RCCP principal spillway. A plunge pool exists at the outfall where flows enter Bynum Run confluent to James Run to the southwest. Multiple fallen large diameter trees were observed upstream of the riser area. The immediate outfall area extending to approximately 100 feet downstream is in good condition.

Figure A-44. View of riser structure from Glenangus Drive (left); Facing southwest towards riser structure, fallen trees behind the infiltration basin (right)

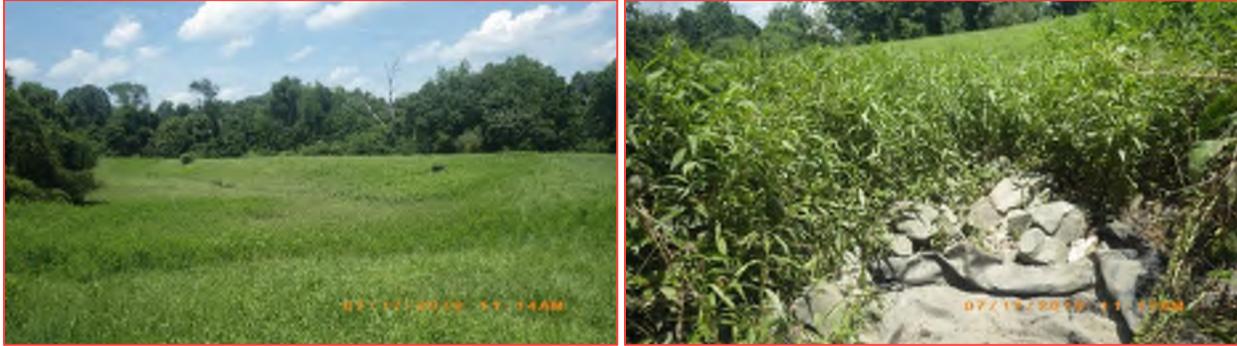
Existing SWM000286 is located northeast of Towson Road, behind residences including 1008 Towson Road. The facility is accessible from private backyards, and the field team had to go around existing yard fences. A utility road exists behind the facility. It is located within the MSB-3 subwatershed. It consists of a dry pond that is routed through a riser control structure and drains to Bynum Run. A 24-inch CMP with headwall conveys flows from residences along Hamburg Drive into the northwest part of the facility. A riprap slope also conveys flows from 922 Hamburg Drive into the northwest part of the facility. A 24-inch CMP with headwall conveys flows from residences along Towson Road into the southeast part of the facility. A 5-foot scour hole and minor riprap displacement exists at this inflow.

Figure A-45. Facing north towards facility (left); Facing downstream at inflow scour hole (right)

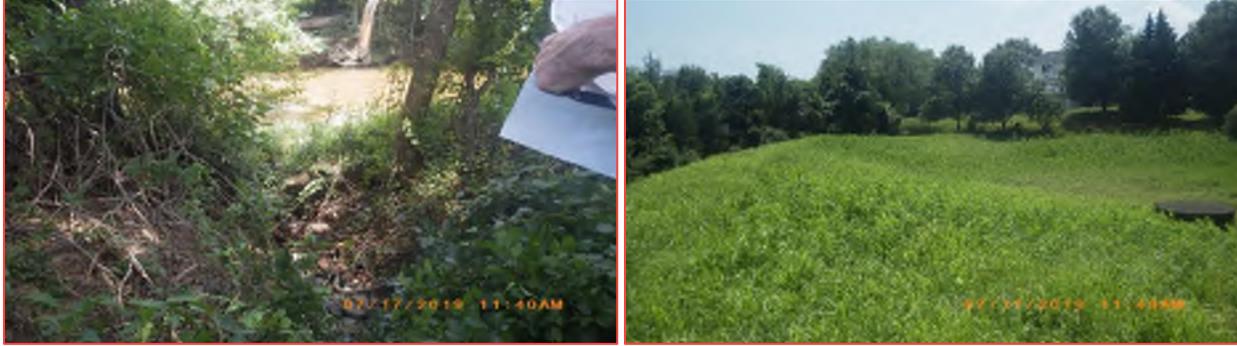
There was 0.41 inch of rainfall observed in the area on the day of the site visit (7/17/19). There were 0.02 inch of rainfall in the area on the two days prior to the site visit. A 57-inch diameter cylindrical CMP riser structure sits on the northern border of the facility. Flows enter through an 8-inch CMP low flow orifice and discharge through a 24-inch principal spillway. There is minor sediment buildup in the principal spillway. The outfall and outfall protection is in fair condition. The outfall channel extending 100 feet downstream is in good condition.

Figure A-46. Facing downstream at outfall channel and Bynum Run (left); Facing south at embankment and access point behind residential yard fences (right)

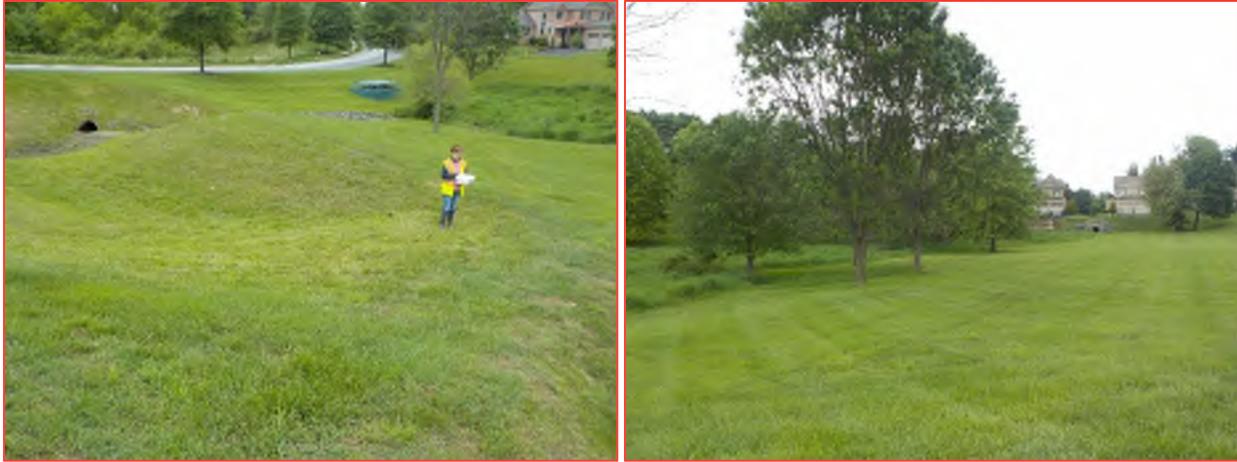
Existing SWM000295 is encircled by Dunkeld Way and its residences. It is easily accessible from the road, well maintained, and does not have a fence. The facility is within the MSB-4 subwatershed. The facility consists of two infiltration basins that drain to an extended dry detention pond. The pond drains through a riser control structure and discharges to a natural channel. Two inflows convey flow into the southeast infiltration basin: a 24-inch RCP and an 18-inch RCP. Both have moderate sediment build up in front of their inflows. The bottom of the infiltration basin is sediment filled. This basin drains over a riprap spillway westward, towards the riser structure which sits at the southern part of the facility. Another inflow exists just north of this basin. A 21-inch RCP conveys flows onto a riprap plunge pool, but flows do not enter the infiltration basin right next to it. Instead, they travel to the pond at the center of the facility. Two inflows convey flow into the northeast infiltration basin: an 18-inch RCP and a 24-inch RCP. This infiltration basin has a 26-foot grass emergency spillway that conveys flow to the pond in the center of the facility. There are three more pipe inflows on the northern border of the facility. A double culvert reinforced with gabions conveys flows into the central pond. The culvert consists of a 36-inch RCP and a 5-foot by 3-foot elliptical RCP. The inflow is in good condition. The other inflow on the northern border (eighth total) is a 24-inch RCP with moderate sediment build up. It conveys flows to the central pond as well.

Figure A-47. Facing south towards southeast inflow pipes, the southeast infiltration basin, and the riser structure (left); Facing north towards the facility and the elliptical culvert inflow pipe (right)

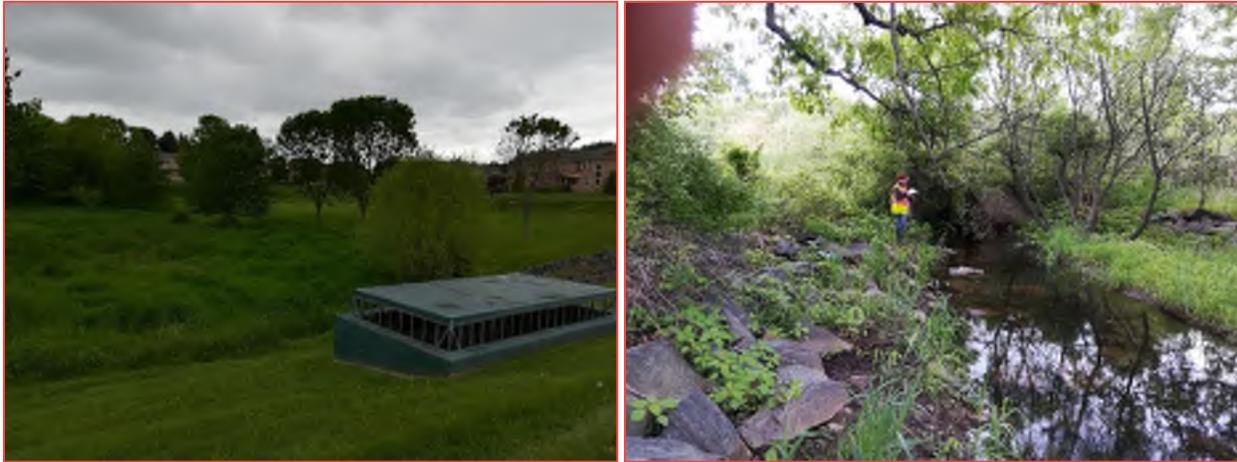
There was no rainfall observed in the area on the day of the site visit (5/14/19). There were 1.45 inches of rainfall in the area on the two days prior to the site visit. The concrete riser structure on the south end of the facility has weir openings on all sides. The riser is in good condition but has graffiti on the inside. Low flows from the pond enter the riser through an 18-inch RCP and discharge through a 60-inch RCP principal spillway. A riprap plunge pool exists at the outfall where flows enter an unnamed tributary to Bynum Run. The immediate outfall area extending to approximately 100 feet downstream is in good condition.

Figure A-48. View of riser structure from Glenangus Drive (left); Looking upstream to the outfall (right)

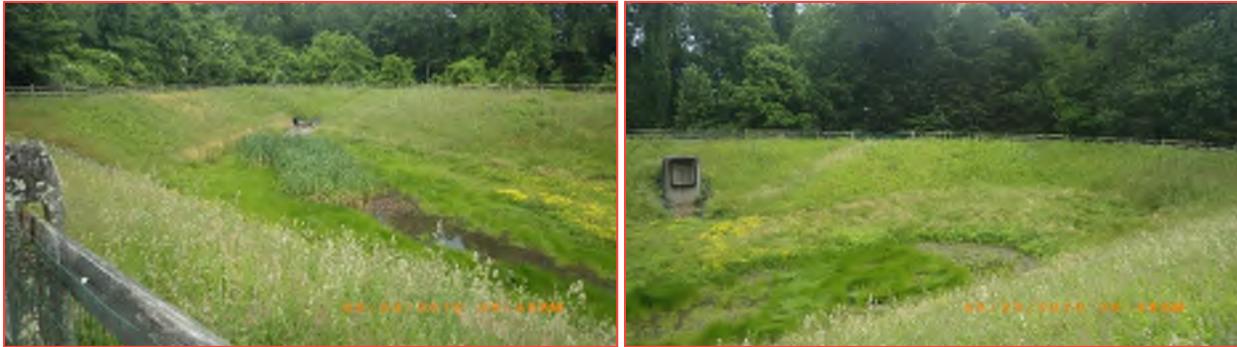
It consists of a wet pond (1.5 feet deep) that drains through a riser control structure and into a natural channel. A 38.5-inch CMP inflow pipe conveys flows into the northwest part of the facility. A plunge pool exists at this inflow. The inflow is in good condition. A riprap channel on the southwest corner of the facility acts as the second inflow point. It conveys flows from the roadway into the facility.

Figure A-49. Facing northwest towards the 38.5-inch CMP inflow (left); Facing northeast towards riser structure, access gate, and east side of the facility (right)

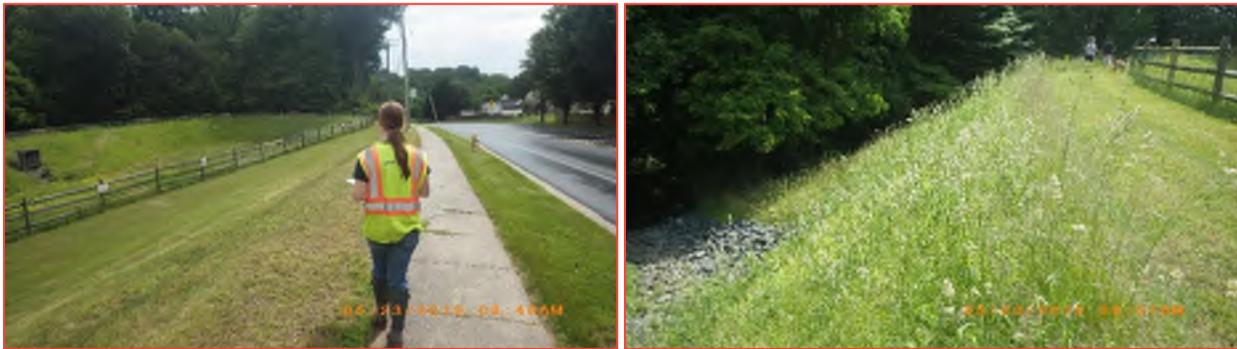
There were 0.47 inch of rainfall observed in the area on the day of the site visit (5/23/19). There was no rainfall in the area on the two days prior to the site visit. The concrete riser structure sits on the northern border of the facility. Flows enter through a 12-inch PVC pipe and discharge through a 48-inch RCP principal spillway. A plunge pool exists at the outfall and there is a steep 6-foot drop at the end of the riprap. Flows enter an unnamed tributary to Bynum Run. The immediate outfall area extending to approximately 100 feet downstream is in good condition.

Figure A-50. Access to facility from Hookers Mill Road (left); Embankment behind the riser structure and the outfall's riprap channel protection (right)

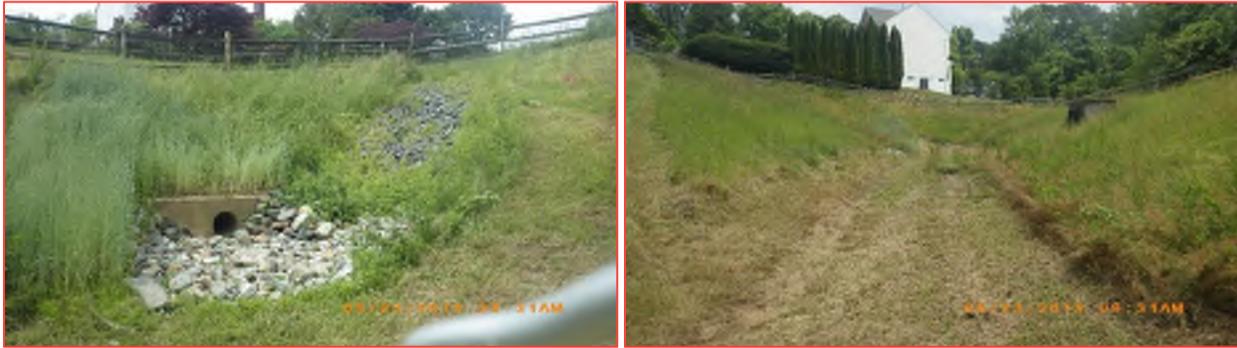
an 18-inch RCP conveys flows from Bynum View Court into the forebay. There is minor vegetation in the riprap channel.

Figure A-51. Southern inflow points (left); View of facility from southern inflow points (right)

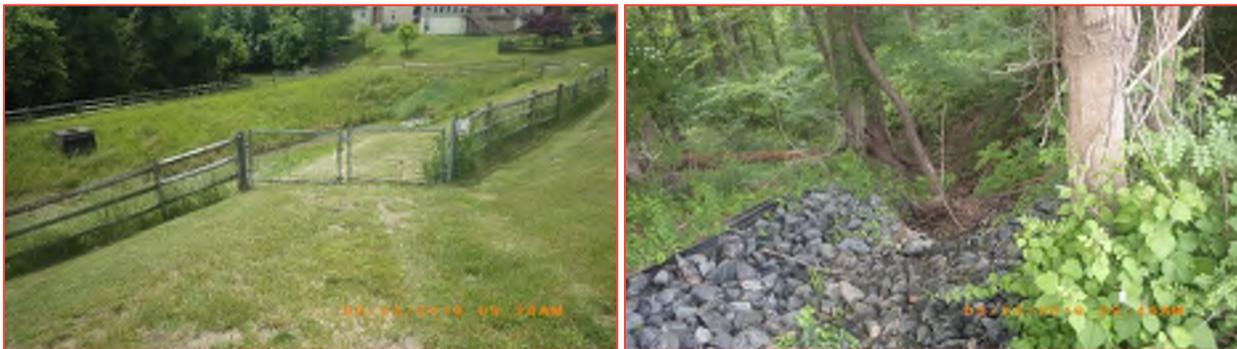
There were 0.47 inch of rainfall observed in the area on the day of the site visit (5/23/19). There was no rainfall in the area on the two days prior to the site visit. The concrete riser structure sits on the eastern border of the facility. Flows enter through a 12-inch PVC pipe dewatering device. Flows discharge out a 27-inch RCP principal spillway and into an 8.5-foot wide plunge pool. There is a 7-foot drop with moderate erosion at the end of the riprap and geotextile is visible. Flows enter Bynum Run confluent to James Run. The outfall area extending to approximately 100 feet downstream is in good condition.

Figure A-52. Access path to facility from Old Ridge Way (left); Downstream at outfall channel (right)

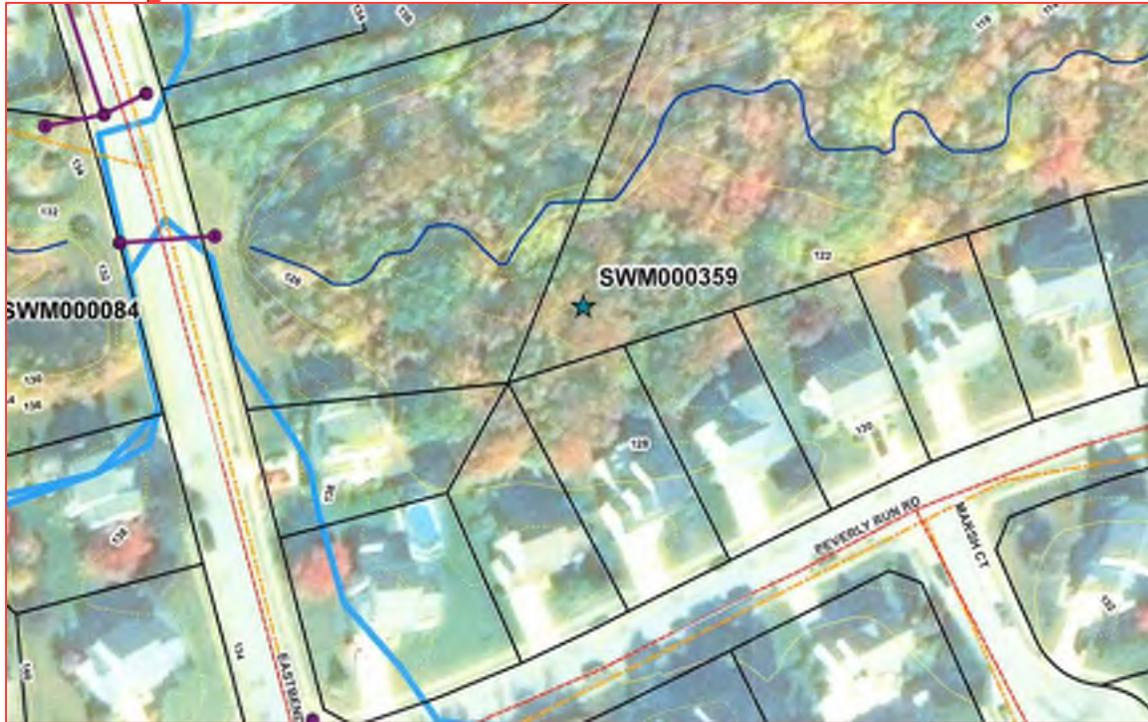
Existing SWM000359 could not be located during field investigations. GIS information indicates it is located along Foxborough Drive west of Bennett Place. The as-built for this facility instead matches that for SWM000084. Its GIS location is in the MSB-3 subwatershed.

Figure A-53. GIS location of SWM000359

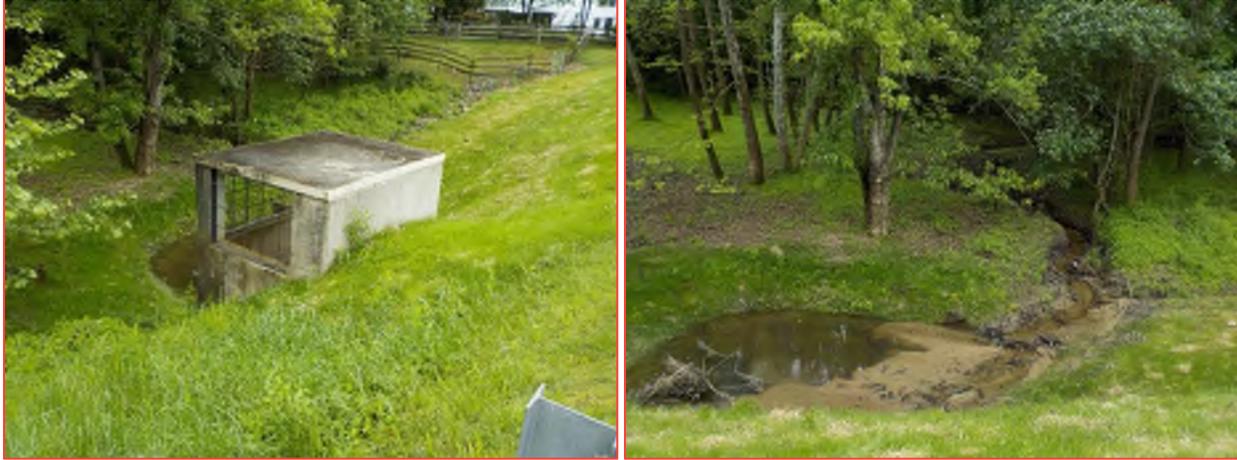
Existing SWM000363 is located off David Drive, adjacent to residences including 540 David Drive. It has an access road and no fence. The facility is within the MSB-5 subwatershed. It consists of an infiltration basin and two streams that convey flow to a dry pond. Flows from the pond are routed through a riser control structure and into a natural channel. The western stream has severe (greater than 5 to 6-foot) bank erosion upstream, while the eastern stream has moderate (greater than 3-foot) erosion along its channel. There is a 3-foot cut in the channel at the point where the streams converge before the pond. An RCP with an unspecified diameter conveys flows into the infiltration basin on the east part of the facility. There was standing water in the basin at the time of the site visit. High flows travel over a riprap weir and enter the pond.

Figure A-54. Facing east towards riser structure and infiltration basin (left)

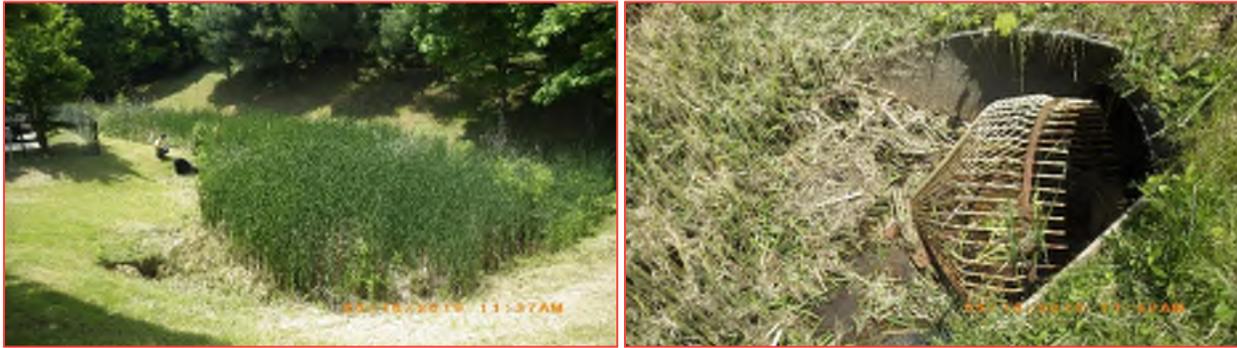
Figure A-56. Facing northwest towards facility (left); Disconnected trash rack (right)

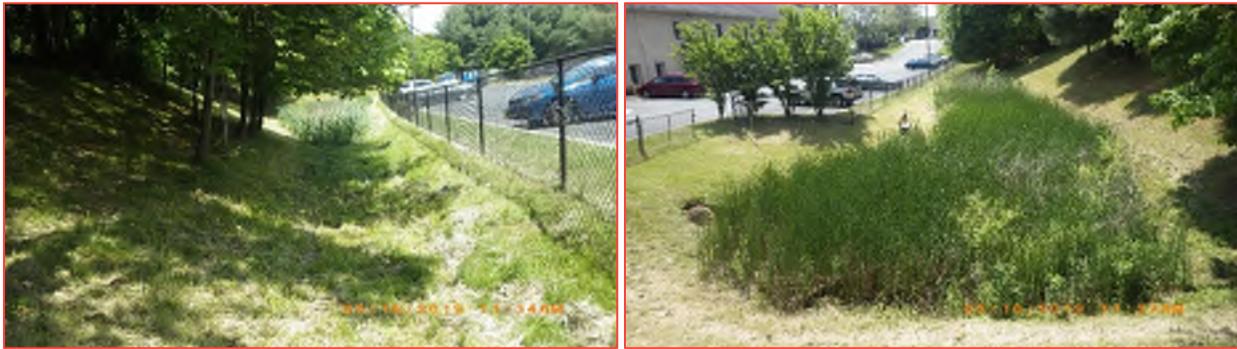
Rainfall totaling 0.02 inch had been observed in the area on the day of the site visit (5/16/19). The facility had standing water and wetland vegetation.

Figure A-57. Facing east towards the facility (left); Facing west towards the facility (right)

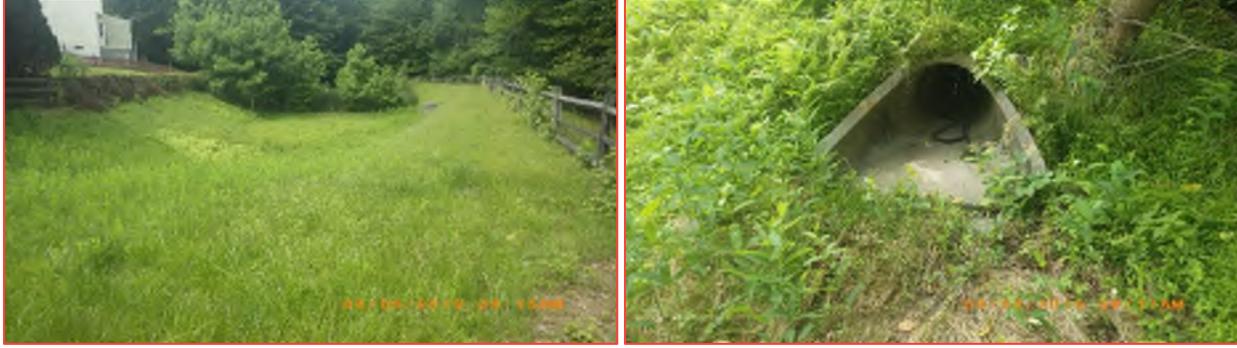
Existing SWM000416 is located off of Tiffany Trail behind the properties located at 4007 and 4009 Andrew Court. It is accessible via an access path off Tiffany Trail leading to a chain link swing gate. The facility is within the MSB-3 subwatershed. One 24-inch RCP conveys flows into the forebay upstream of the main facility. One 12-inch RCP conveys flows directly into the pond. Flows in the 12-inch and 24-inch inflow pipes originate from the storm sewer system running along Tiffany Trail to the northeast. One riprap slope measuring approximately 30-foot wide conveys overland flows from the southwest. A concrete riser structure controls flows out of the facility and discharges through a 24-inch CMP principal spillway. A riprap plunge pool at the principal spillway outfall drains to a channel discharging to an unnamed tributary to Bynum Run to the north. Shallow standing water and wetland vegetation were observed within the facility.

Figure A-58. Facing west towards facility at access gate (left); 24-inch RCP with broken seal (right)

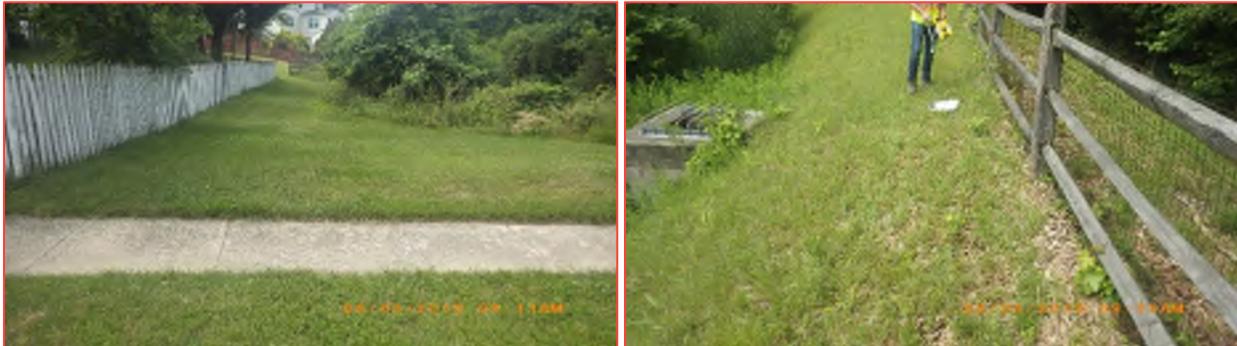
Rainfall totaling 0.05 inch had been observed in the area on the day of the site visit (6/5/19). No rainfall was observed during the two days prior to the field site visit. The pond is functioning as a dry pond in its current condition. Based on record drawings (and confirmed during field work), a low-flow 6-inch perforated PVC pipe is installed at the pond bottom. Flows exiting the 6-inch PVC pipe travel overland across riprap and through a trash rack along the base of the concrete riser structure to enter an 8-inch low flow orifice. Overflow is conveyed through trash racks along the front face and top of the riser

Figure A-59. Access path from Tiffany Trail (left); Embankment behind riser structure (right)

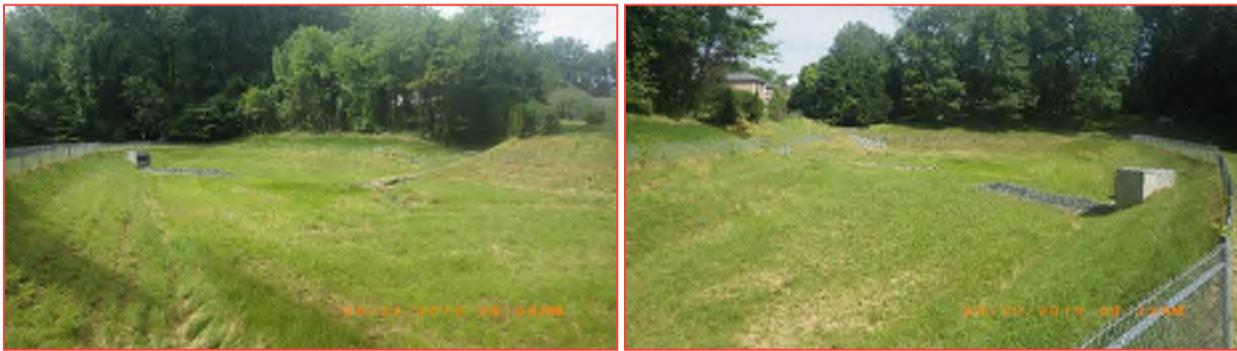
foot wide by 15-foot long plunge pool at the bottom of the facility. There is standing water in the plunge pool.

Figure A-60. Facility from northeast corner (left); Facility from southern corner (right)

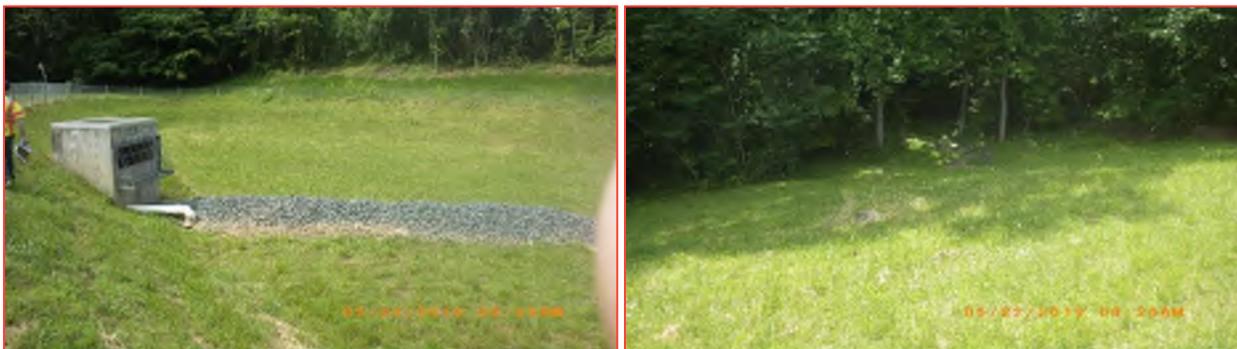
There was no rainfall observed in the area on the day of the site visit (5/22/19). There was no rainfall observed in the area on the two days prior to the site visit either. The concrete riser structure is on the eastern side of the facility. Low flow enters through a 6-inch PVC pipe and high flow enters through a 9-inch PVC pipe. The opening of the 9-inch PVC pipe bends 90 degrees downward toward the facility floor. Flow drains through a 30-inch PVC pipe out of the riser. On the other side of the embankment, the flow drops 8 feet before being discharged by a 24-inch RCP to a plunge pool. Grouting has deteriorated at the seam 6 feet from the outfall. The outfall discharges with some incision. The plunge pool is 12 feet wide by 15 feet long and has some riprap displacement. The outflow has caused minor erosion and sedimentation of the natural channel behind the facility. The stream is in fair to good condition.

Figure A-61. Riser structure (left); Outfall and outfall channel from top of embankment (right)

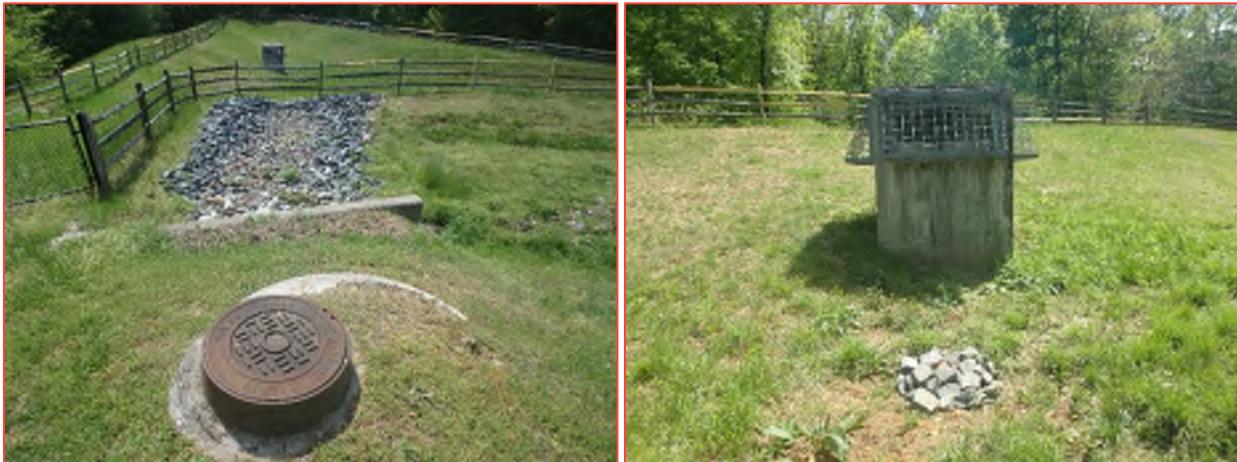
the northern tip of the facility. There is a minor amount of vegetation growing in the riprap. A 23-foot grass emergency spillway exists behind the riser structure on the southern border of the facility.

Figure A-62. Facility from behind the 30-inch RCP inflow pipe (left); Riser structure (right)

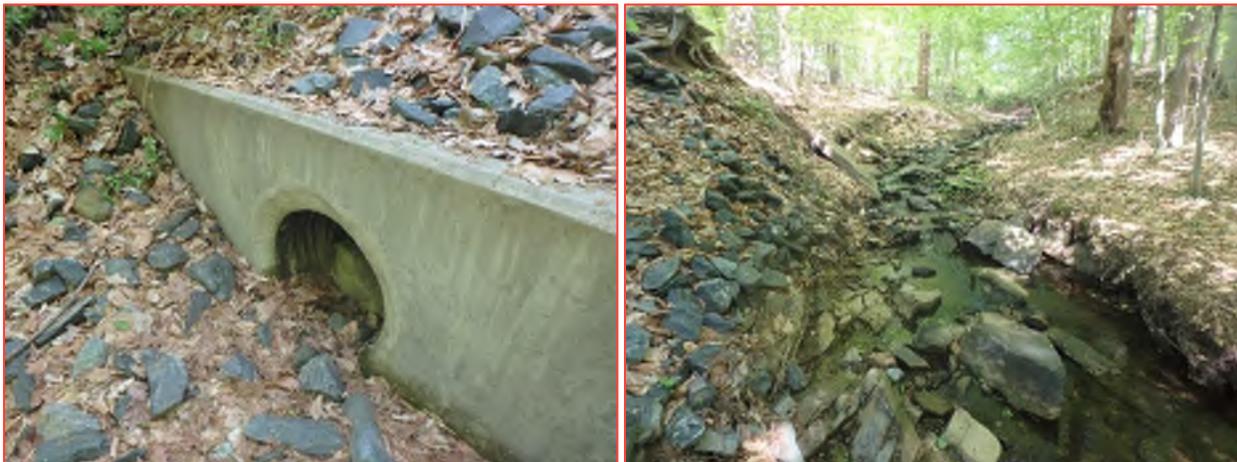
There was no rainfall observed in the area on the day of the site visit (4/30/19). There was 0.02 inch of rainfall in the area on the two days prior to the site visit. The concrete riser structure sits on the southern border of the facility. Flows enter through a 4-inch PVC pipe orifice and discharge through a 30-inch RCP principal spillway. A plunge pool exists at the outfall where flows enter an unnamed tributary to Bynum Run. There is moderate channel erosion extending up to approximately 100 feet from the outfall, but the channel is stabilized beyond.

Figure A-63. Outfall and plunge pool (left); Downstream at outfall channel (right)

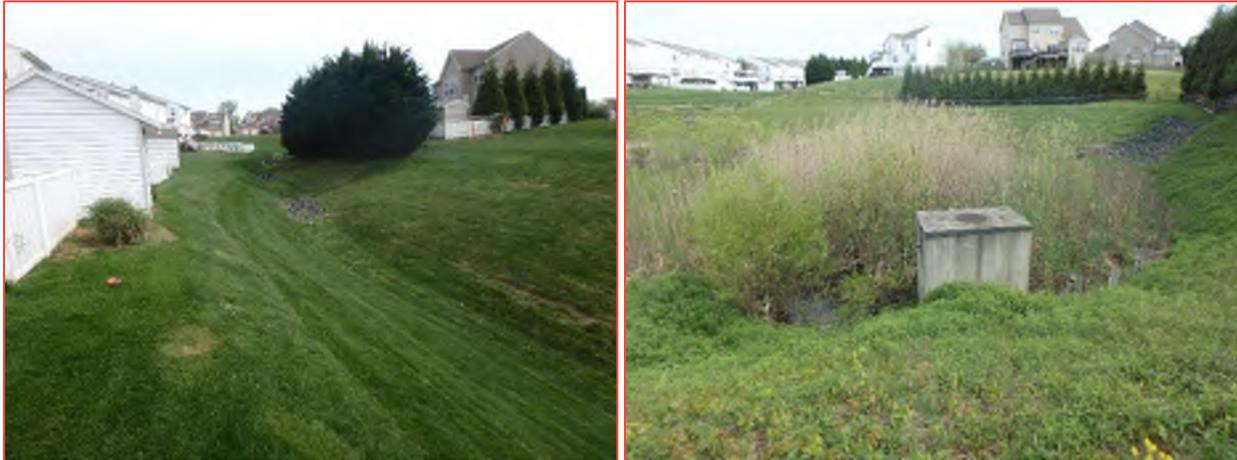
Court and Brunswick Drive into the northern corner of the facility. There are three check dams in the channel upstream of the inflow channel. The riprap, channel, and dams are in good condition and are well maintained. A 24-inch RCP conveys flows from residences on Harling Court and most of Moonshadow Road into the eastern corner of the facility. The plunge pool has a moderate amount of vegetation growing in it. A riprap channel adjacent to the 24-inch RCP conveys flows into the same plunge pool. An 18-inch RCP conveys flows from Blair Court into a forebay in the western corner of the facility.

Figure A-64. Check dams upstream of facility (left); Facility and riser structure (right)

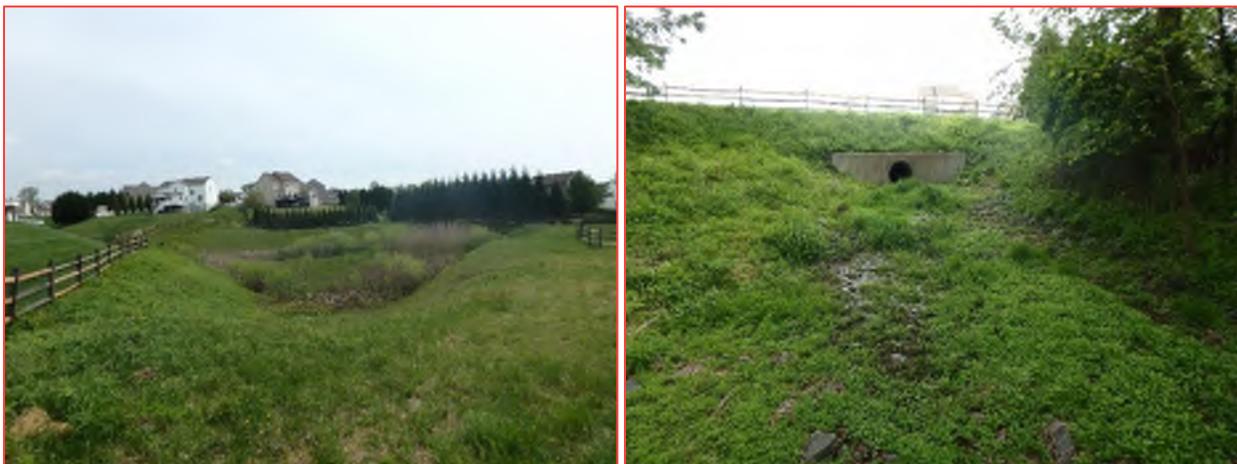
There was no rainfall observed in the area on the day of the site visit (4/30/19). There was 0.02 inch of rainfall in the area on the two days prior to the site visit. The concrete riser structure sits on the southern border of the facility. Flows enter through a 2 inch by 2 inch concrete opening at the bottom of the pond and discharges through a 36-inch CMP principal spillway. A plunge pool exists at the outfall. A 22-foot wide grass emergency spillway exists above the principal spillway. The immediate outfall area extending to approximately 100 feet downstream is in good condition.

Figure A-65. Facility from behind the 18-inch RCP inflow pipe (left); Upstream at outfall and embankment (right)

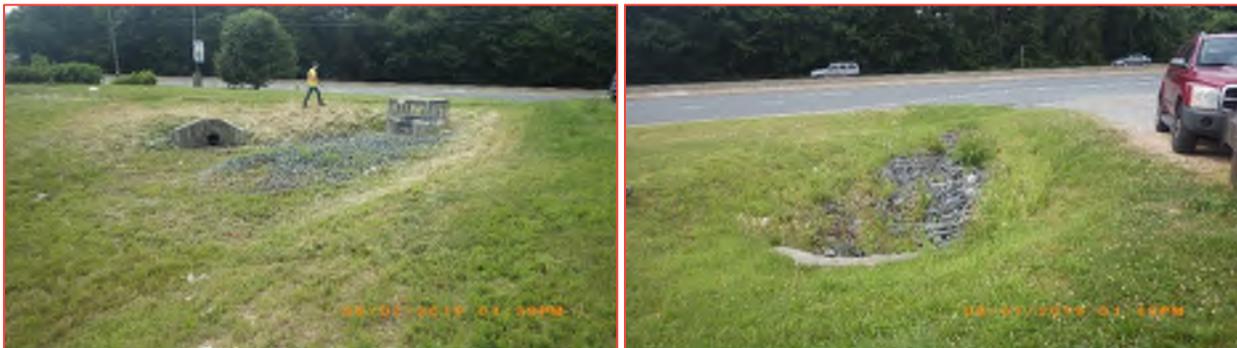
Existing SWM000506 is located along Pulaski Highway (MD-40) immediately east of the 7-Eleven, 3901 Pulaski Highway. The location of the facility does not match the location in the database, which shows it in the wooded area behind Bush River Books & Video, 3909 Pulaski Highway. It is accessible from the 7-Eleven parking lot through a chain link swing gate. There is no other fencing around the facility. The facility is within the Bush River subwatershed. One 18-inch HDPE into the facility conveys flows originating from the storm sewer system that includes drainage from the 7-Eleven parking lot. A concrete riser structure controls flows out of the facility and discharges through an 18-inch CMP principal spillway. The principal spillway drains to a riprap ditch upstream of a 15-inch RCP running under the Bush River Books & Video driveway. There is no emergency spillway. No standing water or wetland vegetation were noted.

Looking at the facility with the Pulaski Highway (MD-40) behind it (left); Looking at the outfall and outfall channel (right)

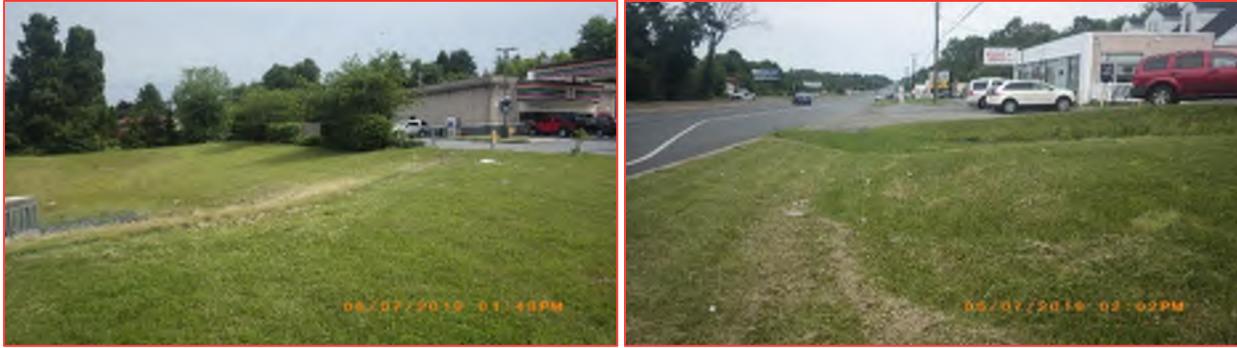
No precipitation had been observed in the area on the day of the site visit (6/7/19). Rainfall totaling 0.07 inch was observed during the two days prior to the field site visit. The pond is functioning as a dry pond in its current condition. Based on record drawings (and confirmed during field observations), low flows enter the riser through an 18-inch CMP pipe constricted to 6-inch by an orifice plate. High flows enter the top of the riser through a trash rack. Currently flows in the roadside ditch along Pulaski Highway bypass the facility.

Figure A-66. Western side of the facility and access point from 7-Eleven (left); Confluence of outfall channel and roadside ditch (right)

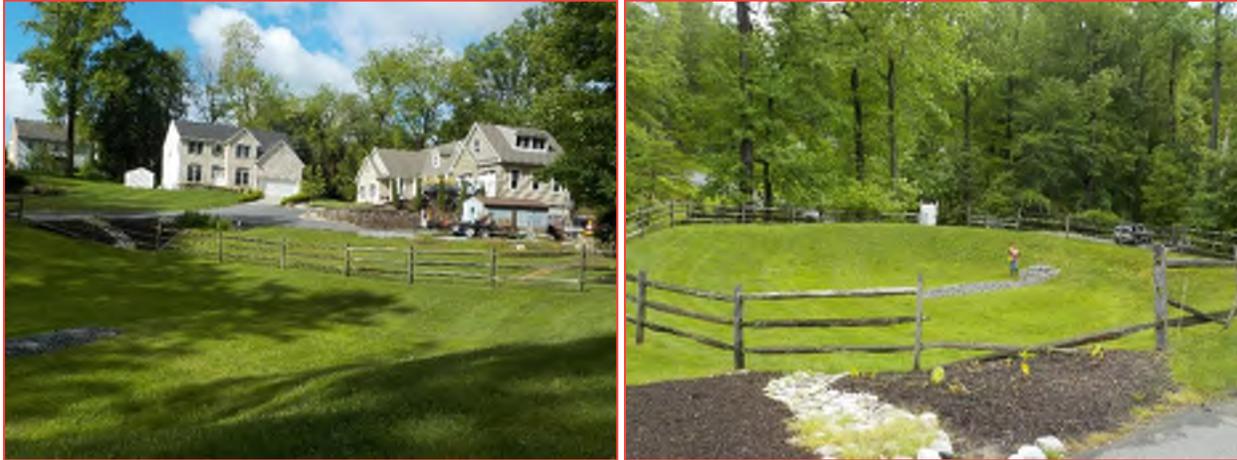
Existing SWM000526 is located at the south end of Balmoral Drive, in front of the residences 1518 and 1522 Balmoral Drive. It has a fence and a gate that is easily accessible from the roadway. The facility is within the MSB-5 subwatershed. It consists of a dry extended detention pond that drains through a control structure to a natural channel. A riprap channel provides the only inflow to facility. It conveys flows from the residences to the west into the pond. The inflow is in good condition.

Figure A-67. Facing west towards facility and residences (left); Facility from top of riprap inflow point (right)

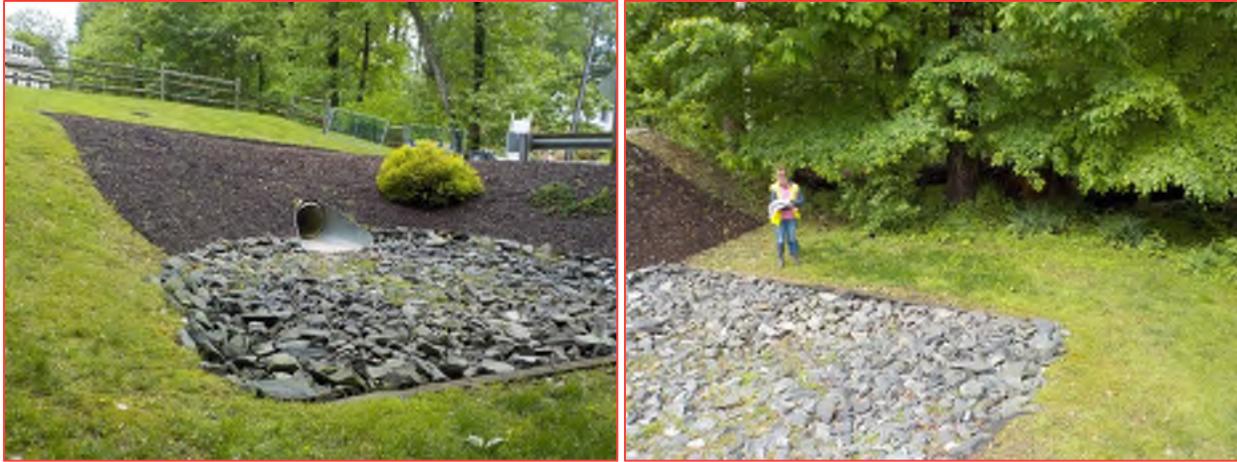
There was no rainfall observed in the area on the day of the site visit (5/14/19). There were 1.45 inch of rainfall in the area on the two days prior to the site visit. The concrete riser structure sits on the eastern part of the facility. Flows enter through a 6-inch PVC pipe orifice that is buried under gravel. Flows discharge through a 24-inch CMP principal spillway that conveys flows under Balmoral Dr. A well-maintained plunge pool exists at the outfall where flows dissipate into the woods. The immediate outfall area was in good condition, and there was no observed downstream channel.

Figure A-68. Upstream view of outfall and outfall protection (left); Downstream view of outfall where flows enter the woods (right)

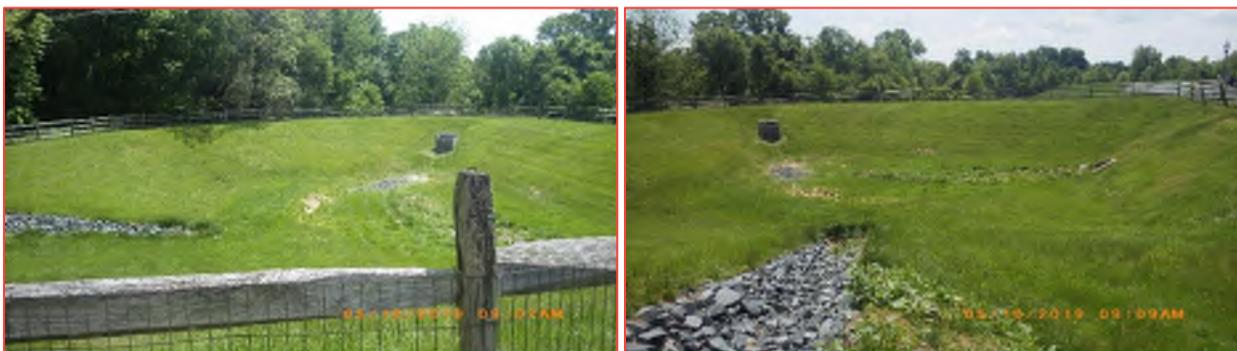
Existing SWM000597 is located behind the Lorien Bel Air assisted living center, 1909 Emmorton Road. It is accessible from the service driveway that runs behind the building. The facility is within the Atkisson Reservoir subwatershed. One 12-inch corrugated HDPE pipe conveys flows upstream of a riprap slope running into the facility from the storm sewer system to the northwest. The riprap slope shows minor erosion where it meets the bottom of the facility. A 30-inch RCP with concrete end section conveys flows into the facility from the southwest. A concrete riser structure controls flows out of the facility and discharges through a 27-inch RCP principal spillway. The downstream segment of pipe has become detached from the previous segment approximately 6 feet from the outfall. A riprap plunge pool at the outfall drains to a channel discharging to an unnamed tributary to Bynum Run to the south. No ponding water or wetland vegetation were observed within the facility.

Figure A-69. View of facility from parking lot of Lorien Bel Air assisted living center (left); View of facility from riprap inflow point (right)

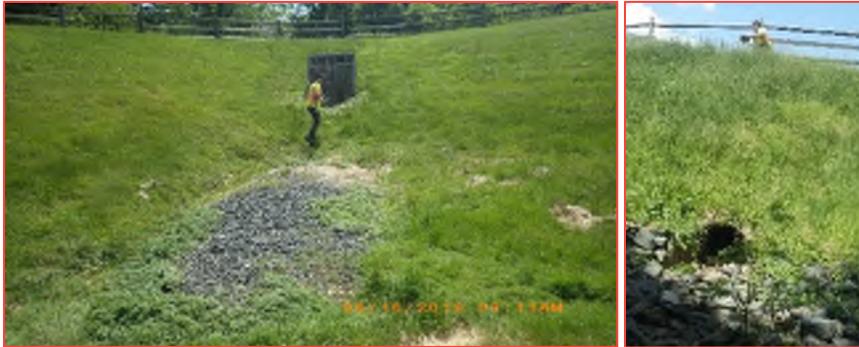
field work), a low-flow 12-inch perforated PVC pipe is installed at the pond floor. High flows enter a 6-inch RCP orifice, while overflow is conveyed through a three-sided weir with a U-shaped opening in the front.

Figure A-70. Riser control structure (left); Upstream view of outfall and embankment (right)

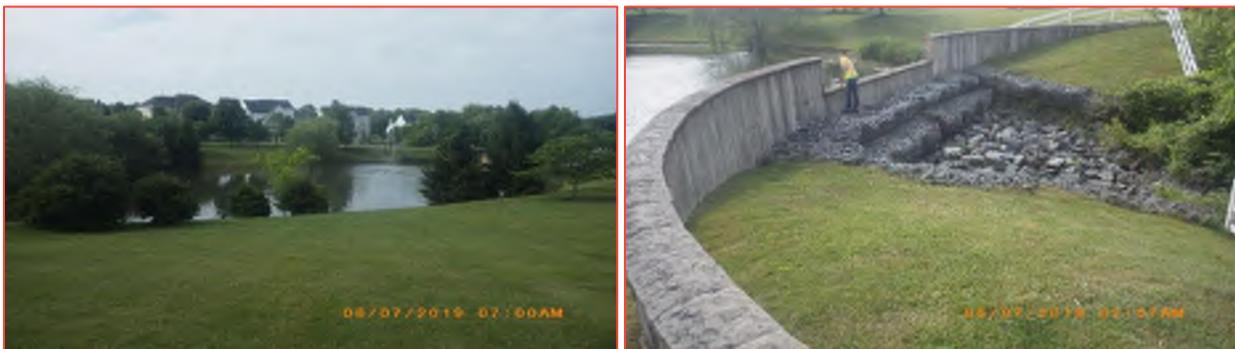
Existing SWM000621 is located off Sparrow Mill Way behind residences including 1154 through 1160 Sparrows Mill Way to the north and 1200 through 1204 Sparrow Mill Way to the south. The pond is functioning as a wet pond in its current condition and contains a decorative fountain. It is accessible from the homeowners association property between the residences at 1160 and 1200 Sparrows Mill Way. The facility is within the MSB-5 subwatershed. One 24-inch RCCP into the facility conveys flows originating from the storm sewer system to the north. One 24-inch RCCP into the facility conveys flows originating from the storm sewer system to the northwest. One 48-inch RCCP into the facility conveys flows originating from the storm sewer system to the south. Since the inflow pipes discharge below the permanent pool elevation, they are not visible, and the sizes and conditions could not be field verified. A concrete weir structure controls flows out of the facility and discharges through a Class II riprap principal spillway. The principal spillway drains to a channel ultimately discharging to Bynum Run to the south. There is a 32-foot grass emergency spillway along the northern edge of the pond. Wetland vegetation was present within the facility.

Figure A-71. View of facility from Sparrow Mill Way (left); Concrete weir and outfall protection (right)

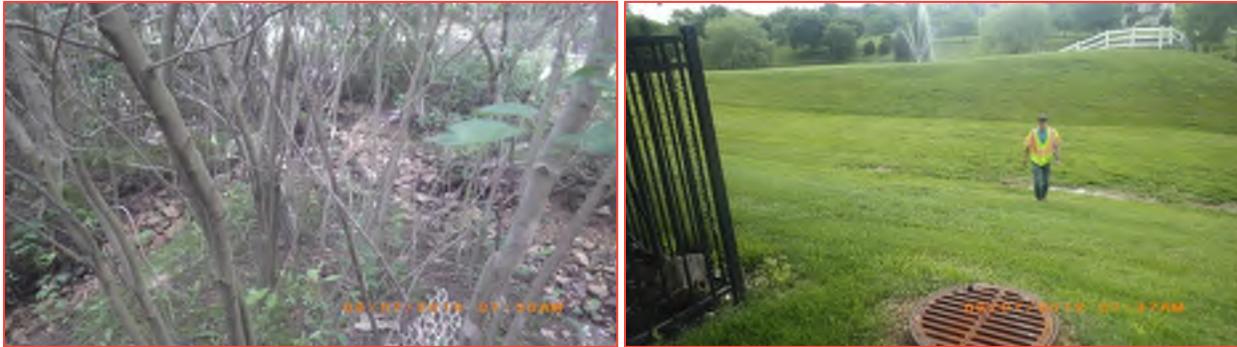
exit the pond through a low flow release device consisting of a vertical 12-inch BCCMP pipe conveying flows through a 12-inch DIP drain discharging through the gabion basket wall downslope of the weir wall crest. High flows enter the weir and spill onto the gabion baskets and riprap spillway.

Figure A-72. Downstream view of outfall channel (left); Natural spring in emergency spillway channel from manhole on northern part of the facility (right)

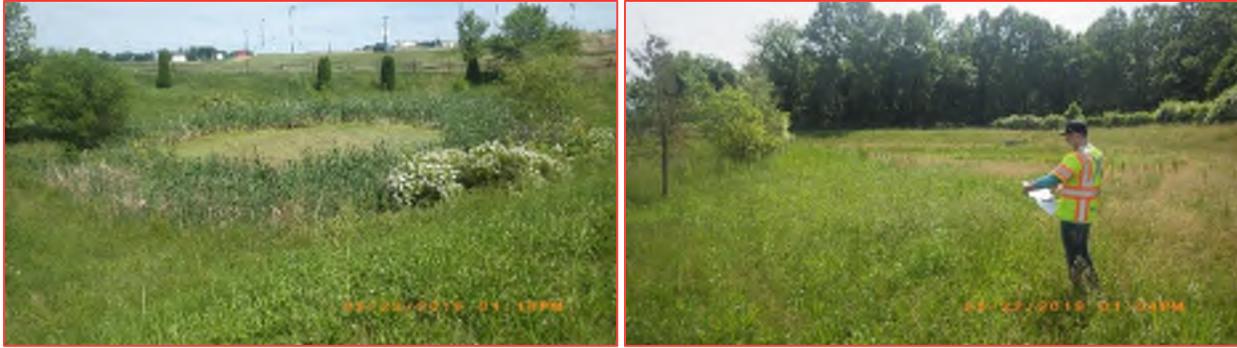
Existing SWM000700 is located on the western side of Cedar Lane Regional Park behind the field with artificial turf. It is accessible from the western parking lot. The facility is surrounded by a fence and the outfall is only accessible through a chain link fence about 200 feet north of the facility. The area around the facility is used for recreation. The facility is within the LB-2 subwatershed. It consists of a dry pond that drains to a natural channel. A 24-inch HDPE inflow pipe with a plastic end section conveys flow from the east into the northern part of the facility and into a plunge pool. The plunge pool has some riprap displacement. A 24-inch HDPE with a plastic end section conveys flow from the east into the southern part of the facility. A wetland has formed at the south inflow.

Figure A-73. Wetland surrounding southern inflow pipe (left); Riser structure at northern end of facility (right)

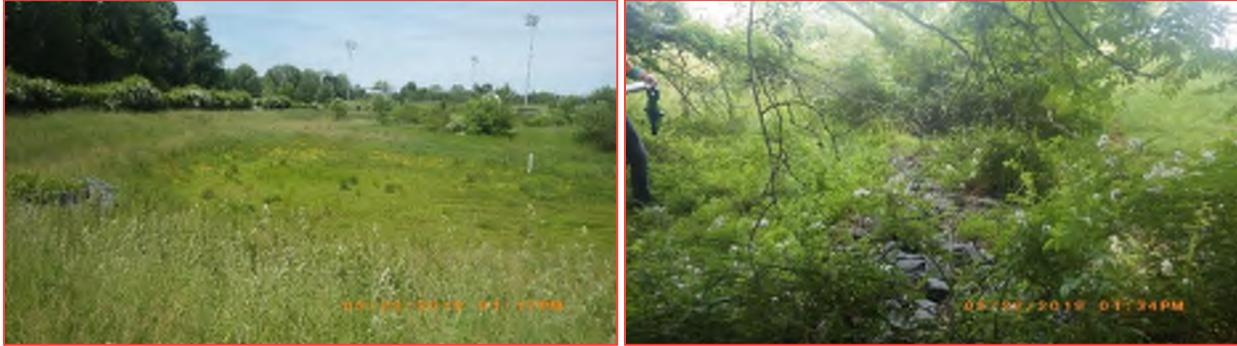
There was no rainfall observed in the area on the day of the site visit (5/22/19). There was no rainfall observed in the area on the two days prior to the site visit. The concrete riser structure sits on the west side of the facility. Low flows enter through twin 6-inch PVC pipes with agri-drain caps at the bottom of the facility and discharge through a 24-inch CMP principal spillway. There is some standing water surrounding the twin low flow pipes. A 13-foot wide by 26-foot long plunge pool exists at the outfall. There is a minor amount of sediment in the outfall plunge pool. The outfall discharges to an unnamed tributary to Bynum Run. Minor soil erosion was observed.

Figure A-74. Facing north towards facility and riser structure (left); Upstream at outfall and outfall protection (right)

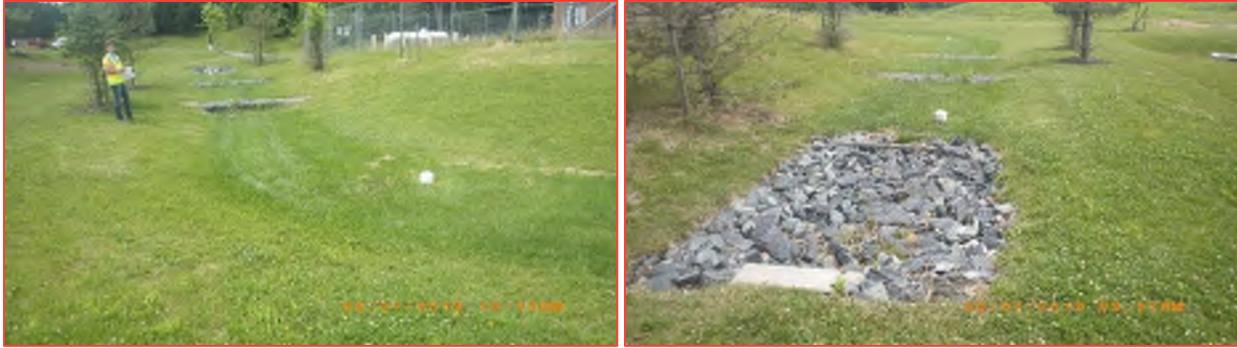
Figure A-75. Downstream end of check dams (left); Upstream end of check dams (right)

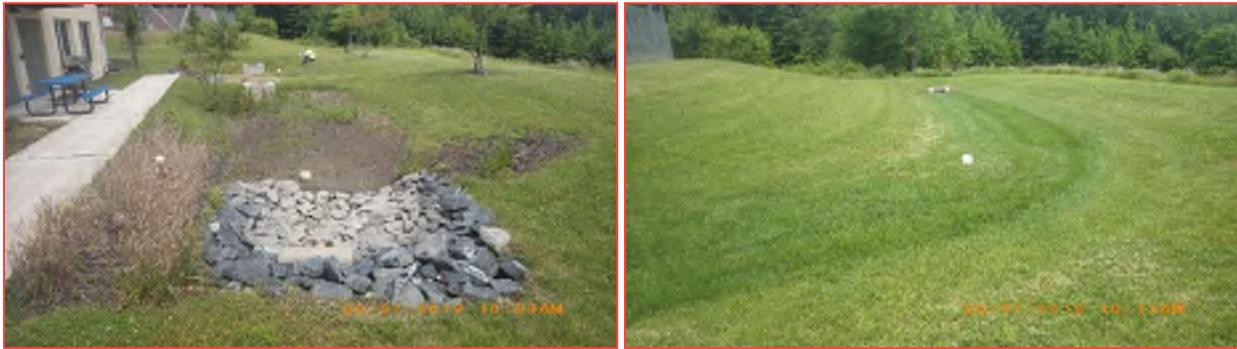
Figure A-76. Micro-bioretentions (left); Yard inlet that conveys flows to existing pond (right)

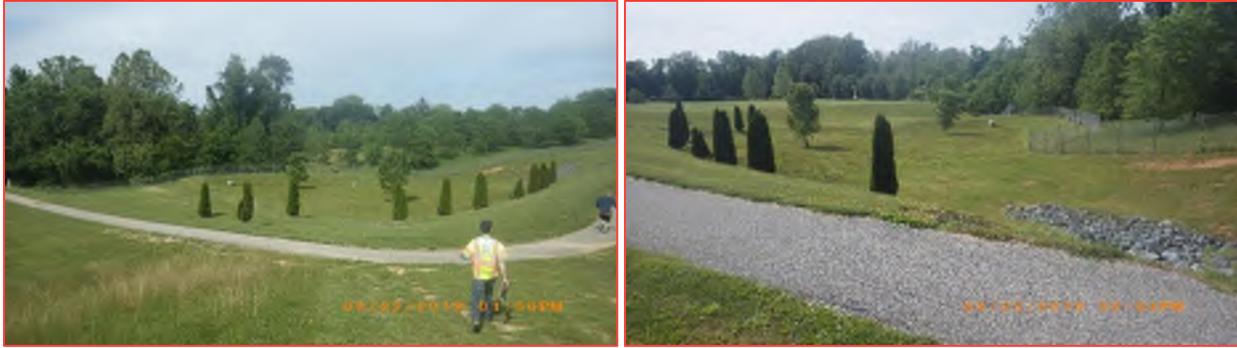
Figure A-77. Facing north towards facility (left); Facing northwest towards facility from foot path above southeastern inflow point (right)
