HARFORD COUNTY DPW

LOWER BYNUM RUN SMALL WATERSHED ASSESSMENT REPORT APPENDICES

DECEMBER 13, 2019

HARFORD COUNTY DEPARTMENT OF
PUBLIC WORKS

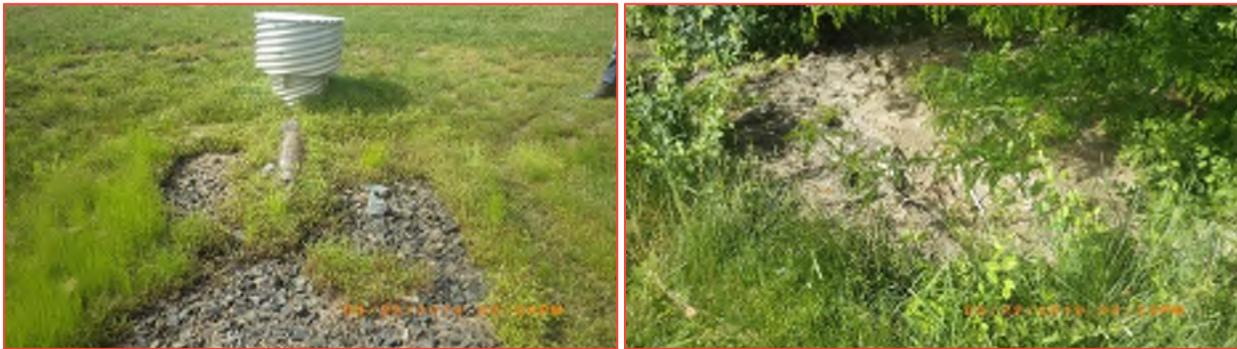
There was no rainfall observed in the area on the day of the site visit (5/22/19). There was no rainfall observed in the area on the two days prior to the site visit. A cylindrical aluminum riser structure sits at the northern most point of the facility. The riser is 39 inches in diameter and 22 inches high, and it is elevated 19 inches off the ground by a smaller aluminum cylinder. A 6-inch CMP with trash rack conveys flow into the riser and a 12-inch CMP drains flow to the principal spillway. A plunge pool exists at the outfall and flow is conveyed into an unnamed tributary to Bynum Run. The plunge pool has major sediment built up in the riprap. Most of the riprap has been displaced. There are wetland plants in the plunge pool. There is minimal erosion from the outfall into the natural channel and the outfall area 100 feet downstream is in good condition.

Figure A-78. Riser and low flow orifice (left); Downstream view of outfall protection an outfall channel (right)

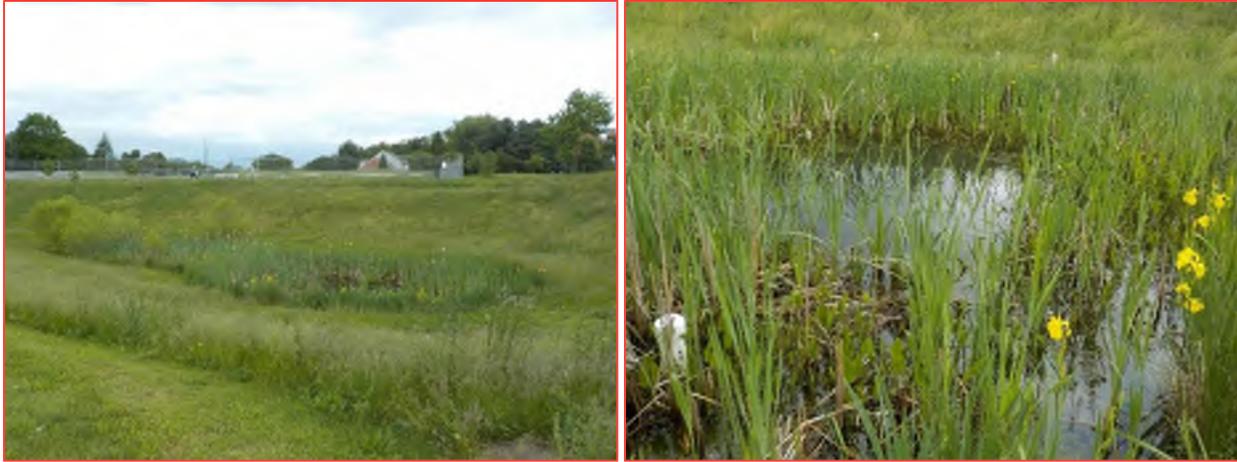
Figure A-79. Facing north toward facility (left); PVC pipe observation well in shallow wetland (right)

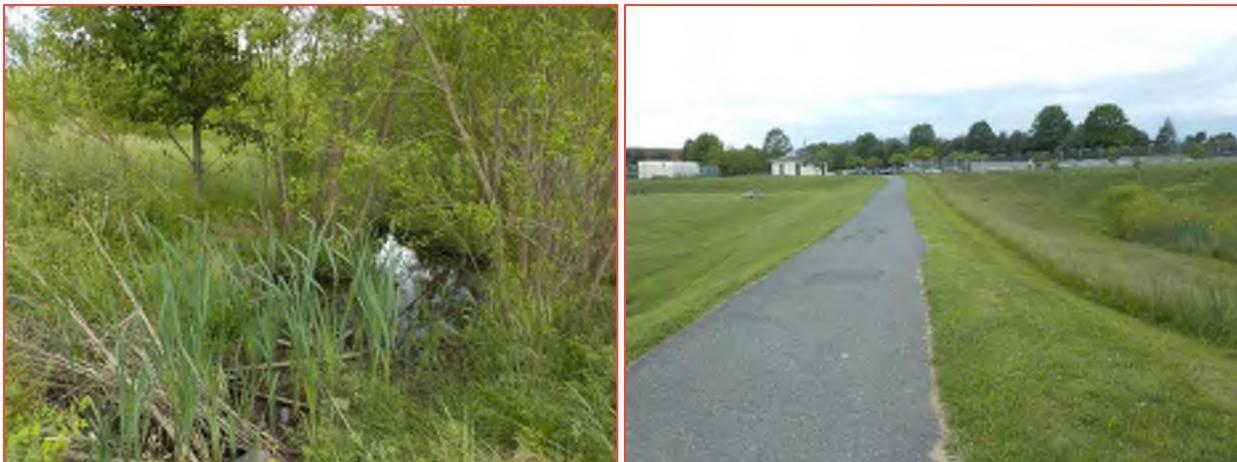
There was no rainfall observed in the area on the day of the site visit (5/14/19). There was 1.45 inches of rainfall in the area on the two days prior to the site visit. An 18-inch RCP principal spillway exists on the eastern tip of the facility. The pipe was submerged during the site visit. Flows are conveyed through the pipe, which transitions to a 24-inch RCP, and into a plunge pool. Outflow drains into an unnamed tributary to Bynum Run. The immediate outfall area extending to approximately 100 feet downstream is in good condition.

Figure A-80. Outfall and plunge pool (left); Facing west towards paved walking path leading to school parking lot (right)

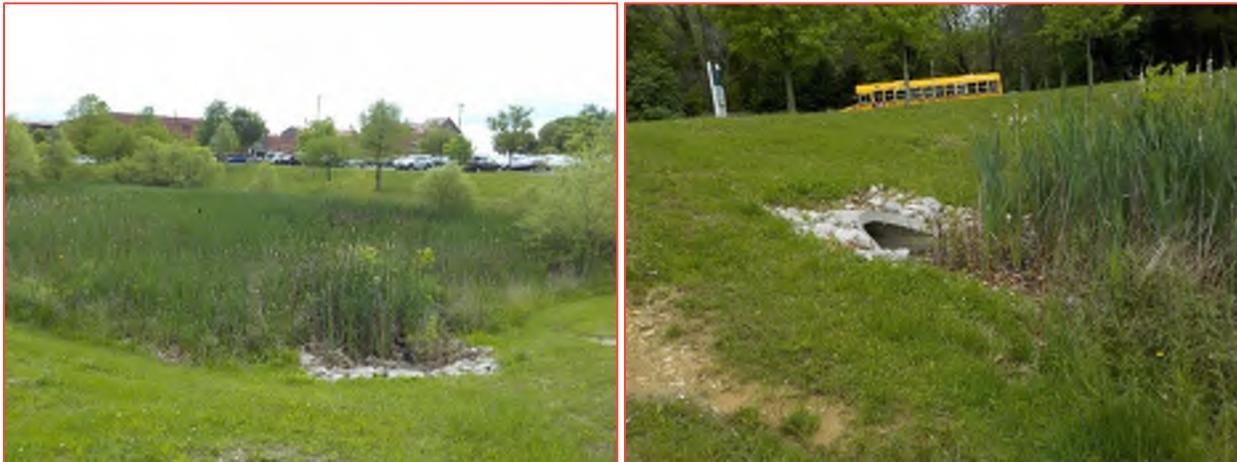
conveys flow from the parking lot and the field team could not see the pipe during their site visit. An 18-inch RCP conveys flow from the northwest into the forebay. It was visible, but half filled with water.

Figure A-81. Facility from behind the 18-inch RCP inflow pipe (left); 18-inch RCP inflow pipe (right)

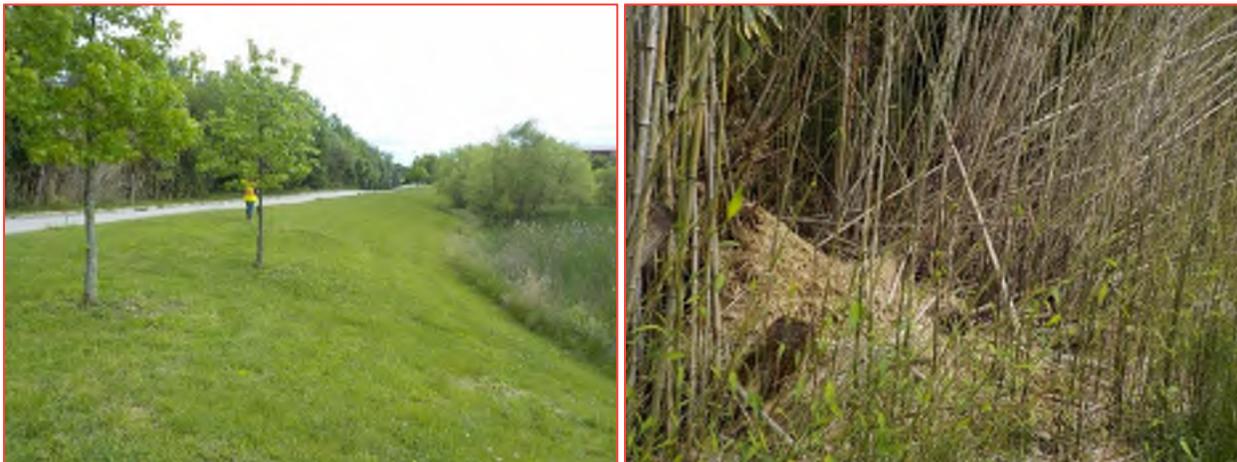
There was no rainfall observed in the area on the day of the site visit (5/14/19). There was 1.45 inches of rainfall in the area on the two days prior to the site visit. The concrete riser structure, which sits on the northern border of the facility, was unable to be located under the thick vegetation. Flows enter through a 4-inch PVC pipe orifice and discharge through a 24-inch RCP. The immediate outfall area extending to approximately 100 feet downstream is so severely overgrown with bamboo that the field team could not verify the outfall condition. The outflow connects to an unnamed tributary to Bynum Run.

Figure A-82. Facility northern border adjacent to Patterson Mill Road (left); Overgrown outfall area (right)

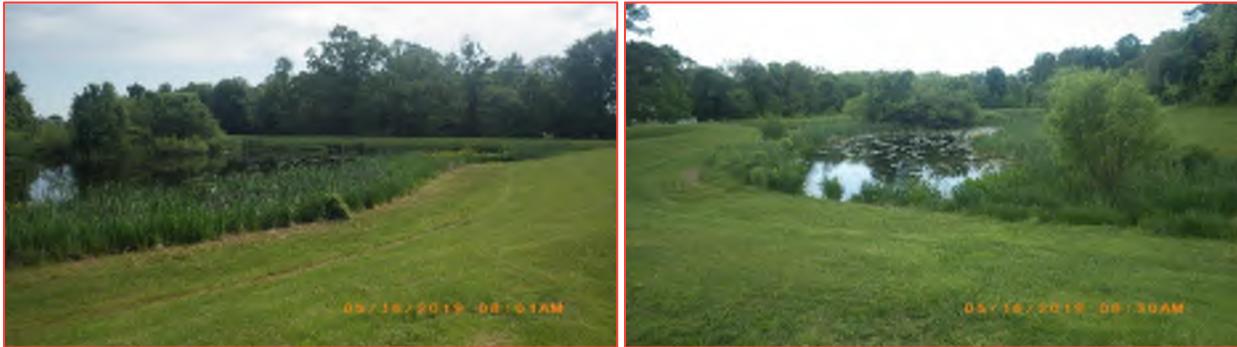
structure located underground and discharge through a 24-inch RCP principal spillway. The downstream segment of pipe has become detached from the previous segment approximately 6 feet from the outfall. A riprap plunge at the outfall drains to a channel discharging to an unnamed tributary to Bynum Run to the southwest. Ponded water and abundant wetland vegetation were observed within the facility.

Figure A-83. Facing north towards facility (left); Facing south towards facility (right)

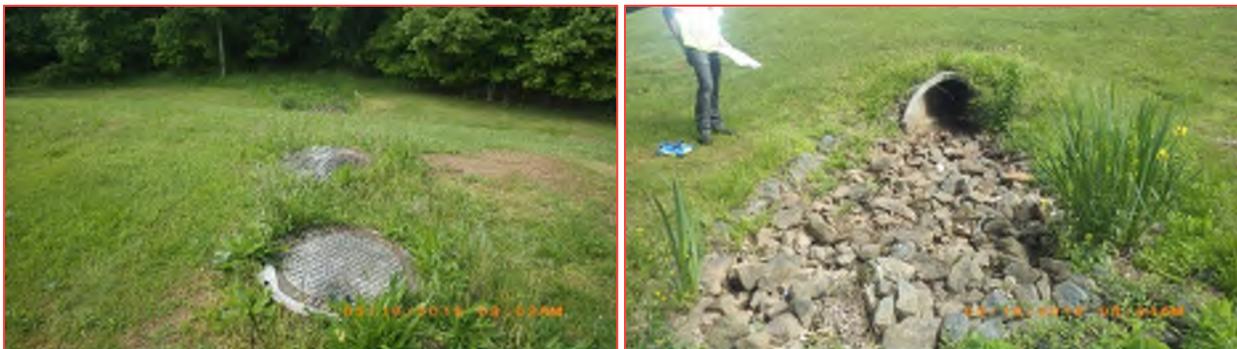
Figure A-84. Facing downstream towards outfall and outfall channel (left); Facing upstream at outfall and outfall protection (right)

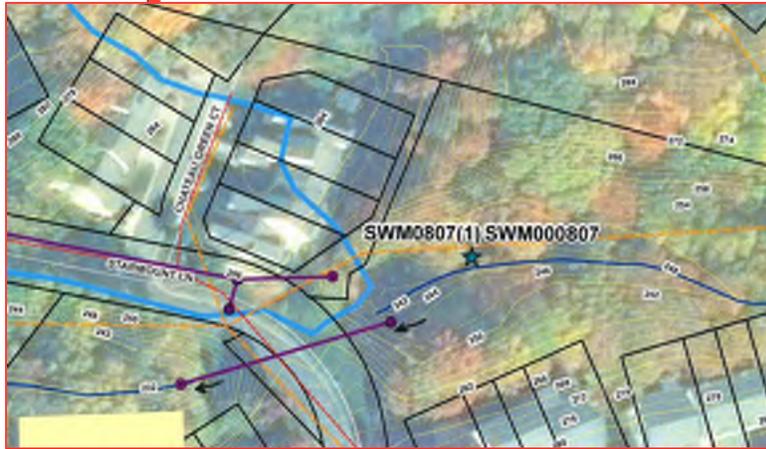
Existing SWM0807(1)/SWM000807 could not be located during field investigations. GIS information indicates it is located northeast of the intersection of Starmount Lane and Chateau Green Court behind residences including 1236 through 1242 Chateau Green Court. The GIS location is within the MSB-5 subwatershed. The as-built for this site matches SWM000312.

Figure A-85. GIS location for facility SWM0807(1) / SWM000807

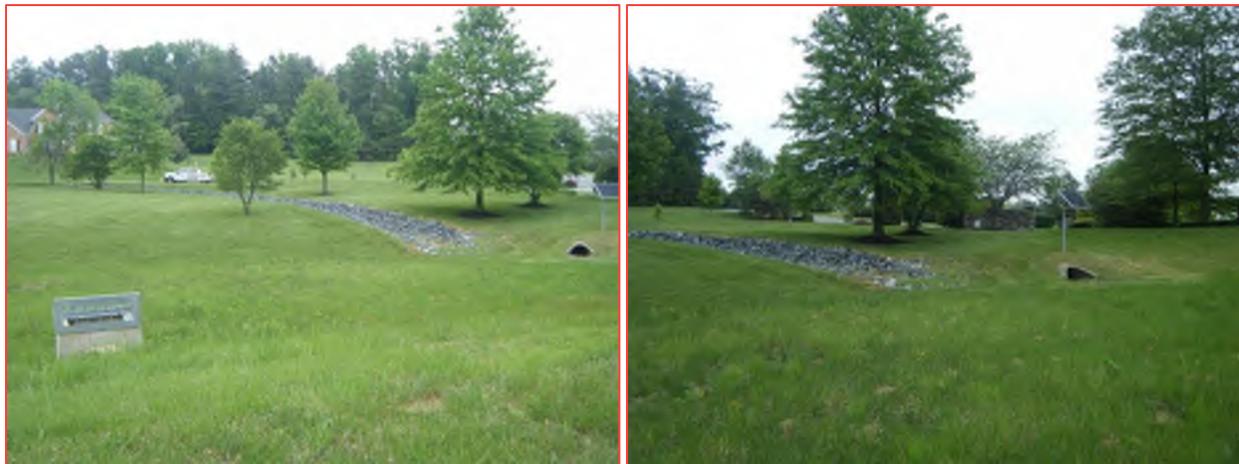
Figure A-86. Facing north towards riser structure and riprap inflow point (left); Facing east towards both inflow points (right)

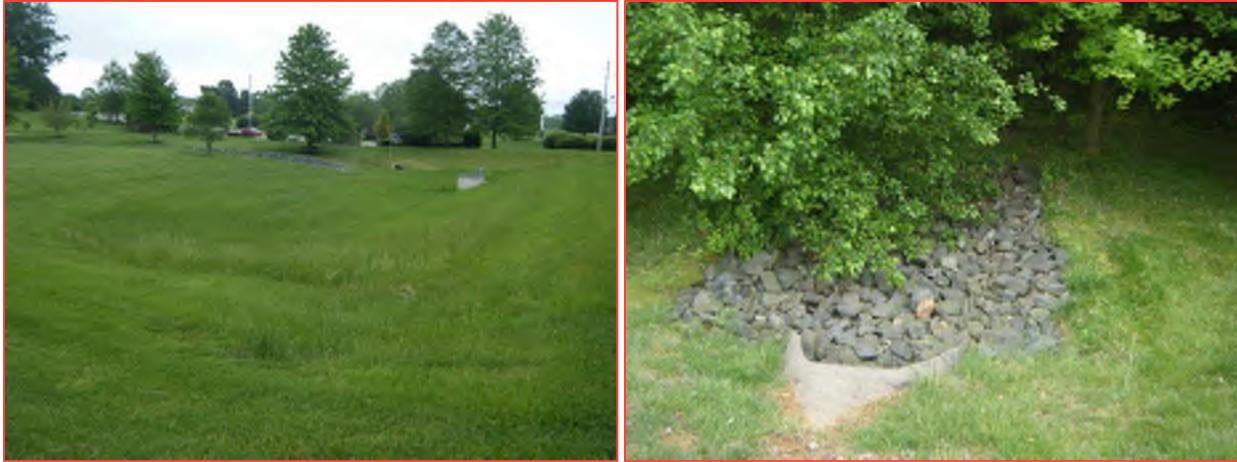
There was no rainfall observed in the area on the day of the site visit (5/9/19). There was no rainfall in the area on the two days prior to the site visit. The concrete riser structure sits on the southern border of the facility. Low flows enter through a 5-inch by 5-inch orifice in the concrete with a circular 5-inch PVC pipe lining it. Flows discharge through a 24-inch RCP principal spillway. A plunge pool exists at the outfall where flows dissipate into the woods. There was no observed downstream channel, but the immediate outfall area was in good condition.

Figure A-87. Facing east towards facility (left); Facing downstream at outfall and outfall protection (right)

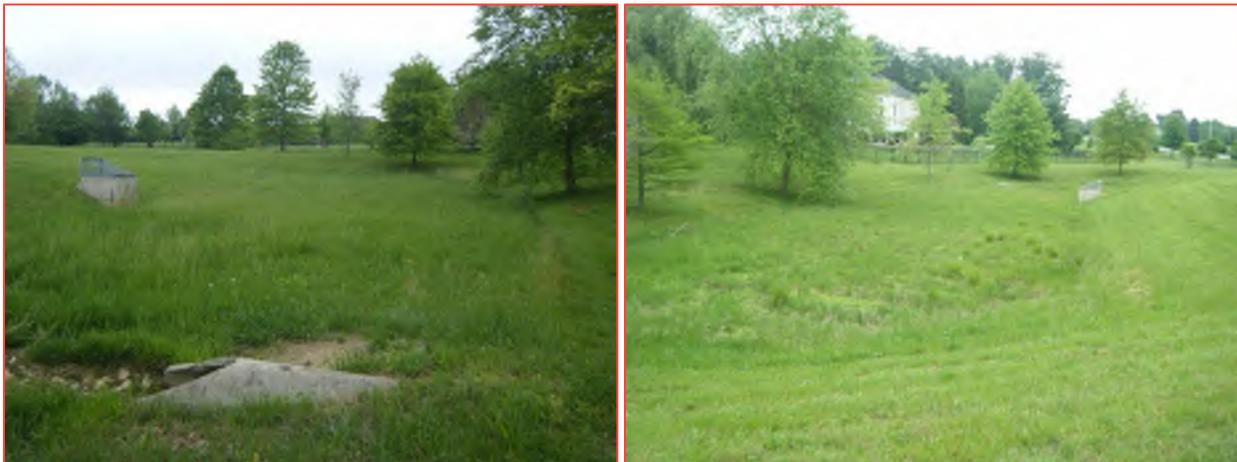
Existing SWM000814 is located behind residences, including 1600 Willowdale Drive. It does not have a fence and is well maintained. The site is accessible from the road. It is within the LB-1 subwatershed. The facility consists of a dry pond that drains through a riser control structure into the nearby woods. The only inflow is a 15-inch RCP that conveys flows from Beechview Court and a few residences on Willowdale Drive. The inflow riprap has a minor amount of sediment.

Figure A-88. Facing west towards the RCP inflow pipe and riser structure (left); Facing east towards facility (right)

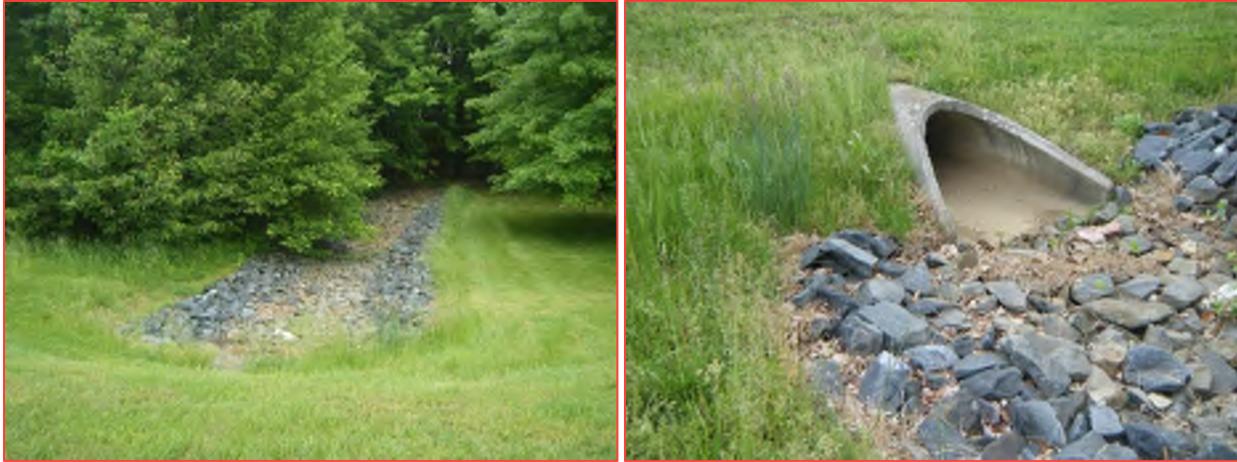
There was no rainfall observed in the area on the day of the site visit (5/9/19). There was no rainfall in the area on the two days prior to the site visit. The concrete riser structure sits on the southern border of the facility. Flows enter through a 5-inch by 5-inch orifice in the concrete and discharge through a 24-inch RCP principal spillway. An 80-foot long plunge pool exists at the outfall where flows dissipate into the woods. There was no observed downstream channel, but the immediate outfall area was in good condition.

Figure A-89. View of downstream outfall and outfall channel (left); Upstream view of outfall and outfall protection (right)

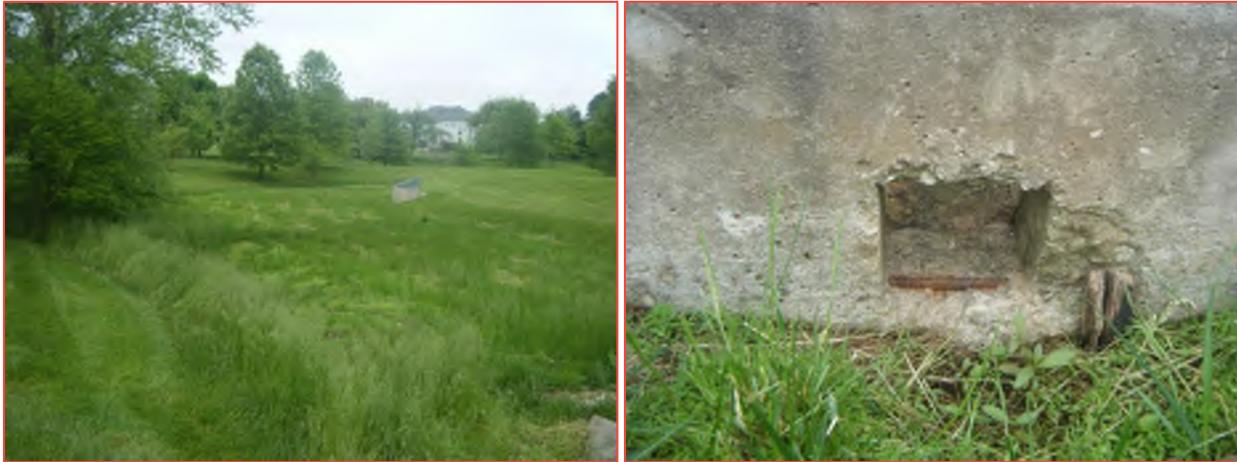
Existing SWM000815 is located behind residences, including 1504 Willowdale Drive. It is accessible between 1504 and 1502 Willowdale Drive. The site does not have a fence and is well maintained. It is within the LB-1 subwatershed. The facility consists of a dry pond that drains through a riser control structure into the nearby woods. The only inflow is a 24-inch RCP that conveys flows from residences along Willowdale Drive. The inflow has moderate sediment build up. A 12-foot grass emergency spillway exists along the northeastern part of the facility.

Figure A-90. View of facility from behind RCP inflow (left); 5-inch by 5-inch orifice (right)

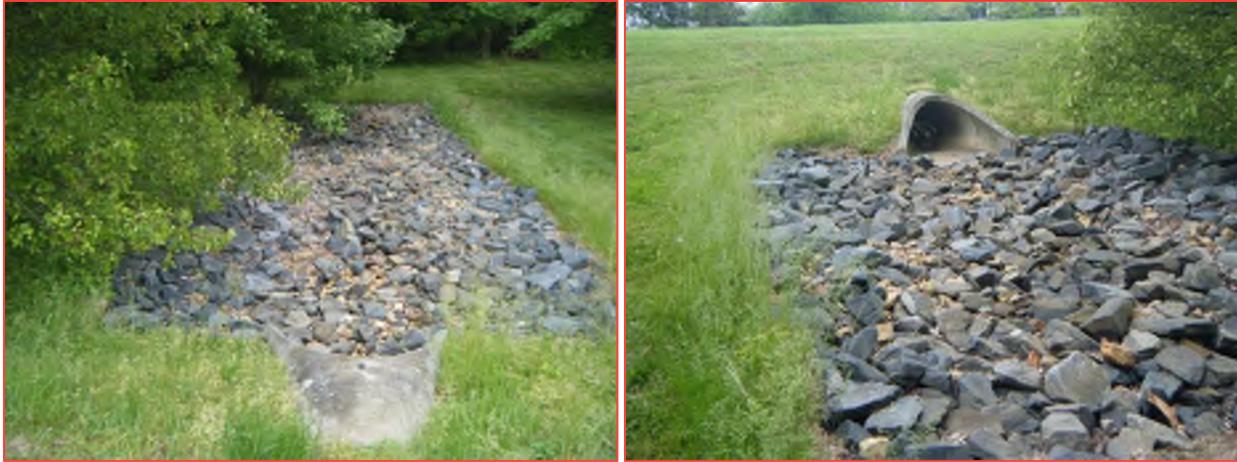
There was no rainfall observed in the area on the day of the site visit (5/9/19). There was no rainfall in the area on the two days prior to the site visit. The concrete riser structure sits on the eastern border of the facility. Flows enter through a 5-inch by 5-inch orifice in the concrete and discharge through a 24-inch RCP principal spillway. A 36-foot long plunge pool exists at the outfall where flows dissipate into the woods. There was no observed downstream channel, but the immediate outfall area was in good condition.

Figure A-91. Downstream view of outfall and outfall channel (left); Upstream view of channel and outfall protection (right)

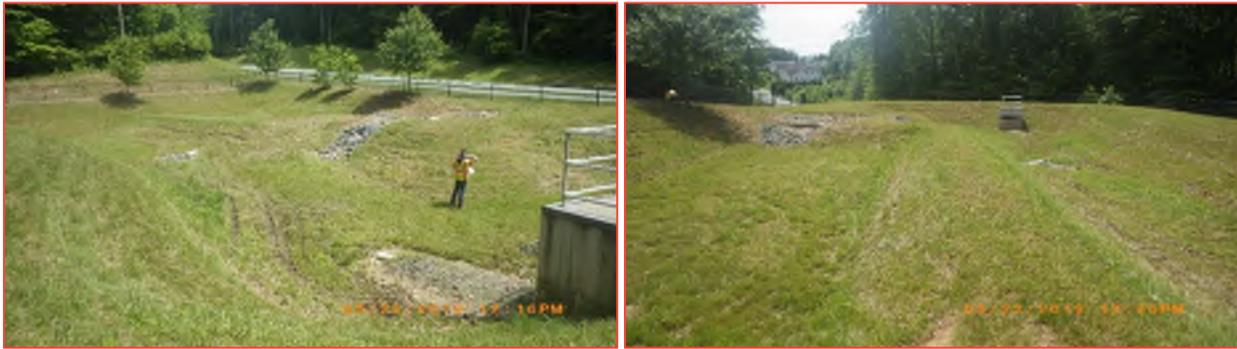
Figure A-92. Facing southeast towards the facility (left); Sediment forebay (right)

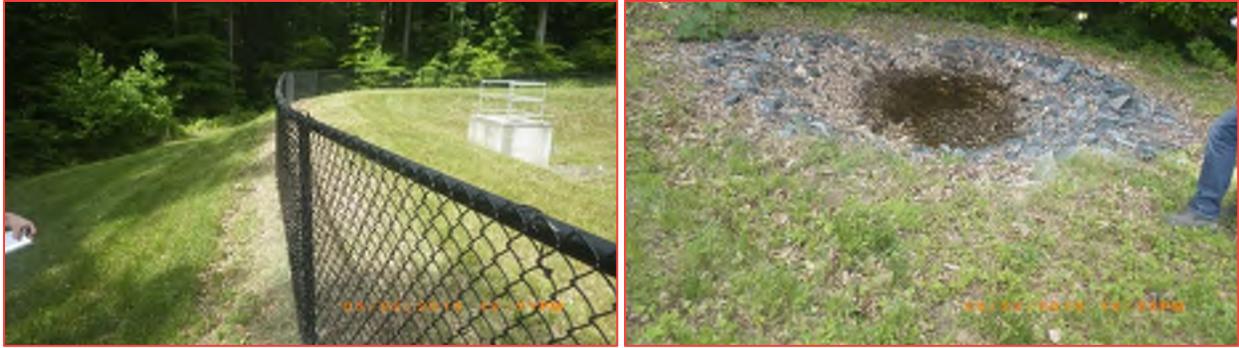
There was no rainfall observed in the area on the day of the site visit (5/22/19). There was no rainfall observed in the area on the two days prior to the site visit. The concrete riser structure sits in the western part of the facility. Flow enters through a 6-inch PVC plated pipe at the bottom of the pond and it drains through a 24-inch RCP with an end section at the outfall. An 18-foot wide by 20-foot long plunge pool exists at the outfall. There is standing water in the plunge pool, but the riprap is in good condition. There was no observable outfall erosion leading down to an unnamed tributary to Bynum Run.

Figure A-93. Embankment behind riser structure (left); Downstream view of outfall and plunge pool (right)

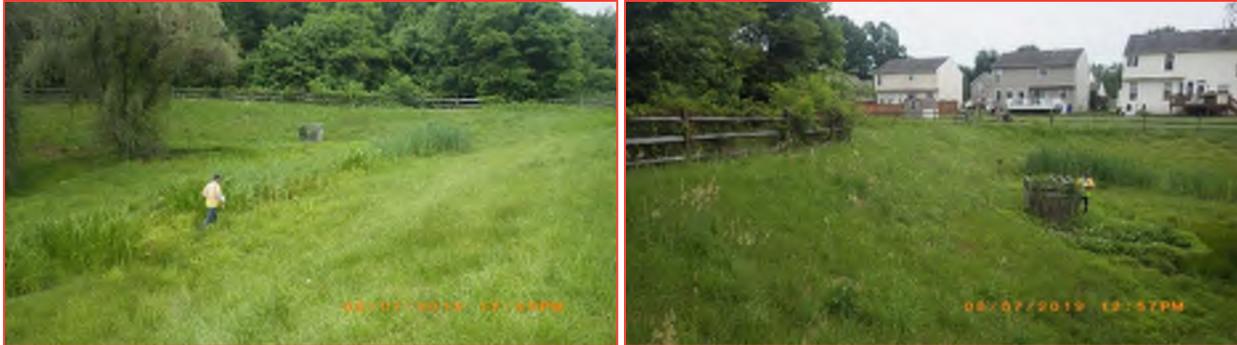
to the south and west. There is a concrete riser structure controls with a 30-inch CMP principal spillway. The principal spillway outlets to a channel discharging to an unnamed tributary to Bush Creek (use I). There is no emergency spillway. Standing water was observed at the inflow point of the 36-inch CMP. Wetland vegetation was present within the facility.

Figure B-1. Wetland vegetation around the riser and inflow pipe (left); Embankment behind the riser structure (right)

- A wet pond retrofit is recommended to target improved water quality for flow exiting the facility into the perennial stream. Permanent pools excavated down from the existing dry pond bottom are to be created to improve water quality.

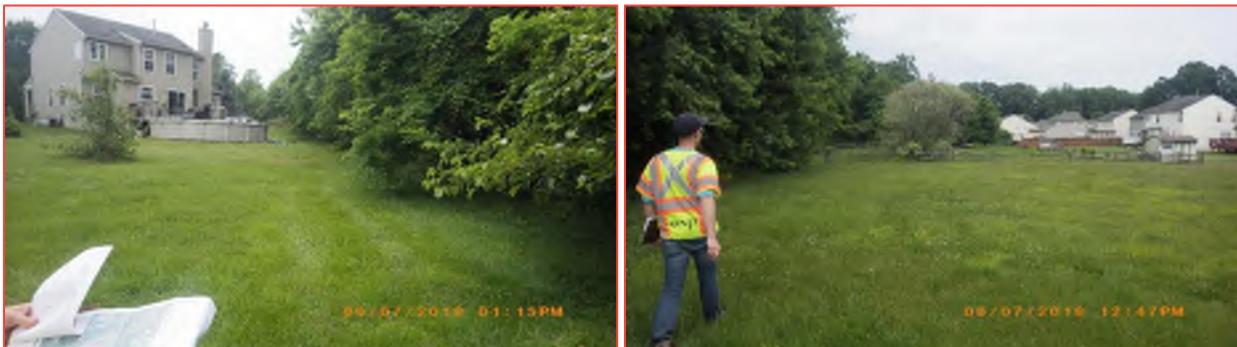
Figure B-2. Access path behind residences on Smiths Landing Court (left); Continuing view of access to facility (right)

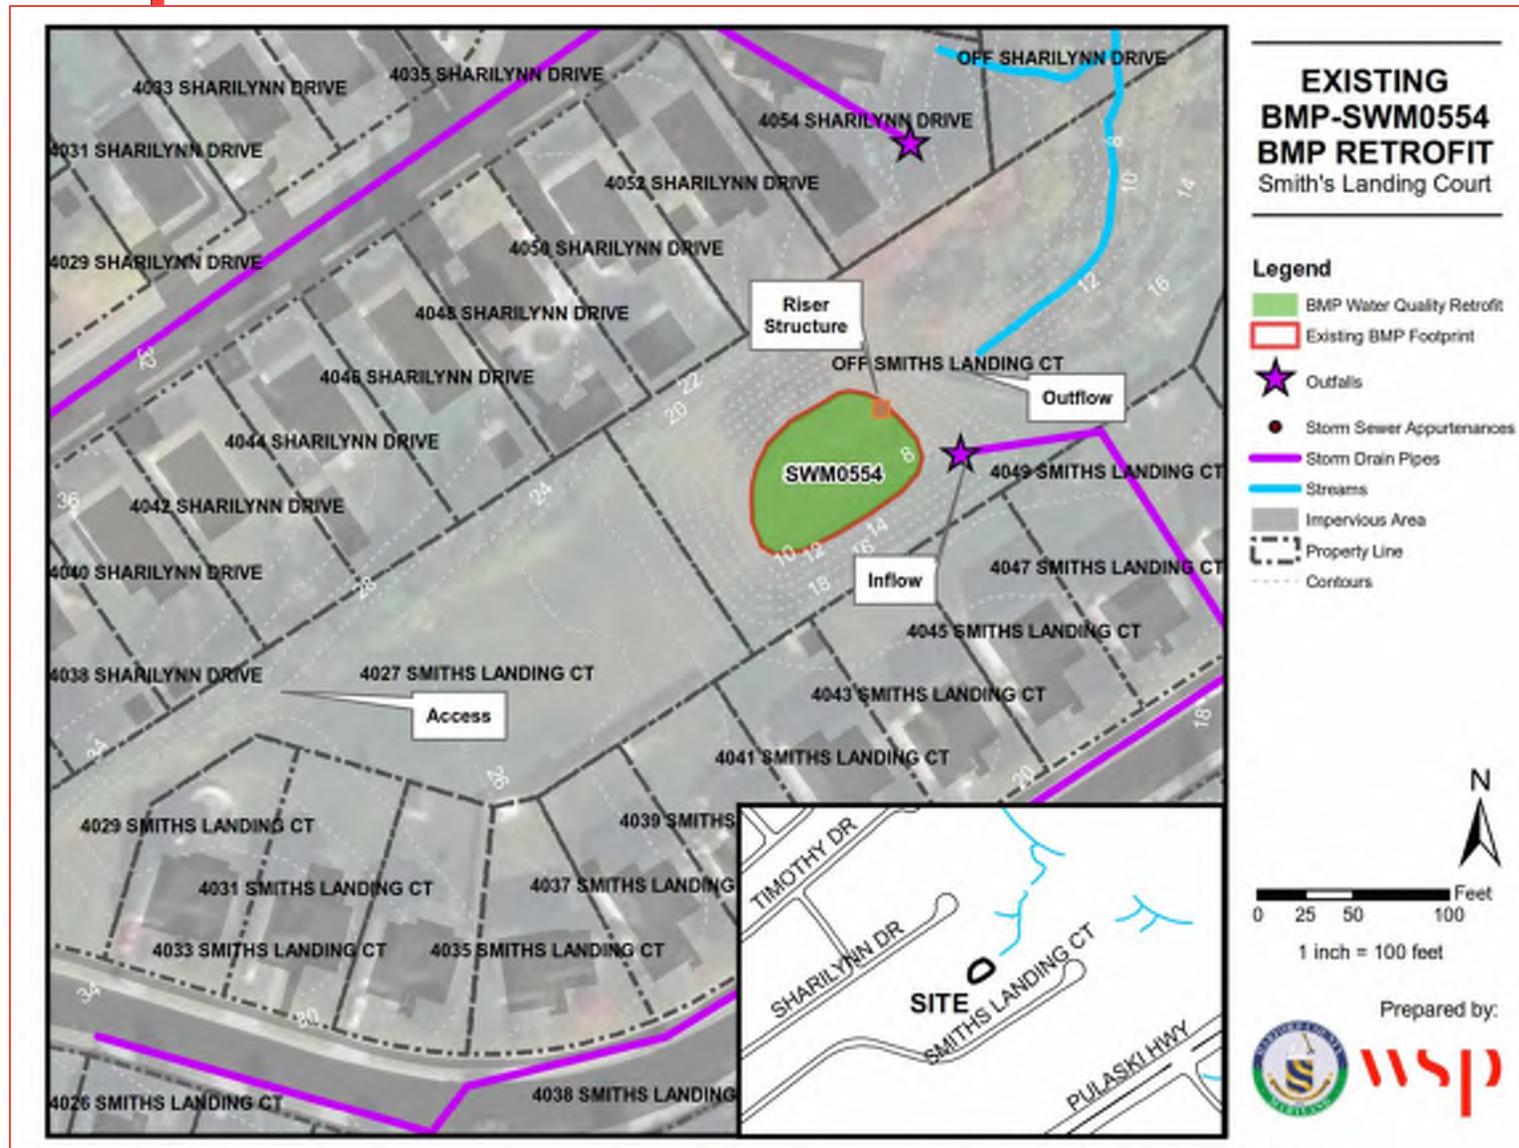
Figure B-3: Site Location and Proposed Retrofit for Existing SWM0554

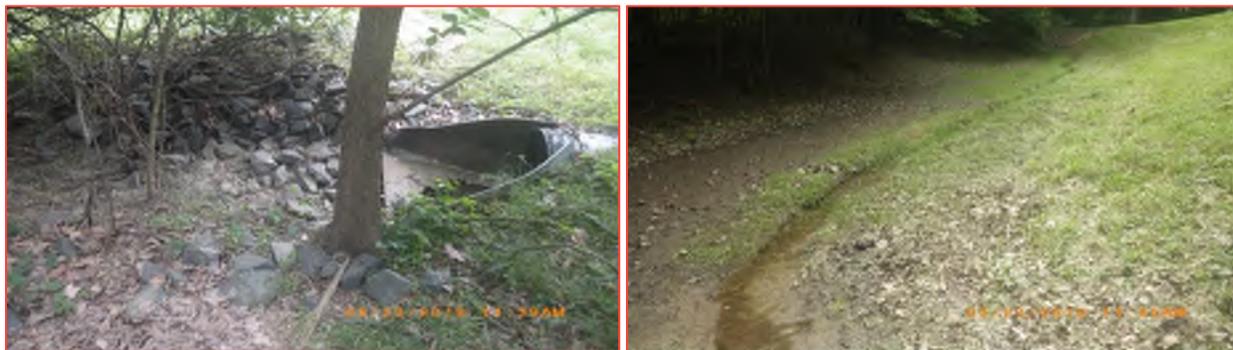
Existing SWM000118 is an extended detention facility surrounded by residences including 34 Mitchell Drive. It can be accessed between 24 Mitchell Drive and 28 Mitchell Drive. The facility is bordered by a gated chain link fence and is well mowed. It is within the MSB-4 subwatershed. A 24-inch RCP conveys flows from residences along Mitchell Drive into a riprap outlet protection on the western tip of the facility. The metal apron has major rust damage. There is minor sediment build up and minor riprap displacement in the outlet protection. The channel conveying flow from the inflow to the center of the facility cuts into the ground (Figure B-4).

Figure B-4. The 24-inch RCP inflow pipe and riprap outlet protection (left); The channel from the inflow pipe to the facility (right)

- To improve water quality, a submerged gravel wetland retrofit is recommended within the western portion of the current extended detention basin footprint to capture the maximum amount of inflow and meet design requirements. The submerged gravel wetland would have a forebay at the inflow and be excavated down from the existing detention basin bottom.
- Proposed project plans are shown in Figure B-6.

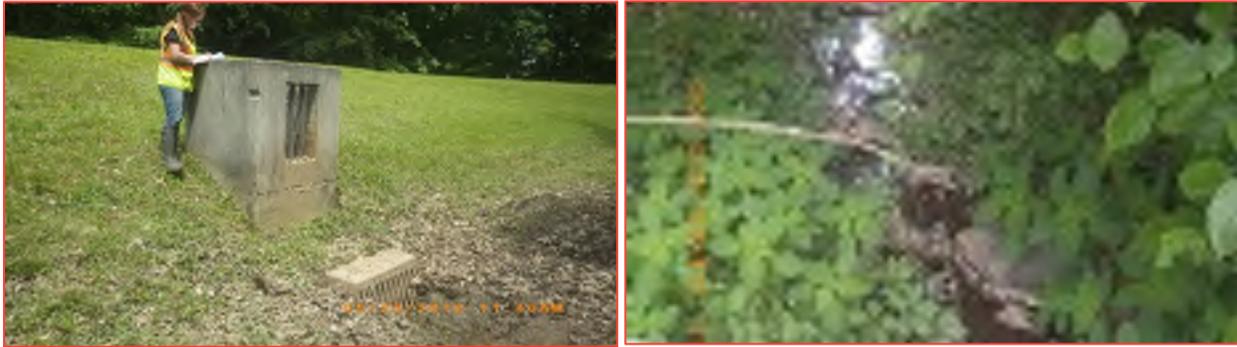
outfall with no observed outfall erosion or sediment build up. The stream extending to approximately 100 feet downstream of the outfall was in good condition (Figure B-5).

Figure B-5. Riser structure and embankment behind it (left); downstream at the outfall channel (right)

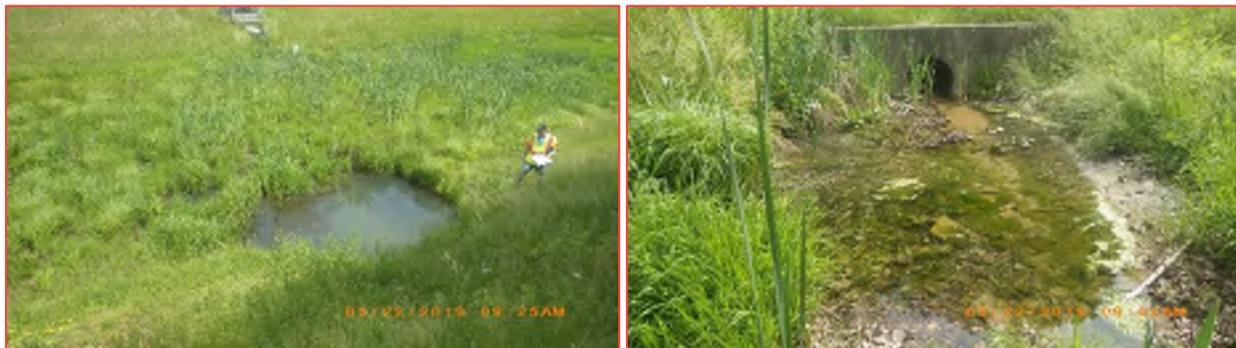
Existing SWM000257 is an extended detention facility located north of Deepwood Court, behind the residential properties of 803 Deepwood Court and 805 Deepwood Court. It is surrounded by a chain link fence and is accessible from a 12-foot wide access road and an 18-foot swing gate. The facility is within the MSB-4 subwatershed. The facility has two inflow points. One is a 30-inch RCP with headwall in the eastern part of the facility. Water has pooled at the inflow point to a depth of 8 inches and there is wetland vegetation around the pool. The second is a 21-inch RCP with a 14-foot long headwall in the southern part of the facility. Water has pooled at the inflow point and there is wetland vegetation surrounding the pool (Figure B-7). There is a 22-foot emergency spillway with riprap in the southwest part of the facility. The slope above the southern inflow is reinforced with riprap in good condition. The slopes of the facility are steep, except for the vehicle access path.

Figure B-7. The southern inflow point and the riser structure (left); The eastern inflow point and the pool in front of it (right)

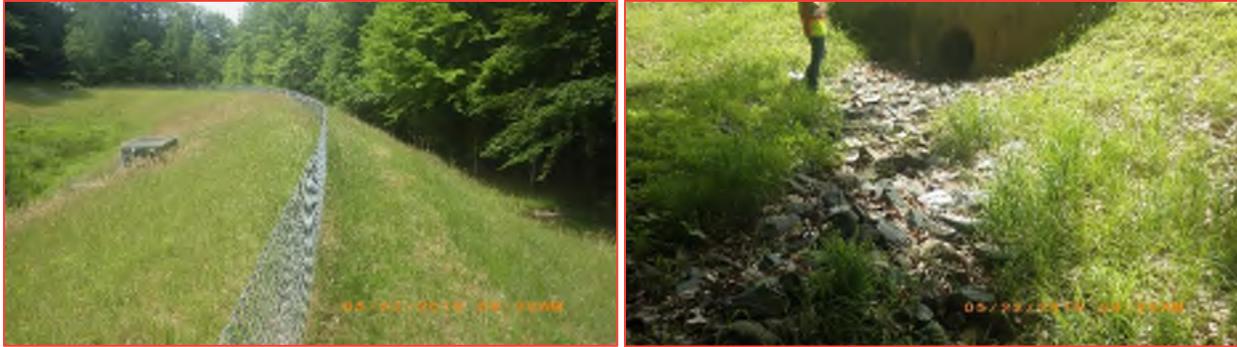
There is a weir above that equipped with a trash rack for high flows. The riser outlet is a 36-inch RCP with a 17-foot long headwall (Figure B-8). There is a 12-foot-wide by 21-foot-long riprap protection at the outfall where flow enters Bynum Run confluent to James Run to the northwest. The immediate outfall area extending to approximately 100 feet downstream is in good condition.

Figure B-8. The embankment behind the riser structure (left); Outfall headwall (right)

- To improve water quality, a submerged gravel wetland retrofit is recommended within the eastern portion of the current extended detention basin footprint to capture the maximum amount of inflow and meet design requirements. The submerged gravel wetland would have a forebay at the inflow and would be excavated down from the existing detention basin bottom.
- Proposed project plans are shown in Figure B-9.

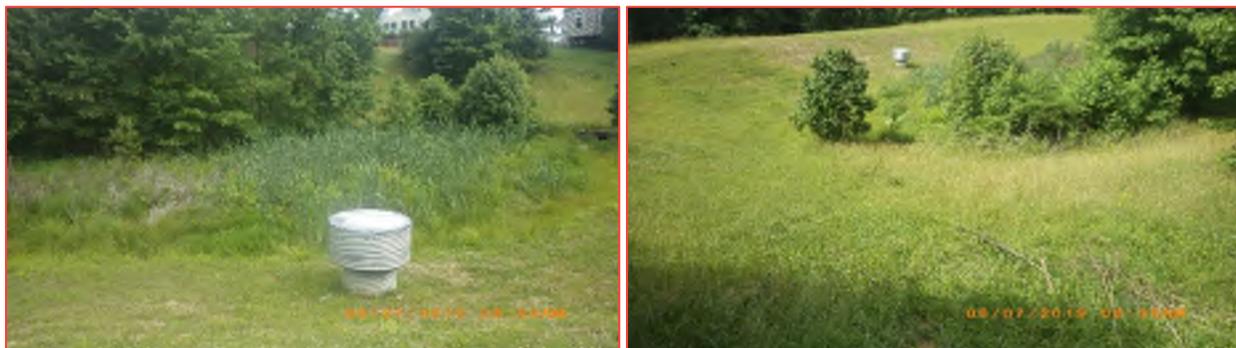
Existing SWM000287 is an extended detention facility located southeast of the intersection of Gittings Court and Pouska Road, and behind residences 3301 Pouska Road and 899 Gittings Court. It is accessible from Pouska Road adjacent to 3305 Pouska Road. The facility is within the MSB-3 subwatershed. One 18-inch CMP into the facility conveys flows originating from the storm drainage system to the northwest. Another 18-inch CMP into the facility conveys flows originating from the storm drainage system to the northeast. There is a concrete riser structure that discharges through a 24-inch BCCMP principal spillway, which drains to a channel discharging to an unnamed tributary to Bynum Run to the south (Figure B-10). One to three inches of standing water and wetland vegetation were observed in the facility.

Figure B-10. The riser structure, pond, and the northwest inflow pipe (left); Facing southwest towards the facility from the manhole above the northwest inflow pipe (right)

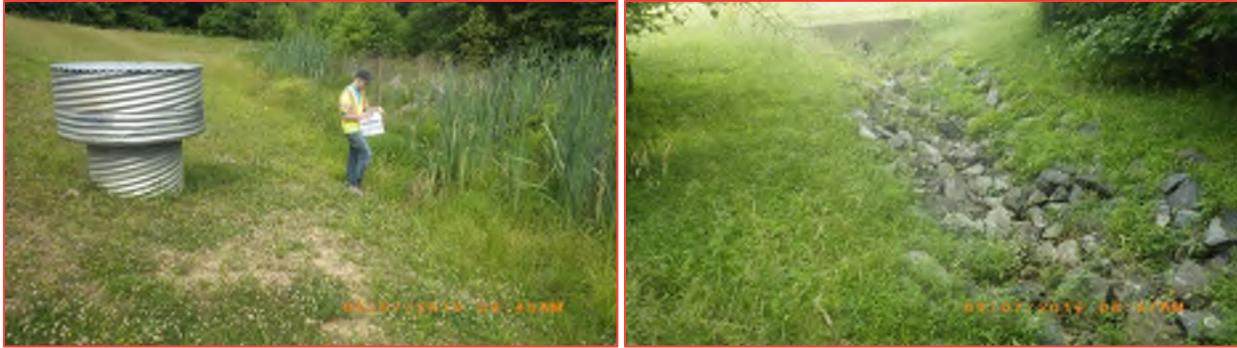
No precipitation had been observed in the area on the day of the site visit (6/7/19). Rainfall totaling 0.07 inch was observed during the two days prior to the field site visit. The pond is functioning as a dry pond in its current condition. Based on record drawings (and confirmed during field observations), there is an 8-inch BCCMP in the riser for low flows. There is no emergency spillway (Figure B-11).

Figure B-11. Riser structure (left); The outfall channel (right)

- To improve water quality, a submerged gravel wetland retrofit is recommended in the extended detention basin footprint. The submerged gravel wetland would have a forebay at each inflow and would be excavated down from the existing detention basin bottom.
- Proposed project plans are shown in Figure B-12.

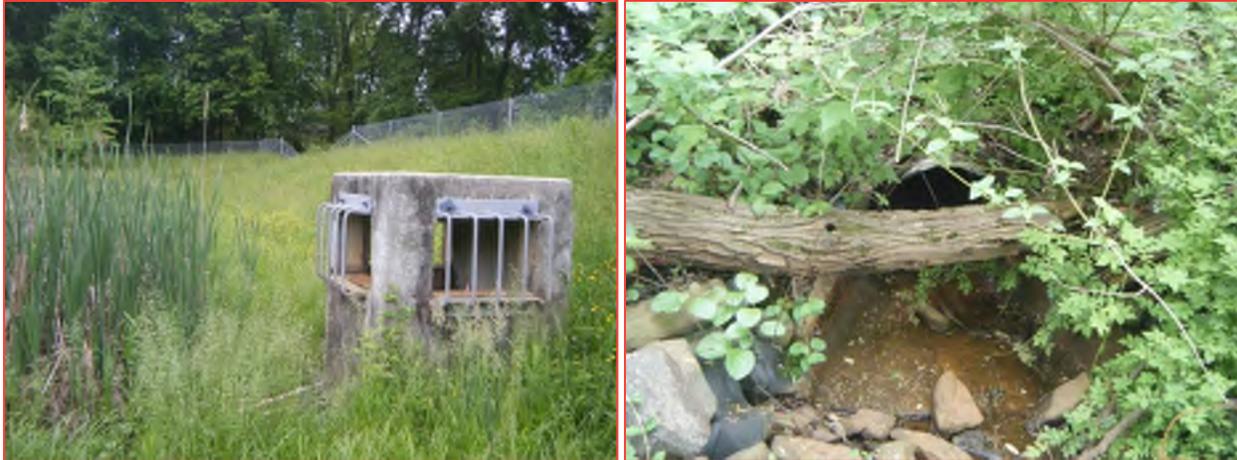
the facility with an 8-inch PVC pipe orifice inflow and an 18-inch CMP principal spillway outflow (Figure B-14). Riprap protection exists at the outfall and flows into an unnamed tributary to Bynum Run 25 feet from the outfall. The end section of the outfall is rusted and there is moderate riprap displacement. The stream area extending approximately 100 feet downstream is in good condition.

Figure B-14. Riser structure and emergency spillway in the background (left): Outfall (right)

- To improve water quality, a submerged gravel wetland retrofit is recommended within the western portion of the current extended detention basin footprint to capture the maximum amount of inflow and meet design requirements. The submerged gravel wetland would have a forebay at the inflow and would be excavated down from the existing detention basin bottom.
- Proposed project plans are shown in Figure B-15.

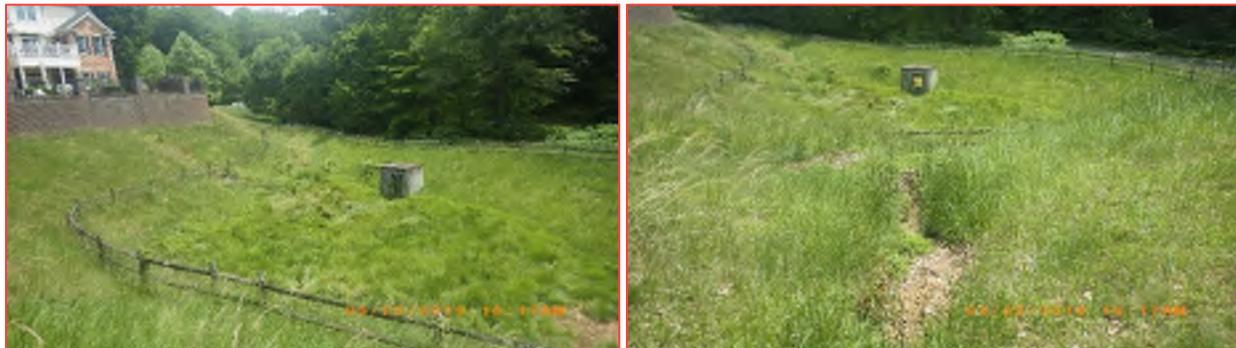
Existing SWM000342 is an extended detention facility located behind 511 Cedar Hill Court in a residential area and is accessible from Cedar Hill Court. The facility is in the MSB-4 subwatershed. There is high grassy vegetation in and around the pond. The facility drains through a riser structure that conveys flow into a natural channel. There is standing water and wetland vegetation around the riser structure. The facility has two inflow points. The first is a 24-inch RCP with end section that conveys flow from Cedar Hill Court into the northeastern part of the facility. There is some riprap displacement at the inflow. The second consists of surface drainage from behind residences on Cedar Hill Court entering the facility from the west. There is also a corrugated 4-inch HDPE conveying flow from the property at 511 Cedar Hill Court into a 10-foot wide spillway on the northern part of the facility (Figure B-16). A 10-foot wide grass emergency spillway is on the eastern part of the facility.

Figure B-16. Facing east towards the facility with the 10-foot spillway entering from the residence (left); The surface drainage inflow point (right)

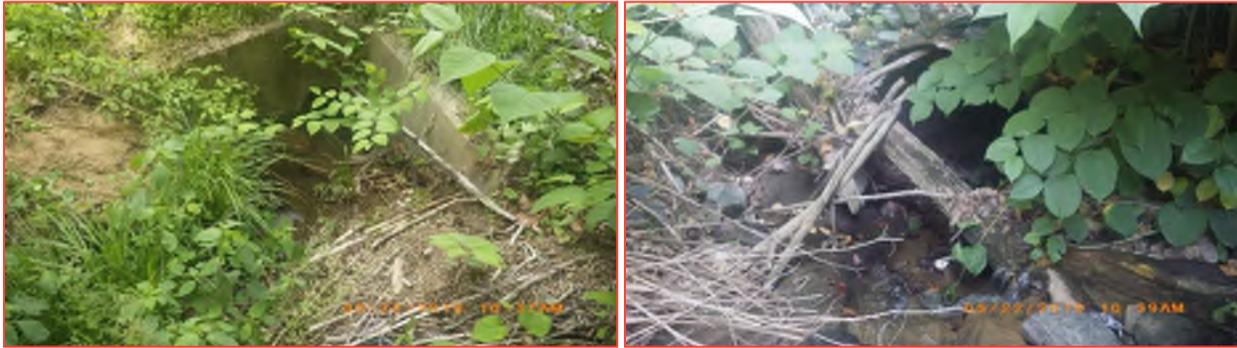
There was no rainfall observed in the area on the day of the site visit (5/22/19). No rainfall was observed during the two days prior to the field site visit. The concrete riser structure sits on the southern part of the facility. There is a 6-inch low flow PVC pipe and an 18-inch RCP with a wingwall at the outfall. There is severe outfall sediment, but the outfall is still hydrologically connected to the natural stream behind

it. There is some erosion where the outfall enters Bynum Run confluent to James Run. Flow travels southeast, under Cedar Lane, via a 60-inch wide and 44-inch high elliptical CMP culvert (Figure B-17).

Figure B-17. Looking upstream at the sediment build-up at the outfall (left): The upstream end of the elliptical CMP culvert conveying flows under Cedar Lane (right)

- To improve water quality, a submerged gravel wetland retrofit is recommended within the eastern portion of the current extended detention basin footprint and would capture stormwater entering through the 24-inch RCP. The submerged gravel wetland would have a forebay at the inflow and would be excavated down from the existing detention basin bottom and include a forebay at the inlet.
- Proposed project plans are shown in Figure B-18.

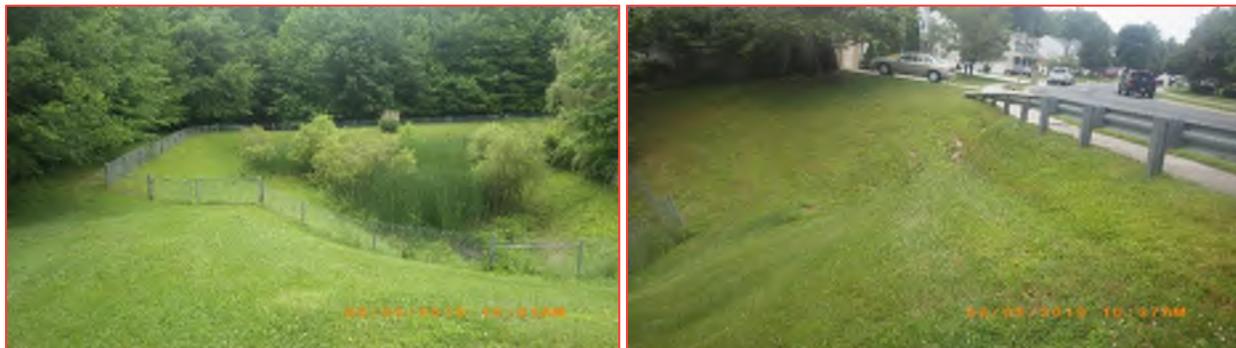
Existing BMP-SWM000347 is an extended detention facility located adjacent to 3030 Clarkson Drive within the MSB-3 subwatershed. One 21-inch RCP with a concrete end section conveys flows into the site from the storm drain system. Incoming flows originate from the west and are conveyed through the system under Clarkson Drive (Figure B-19). One riprap slope measuring approximately 30 feet wide conveys overland flows from the southwest. Shallow standing water and wetland vegetation were observed within the facility. A concrete riser structure controls flows out of the facility and discharges through a 24-inch RCP principal spillway. The principal spillway outfall drains to a channel discharging to an unnamed tributary to Bynum Run to the south.

Figure B-19. Facing southeast towards the facility (left); Erosion behind the 21-inch RCP inflow point (right)

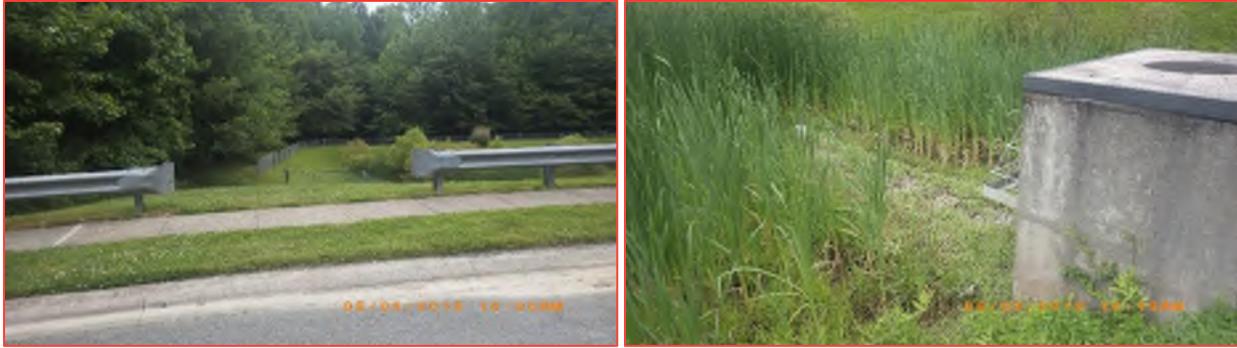
Rainfall totaling 0.05-inch had been observed in the area on the day of the site visit (6/5/19). The facility is functioning as a dry pond in its current condition. Based on record drawings (and confirmed during field work), there is a low-flow 6-inch perforated PVC pipe. Overflow is conveyed through a two-sided weir with trash racks (Figure B-20).

Figure B-20. The access path from Clarkson Drive (left): The riser structure (right)

- To improve water quality, a submerged gravel wetland retrofit is recommended within the northern portion of the current extended detention basin footprint to capture the maximum amount of inflow and meet design requirements. The submerged gravel wetland would have a forebay at the inflow and would be excavated down from the existing detention basin bottom.
- Stabilize the slope behind the 21-inch inlet.
- Proposed project plans are shown in Figure B-21.

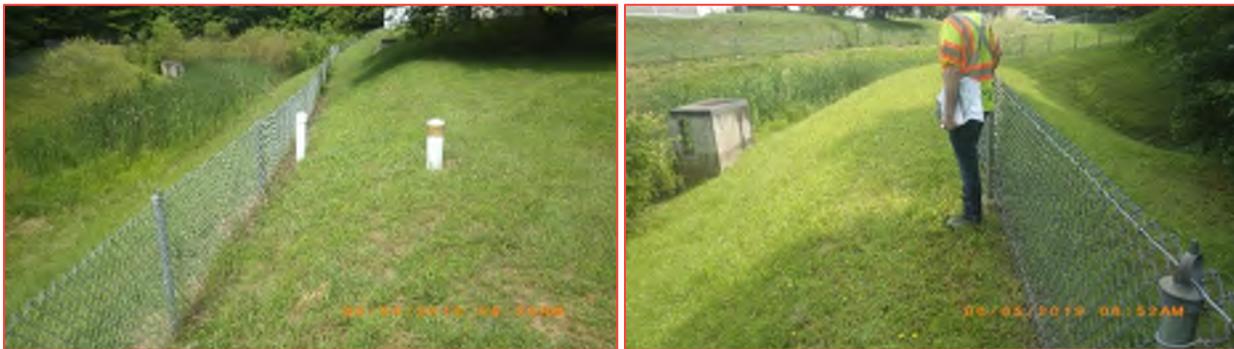
Existing SWM000415 is an extended detention facility located behind the property at 805 Tiffany Trail. It is fenced and accessible via a chain link swing gate located directly off Tiffany Trail. It is within the MSB-3 subwatershed. One 36-inch RCP conveys flows originating from the storm sewer system from the northeast into the facility. One riprap slope at the northwest corner of the facility conveys overland flows from the northwest. There is a concrete riser structure with a 36-inch CMP principal spillway. A riprap apron at the principal spillway outfall drains to a channel discharging to an unnamed tributary to Bynum Run to the south. Shallow standing water and wetland vegetation were observed within the facility (Figure B-22).

Figure B-22. Facing west towards the facility from Tiffany Trail (left): The embankment behind the riser structure (right)

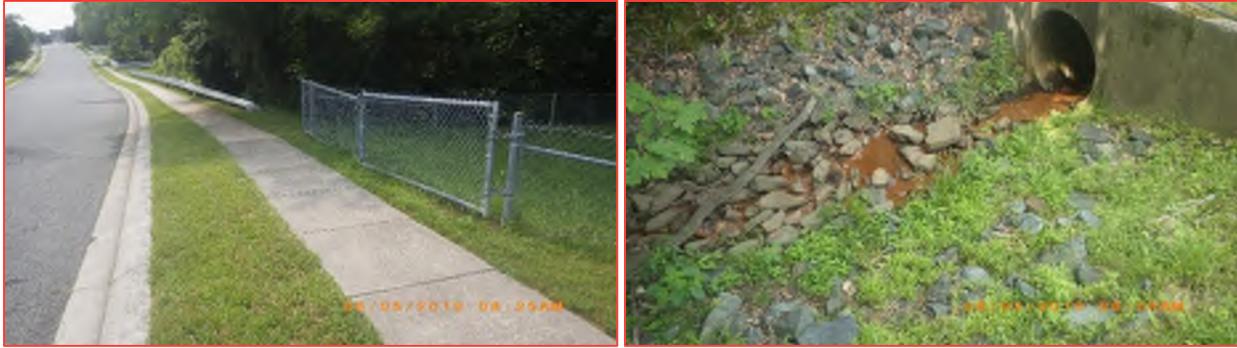
Rainfall totaling 0.05-inch had been observed in the area on the day of the site visit (6/5/19). No rainfall was observed during the two days prior to the field site visit. The pond is functioning as a dry pond in its current condition. Based on record drawings (and confirmed during field work), there is an 8-inch low flow CMP in the riser structure. Overflow is conveyed through a trash racks along the front face and two sides of the riser (Figure B-23).

Figure B-23. Access gate from Tiffany Trail (left); The outfall and outfall channel (right)

- To improve water quality, a submerged gravel wetland retrofit is recommended within a portion of the current extended detention basin footprint to capture the maximum amount of inflow and meet design requirements. A berm is needed to extend the time stormwater is in the facility. The submerged gravel wetland would have a forebay at the inflow and would be excavated down from the existing detention basin bottom.
- Proposed project plans are shown in Figure B-24.
