HARFORD COUNTY DPW

LOWER BYNUM RUN SMALL WATERSHED ASSESSMENT REPORT APPENDICES

DECEMBER 13, 2019

HARFORD COUNTY DEPARTMENT OF
PUBLIC WORKS

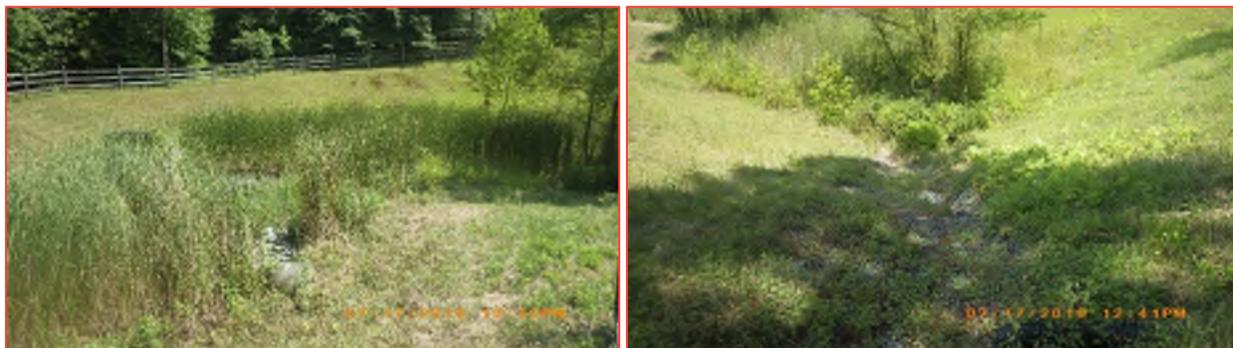
Existing SWM000428 is an extended detention facility located behind the residence at 3139 Birch Brook Lane. It is accessible from Birch Brook Lane between 3139 Birch Brook Lane and 3137 Birch Brook Lane. It is fenced with unobstructed access to an 18-foot swing gate. The facility is within the MSB-3 subwatershed. A 24-inch RCP conveys flows from residences along Birch Brook Lane into the northeast part of the facility. Another inflow point is an 8-foot gabion reinforced slope in the southwest corner of the facility (Figure B-25). Two 4-inch HDPE residential drains convey flows to the top of this slope. This area of the facility has moderate erosion. There is a 4-inch HDPE residential drain into the southeast corner of the facility.

Figure B-25. The 24-inch RCP and facility from access path (left): Southwest corner of facility (right)

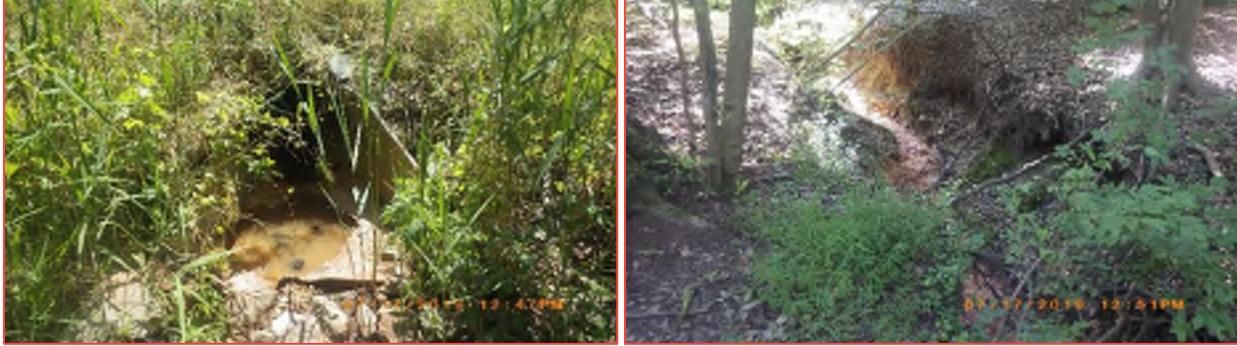
There was 0.41-inch of rainfall observed in the area on the day of the site visit (7/17/19). There were 0.02-inch of rainfall in the area on the two days prior to the site visit. A 36-inch diameter cylindrical CMP riser structure sits on the northern border of the facility. Low flows enter through a 24-inch CMP and discharge through a 24-inch CMP principal spillway. The end section of the principal spillway is rusted out. The outfall channel acts as the head of a natural channel. A 5-foot headcut exists 16 feet downstream of the outfall. The channel downstream has 5 to 6 feet of erosion on its banks (Figure B-26).

Figure B-26. The outfall and end section (left); Upstream at outfall channel erosion – headcut visible in upper left corner (right)

- To improve water quality, a submerged gravel wetland retrofit is recommended within the current extended detention basin footprint. A berm is needed to extend the time stormwater is in the facility. The submerged gravel wetland would have a forebay at the inflow and would be excavated down from the existing detention basin bottom.
- Repair slope where the 4-inch HDPE residential pipes are located.
- Proposed project plans are shown in Figure B-27.

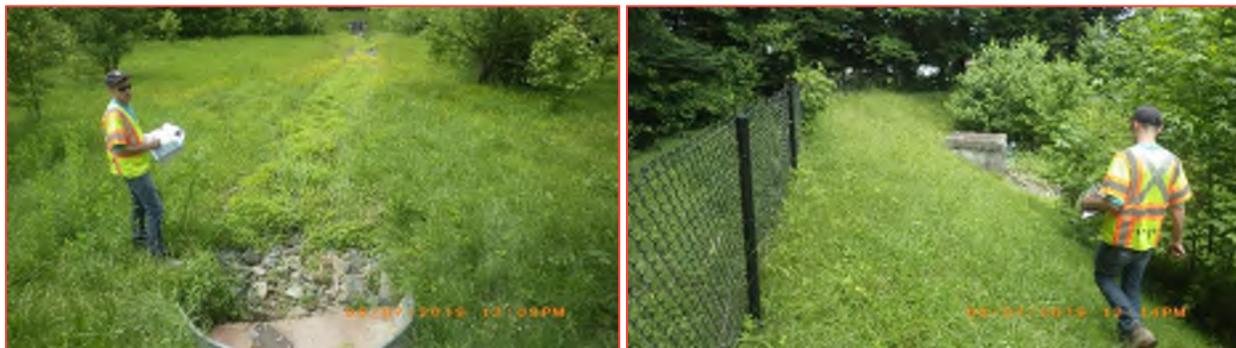
Existing SWM000472 is an extended detention facility located northeast of Lobo Court. It is accessible from Lobo Court between 1219 Lobo Court and 1220 Lobo Court. The facility is within the MSB-2 subwatershed. One 36-inch CMP into the facility conveys flows originating from the storm sewer system to the east and south. The facility also receives runoff along a grass slope to the south. There is a concrete riser structure with a 24-inch RCP principal spillway. The principal spillway drains to a channel discharging to Bynum Run to the north. Overflows drain to a 40-foot grass emergency spillway along the southwest corner. No standing water or wetland vegetation were noted (Figure B-28).

Figure B-28. The riser structure behind the 36-inch CMP inflow pipe (left); The embankment behind riser structure (right)

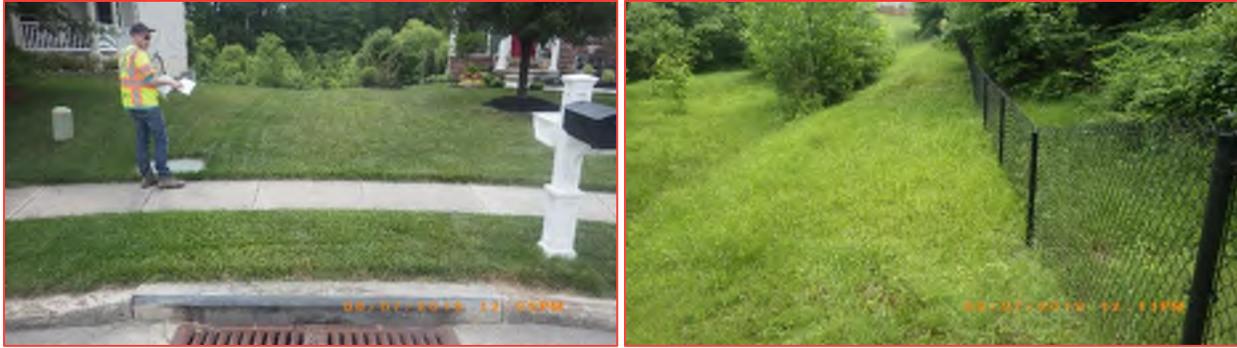
No precipitation had been observed in the area on the day of the site visit (6/7/19). Rainfall totaling 0.07-inch was observed during the two days prior to the field site visit. The pond is functioning as a dry pond in its current condition (Figure B-29). Based on record drawings (and confirmed during field observations), there is a 5-inch low flow RCP orifice with a trash rack. Note that the 24-inch principal spillway is currently smaller than the 36-inch inflow pipe.

Figure B-29. Access path from Lobo Court (left); Western border of facility and emergency spillway in the background (right)

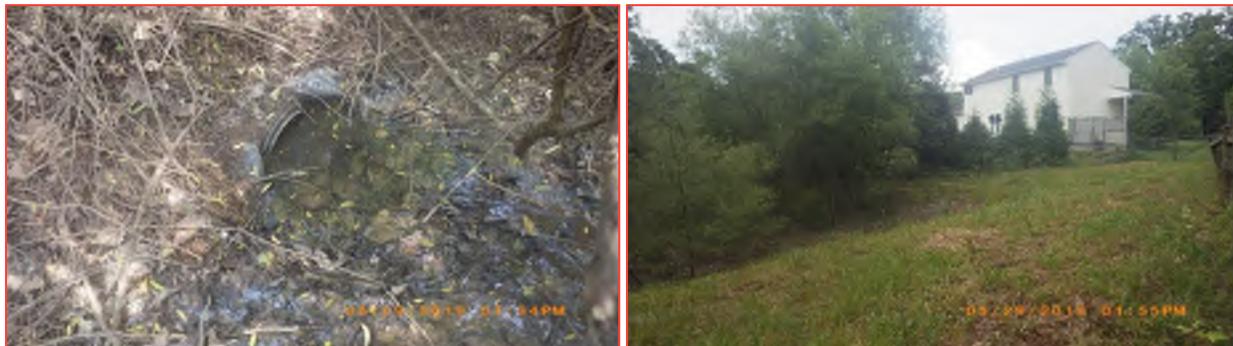
Existing SWM000622 is an extended detention facility located off Hookers Mill Road, behind residences including 720 Hookers Mill Road. It is accessible from a 12-foot wide access driveway off the road. It is fenced and has an 18-foot swing gate. The facility is within the MSB-3 subwatershed. A 15-inch HDPE pipe conveys flows into the eastern part of the facility. The inflow has severe sediment build-up that may hinder flows during high flow events. Most of the fencing around the facility needs repair (Figure B-31).

Figure B-31. Clogged inflow pipe (left); Broken fence behind inflow pipe (right)

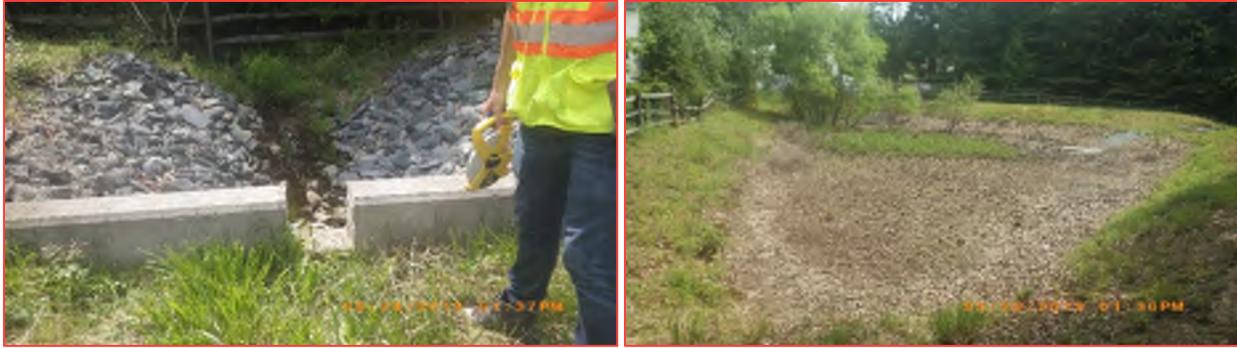
There was no rainfall observed in the area on the day of the site visit (5/29/19). There was 0.09-inch of rainfall in the area on the two days prior to the site visit. There is no riser structure on the facility. There is a 6-inch plated PVC principal spillway for low flows and a 12-inch wide concrete weir for high flows. A 19-foot wide by 17-foot long riprap outfall protection exists at the outfall where flows dissipate into an open field downstream (Figure B-32). The immediate outfall area extending to approximately 100-feet downstream is in good condition but may need channel protection if flows increase.

Figure B-32. Concrete weir and outfall channel (left); Facility from northern corner (right)

- To improve water quality, a submerged gravel wetland retrofit is recommended within a portion of the current extended detention basin footprint to capture the maximum amount of inflow and meet design requirements. The submerged gravel wetland would have a forebay at the inflow and would be excavated down from the existing detention basin bottom.
- Repair and unclog the 15-inch HDPE inflow pipe.
- Proposed project plans are shown in Figure B-33.

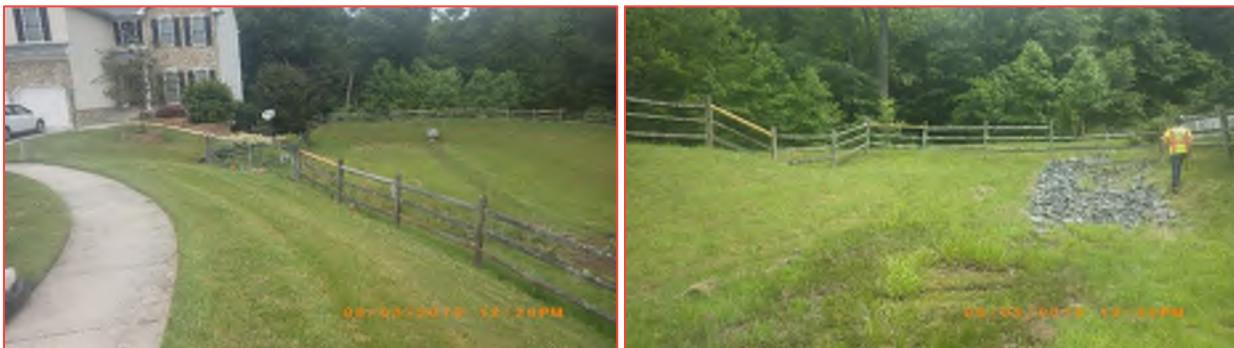
Existing SWM000683 is an extended detention facility located off Hidden Brook Court adjacent to residences including 1300 Hidden Brook Court and 1302 Hidden Brook Court. It is accessible from the Homeowners Association property between the residences noted above and is within the MSB-2 subwatershed. One 18-inch CMP into the facility conveys flows originating from the storm sewer system to the west. One 15-inch CMP into the facility conveys flows originating from the storm sewer system to the north. There is a CMP riser structure with an 18-inch CMP principal spillway. The principal spillway drains to a channel ultimately discharging to Bynum Run to the north. The slope spanning approximately 5 feet downstream of the spillway to the confluence with the existing natural channel is severely eroded. Undercutting, vertical bank incision of 5 to 10 feet, and various downed large diameter trees were observed along the eroded slope. There is a 20-foot grass emergency spillway at the southeast corner of the pond. No standing water or wetland vegetation were observed within the facility (Figure B-34).

Figure B-34. Access gate from Hidden Brook Court (left); Emergency spillway and riprap inflow point (right)

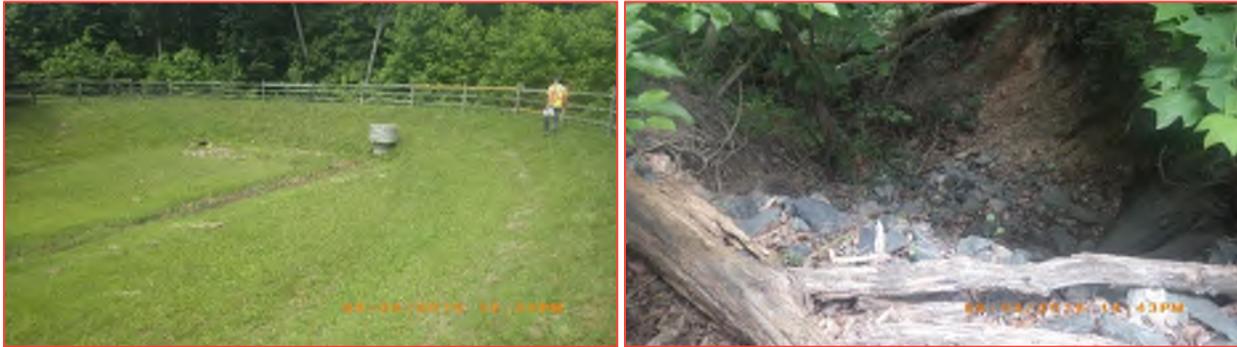
pond in its current condition. Based on record drawings, there is a 6-inch CMP low flow orifice. High flows enter the CMP riser structure (Figure B-35).

Figure B-35. Embankment behind riser structure and 15-inch CMP inflow pipe (left); Eroded outfall channel (right)

- To improve water quality, a submerged gravel wetland retrofit is recommended within a portion of the current extended detention basin footprint. The submerged gravel wetland would have a forebay at each inflow and would be excavated down from the existing detention basin bottom.
- Proposed project plans are shown in Figure B-36.

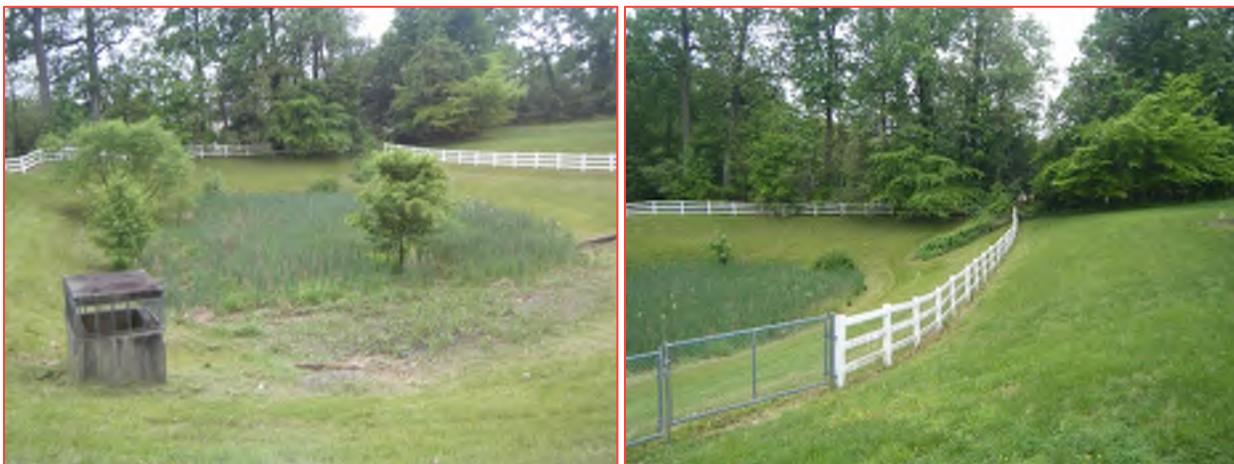
Existing SWM000685 is an extended detention facility located on the south end of Forest Oak Court, behind the residence at 1306 Forest Oak Court. It is accessible between 1306 Forest Oak Court and 1307 Forest Oak Court. The site has a painted wooden fence and gate. A resident is concerned about a damaged portion of the fence on the northwestern border. The facility is within the LB-1 subwatershed. A 36-inch RCP conveys flows from residences along Stone Ivy Place, Briar Post Court, and Forest Oak Court into the facility. Flows enter a forebay with minor riprap displacement. A 23-foot grass emergency spillway exists at the southern end of the facility. There is wetland vegetation, but no standing water, in the pond (Figure B-37).

Figure B-37. Facility from behind riser structure (left); Western part of the facility from access path via Forest Oak Court (right)

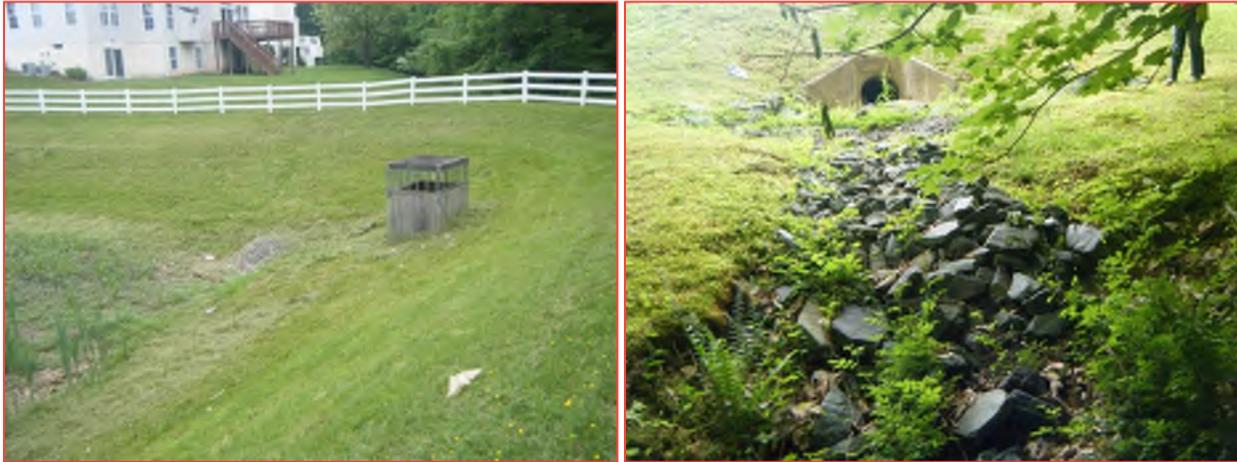
Run. There is minor riprap displacement at the outfall. There are minor outfall issues extending to approximately 100 feet downstream (Figure B-38).

Figure B-38. The embankment behind the riser structure (left); Facing upstream at the outfall and outfall protection (right)

- To improve water quality, a submerged gravel wetland retrofit is recommended the current extended detention basin footprint. A berm is needed to extend the time stormwater is in the facility. The submerged gravel wetland would have a forebay at the inflow and would be excavated down from the existing detention basin bottom.
- Proposed project plans are shown in Figure B-39.

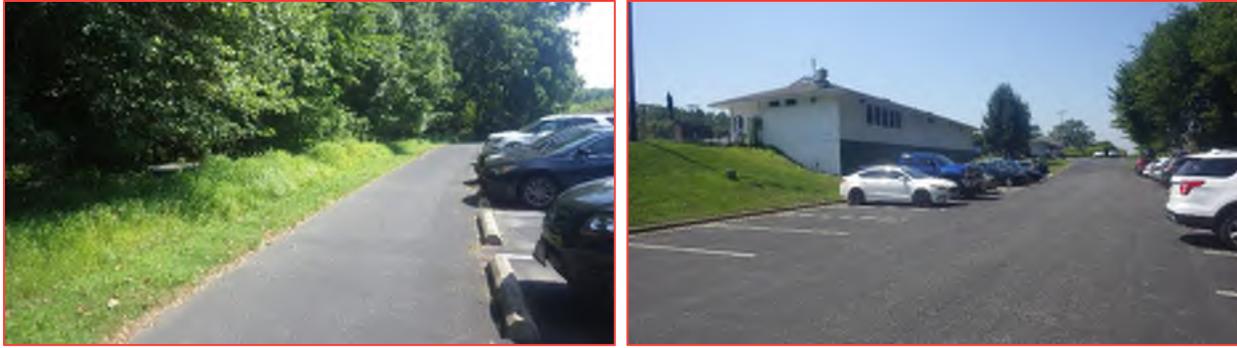
The Maryland Golf and Country Club is located near the intersection of East Macphail Road and Old Macphail Drive within the MSB-5 subwatershed. Under current conditions, a portion of the pool area and lower parking lot sheet flows to a grassy area adjacent to the lower parking lot (Figure B-40) prior to discharging into an existing stream in the woods. Additionally, there are two 12-inch RCP outfall pipes located near the proposed BMP that are heavily damaged. Both pipes are separated/broken at the joints and undermined approximately 3 feet (Figure B-41). The downstream outfall channel is significantly eroded. Approximately 1.08 acres of drainage area with 0.52 acres of impervious area drain to the existing grassy area adjacent to the parking lot.

Figure B-40: Existing grass area adjacent to parking lot – facing North (left); Existing lower parking lot – facing South (right)

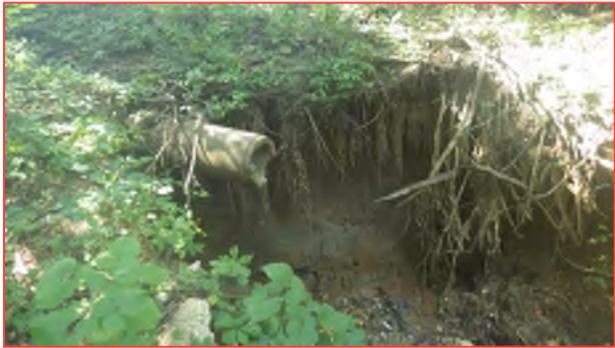
Figure B-41: Heavily damaged outfall prior to discharge into stream

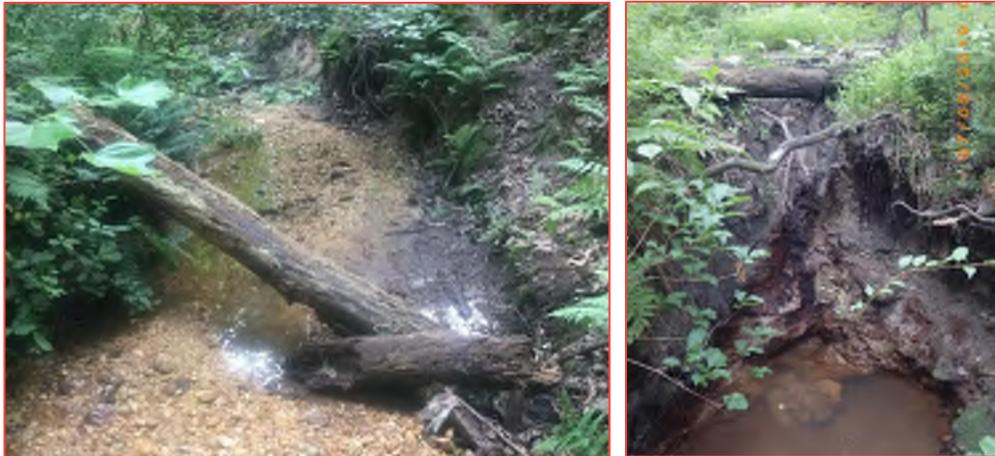
Throughout the stream there is some deposition (Figure C-2, left). There are two headcuts, one 3 feet and the other 4 feet (Figure C-2, right). Lastly, there is some debris accumulation and one area with trash in the stream.

Figure C-2: Stream deposition (left); 4-foot headcut along tributary (right).

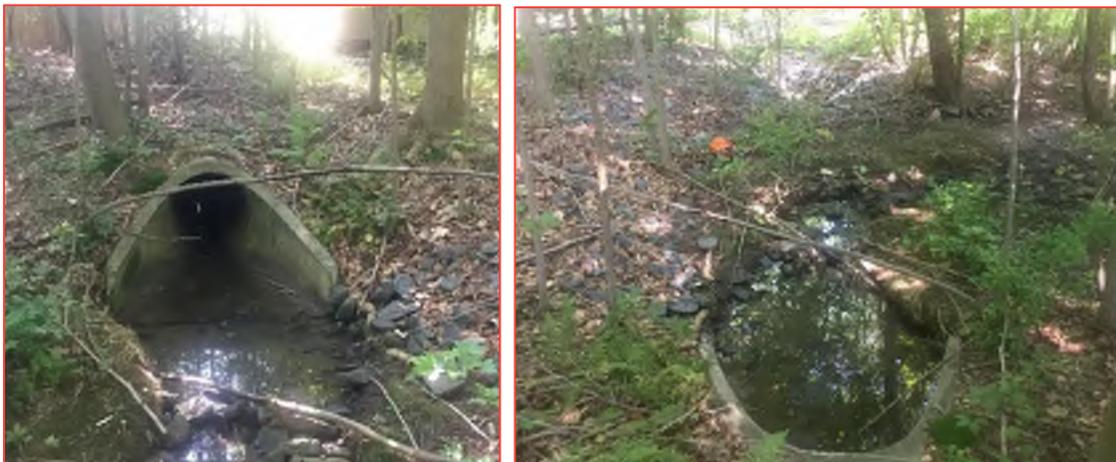
The upstream limit of MSB-2C is located between Swift Run Court and Hidden Stream Drive. It proposes a stand-alone stabilization of Outfall 17 which receives discharge from the southeastern portion of the Hidden Stream community. The outfall consists of a 30-inch diameter RCP pipe and a concrete end section. Both the outfall pipe and end section are in good condition (Figure C-10). The outfall channel protection is comprised of riprap and extends approximately 55 feet until the channel's confluence with its receiving stream. A 4-foot headcut is located 30 feet downstream of the end section, where the riprap protection has been pushed downstream, leaving exposed geotextile. Downstream of the headcut, there is an additional exposed, 6-inch underdrain PVC pipe, surrounded by eroded, bare earth where geotextile and riprap have been disturbed, which is visible from the receiving stream channel (Figure C-11).

Figure C-10: Upstream view of OF-17 pipe and structure (left); Downstream view of OF-17 channel (right)

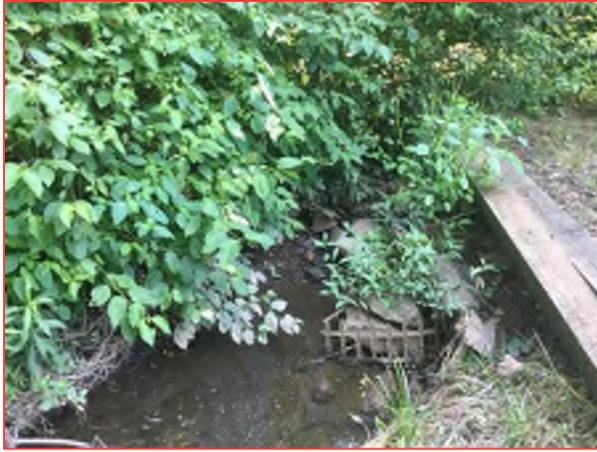
Along the right bank there are three 4 in PVC diameter downspout pipes. Approximately 360 feet downstream of the start of MSB-4A, there is a debris jam that is too high to allow fish passage (Figure C-14). The last 760 feet of the left bank have an inadequate buffer of only shrubs and small trees.

Figure C-14: Debris jam/fish barrier

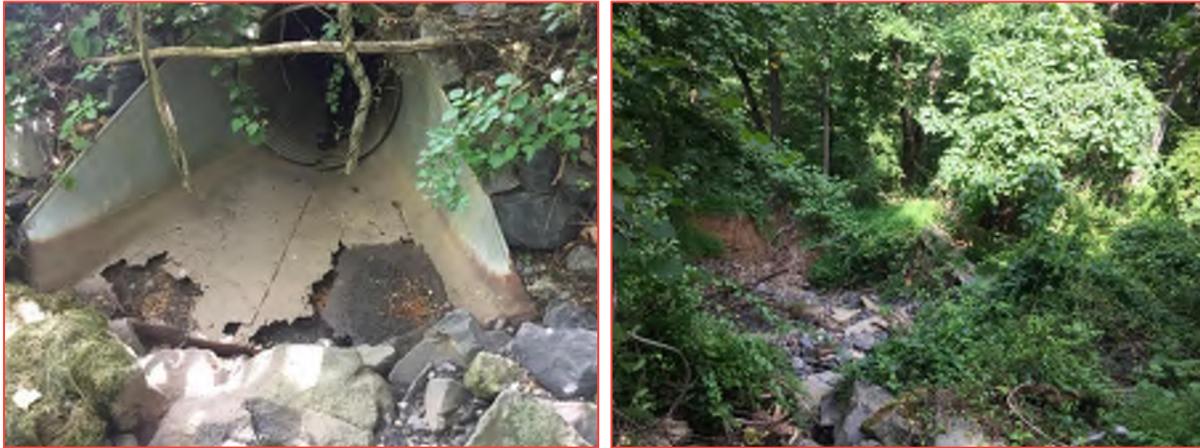
Outfall 58 enters the stream on the right bank approximately 800 feet downstream of the beginning of the project. The metal apron has begun to rust and the outfall channel is steep and severely eroded (Figure C-22, left). The original outfall channel is lined in riprap. At some point, the outfall channel eroded to the west, forming a new channel for approximately 85 feet. The new channel is actively eroding

and does not have riprap protection (Figure C-22, right). The new channel and original channel converge approximately 70 feet downstream of the outfall.

Figure C-22: Rusty apron at outfall 58 (left); Looking downstream from outfall towards erosion along new channel (right)

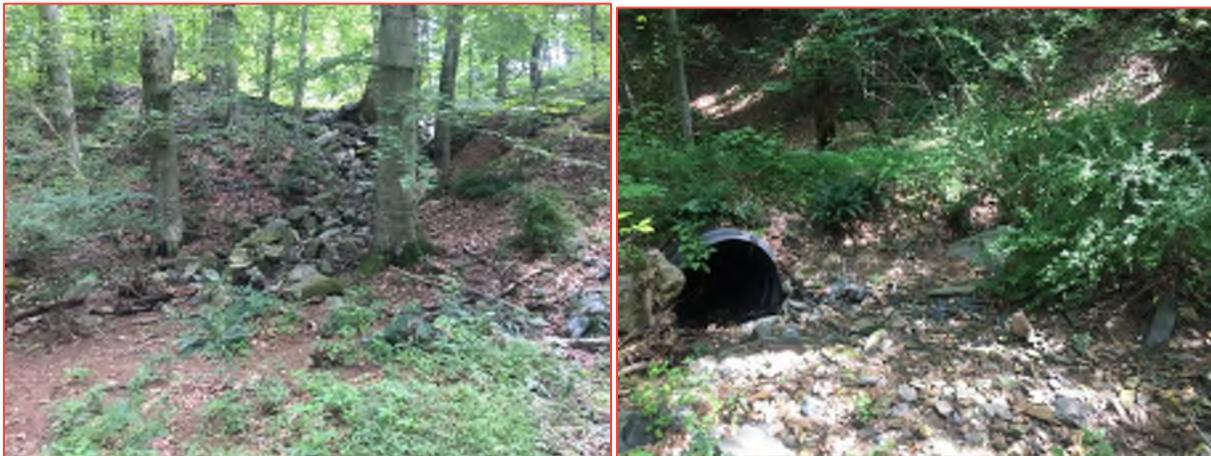
The next 100 feet of channel is steep and 20 feet wide. Boulders and riprap line the channel. This portion of the channel appears stable (Figure C-23, left). Approximately 185 feet downstream of the outfall, the riprap channel ends, the ground levels out, and the channel becomes undefined. From the outfall to this location is about a 45-foot elevation change. Twenty feet further downstream is a 36-inch HDPE pipe that may have been installed and left in place during construction (Figure C-23, right). The pipe conveys flow parallel to the stream for 150 feet before it outfalls to the stream channel. The outfall of this 36-inch pipe is just downstream of a sewer manhole structure along the stream bank.

Figure C-23: Stable, riprap lined steep channel, Outfall 58 (left); 36-inch HDPE pipe downstream of Outfall 58 (right).

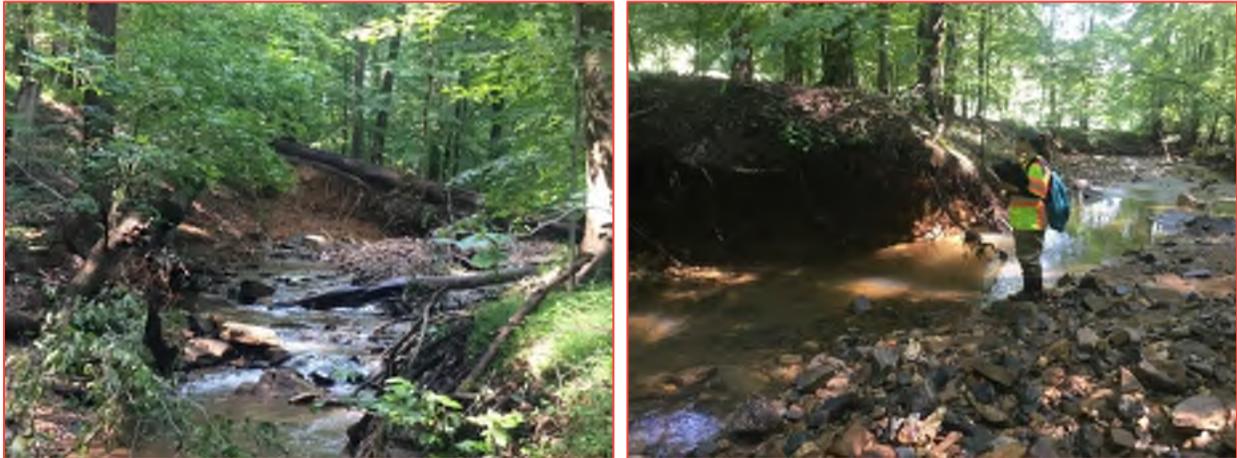
MSB-4B, Segment 2, runs parallel to Wheel Rd and contains 1,136 feet of proposed stream restoration and no outfalls. This stream segment receives flow from MSB-4B, Segment 1, after it flows under East Wheel Road as well as the stream that runs parallel to Wheel Road. The 460 feet of stream upstream of the confluence with MSB-4B, Segment 1, is severely eroded. One stream bend has a 20' high eroded stream

bank (Figure C-24, left). In other areas of this stream reach, stream banks are consistently over 7 feet high (Figure C-24, right).

Figure C-24: Severe erosion on the right bank (left); Severe erosion on the left bank (right)

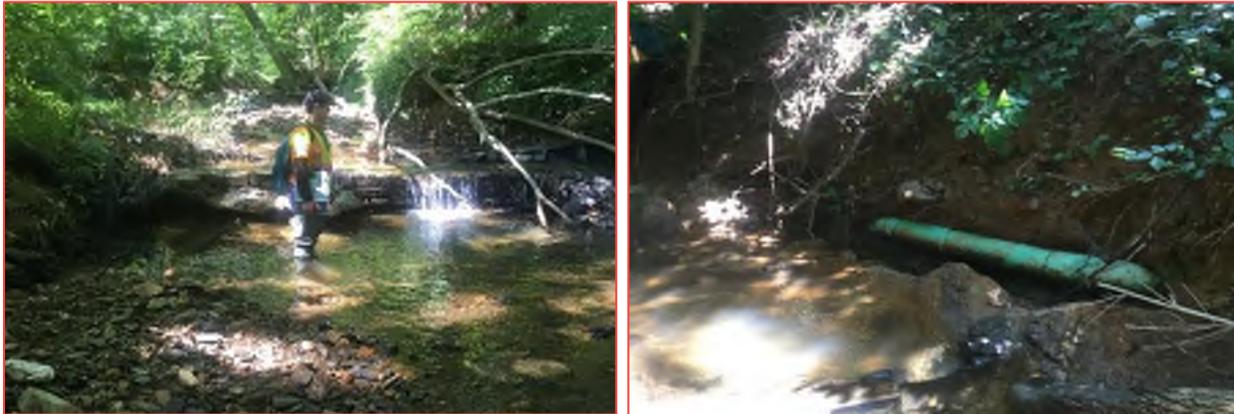
The final 723 feet of stream has heavily eroded banks, with an average exposed bank height of 7 feet. Along with the severe erosion, there are 243 feet of inadequate buffer where lawns are mowed to the banks of the stream. There are two debris jams within MSB-4D, one being at the confluence of a tributary and the other in the middle of the stream. Lastly, there is a concrete dam with eroded banks and a scour hole (Figure C-36, left) and an exposed plastic sewer pipe (Figure C-36, right).

Figure C-36: Concrete dam with scour hole and eroded banks (left). Exposed plastic sewer pipe above bedrock on a moderately eroded bank (right).

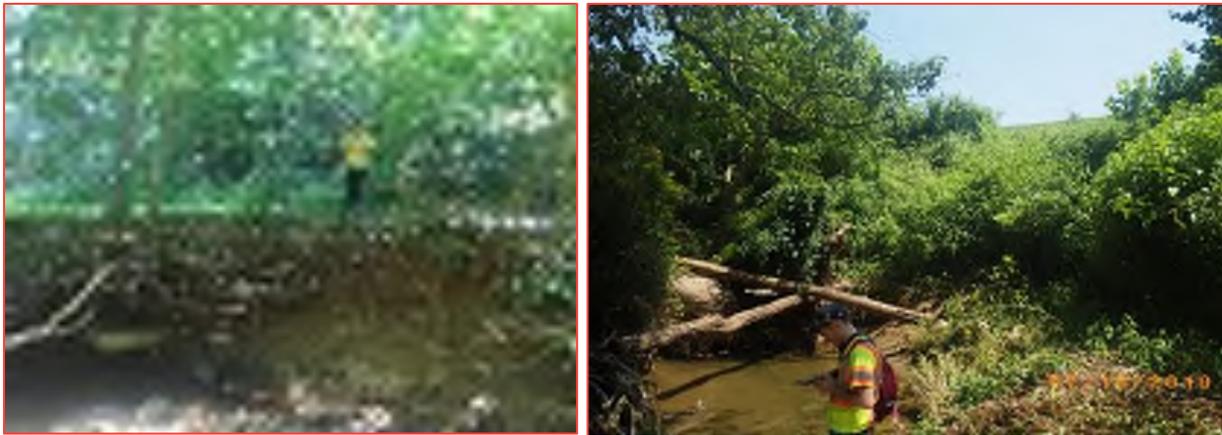
MSB-4E is south of Lindsay Court and runs perpendicular to Laurel Bush Road. This project proposes 3,325 feet of stream restoration and the stabilization of outfall 185. The left and right banks are severely eroded for the entire length of the stream project with an average exposed bank height of 4 feet and in some areas, erosion is threatening a paved path (Figure C-41, left). Approximately, 900 feet of both banks have an inadequate buffer due to pasture and residential land use (Figure C-41, right).

Figure C-41: Severe erosion on the left bank's proximity to the paved path (left); Inadequate buffer on the right due to lawns (right)

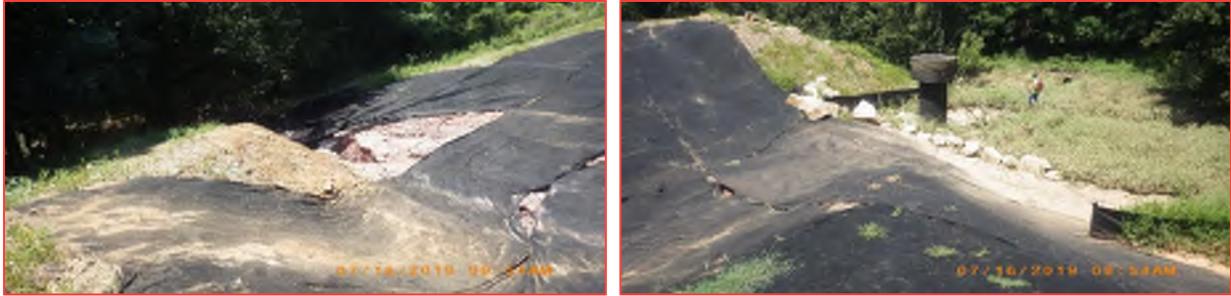
BMP SWM000040 outfalls to the left bank of MSB-4E approximately 400 feet downstream of the start of the project and receives runoff from nearby neighborhoods. A gap in the embankment has been stabilized with geotextile material (Figure C-42). The outfall channel is approximately 100 feet long and is stable.

Figure C-42: BMP under construction.

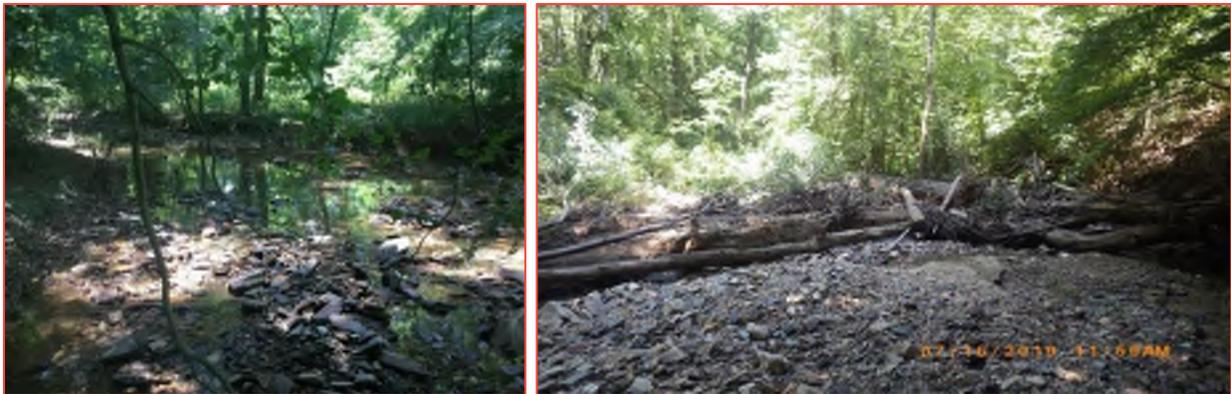
A large debris jam has occurred approximately 1,200 feet downstream. Upstream of the debris jam, the stream has widened and is very shallow. Sediment and stone have accumulated behind the debris jam. The stream is narrower and deeper downstream of the debris jam (Figure C-43).

Figure C-43: Stream widening before debris jam constriction.

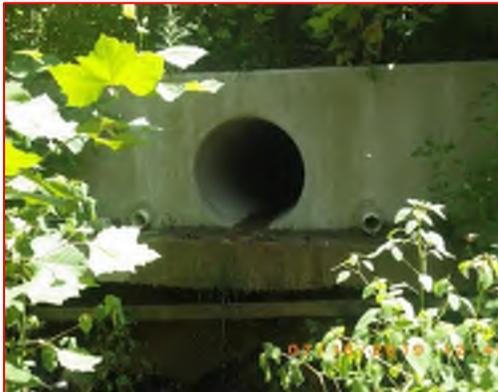
Outfall 185 is the outfall for an unnumbered BMP and is located northwest of Oat Grass Court. The outfall channel has eroded and caused undercutting of the outfall endwall (Figure C-44).

Figure C-44: Undercutting of Outfall 185 endwall.

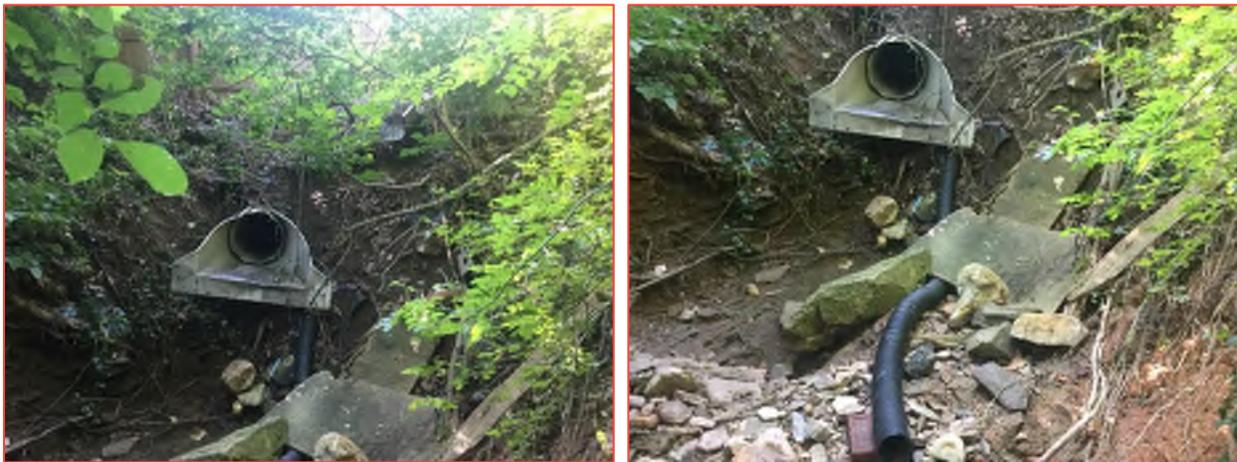
The upstream limit of MSB-4F is located at the northeast corner of 214 Laurentum Parkway, a private residence. It proposes a restoration of Outfall 35 which receives discharge from the northeastern portion of the Box Hill community. The outfall consists of a 15-inch diameter CMP pipe and a winged, plastic endwall. Both the outfall pipe and endwall are in good condition (Figure C-50) but are suspended 5 feet above the channel bed. There is minimal outfall channel protection comprised of riprap and 5 feet of exposed bank extend 80 feet from the outfall structure (Figure C-51, left). Erosion has exposed bedrock within the outfall channel. The eroded banks continue approximately 80 feet until the channel's confluence with its receiving stream (Figure C-51, right).

Figure C-50: View of Outfall 35 showing distance from the top and bottom of bank (left); View of outfall height above channel bottom (right)

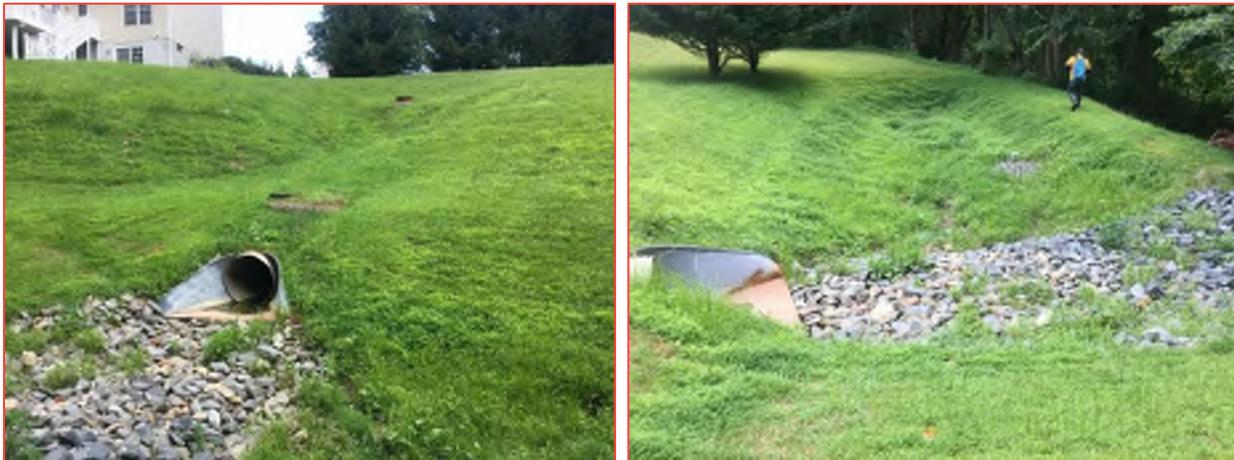
MSB-4G is located between 2210 and 2212 Gelding Way in a designated open space area owned by the Saddle Ridge Homeowner’s Association. It proposes a restoration of Outfall 65 which receives discharge from the central portion of the Saddle Ridge community. The outfall consists of a 36-inch diameter CMP pipe and a metal end section. Both the outfall pipe and end section are in good condition (Figure C-53, left). The outfall structure is located at the end of a series of three drop structures and adjacent to a shallow, residential BMP (Figure C-53, right). There is a water quality basin at the outfall.

Figure C-53: View of 3 drop structures to Outfall 65 (left); Adjacent water quality basin to Outfall 65 (right)

- **Stream Restoration**
 - MSB-4G: Grade channel towards stream and line with riprap protection.
- **Outfall Maintenance**
 - *Outfalls 65*: Replace drop structure with one that is 7 feet deep and install plunge pool.
- Proposed project limits are shown in Figure C-55.

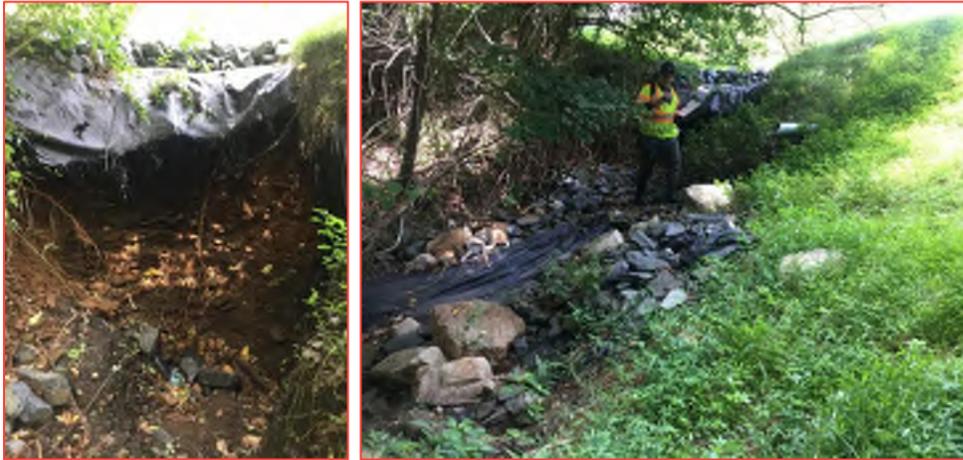
There is 25 feet of riprap channel protection immediately downstream of the outfall structure and upstream of a 7-foot headcut (Figure C-54, left). The riprap and geotextile has been disturbed upstream and downstream of the headcut and banks are exposed as a result. The outfall channel converges with the stream channel 160 feet downstream of the 7-foot headcut. There is an additional 2-foot headcut, 45 feet downstream of the 7-foot headcut. The channel following the 2-foot headcut splits into two separate,

parallel lengths consisting of braided channels to the left and a new and eroded channel to the right. The new, eroded channel lacks channel protection (Figure C-54, right).

Figure C-54: 7 ft high headcut with exposed geotextile and soil (left); View of exposed geotextile downstream of large headcut moving towards the new, eroded, channel to the right (right).

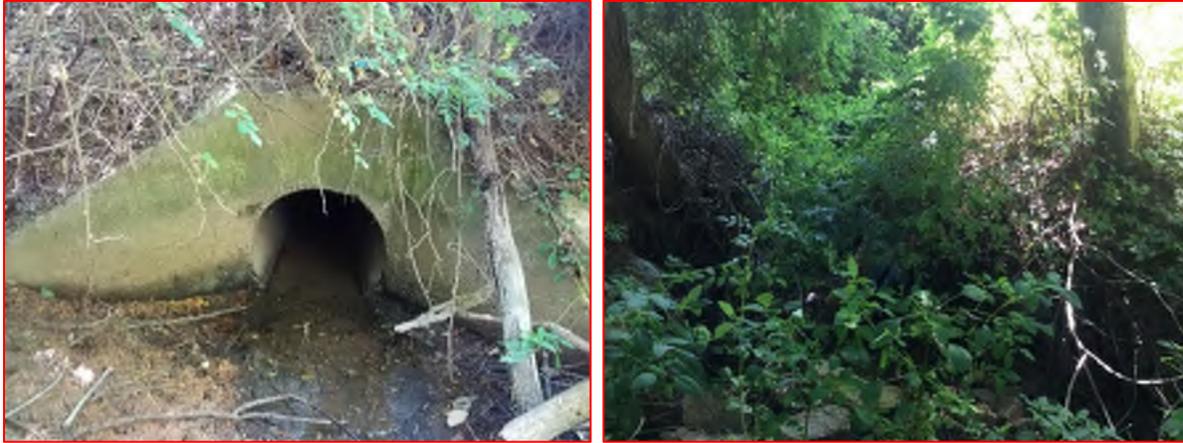
Outfall 124 is at the headwater of the stream and conveys flow from neighborhoods east of Foxborough Drive. The outfall is a 30-inch diameter RCP pipe with an endwall (Figure C-62, left). The structure is in good condition; however, a large earth and tree debris jam is blocking the flow from the rest of the outfall channel and stream (Figure C-62, right).

Figure C-62: Looking at Endwall for Outfall 124 (left); Looking downstream of Outfall 124 at large debris jam (right).

- **Stream Restoration**
 - MSB-5B: 1,327 feet from 74 feet from Outfall 125 to 233 feet upstream of Outfall 115.
- **Outfall Maintenance**
 - *Outfall 124*: Remove tree debris jam to restore positive grade and repair riprap channel

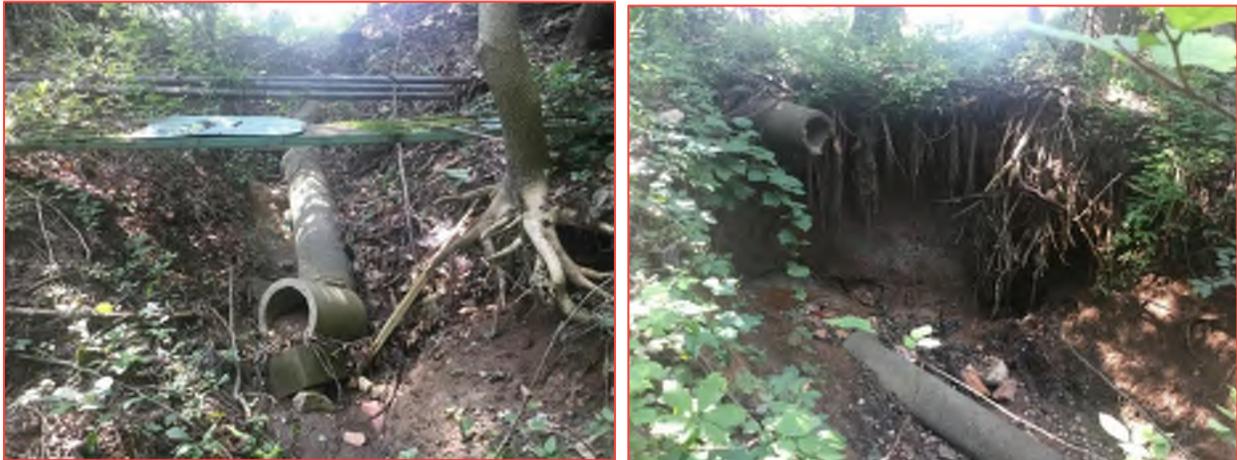
Outfalls 98 and 99 convey flow from the Maryland County Club (Figure C-67). Multiple pipe sections have broken off into the eroded outfall channel. The eroded banks in these outfall channels are approximately 6 to 8 feet high. Both outfalls convey flow the left stream bank. Outfall 99 enters the left bank 300 feet downstream of the start of the project. The outfall channel for Outfall 98 ties into the stream on the left bank an additional 160 feet downstream of the Outfall 99 channel.

Figure C-67: Looking upstream toward Outfall 98 (left); Looking upstream toward Outfall 99 (right).

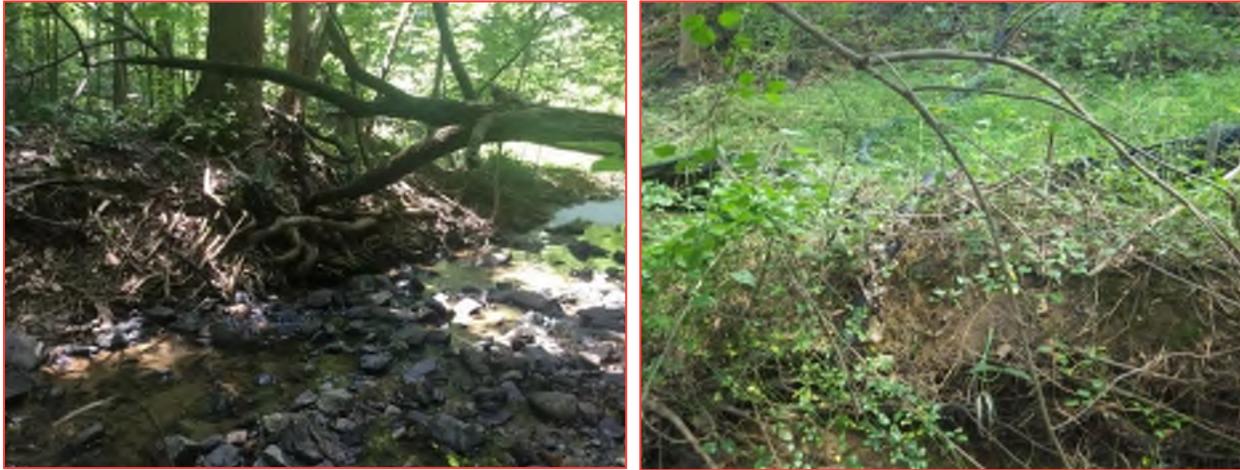
The first 420 feet of stream below Outfall 100 contains 3 feet of exposed banks on either bank (Figure C-69, left). The next 300 feet, a more sinuous section, contains average exposed bank heights of 4 feet. The final 430 feet upstream of the tributary confluence has an of average 5 feet exposed bank. A silt fence currently runs along the right bank (Figure C-69, right).

Figure C-69: Downstream view of left bank erosion (left); Silt fence adjacent to stream channel (right).

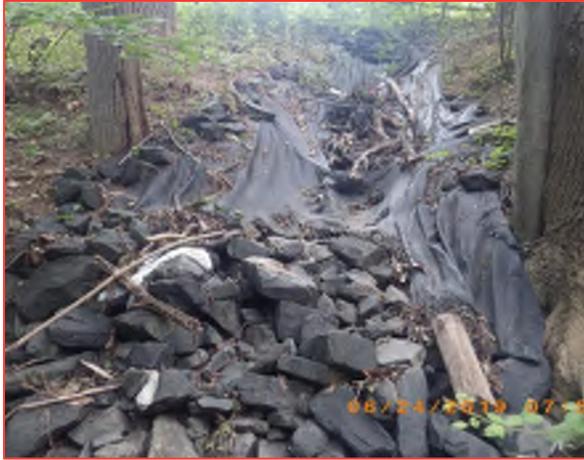
Outfall 85 is located along the tributary, approximately 165 feet downstream of the start of the project. The outfall is a 30-inch RCP pipe with a concrete endwall. A sediment basin is located at the outfall and is in poor condition. The outfall basin is surrounded by a wooden fence, is overgrown with trees and shrubs, and is filled with sediment. Approximately 65 feet downstream of the outfall, the outfall channel experiences a 2-foot headcut along with steep slopes. Riprap in this section of the outfall channel has been pushed downstream, revealing the underlying geotextile material (Figure C-79). Another 3.5-foot headcut was observed where the outfall channel ties in with the stream.

Figure C-79: Exposed geotextile and missing riprap along steep section of Outfall 85 channel

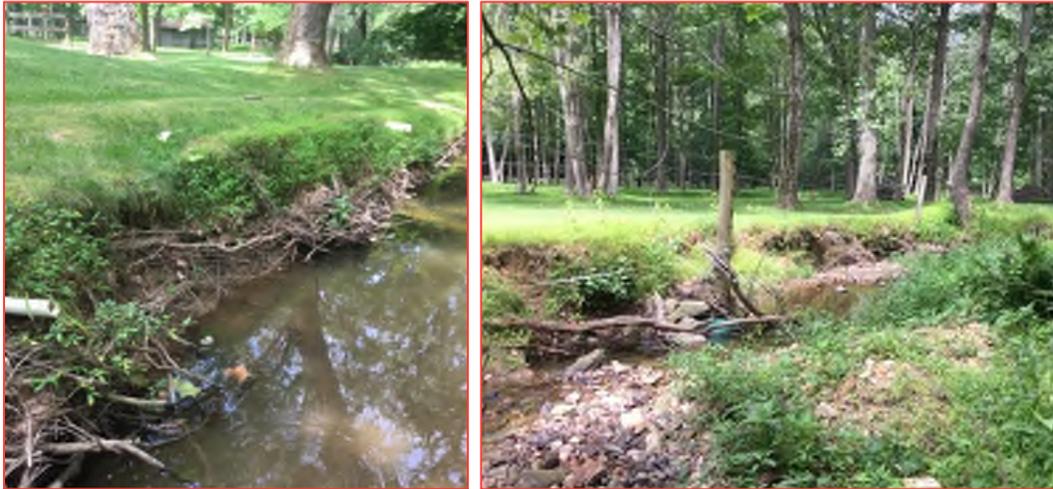
remaining 110 feet of stream have exposed banks 4 feet high at the edge of a horse pasture. The stream has eroded and shifting, requiring the posts to be placed in the stream channel (Figure C-85, right).

Figure C-85: Residential pipe outfalls and inadequate buffer at the back of residential property (Left); Moderate severity bank erosion with an average of 4 feet exposed bank height on both banks (right).

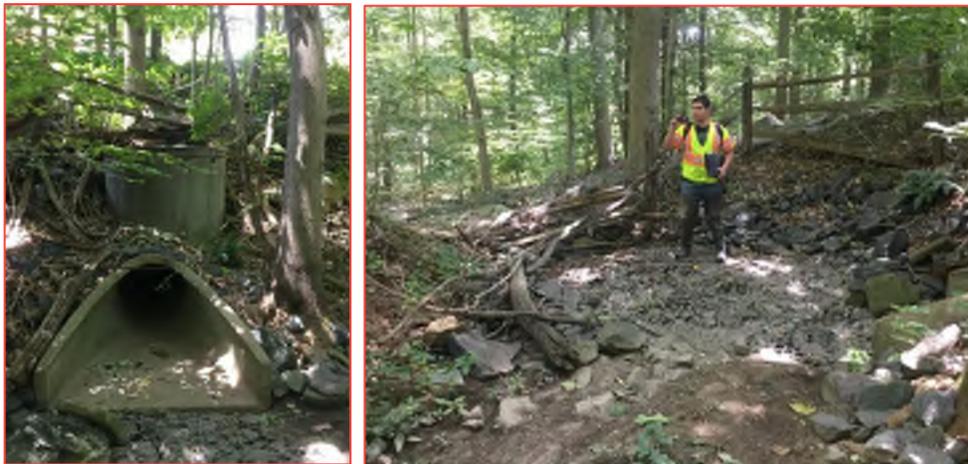
The upstream limit of MSB-5F is located behind the private residences of 435 Rambler Road and 437 Rambler Road. It proposes a stand-alone stabilization of 90 feet of channel at outfall 80. The outfall consists of a 30-inch diameter RCP with a concrete end section. The manhole structure is cracked with exposed rebar and the end section is no longer connected to the RCP (Figure C-87, left). The outfall protection consists of a gabion mattress, with riprap displaced and a fence missing at the overflow location (Figure C-87, right).

Figure C-87: Outfall 80 (left); Gabion mattress at outfall (right)

- **Outfall Stabilization**
 - *Outfalls 80:* Fill in sediment basin, replace drop structure with 6-foot deep drop structure, install plunge pool, grade outfall channel and line with riprap protection.
- Proposed project limits are shown in Figure C-89.

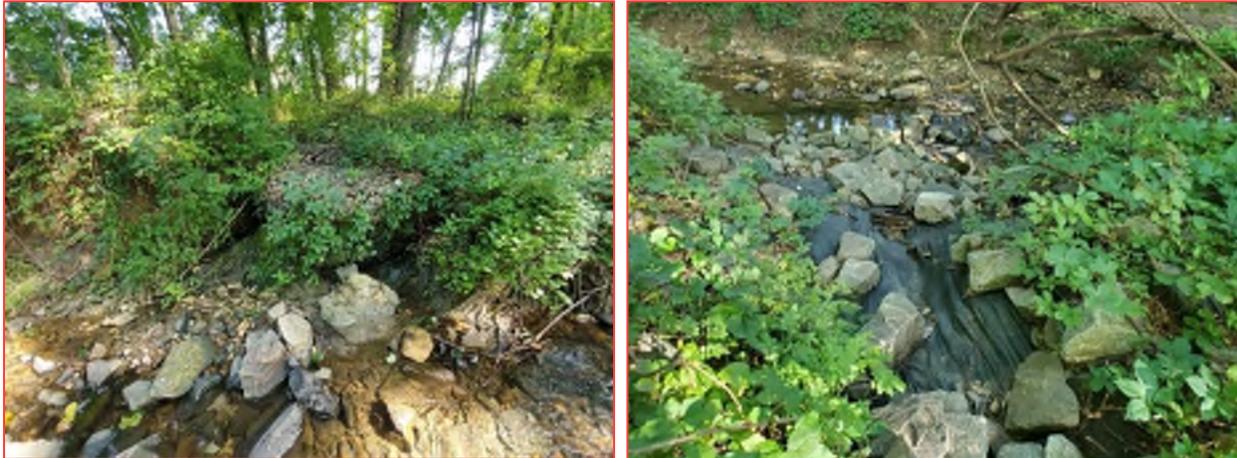
Project MSB-6A is comprised of two segments of stream, totaling 2,649 feet. The first segment is located southeast of Fountain Glen Drive and contains 1,752 feet of proposed stream restoration and five outfalls. Four of the outfalls (141, 143, 144, and 145) have eroded at the end of the outfall protection (Figure C-90 & Figure C-91).

Figure C-90: Eroded end of outfall protection for Outfall 141 (left); Outfall 143 (right).

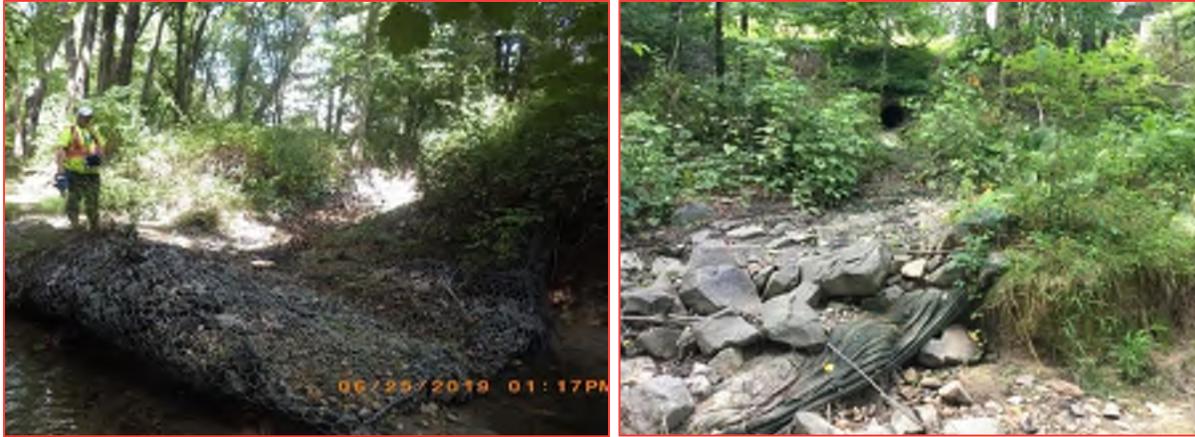
Figure C-91: Eroded end of outfall protection for Outfall 144 (left): Outfall 145 (right).
