Appendix F2 – Assessment of Controls (Stormwater Management Assessment)

Wexford Annual Physical Assessment 2021

November 2022

KCI Technologies, Inc.

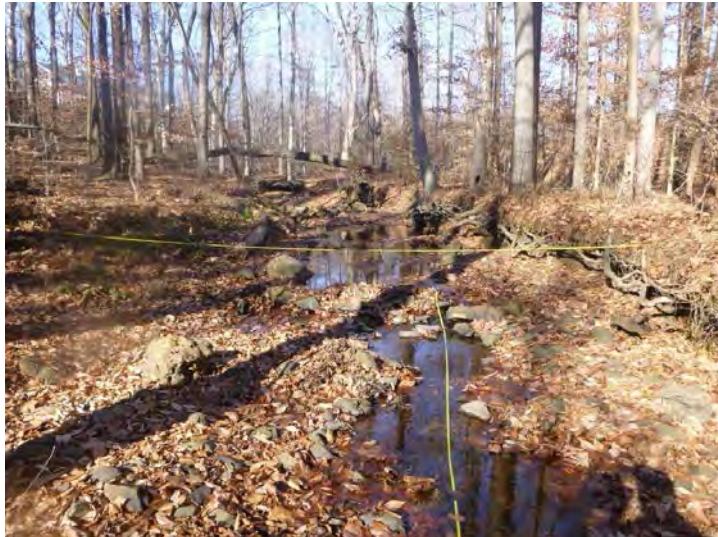
XS-2 Upstream

In the vicinity of Cross-section 2, approximately 1.1 feet of bed erosion occurred between 2005 and 2021. Additionally, approximately 3.1 feet of bank erosion has occurred on the left bank. The left bank and bed erosion have caused an increase in the bankfull area by 10.0 ft² and an increase in the top of bank area of 21.5 ft² (Table 4, Figure 8). The greatest increase in the left bank erosion occurred between 2009 and 2013. Between 2020 and 2021 there was no increase in bank erosion, however, there was 3-6" of bed erosion along the thalweg.

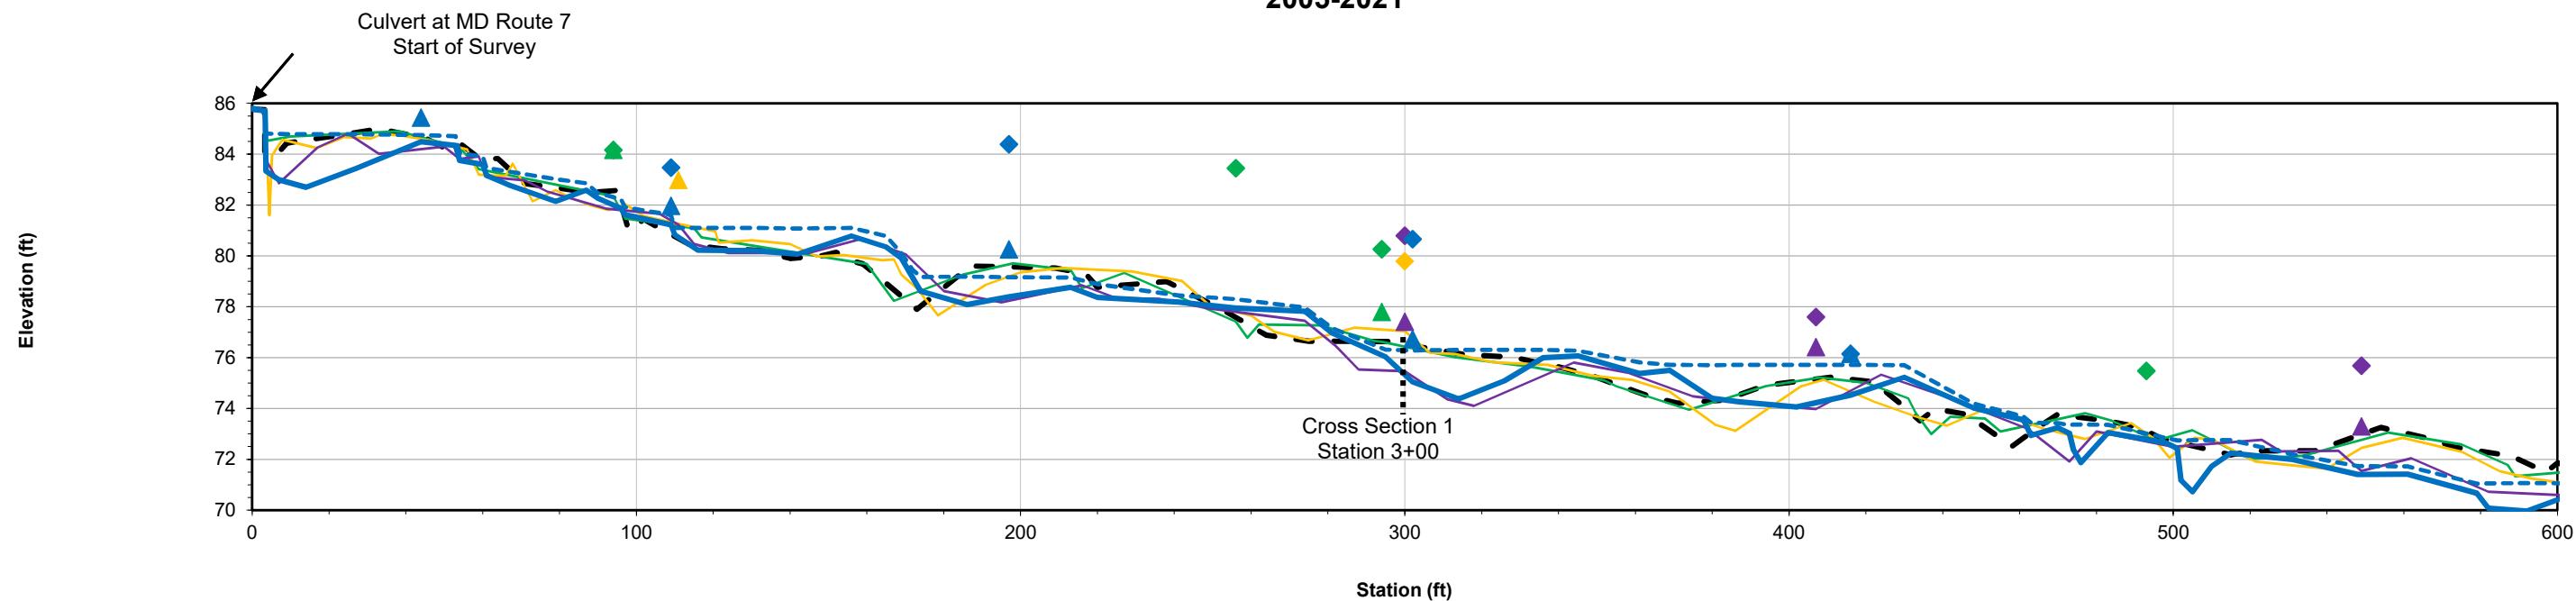
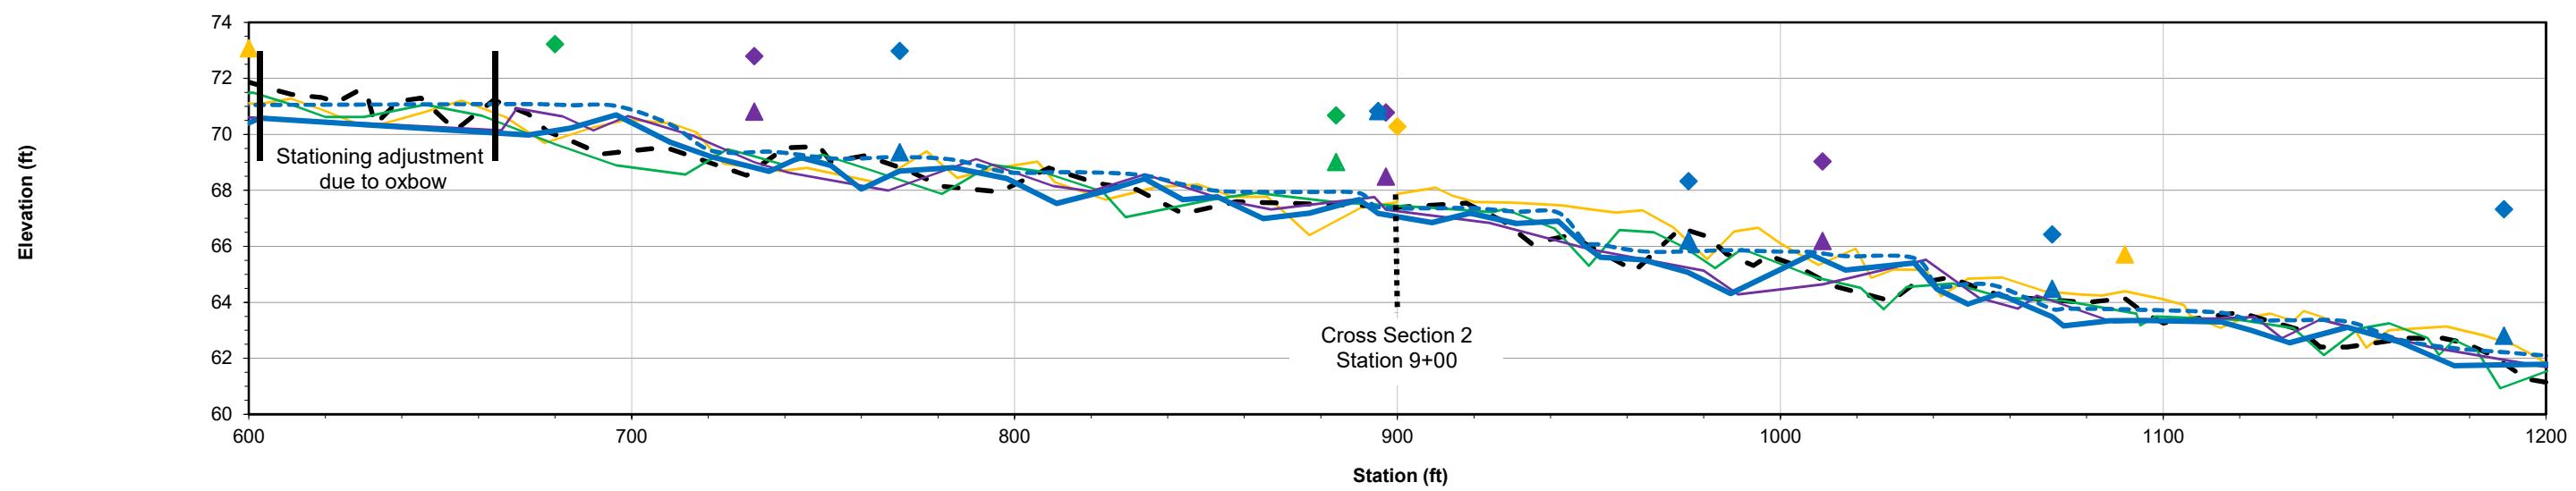
Longitudinal Profile Station 0+00 to 12+00
2005-2021

The seventeenth year of monitoring results indicate that the Wexford site continues to degrade over time. The upstream half of the reach, station 0+00 to 12+00, remains relatively stable with a moderate increase in bar formation and bed material comprised of larger cobble substrate. Cross-section 1, located at station 3+00, was previously the most stable, but between 2017 and 2018 large amounts of bed deposition and incision occurred while the banks have remained stable. No major changes occurred between 2020 and 2021 at Cross-section 1, only a slight deepening of the thalweg. As the survey continues downstream, a decrease in slope occurs with a transition to smaller gravel and sand substrate along with an increase in bar formation and transverse riffles. Pools in this part of the reach continue to both deepen and fill in, in addition to upstream and downstream shifting of riffle crests. Cross-section 3 had also actively changed between 2017 and 2018, with the thalweg migrating from the right side of the channel to the left. Between 2020 and 2021 approximately 4 inches of bed aggradation occurred along the thalweg, while the right-side bar feature continued to increase. Station 16+00 to 23+00 experienced the greatest fluctuation between 2020 and 2021 with changes occurring primarily within the pool features. Previously, cross-section 4 was the most unstable, with significant increases in cross-sectional area, but remained moderately stable this year in comparison to the 2017 survey. Cross-section pebble counts in future surveys could help identify bed material changes and if material composition has any effect on the stability at each cross-section. Continued monitoring will help identify areas of increased degradation and help further enhance the long-term data set allowing for more definitive conclusions and trend analysis.
