# Sam's Branch Tributary Watershed Assessment and Baseline Stream Monitoring

*Final Report*

*August 2012*

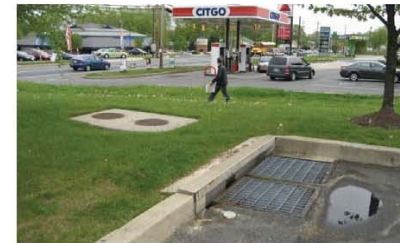
*Existing inlet at east corner of lot*

Bioretention - Commercial - SBO

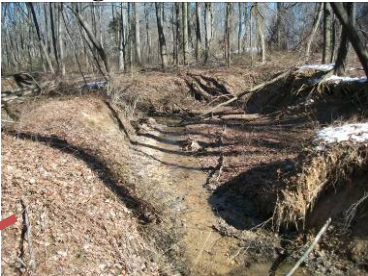
Existing: Over-widened Channel

Proposed: Regenerative Stream Channel
