Appendix E2. a – Restoration Plans and TMDLs (Impervious Area Assessment)

Impervious Area Assessment

Harford County, MD Department of Public Works
 Watershed Protection and Restoration
 Watershed Restoration Status (MS4 Permit 11-DP-3310)

Stormwater and stream restoration - inspections FY2020

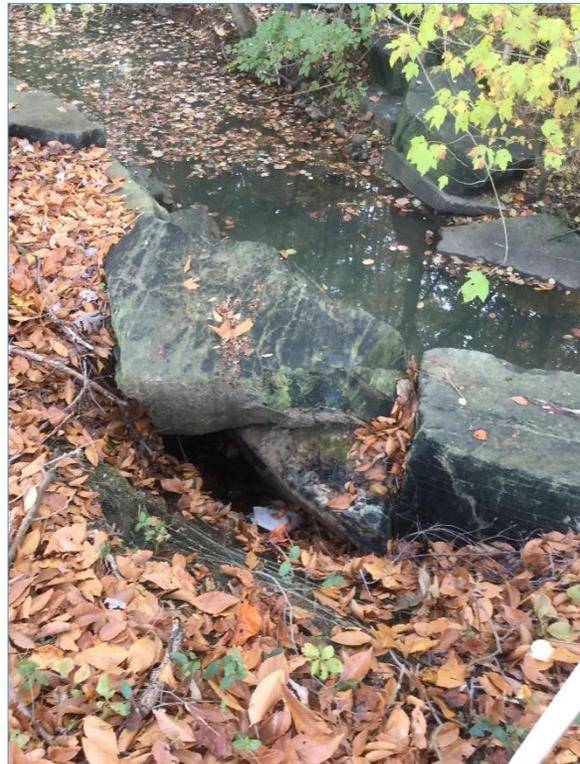
Scour hole left bank of step pool channel Sta. 10+40

- Evaluate watershed for illicit discharge.
- Assess need for stormwater dissipation feature on Kensington Parkway and/or placement of stone backfill behind step pool channel at Station 10+40.

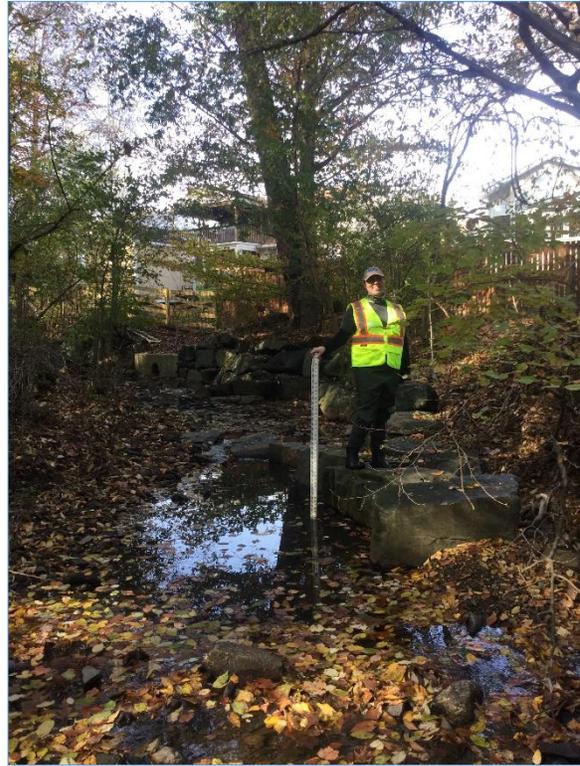
Minor instability downstream left bank Sta. 6+00

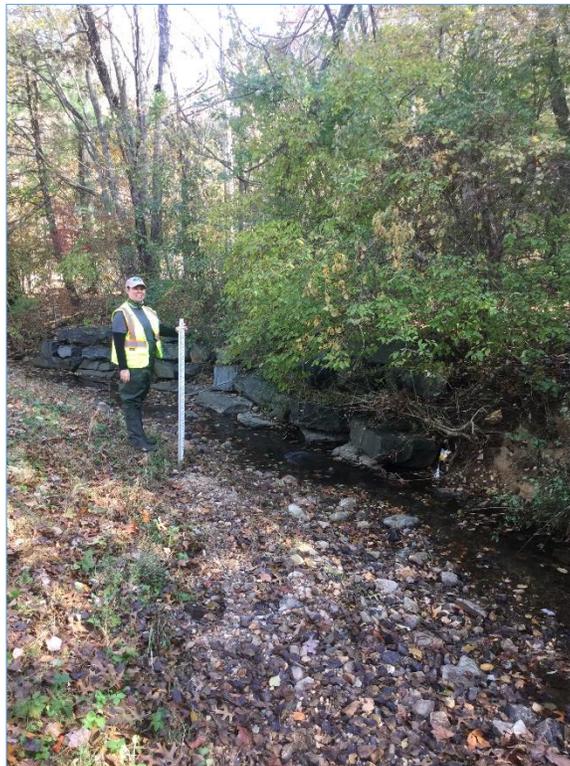
Minor instability upstream right bank Sta. 1+30

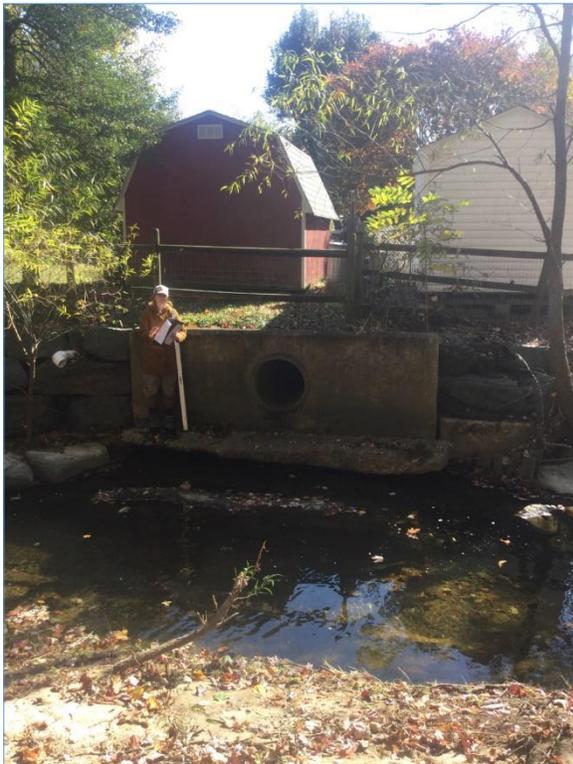
Concrete outfall apron detached Sta. 12+25

- Evaluate outfall structure at Station 12+25 for maintenance.
- Assess need for bamboo treatment at Station 16+00.
- Assess need for removal of wooden fence at Bynum Road culvert.

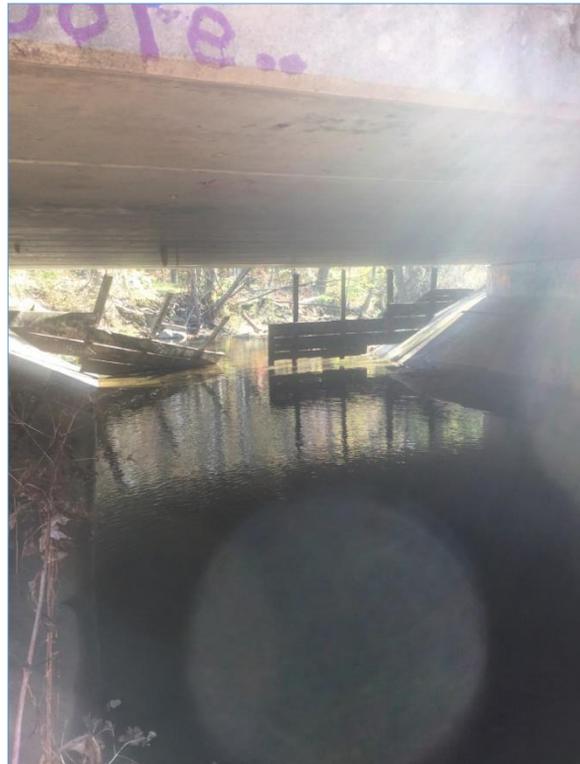
Wooden fence crossing channel at Bynum Road

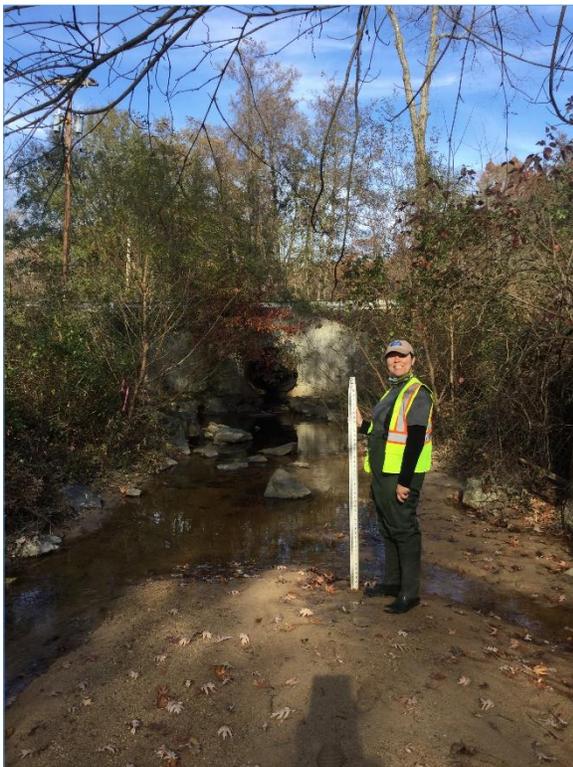
Displacement of Outfall #1 class 2 riprap

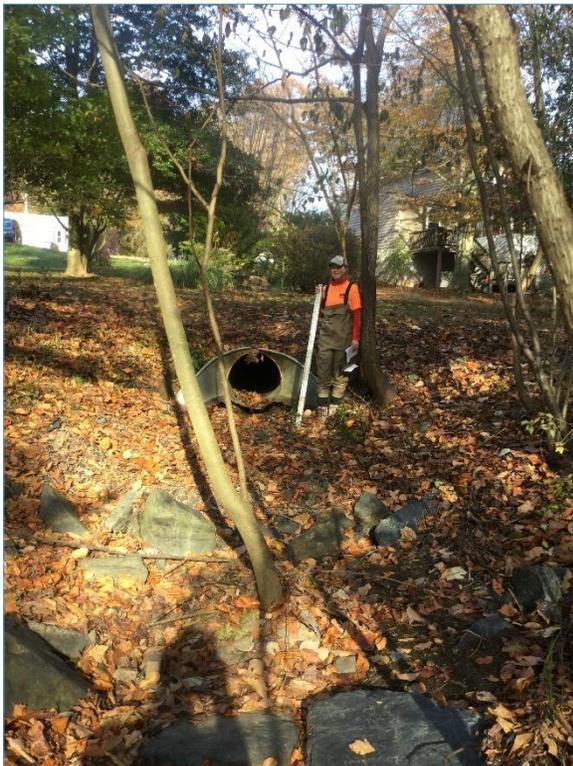
Scour behind existing outfall endwall

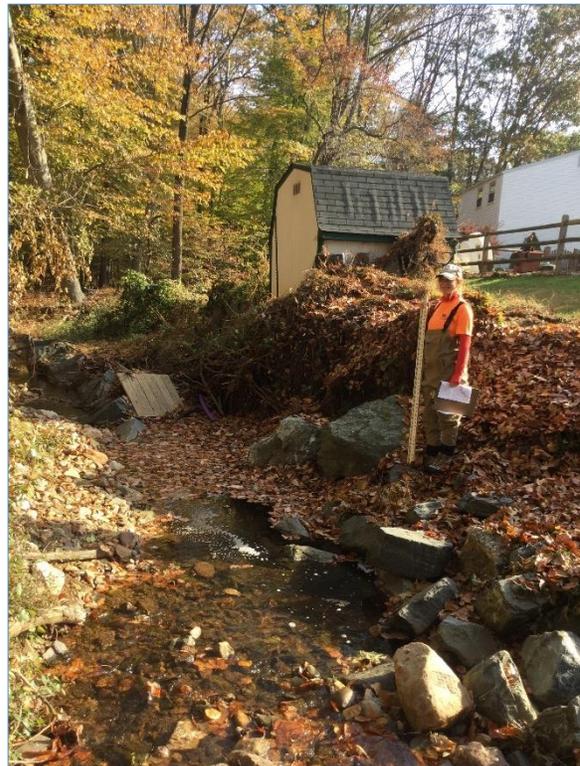
Erosion and stone migration Sta. 4+00 to 4+40

- Educate homeowners on importance of stream buffer to prevent stream and lawn erosion.
- Evaluate need for addition of stone to right bank from Station 4+00 to 4+40 and 9+30 to 9+50.
- Assess need for porcelainberry and bamboo treatment throughout project.

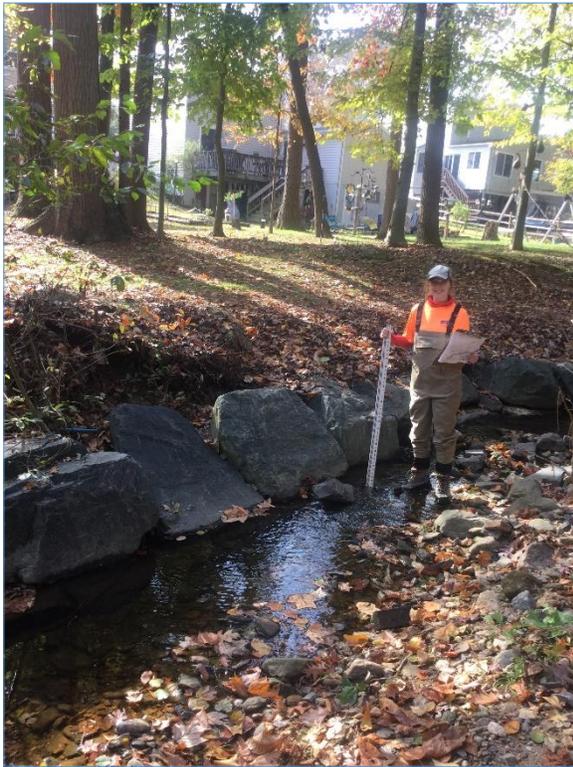
Scour behind stone toe protection Sta. 7+50

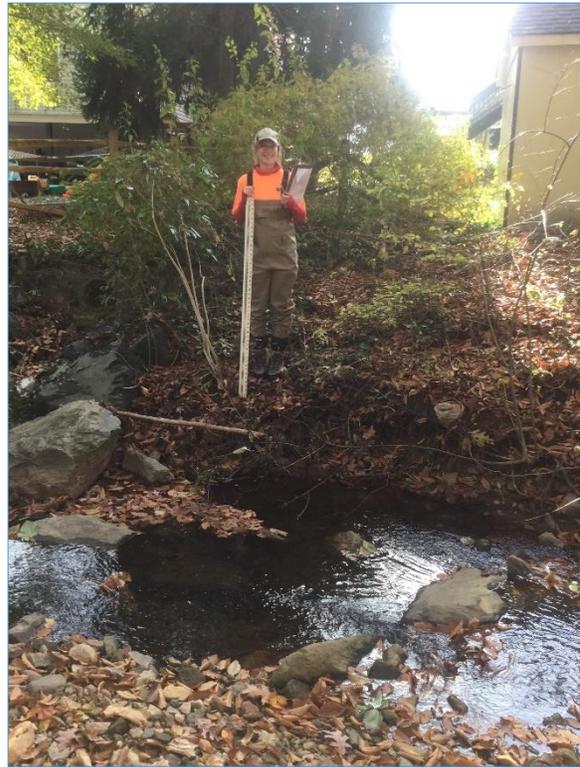
Bank migration and stone toe displacement Sta. 9+40

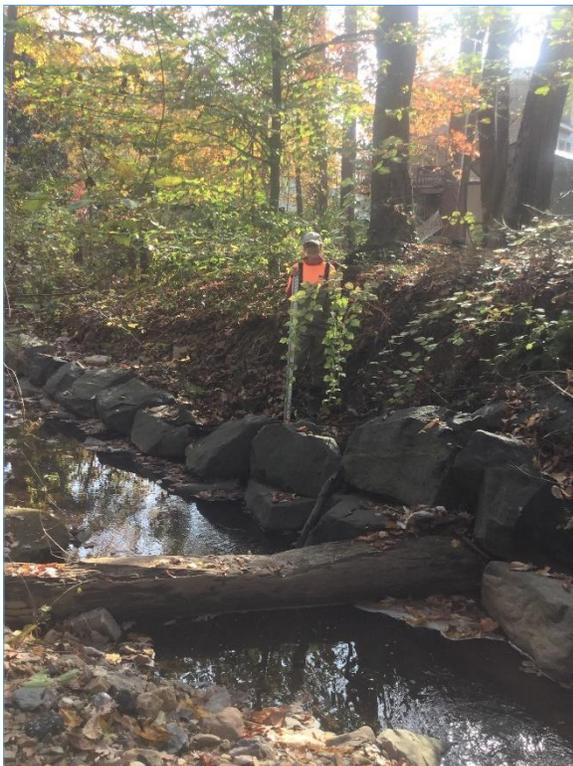
Flow under log weir and right bank scour at Station 10+65

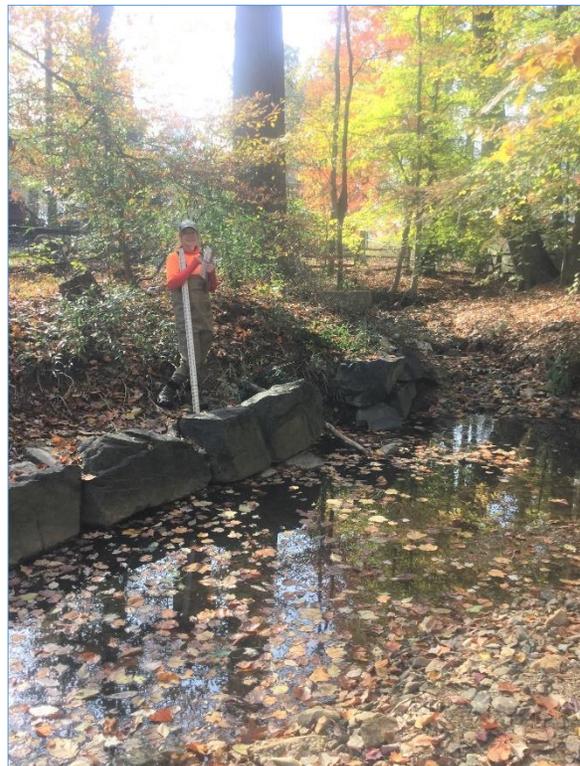
Scour behind stone toe protection at Station 12+40

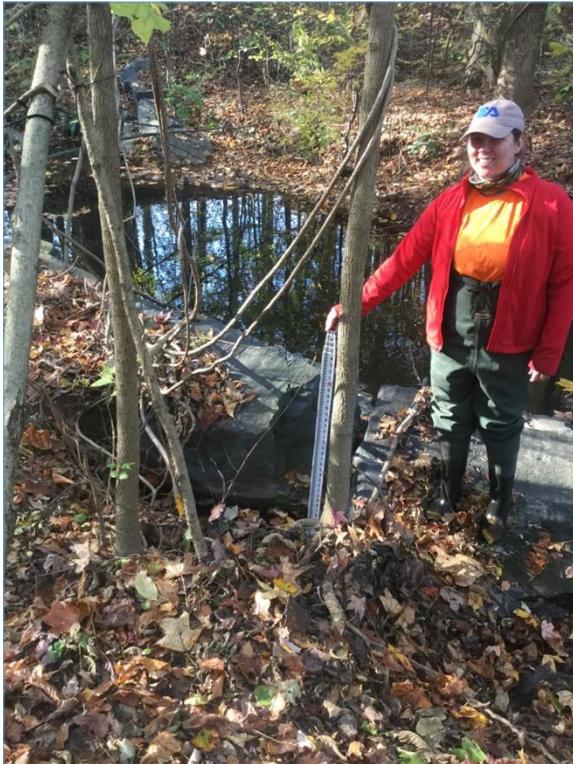
Two-foot scour hole behind weir Sta. 5+15

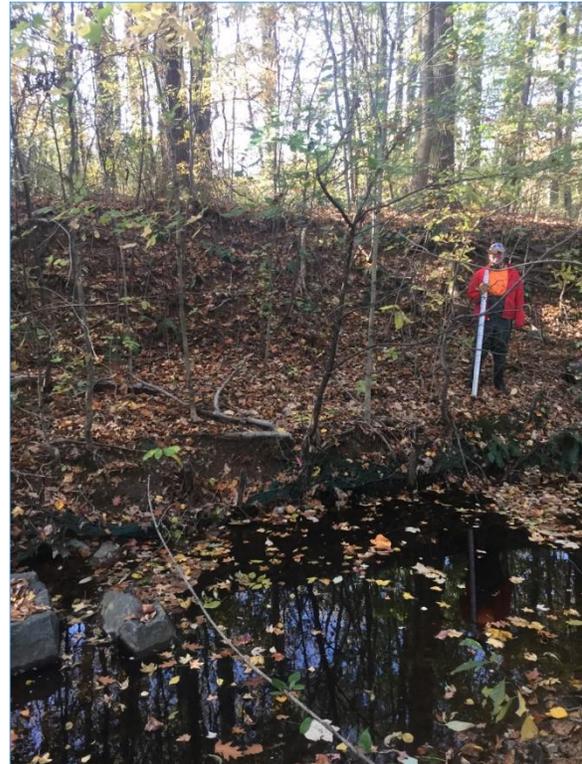
Erosion on left bank between structures Sta. 3+85 to 5+15

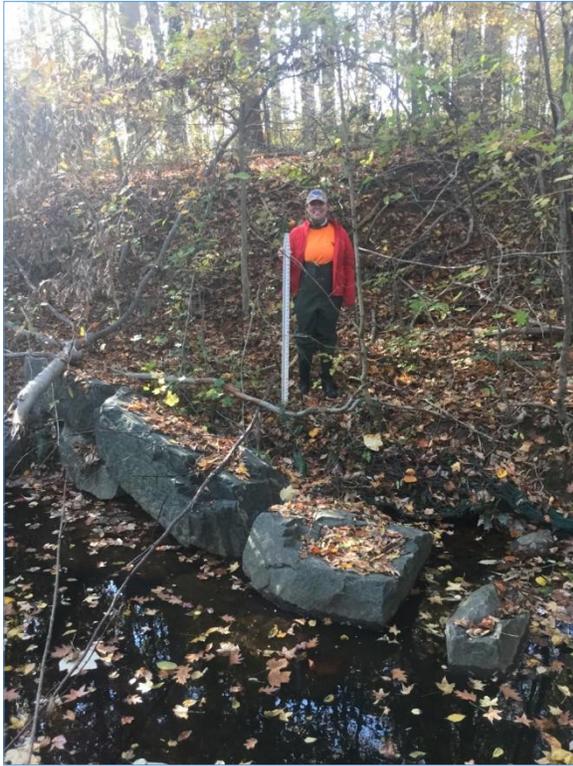
Scour behind boulder spur Sta. 4+28

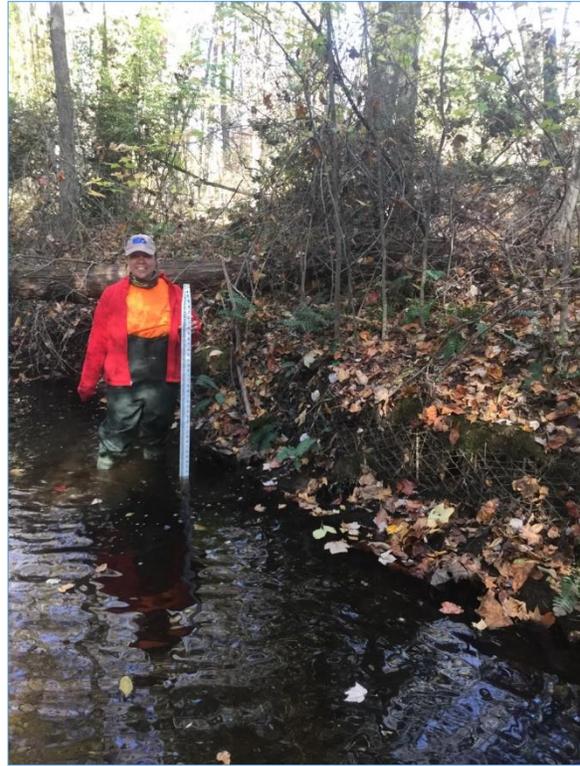
Erosion on left bank between Sta. 0+50 and 2+10

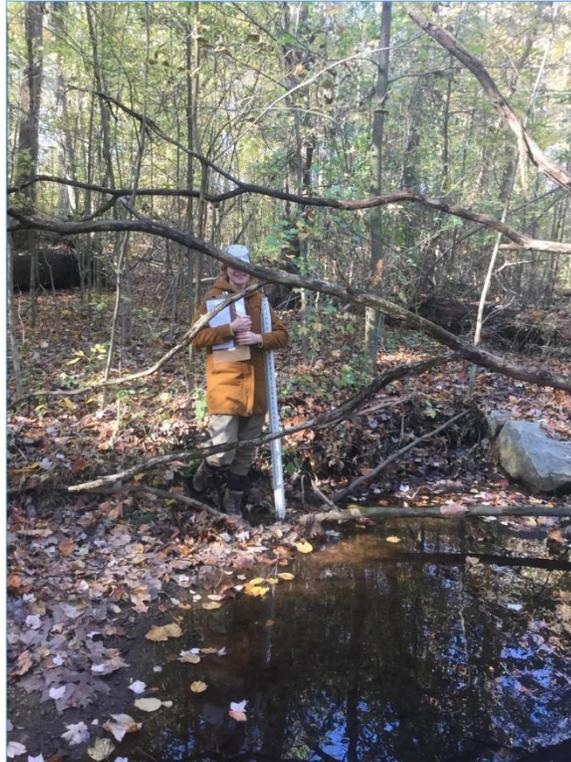
Scour behind boulder spur with grade control Sta. 0+80

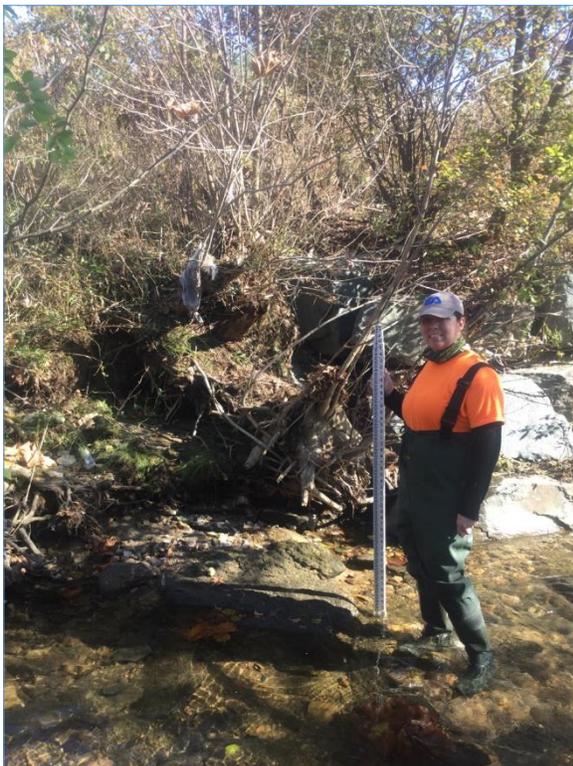
Severe erosion upstream of boulder bank Sta. 9+80

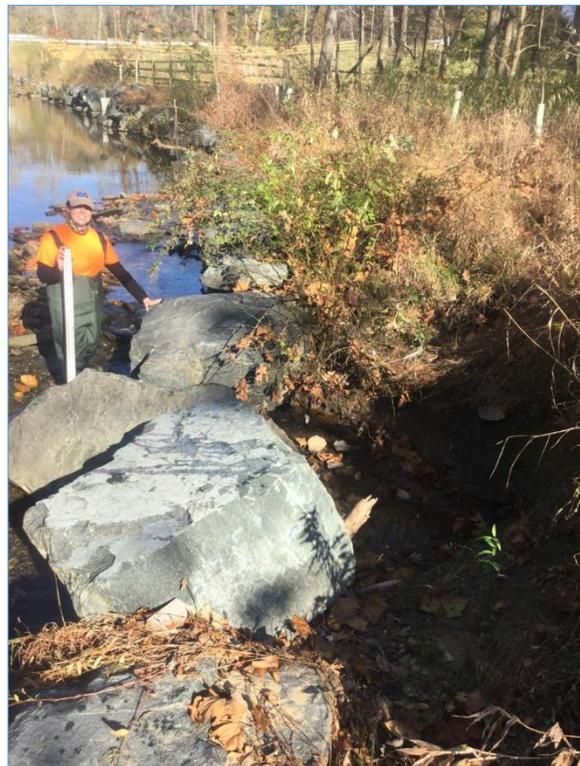
Severe erosion and bank migration behind rock Sta. 16+25

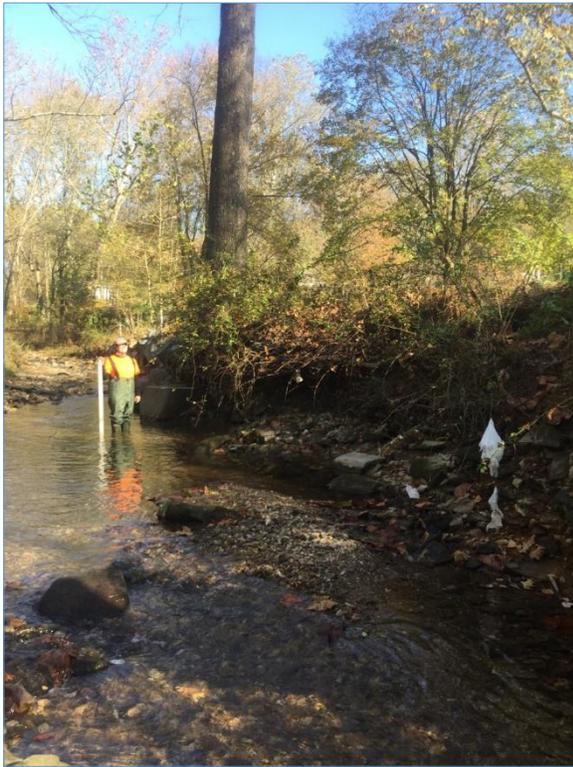
Severe erosion on left bank Sta. 18+50

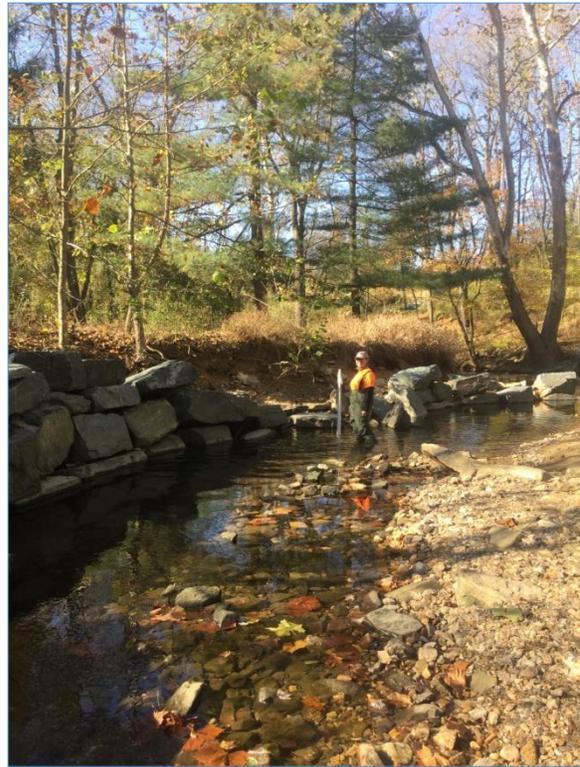
Severe erosion and bank migration behind rock Sta. 20+00

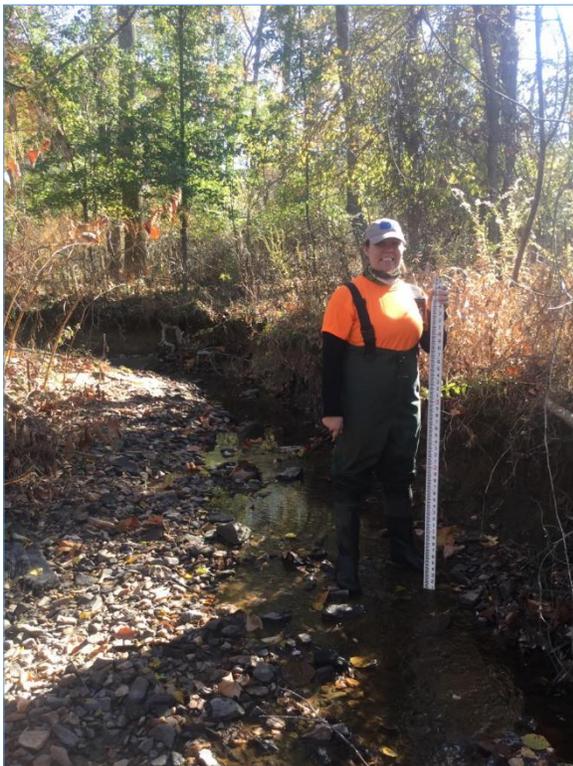
Severe erosion and displaced structure Sta. 5+00

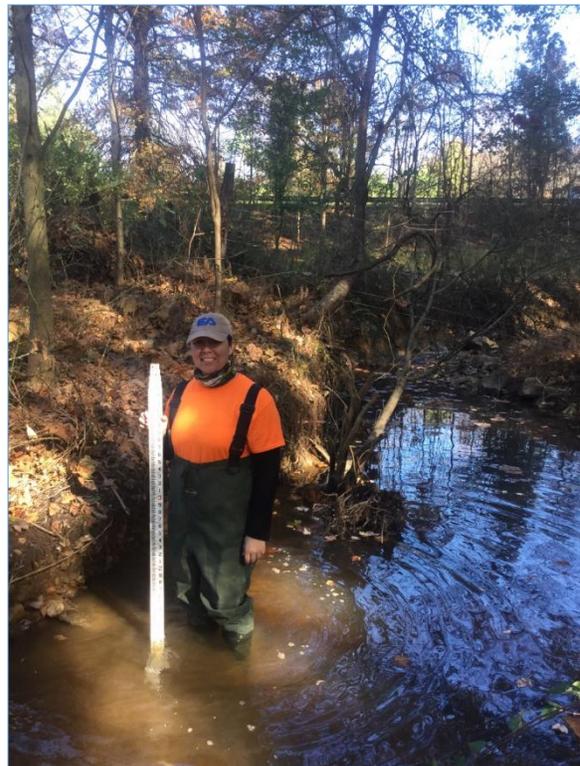
Severe erosion Sta.1+50

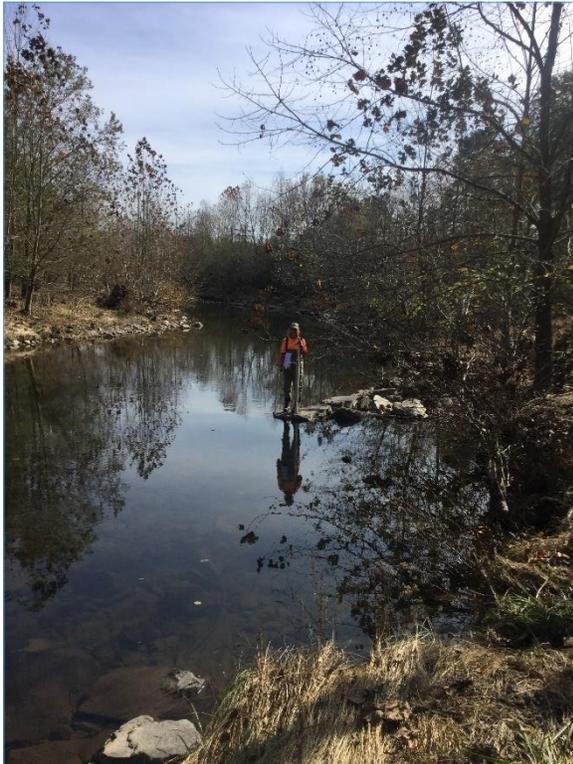
Minor erosion between vanes Sta.1+25

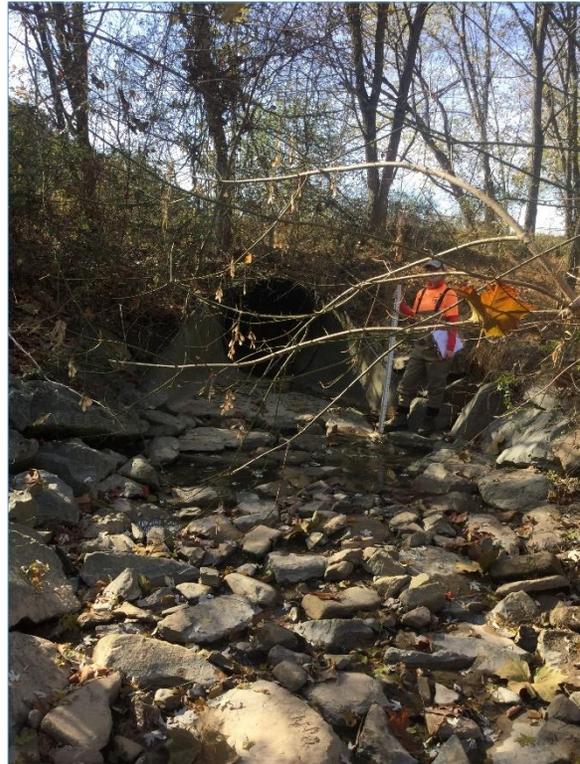
Scour behind outfall endwall structure

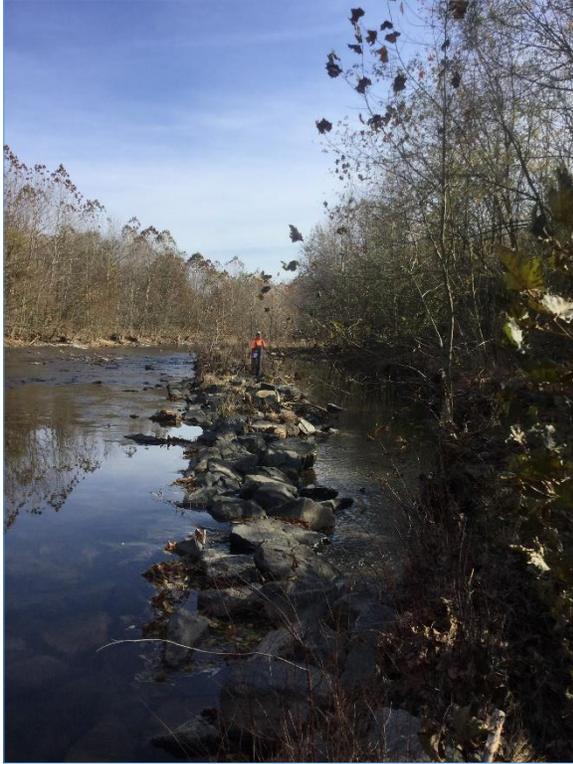
Right bank migration Sta. 4+25

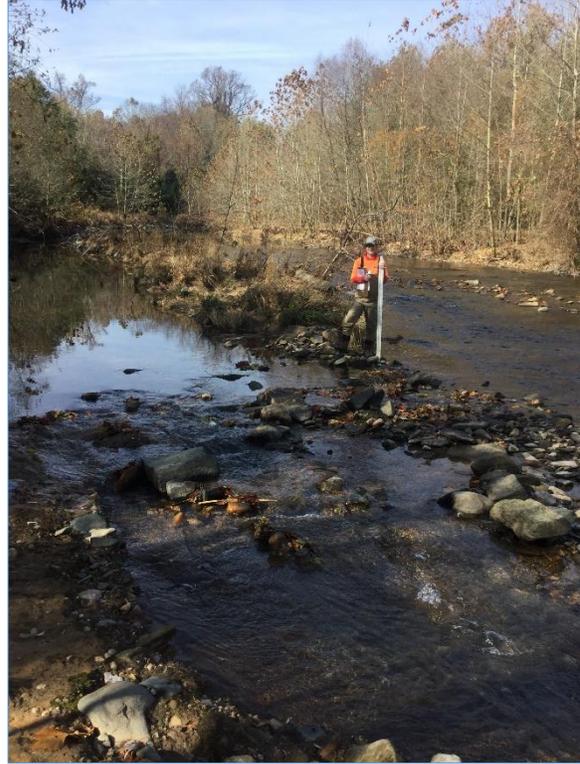
Right bank migration Sta. 6+50

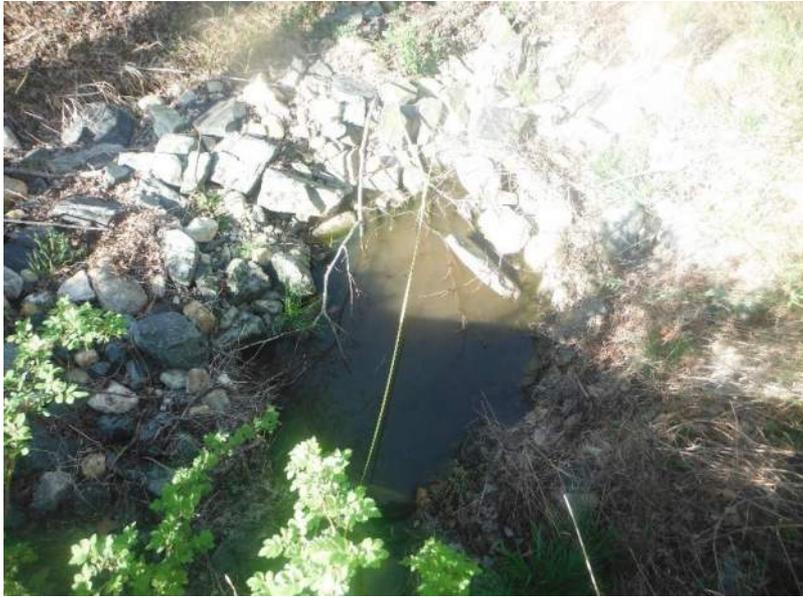
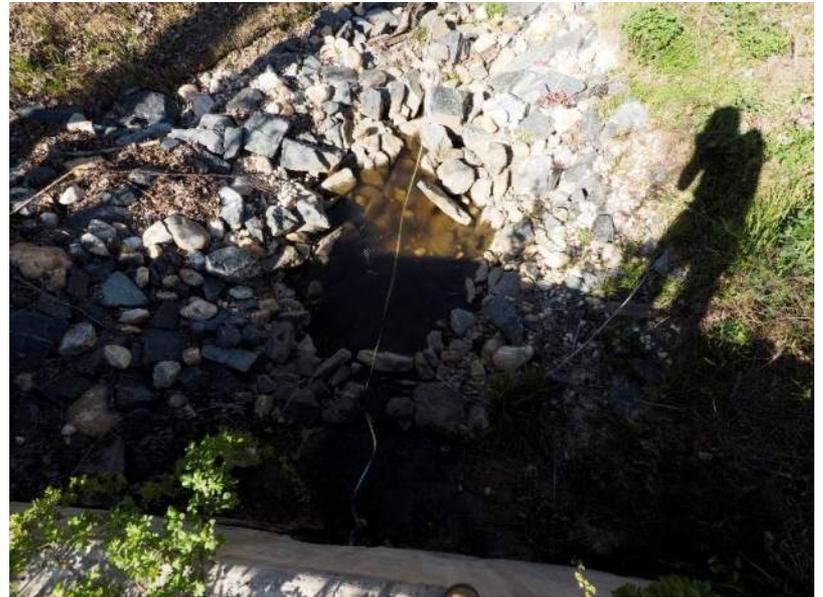
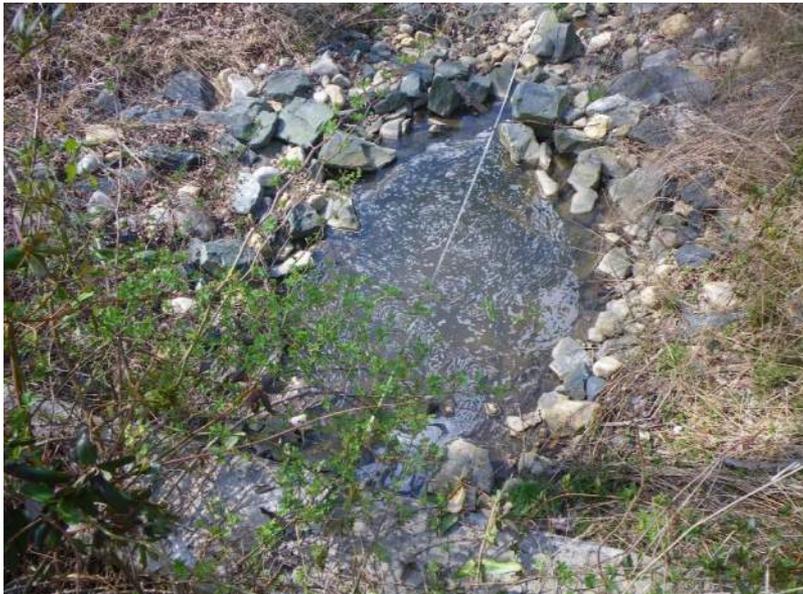
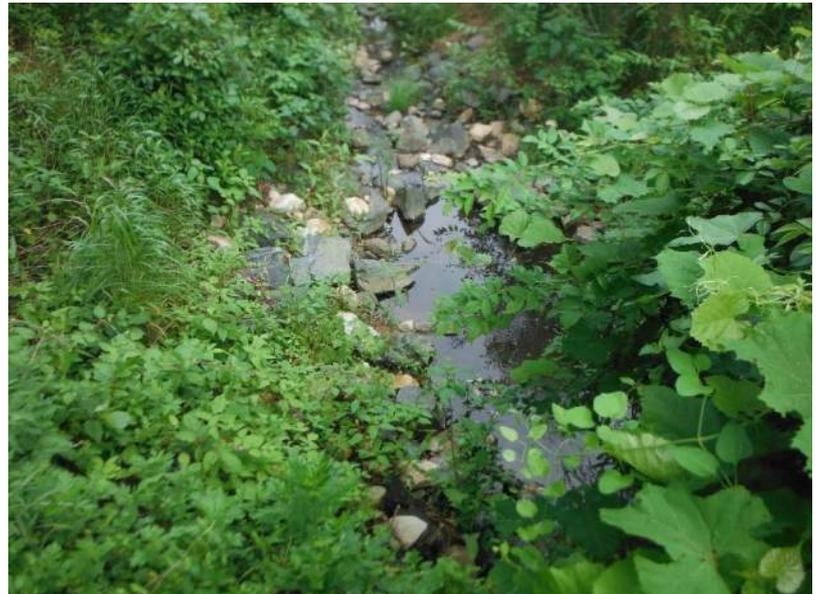
Station 0+00 facing downstream; culvert invert

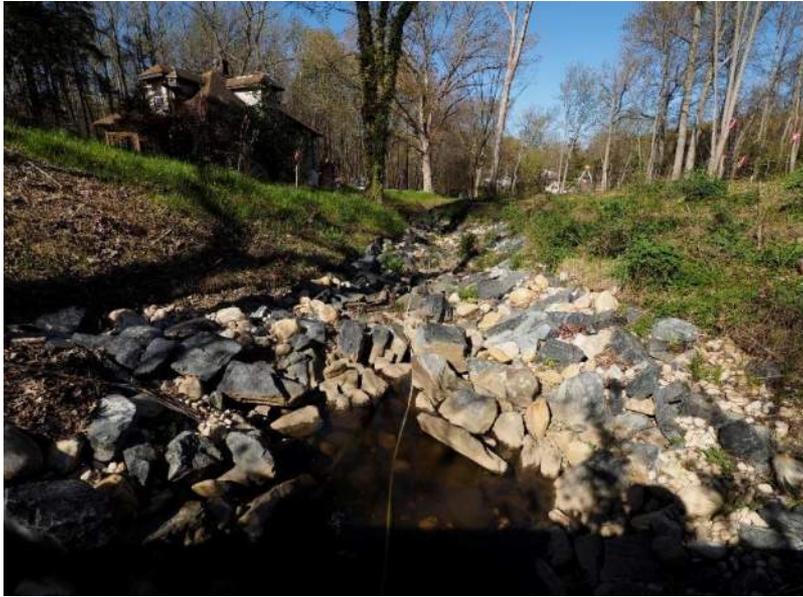
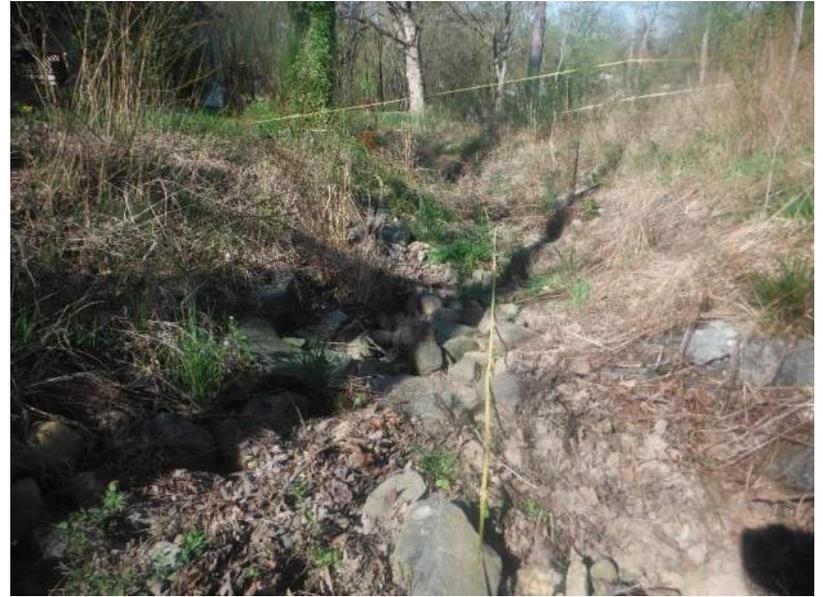
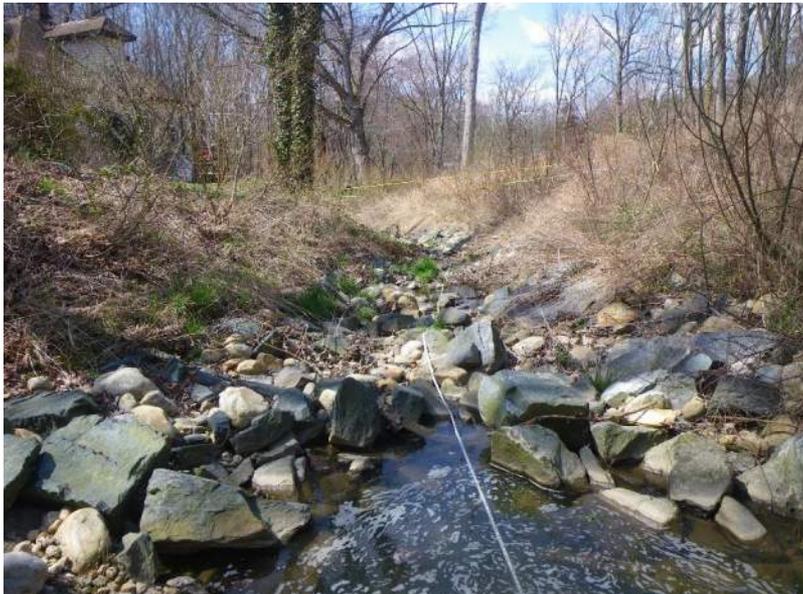
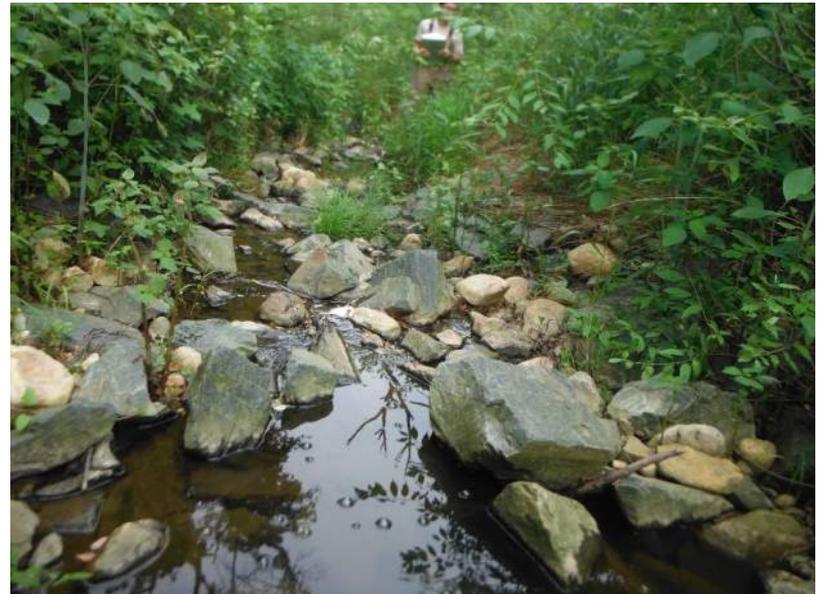
Station 0+09 facing downstream

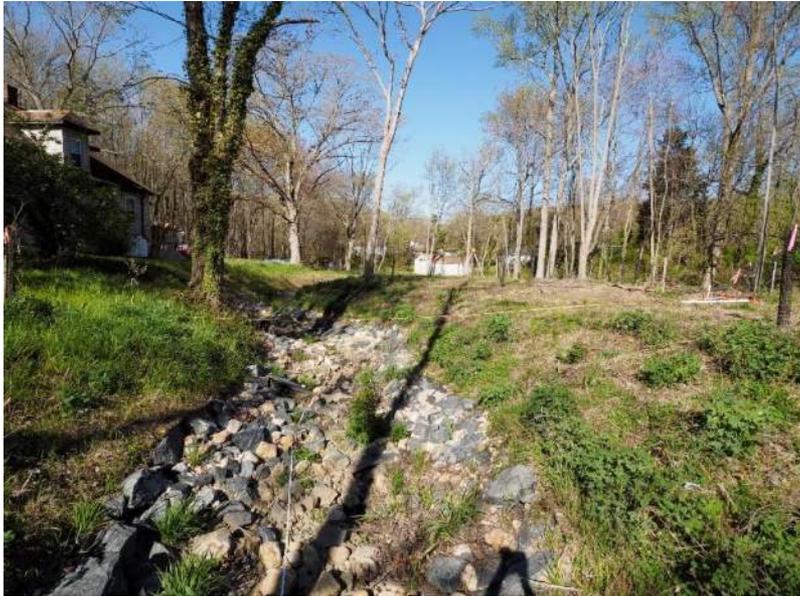
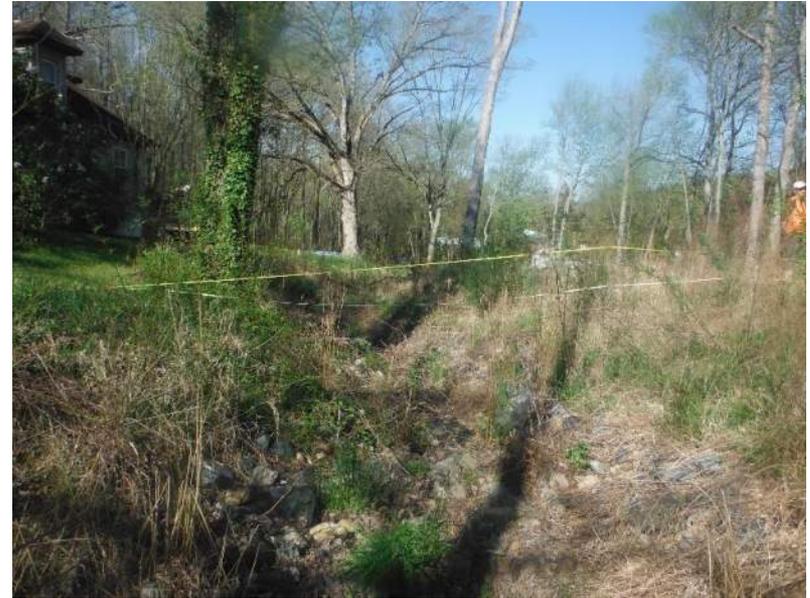
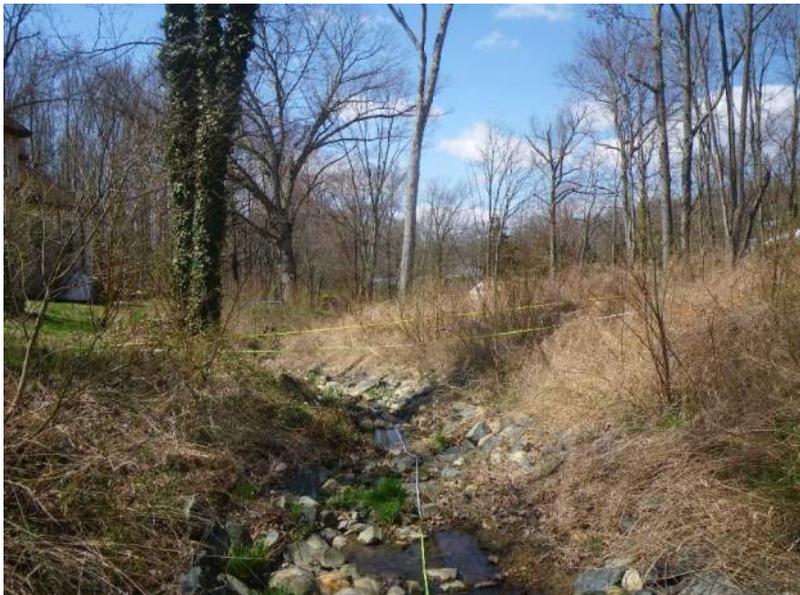
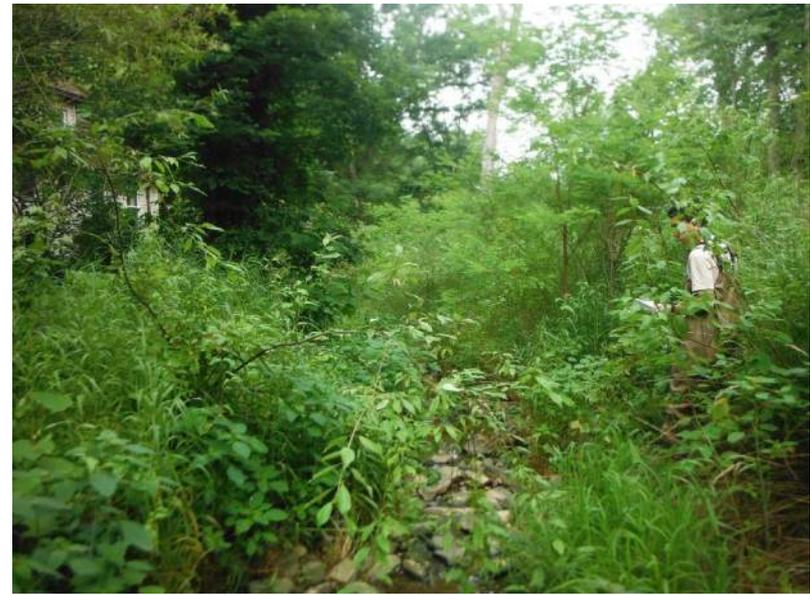
Station 0+43 at cross section 1 facing downstream

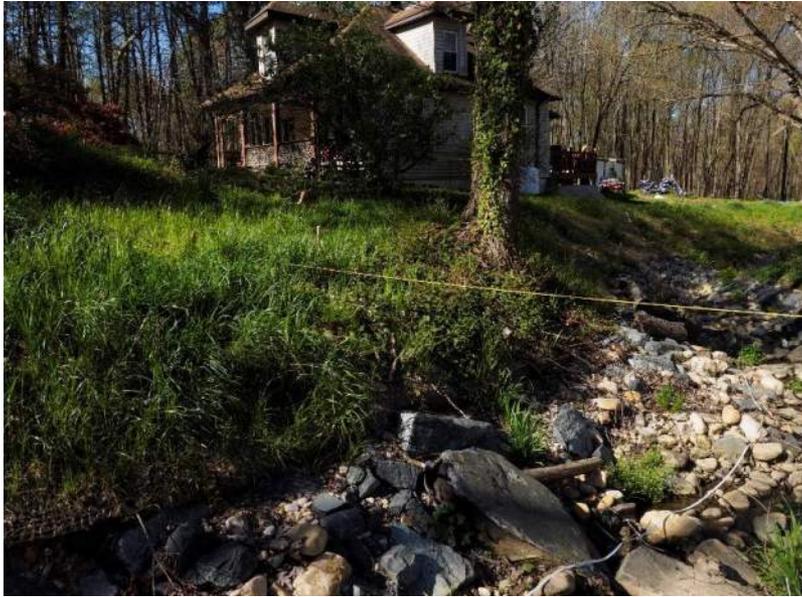
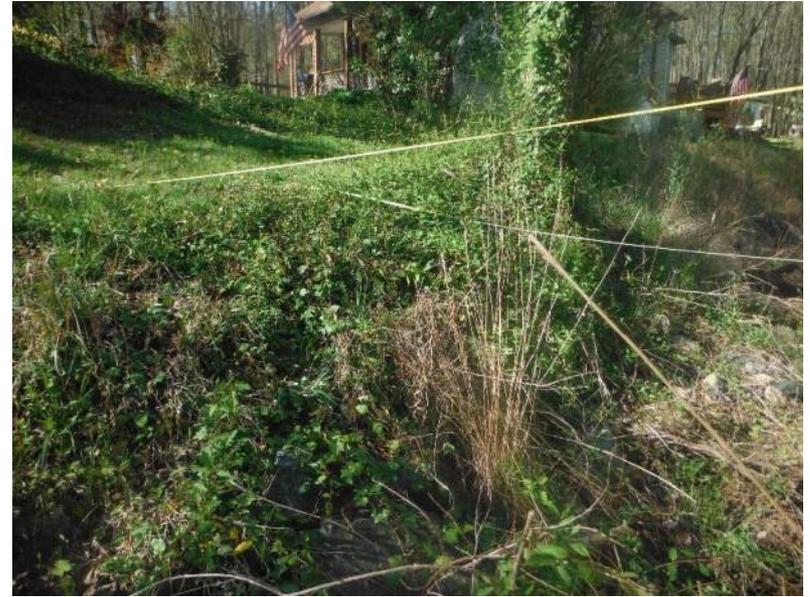
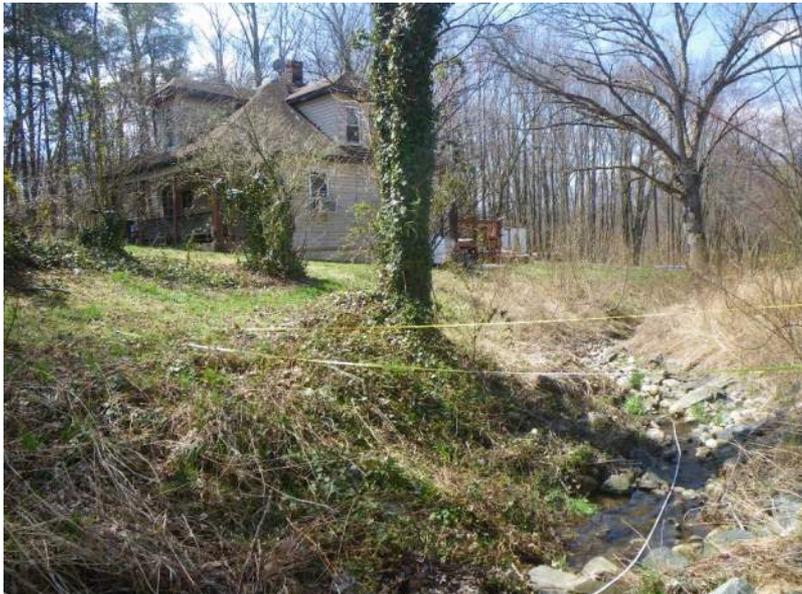
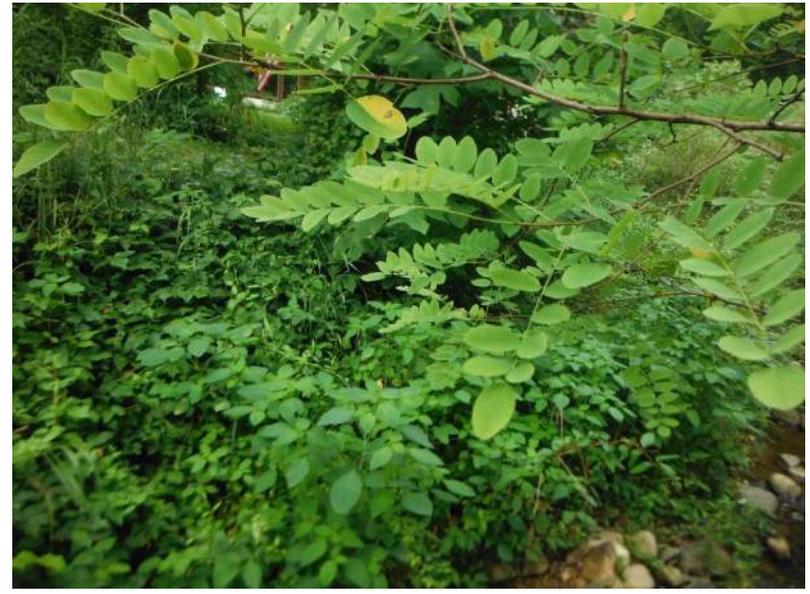
Station 0+43 at cross section 1 facing left bank

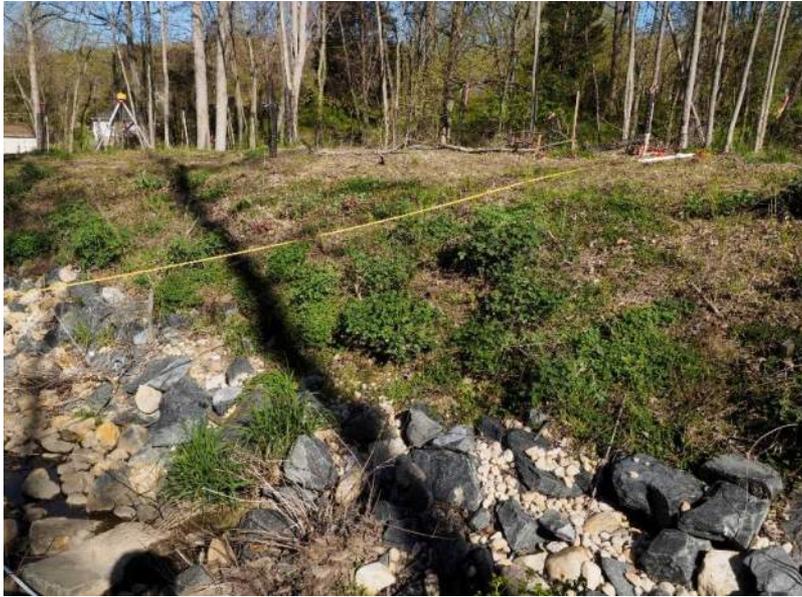
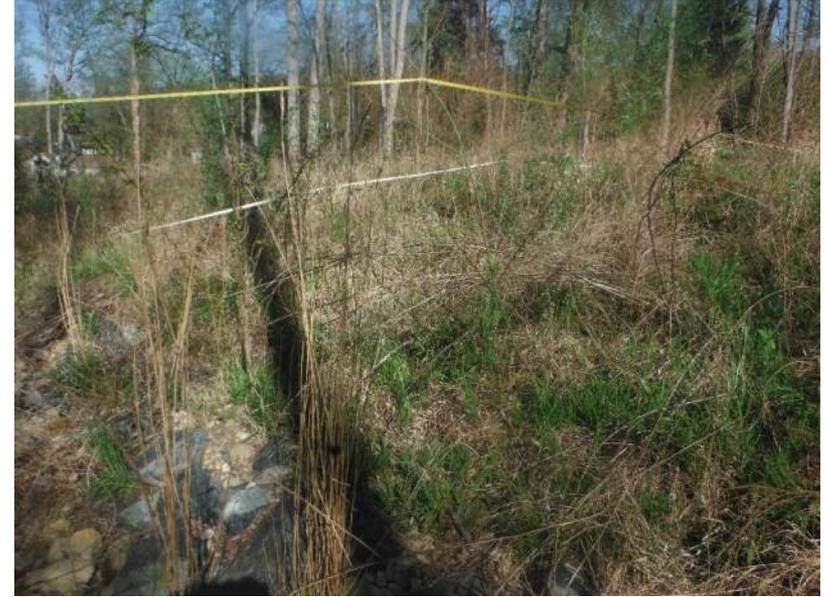
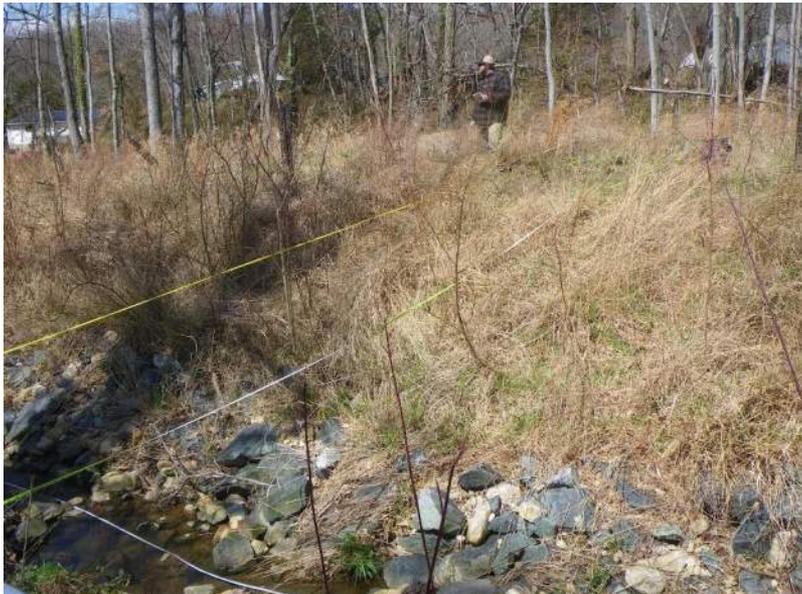
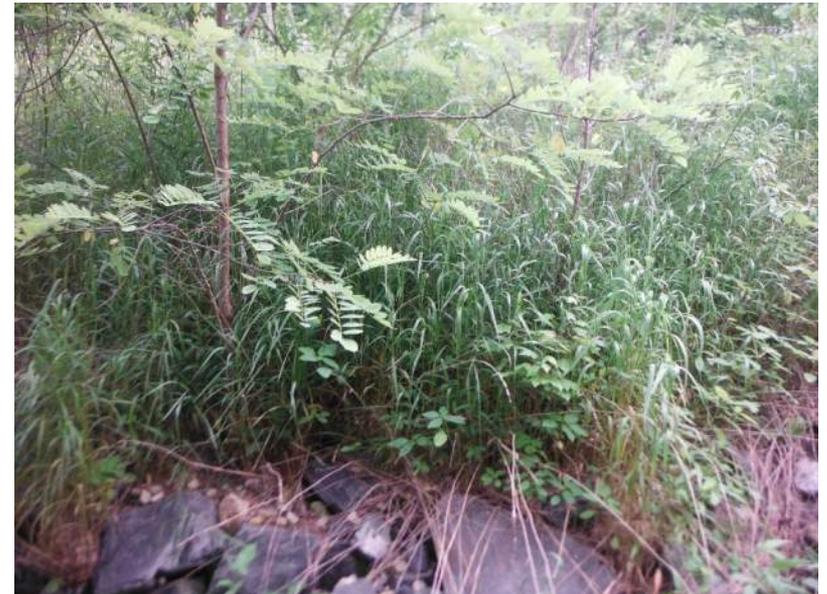
Station 0+43 at cross section 1 facing right bank
