Appendix E2. a – Restoration Plans and TMDLs (Impervious Area Assessment)

Impervious Area Assessment

Harford County, MD Department of Public Works
 Watershed Protection and Restoration
 Watershed Restoration Status (MS4 Permit 11-DP-3310)

Stormwater and stream restoration - inspections FY2020

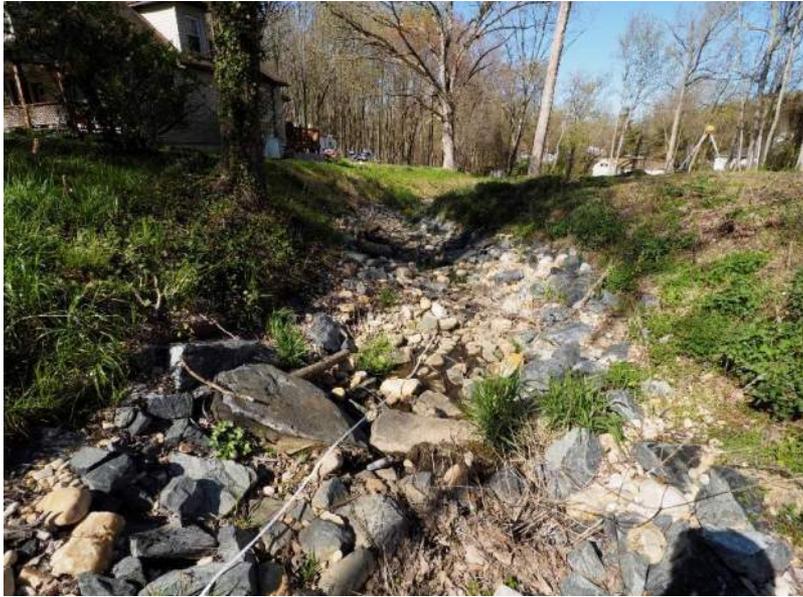
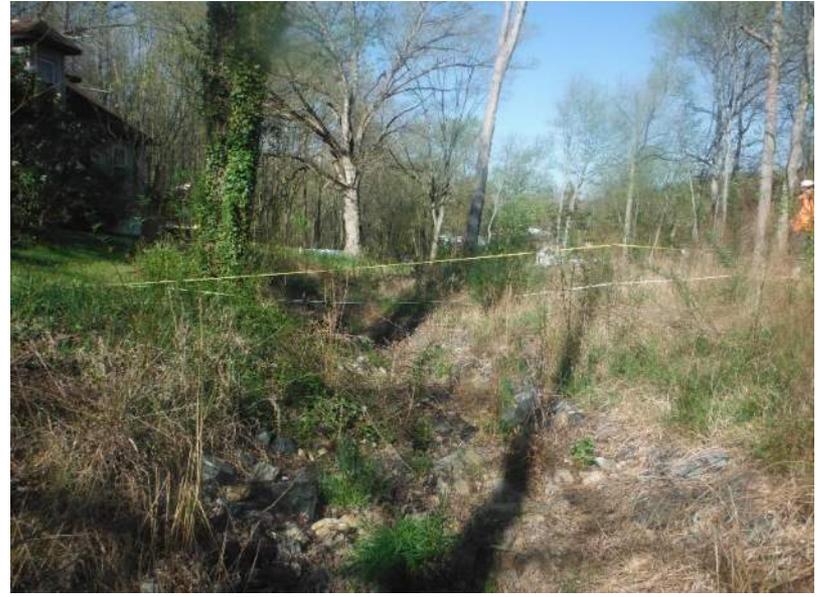
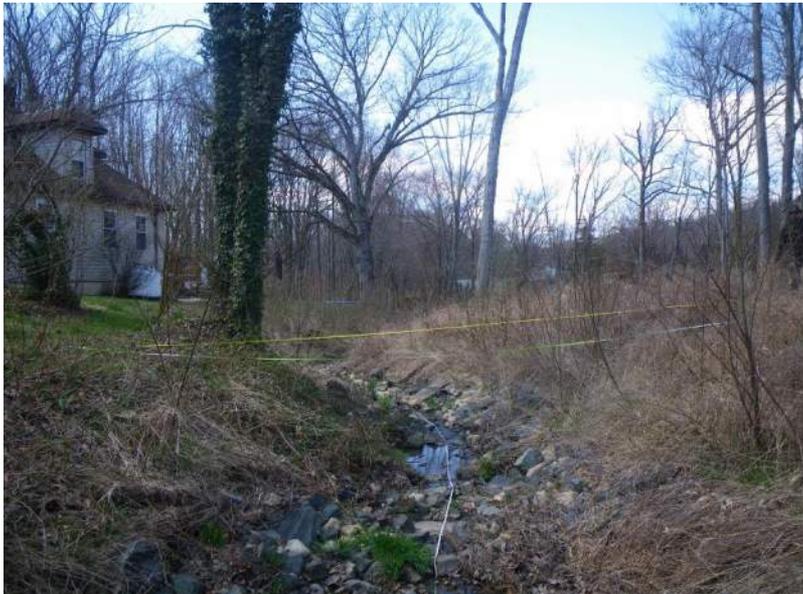
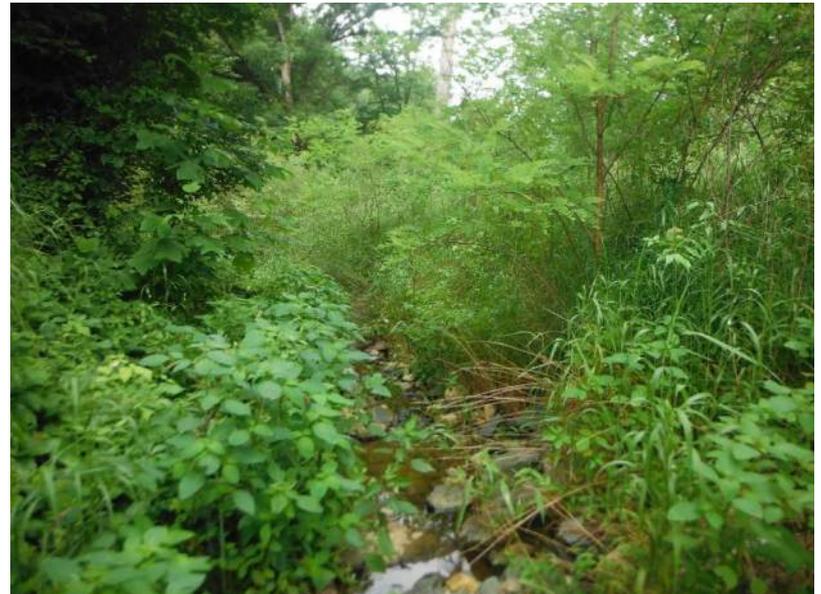
Station 0+47 at cross section 2 facing downstream

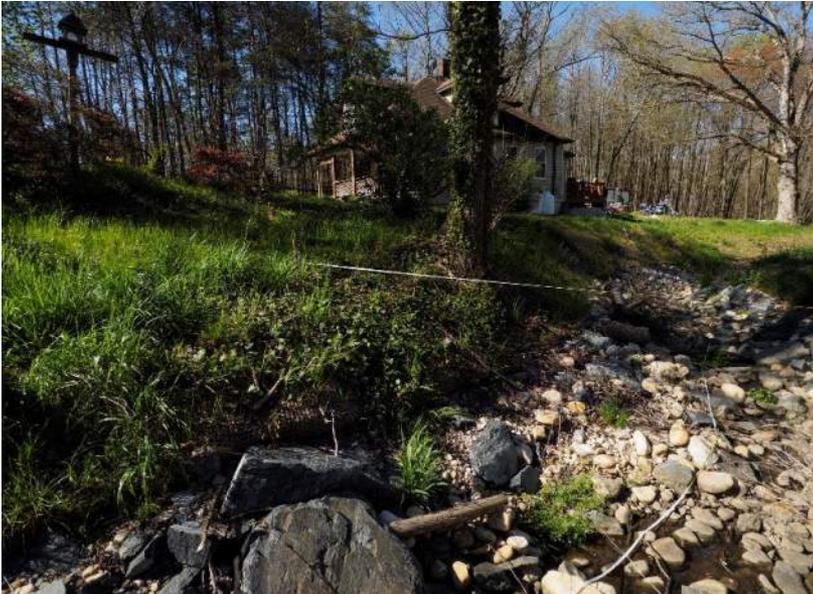
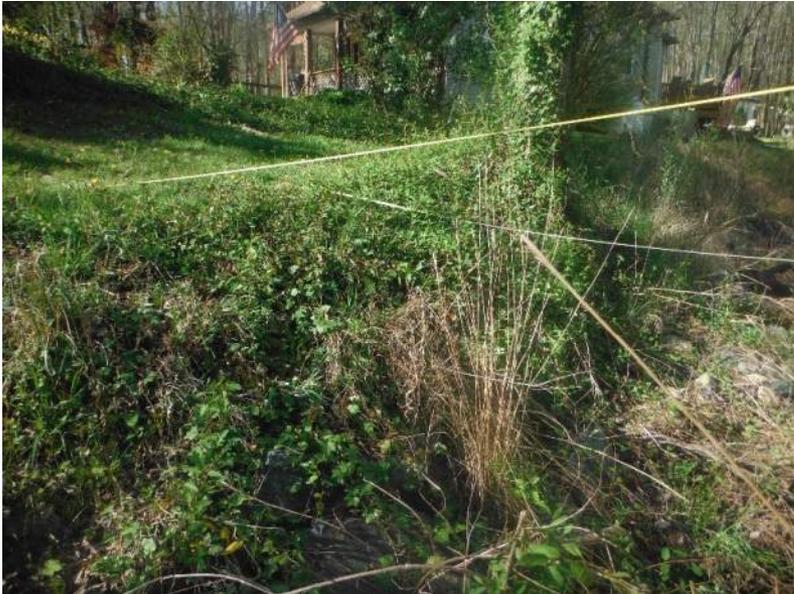
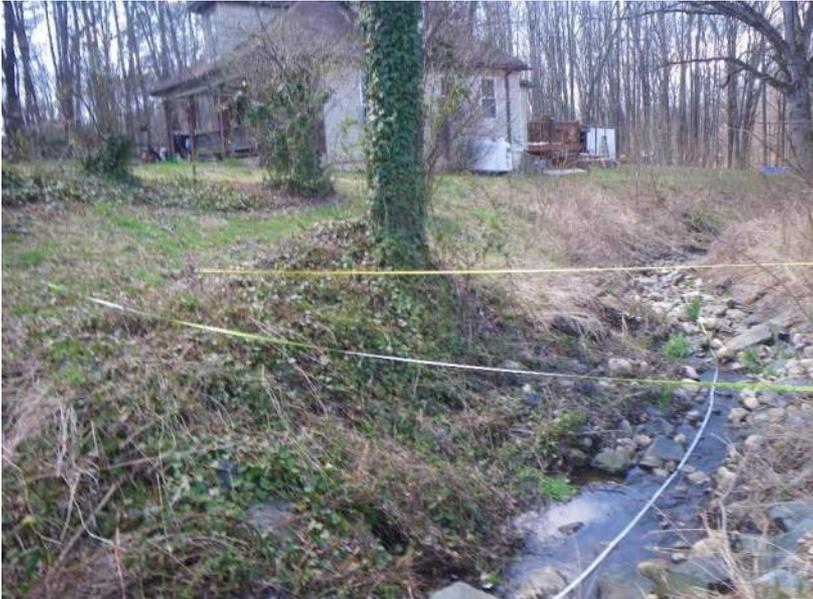
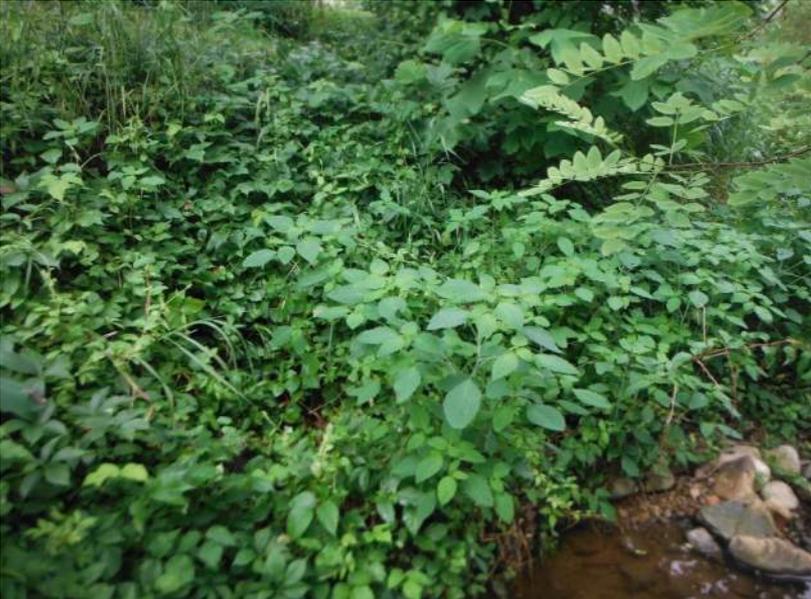
Station 0+47 at cross section 2 facing left bank

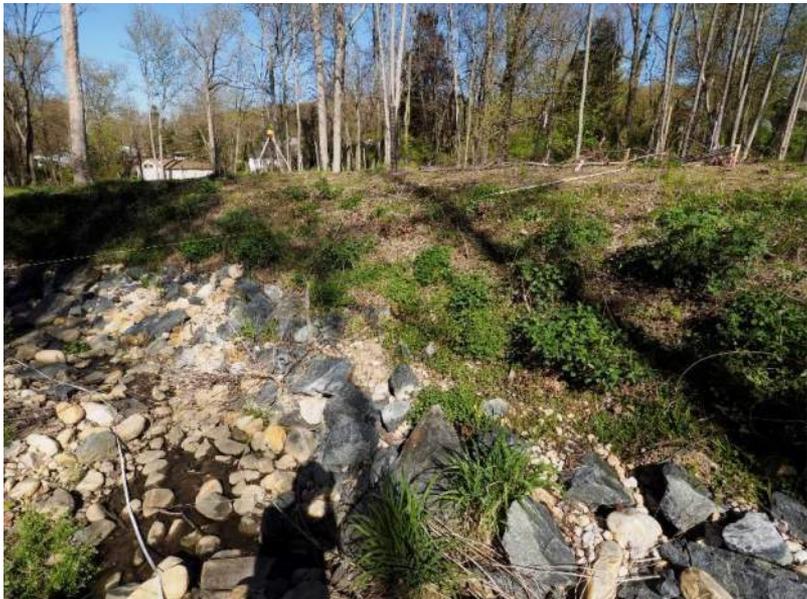
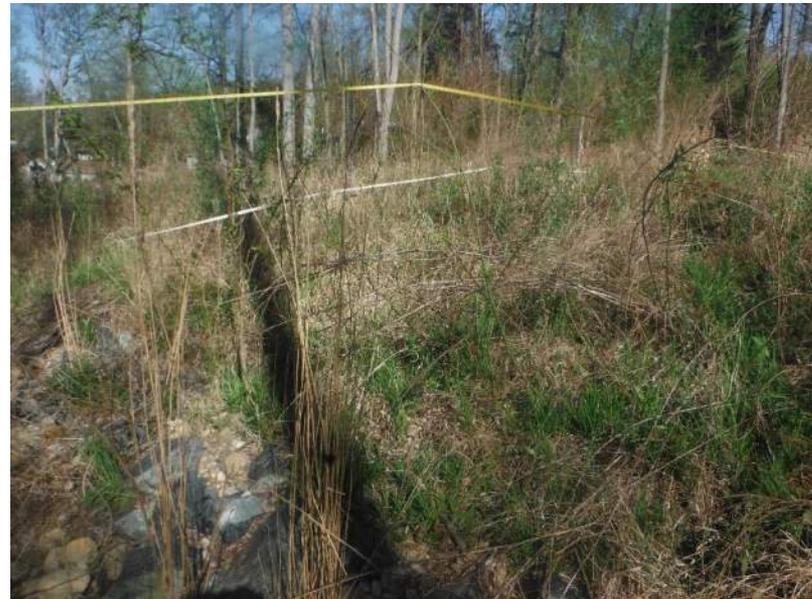
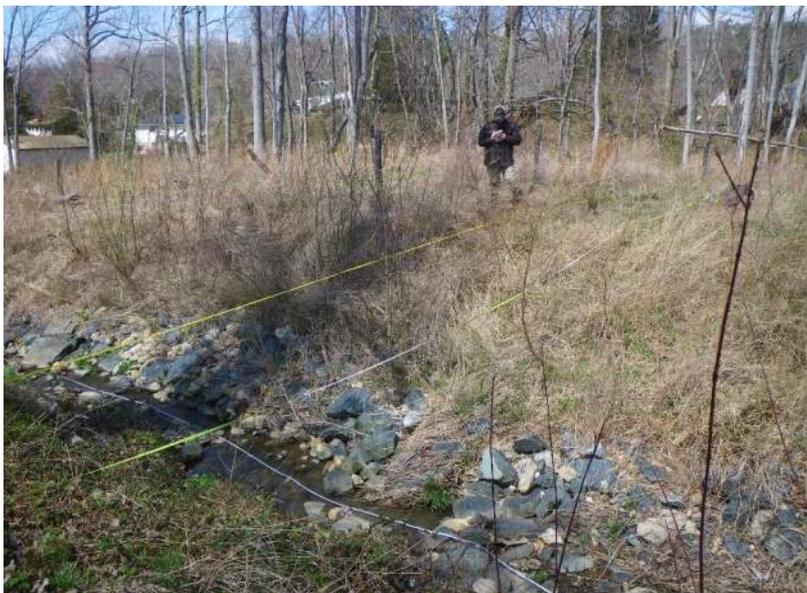
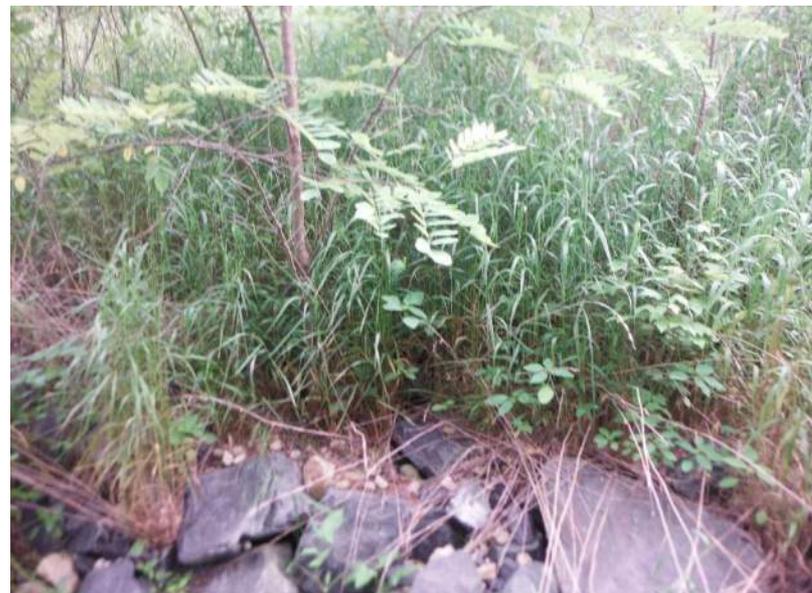
Station 0+47 at cross section 2 facing right bank

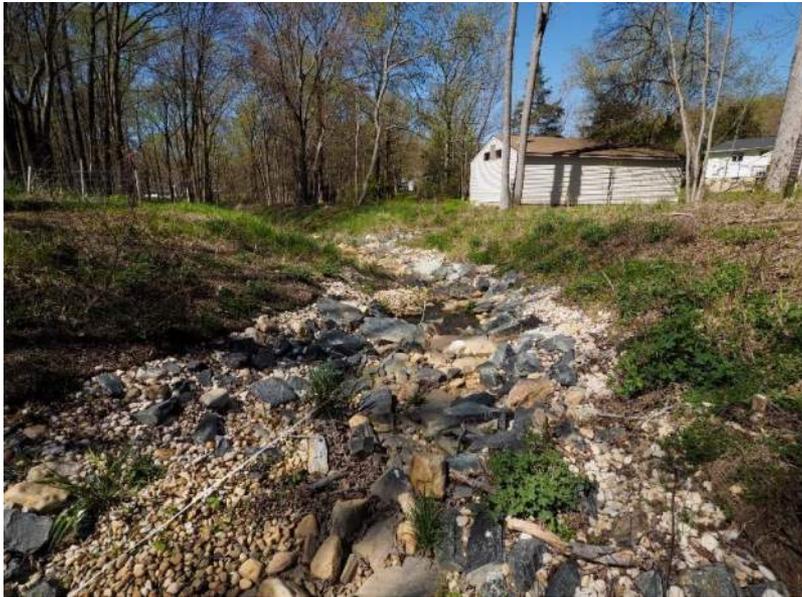
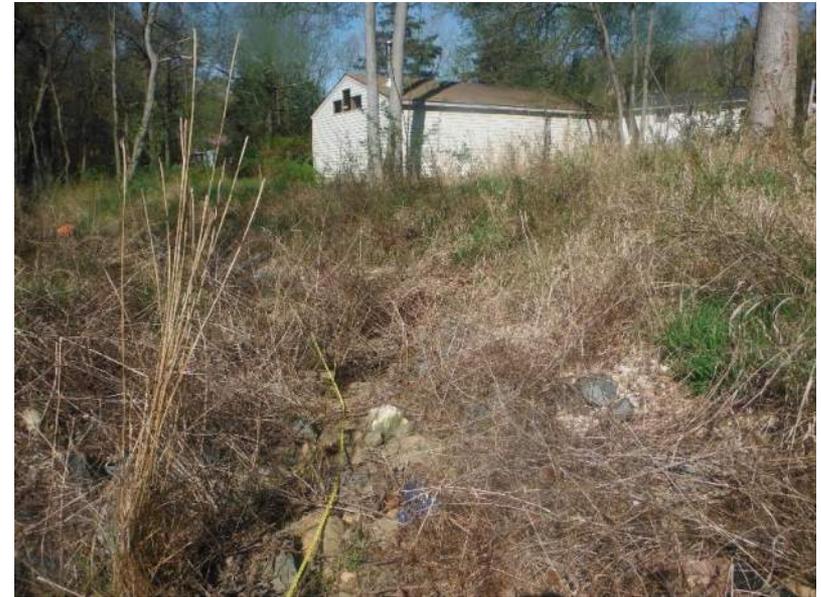
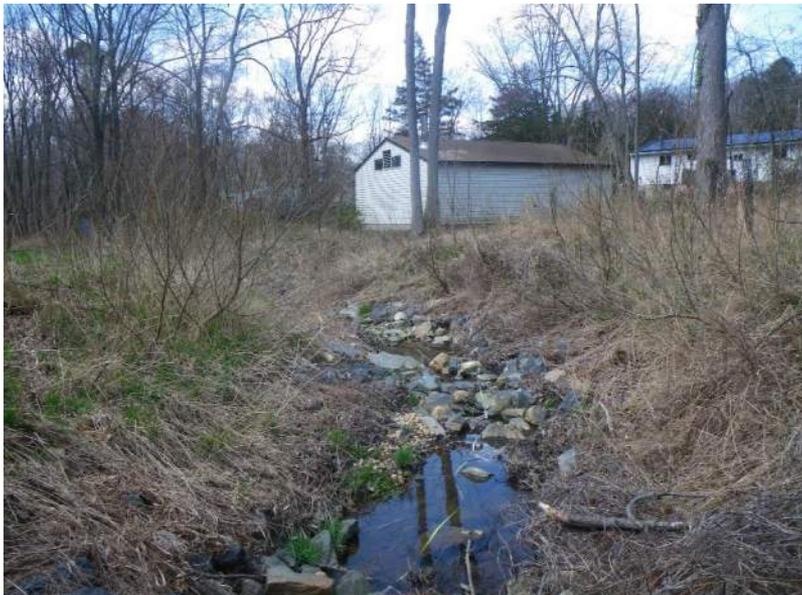
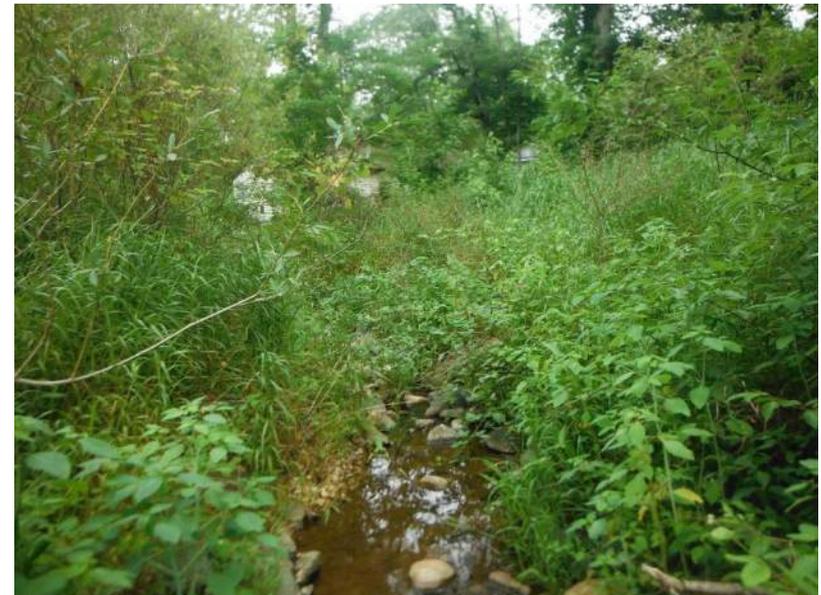
Station 2+25 facing downstream; pool and downstream riffle are dry

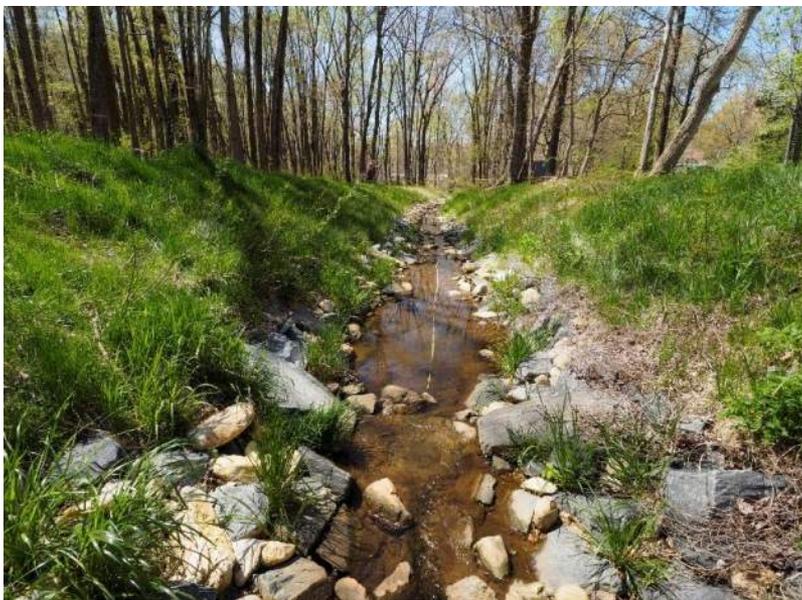
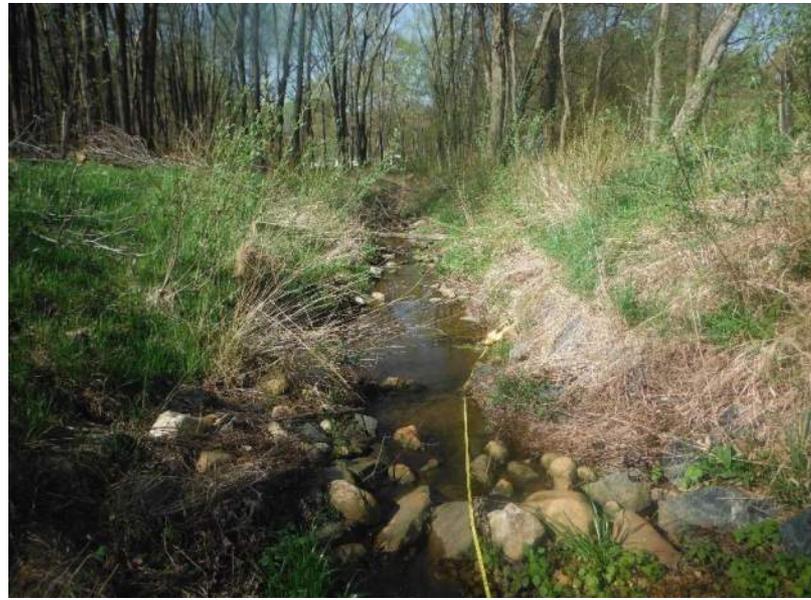
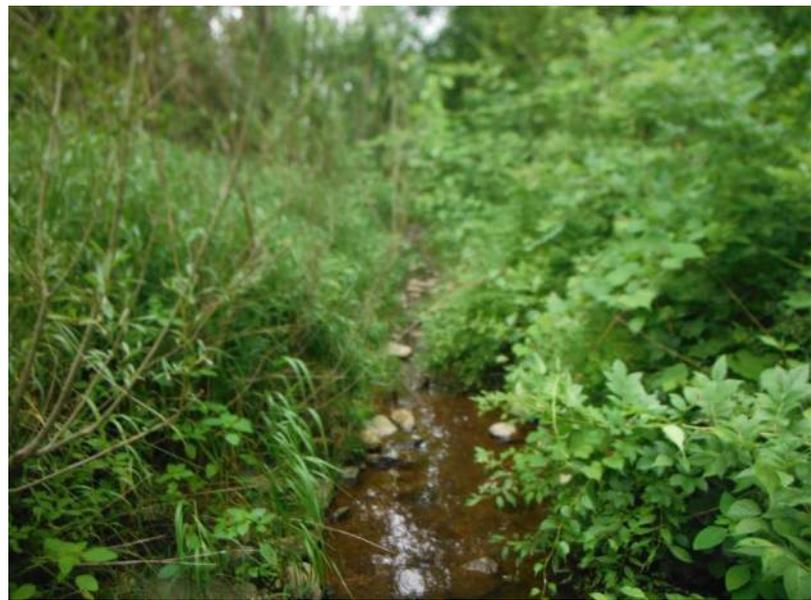
Station 2+87 facing downstream; tributary confluence on right bank

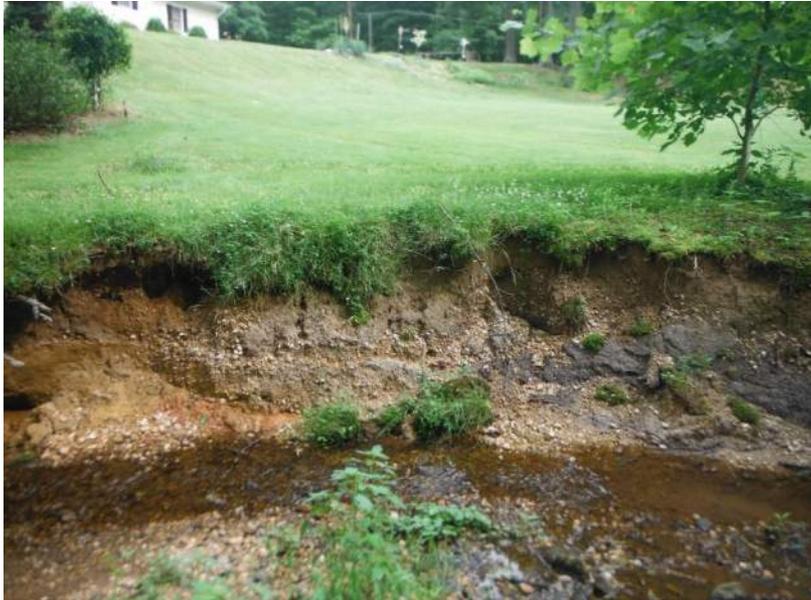
Facing right bank erosions at station 11+30

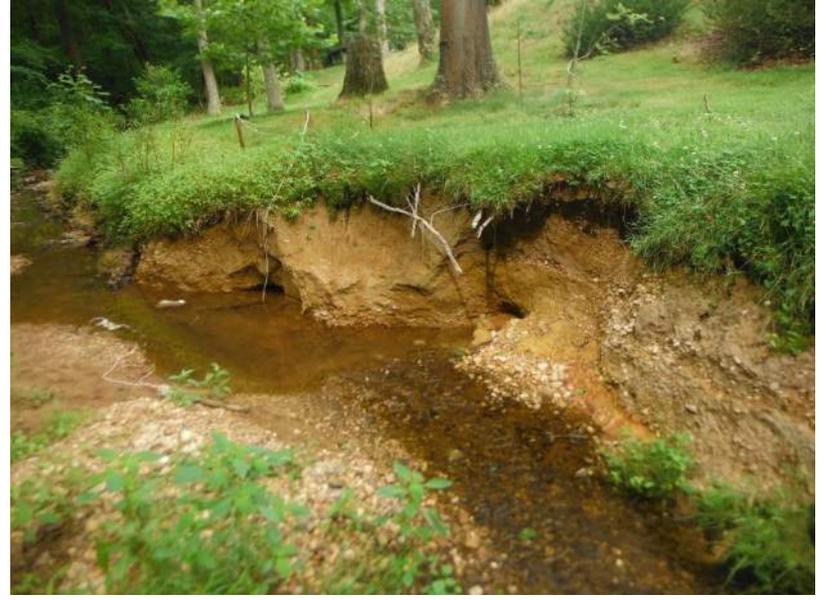
Facing right bank erosion at stations 11+40

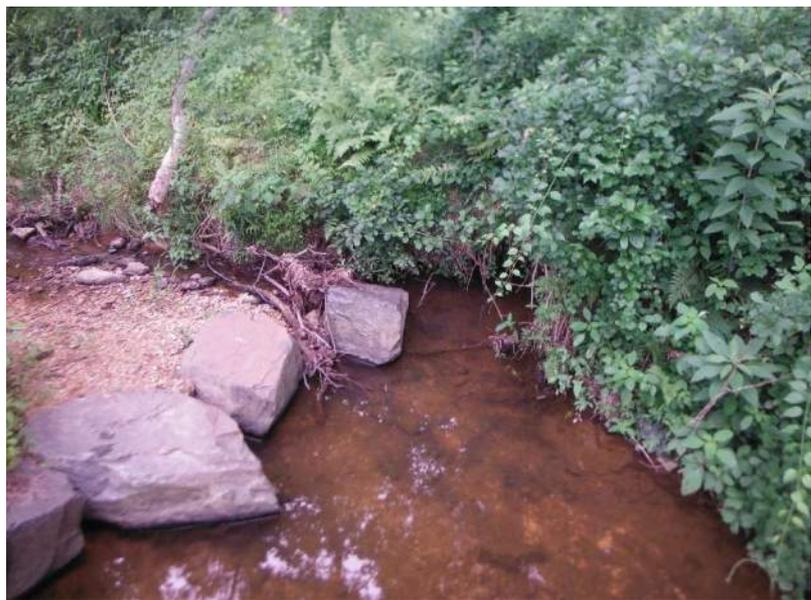
Facing right bank scour at weir from station 12+10

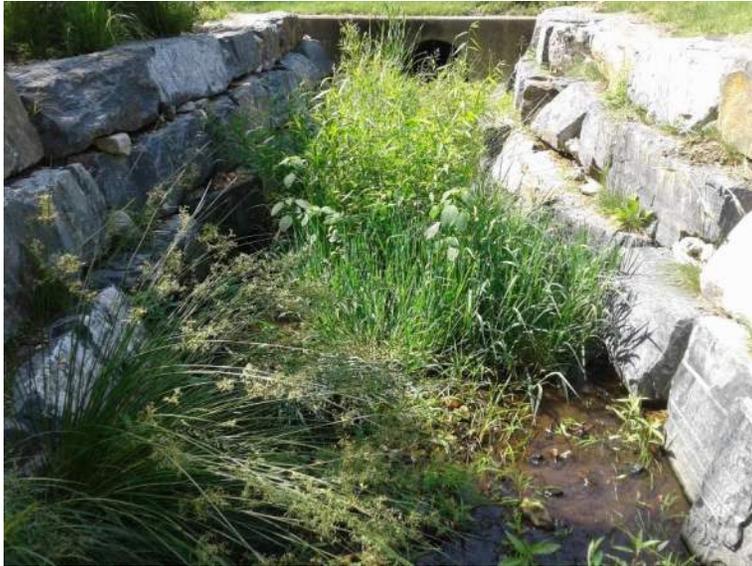
Photo 1 - Mid channel bar at station 0+50 – Minor Concern

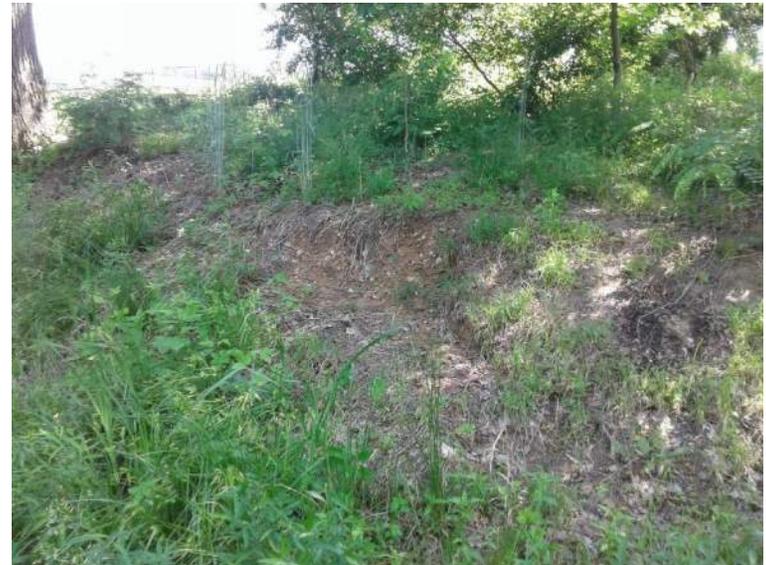
Photo 4 - Minor erosion at station 3+80 – Moderate Concern

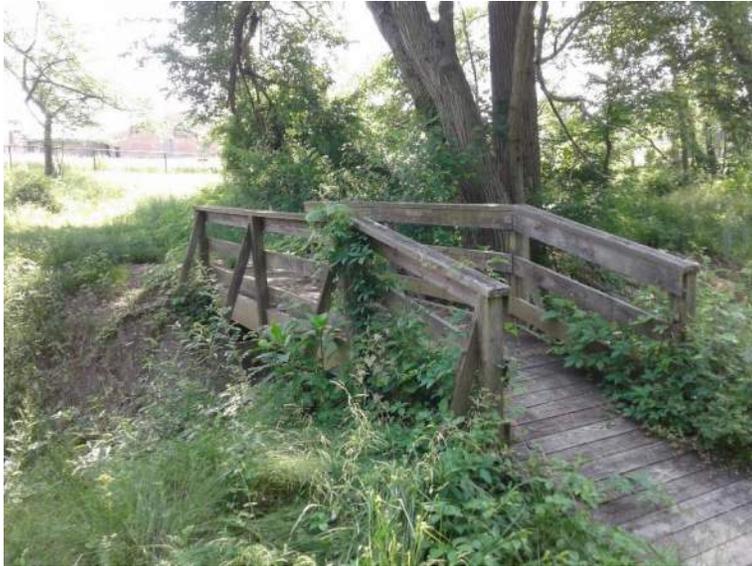
Photo 5 - Bridge to be removed per plans is not removed and covered in invasive species at station 4+30 – Moderate Concern

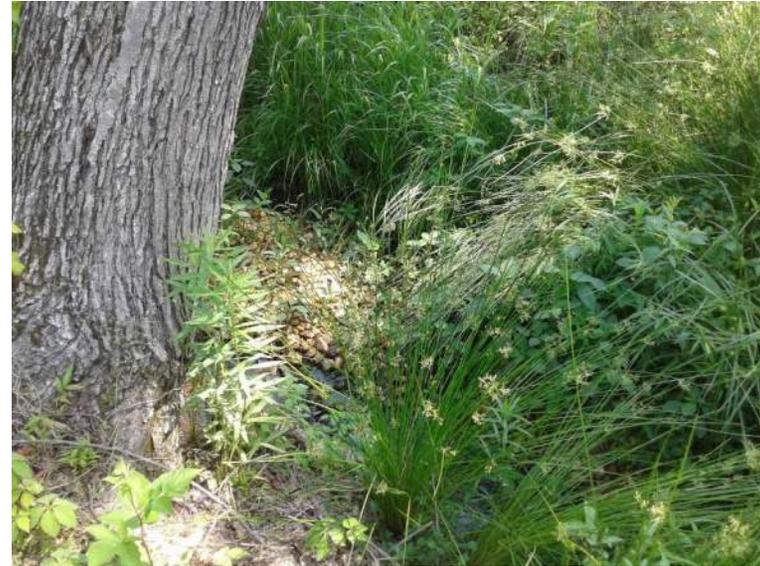
Photo 6 - Small bar forming at station 4+75 – Minor Concern

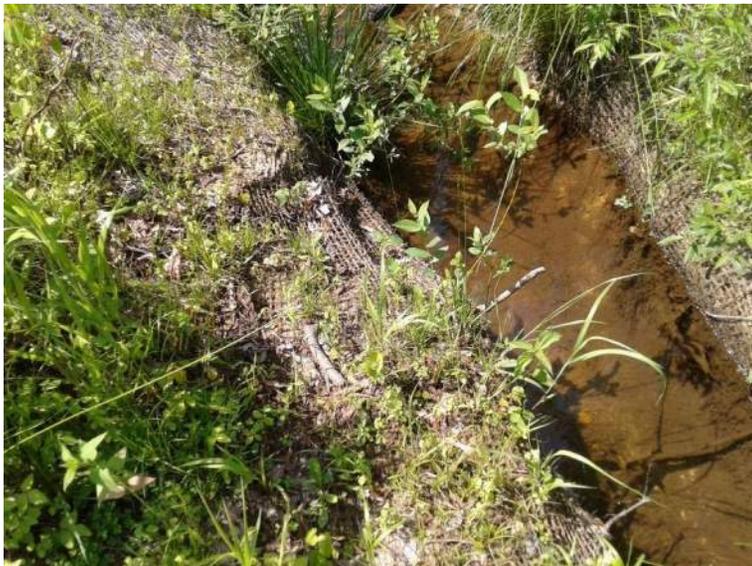
Photo 7 - Erosion under matting exposing clay layer at station 5+00 – Minor Concern

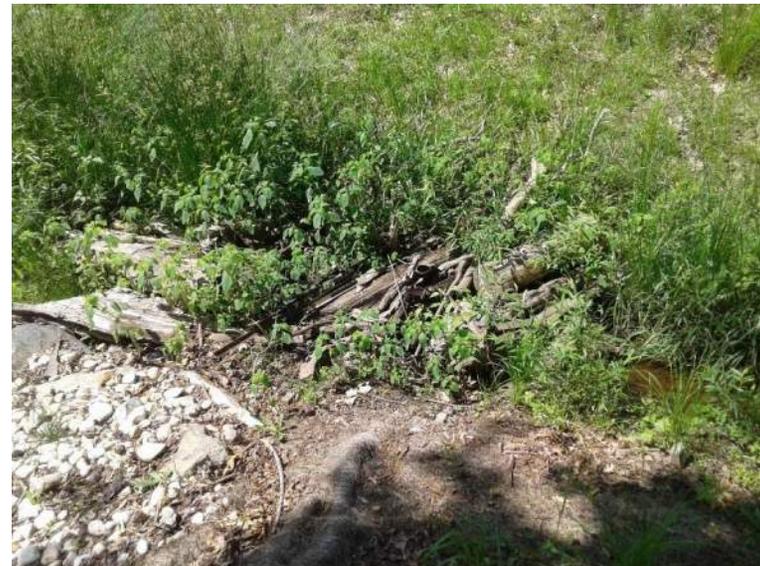
Photo 8 - Very large debris jam causing backwater at station 5+50 – Moderate Concern

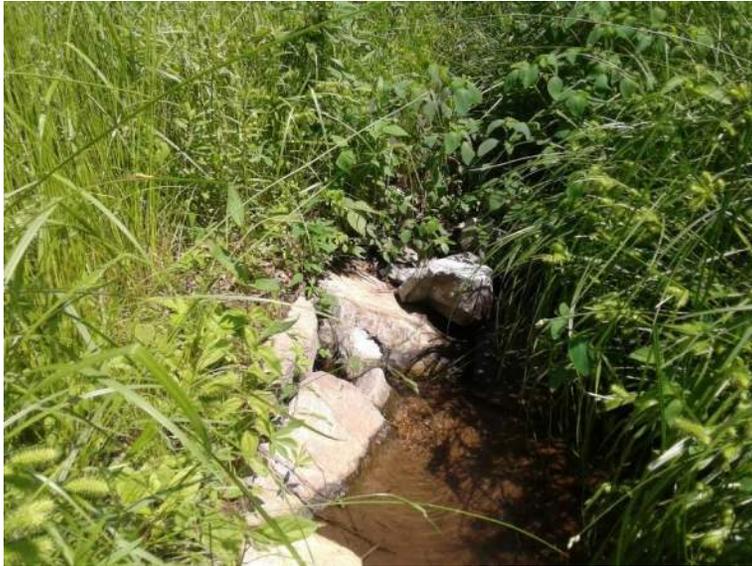
Photo 9 - Rocks piled up creating small dam at station 9+00 – Minor Concern

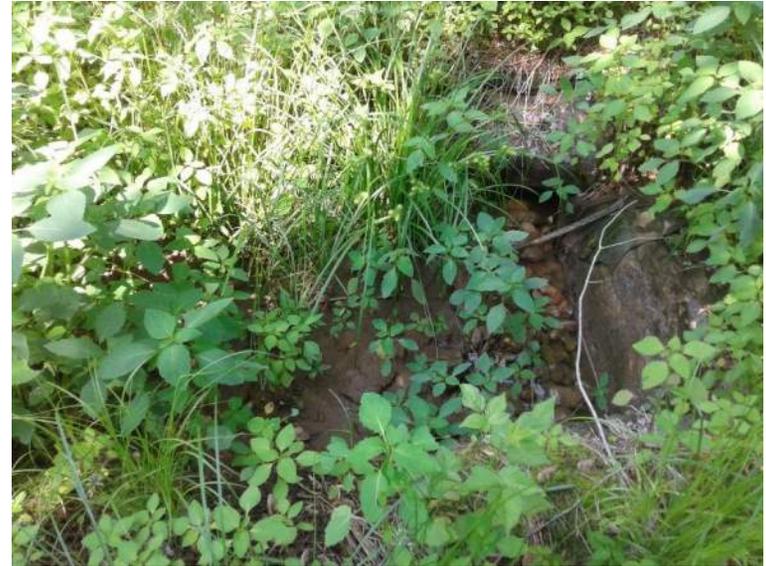
Photo 10 - Subsurface flow at station 10+25 – Minor Concern

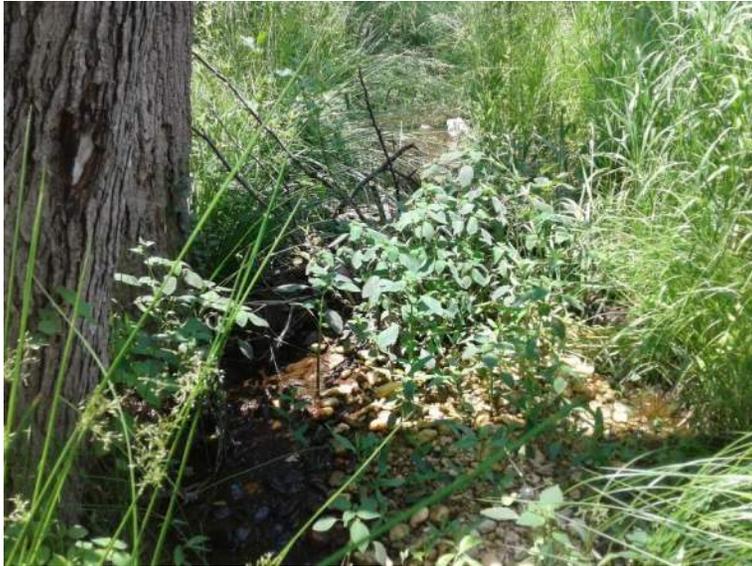
Photo 17 - Riffle crest at station 4+70 with small bar forming

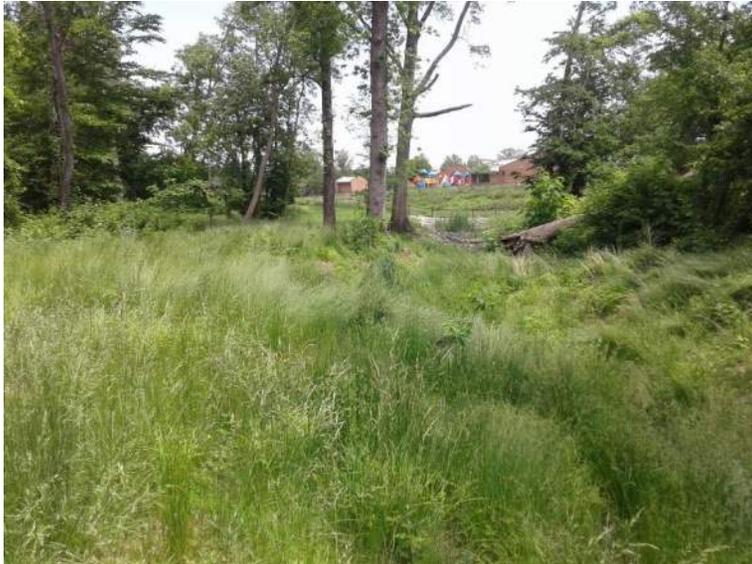
Photo 1 – Representative - Ground cover has improved from As Built Monitoring

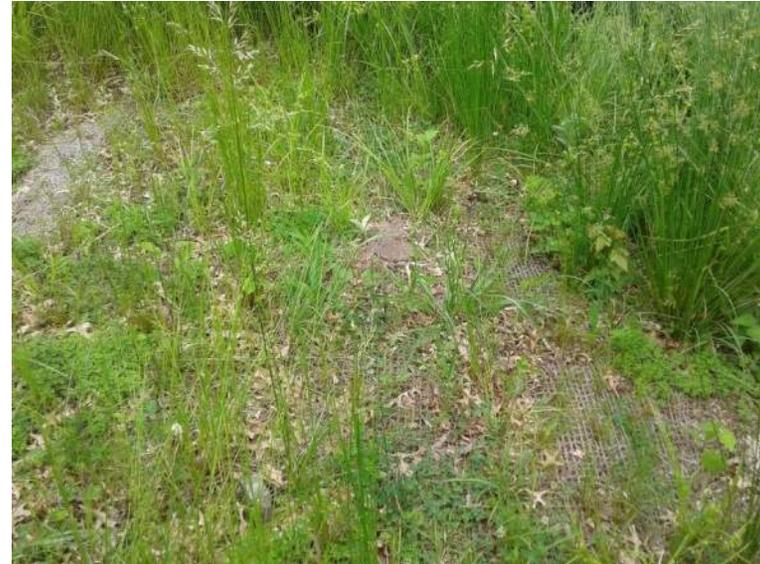
Photo 2 - Bare spot

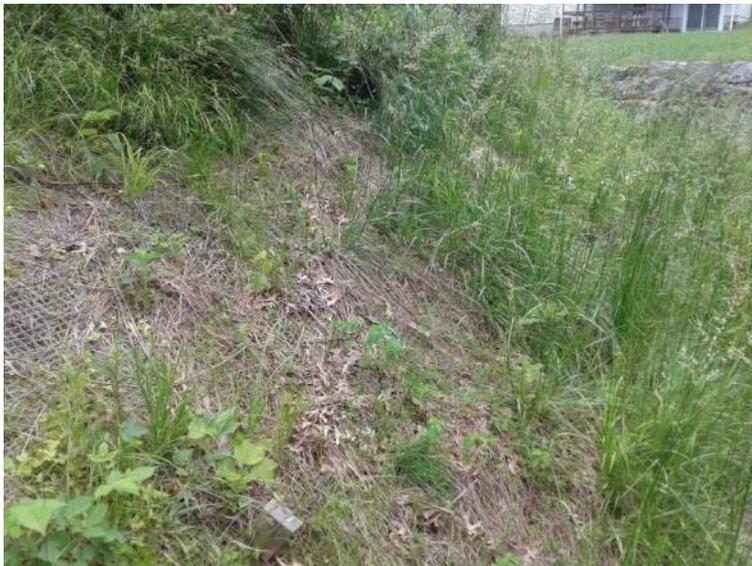
Photo 3 - Bare spot

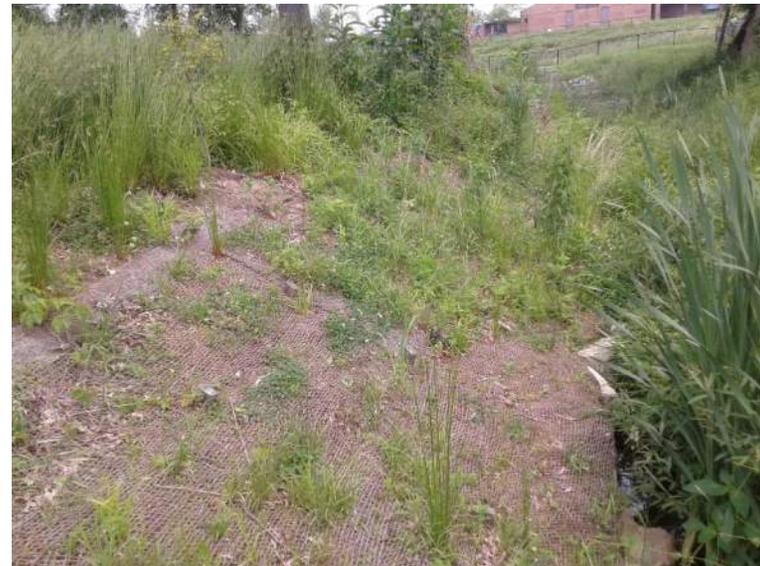
Photo 4 - Bare spot – Most bare spots are located at the downstream extents of the project

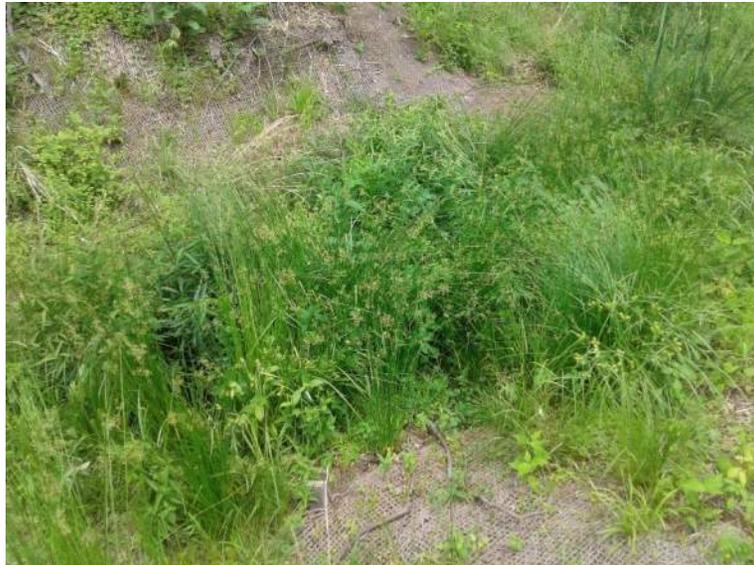
Photo 5 - Bare spots

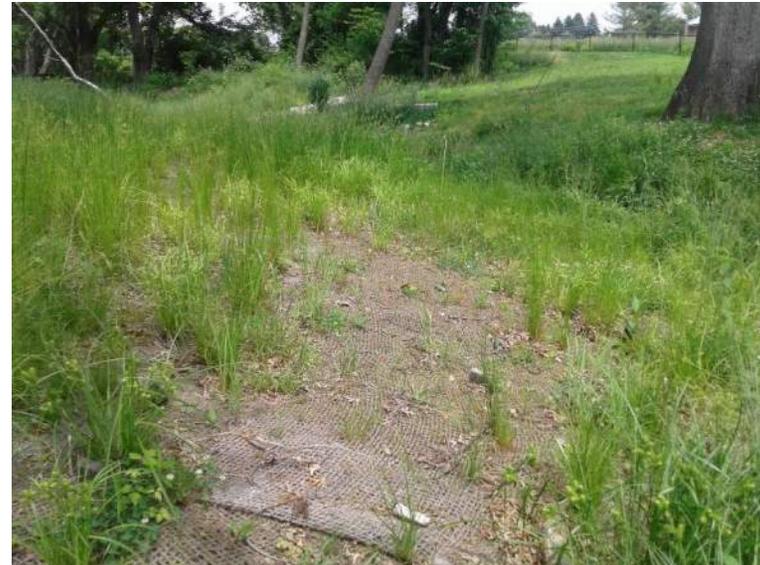
Photo 6 - Bare spot

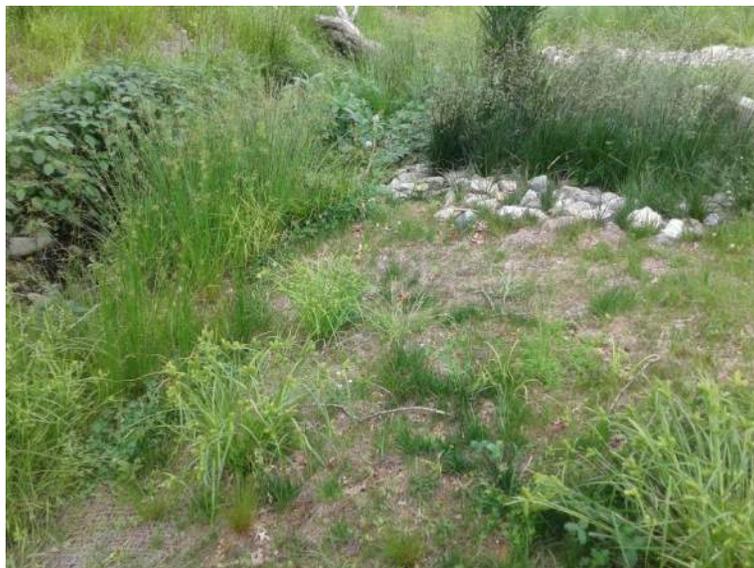
Photo 7 - Bare spots

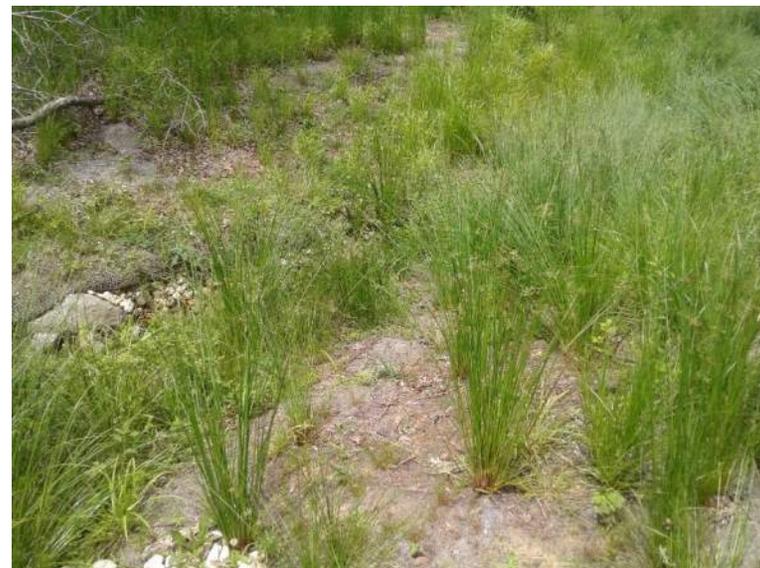
Photo 8 - Bare spot

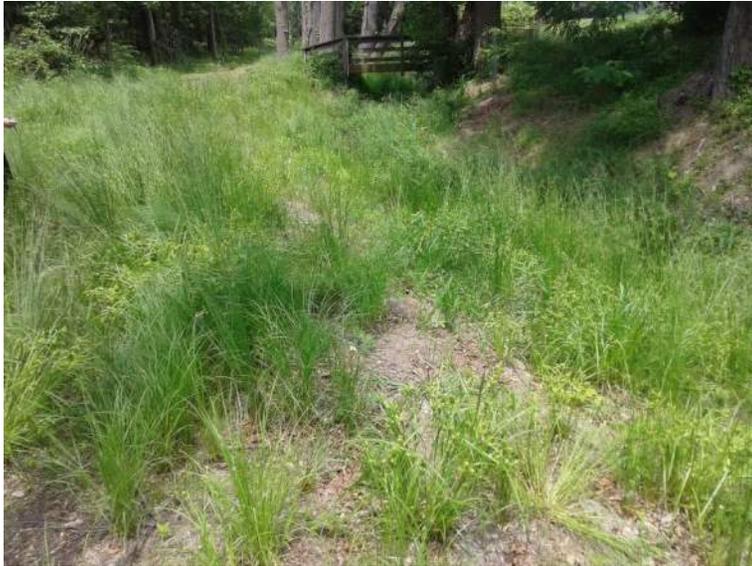
Photo 9 - Bare spots

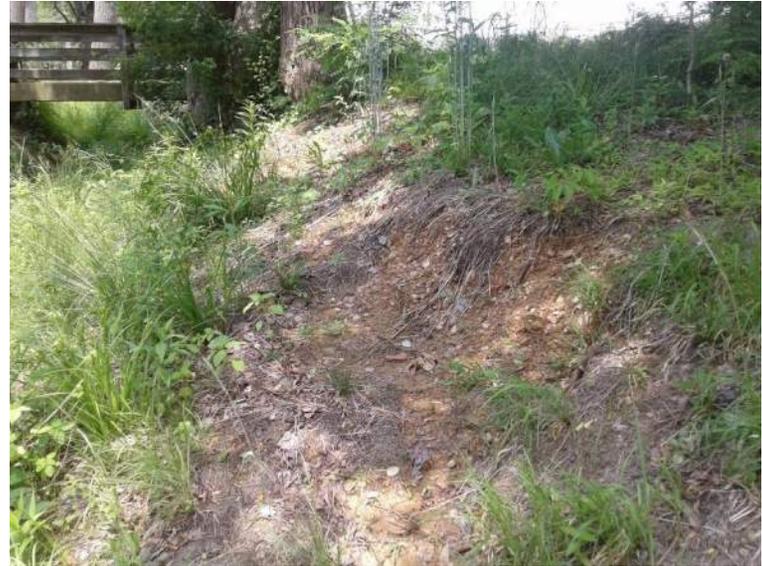
Photo 10 - Bare spots with minor erosion

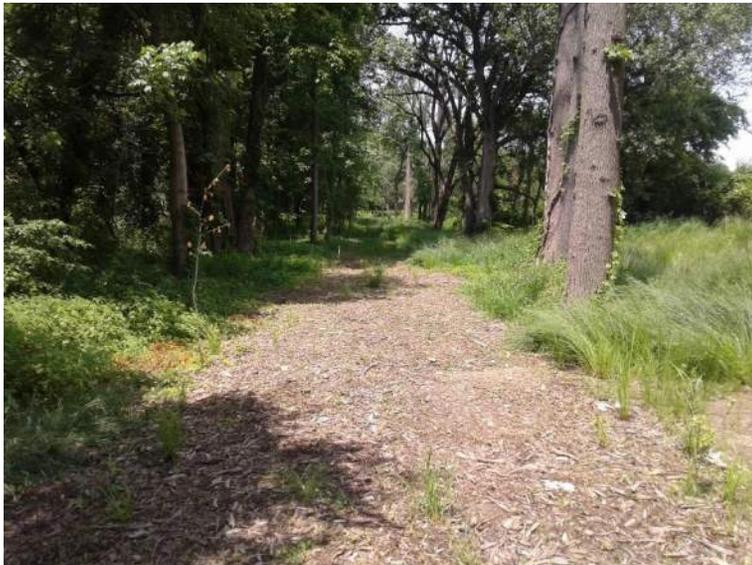
Photo 11 - Bare spot extending through most of right bank where the access road was located

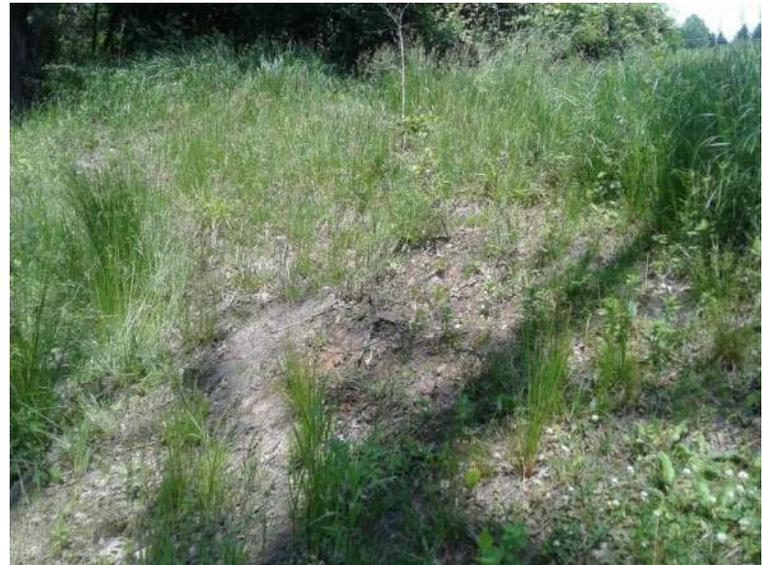
Photo 12 - Bare spot

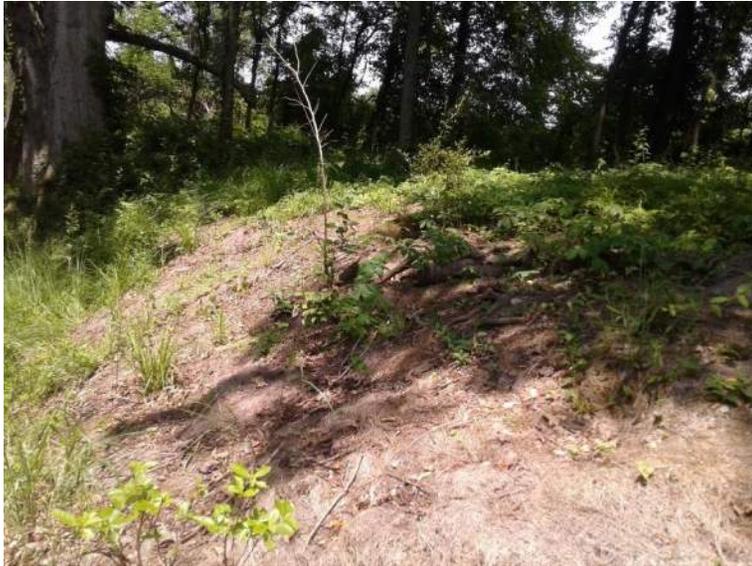
Photo 13 - Bare spot and dying planted trees

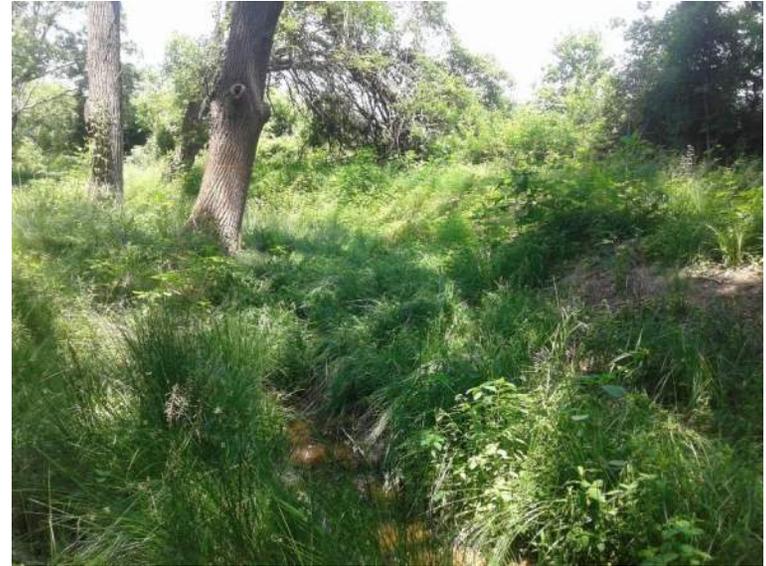
Photo 14 – Representative ground cover and healthy existing trees

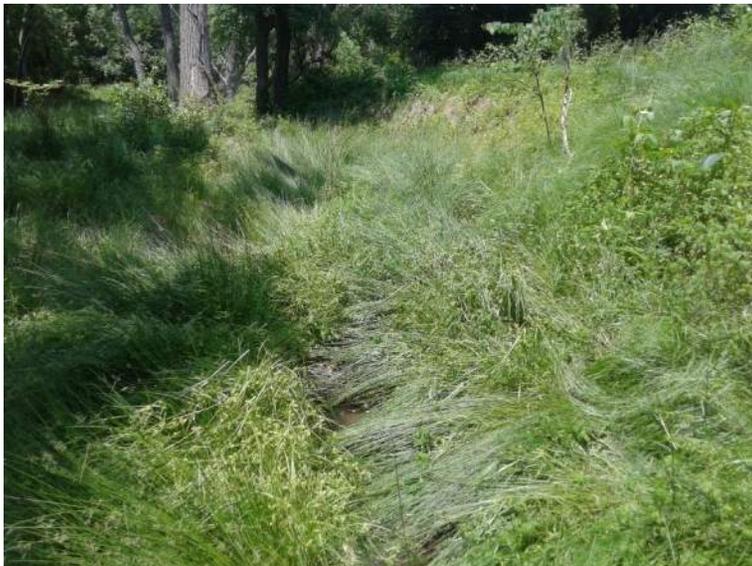
Photo 15 - Representative ground cover with healthy planted trees

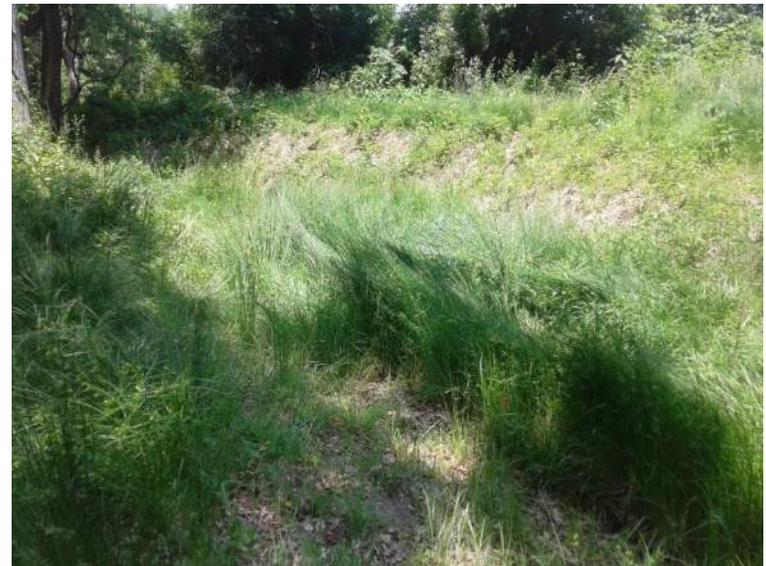
Photo 16 – Small bare spots

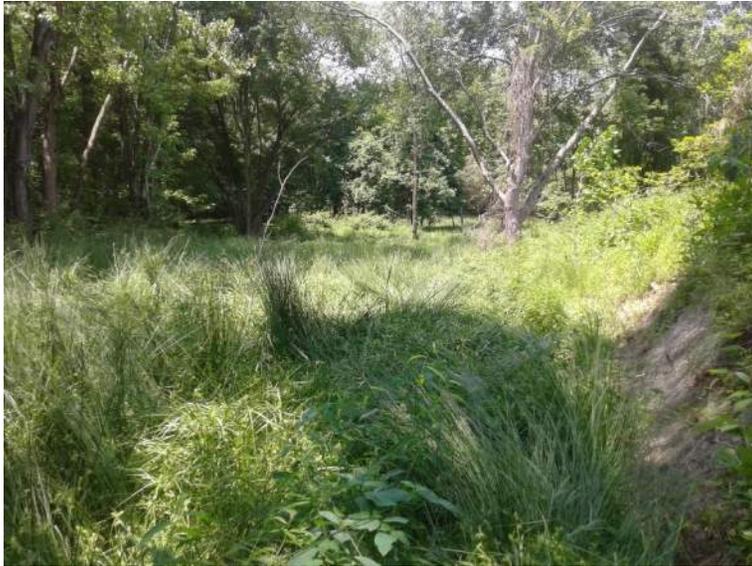
Photo 17- Representative - Good ground cover but some planted trees are dying in the photographed area

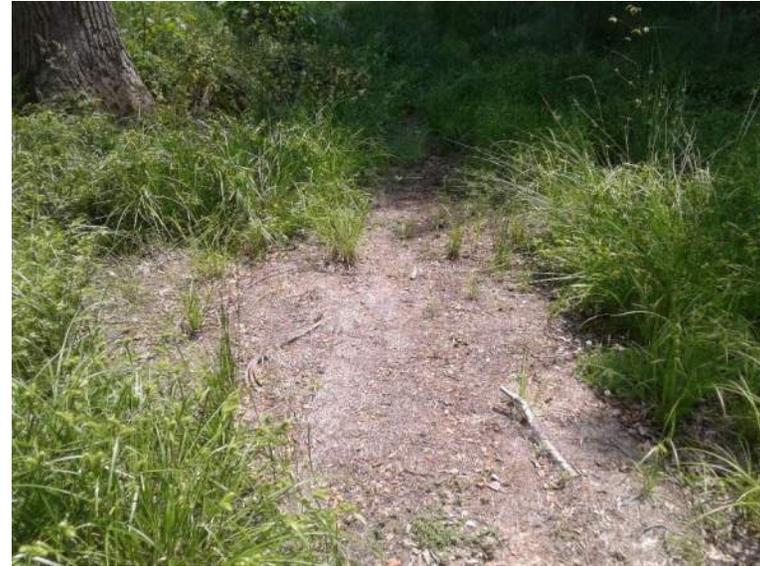
Photo 18 - Bare spot

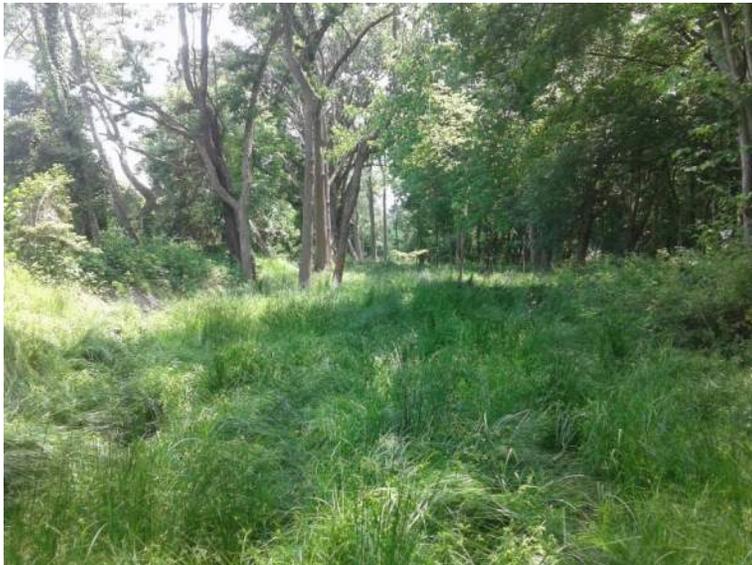
Photo 19 – Representative – Good ground cover with healthy existing and planted trees towards upstream extents of project
