Appendix E2. a – Restoration Plans and TMDLs (Impervious Area Assessment)

Impervious Area Assessment

Harford County, MD Department of Public Works
 Watershed Protection and Restoration
 Watershed Restoration Status (MS4 Permit 11-DP-3310)

Stormwater and stream restoration - inspections FY2020

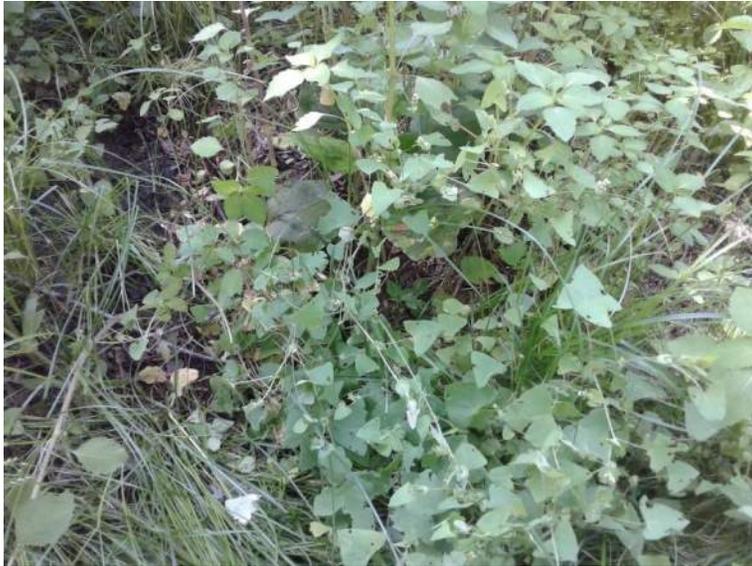
Photo 1 - Mile a minute

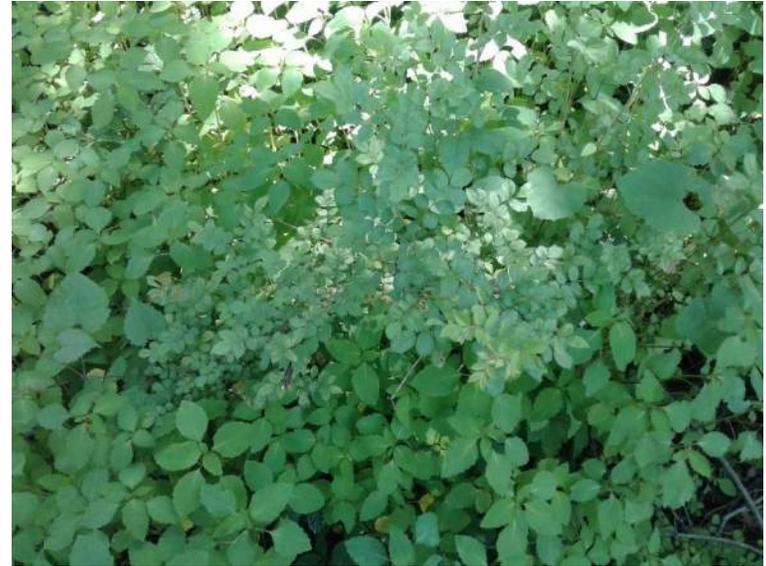
Photo 2 - Multiflora rose

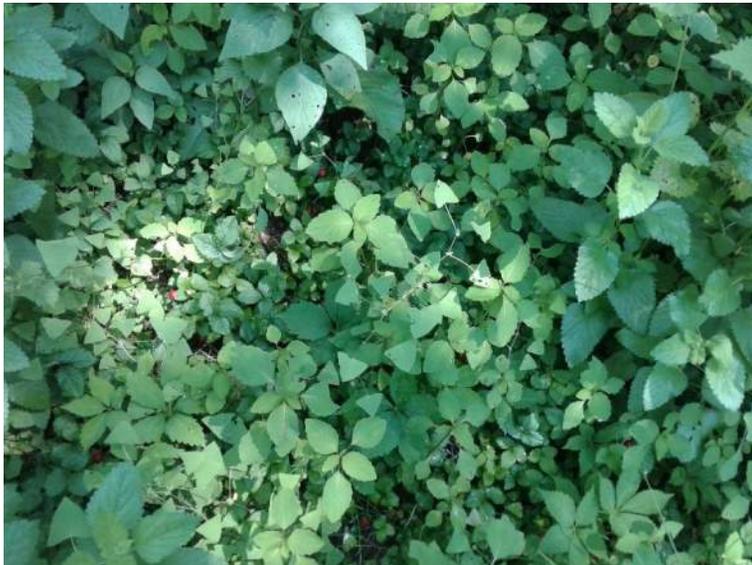
Photo 3 - Mile a minute

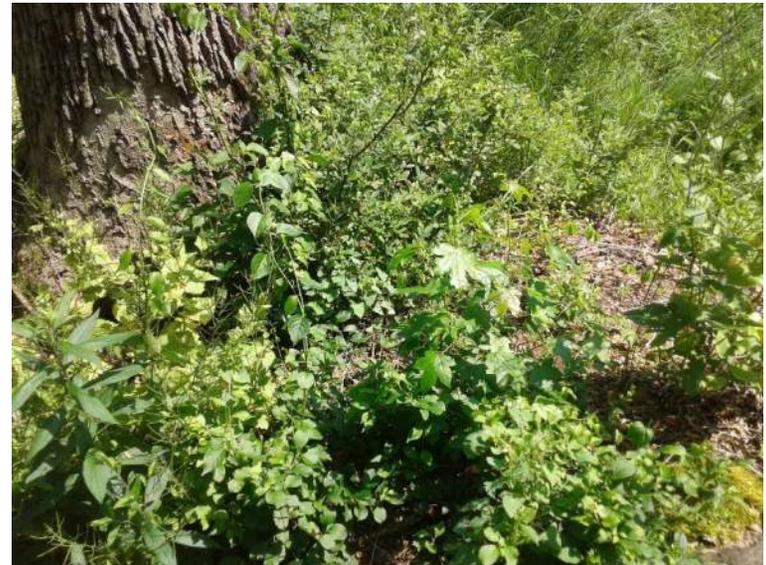
Photo 4 - Multiflora rose and mile a minute

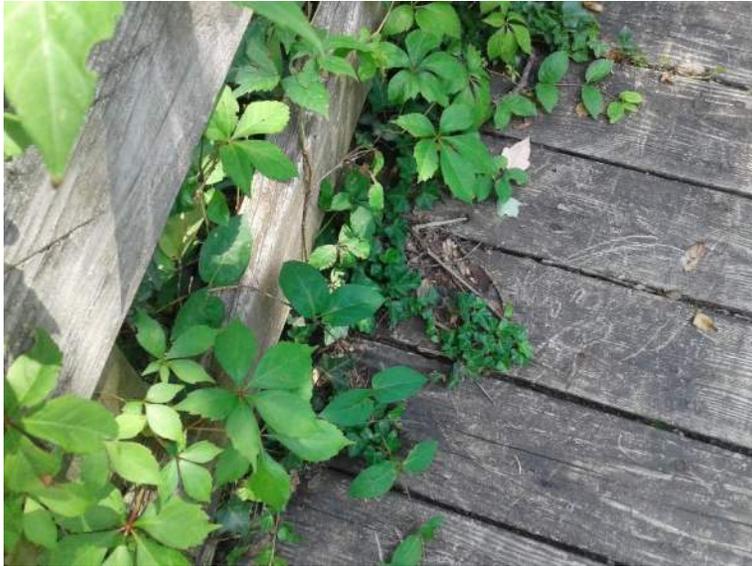
Photo 5 - English Ivy on existing footbridge that should be removed per plans

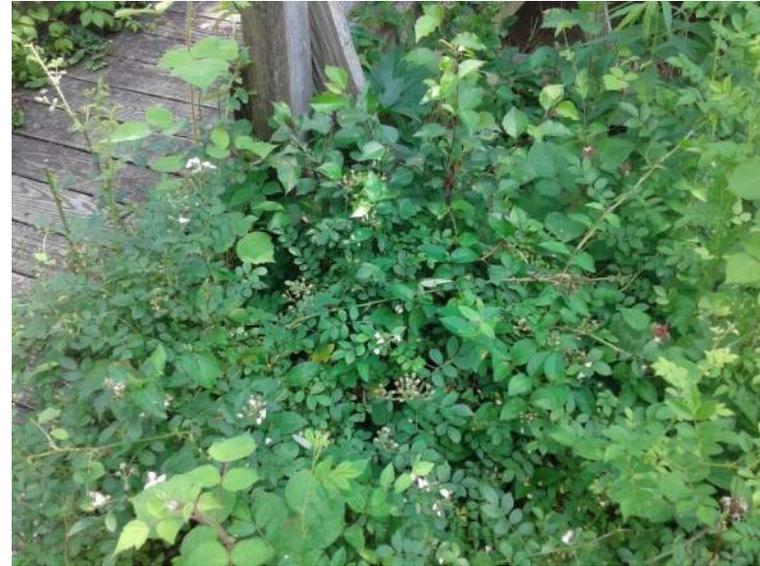
Photo 6 - Multiflora rose next to existing footbridge

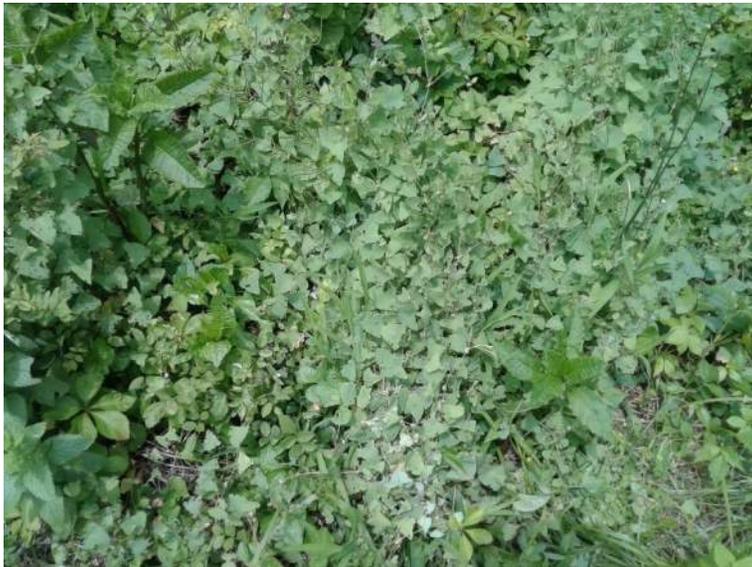
Photo 7 - Mile a minute

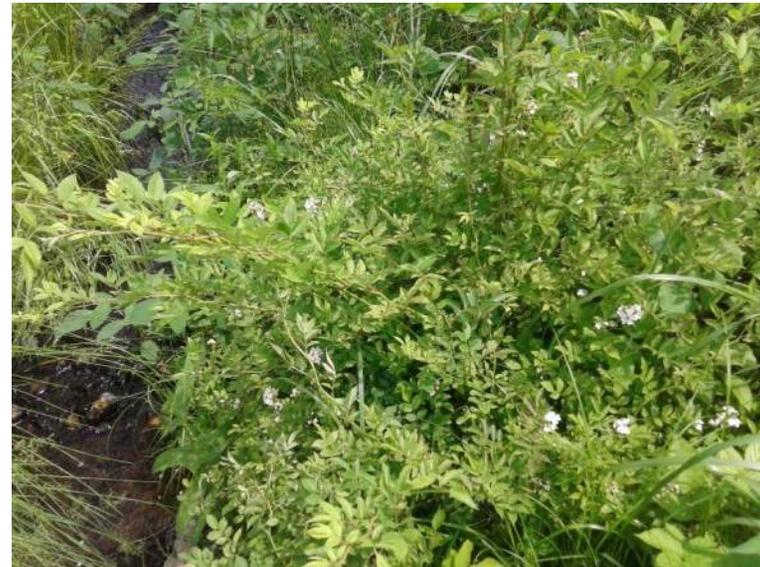
Photo 8 - Multiflora rose

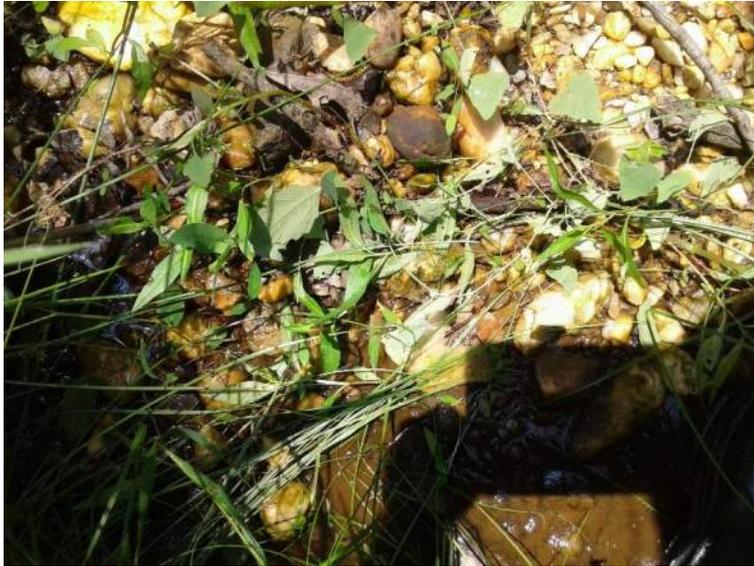
Photo 9 - Mile a minute near and in the stream channel

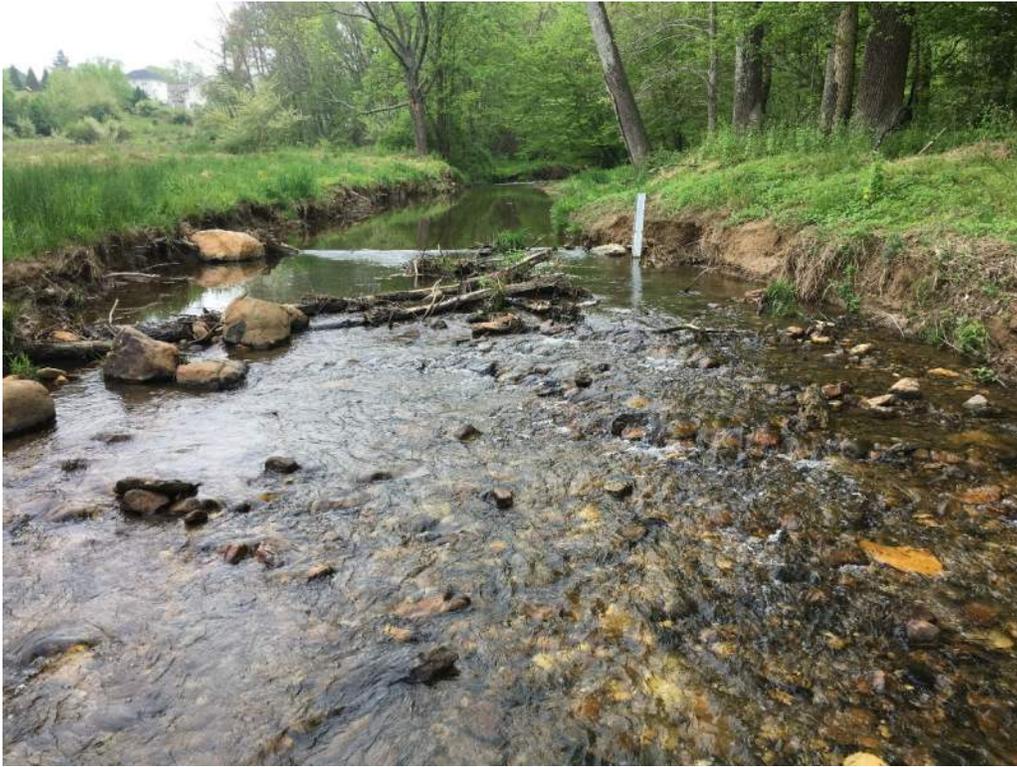
Photo 1: View of riffle crest at station 1+38.

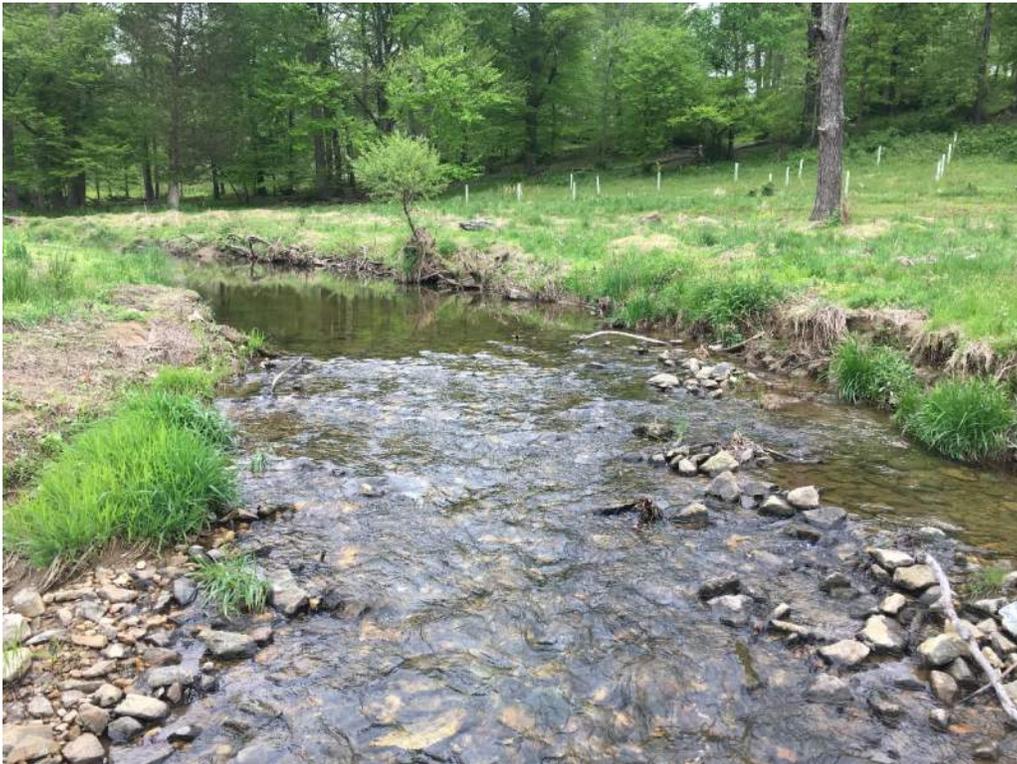
Photo 2: View of riffle crest at station 3+19.

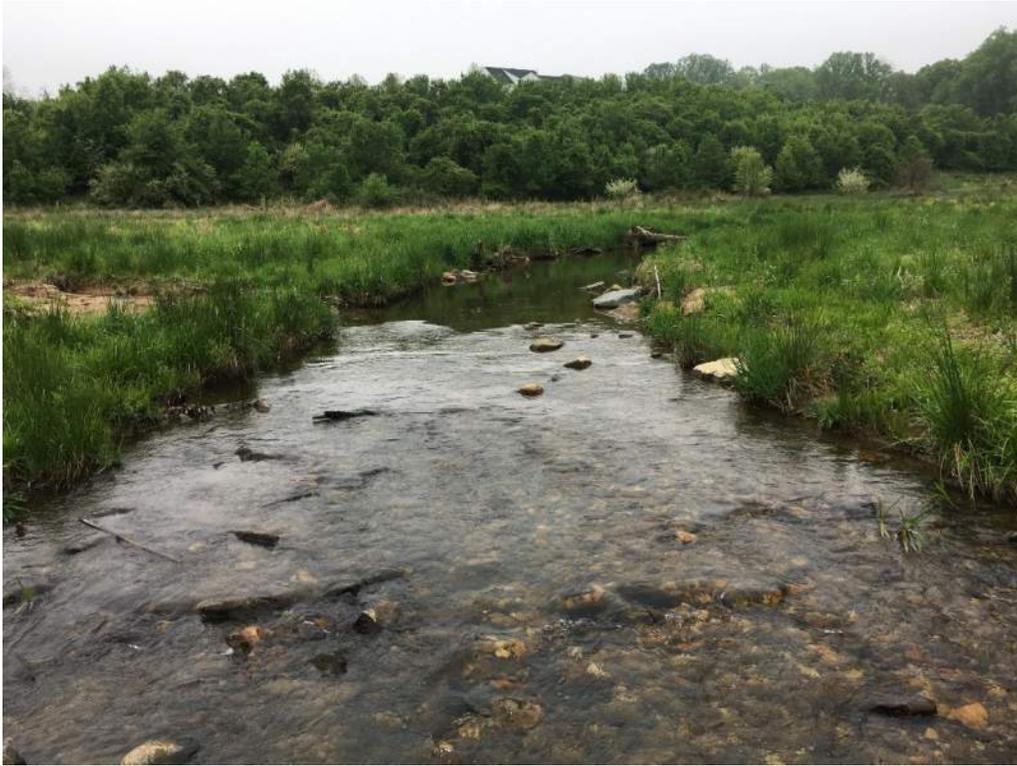
Photo 3: View of riffle crest at station 6+34.

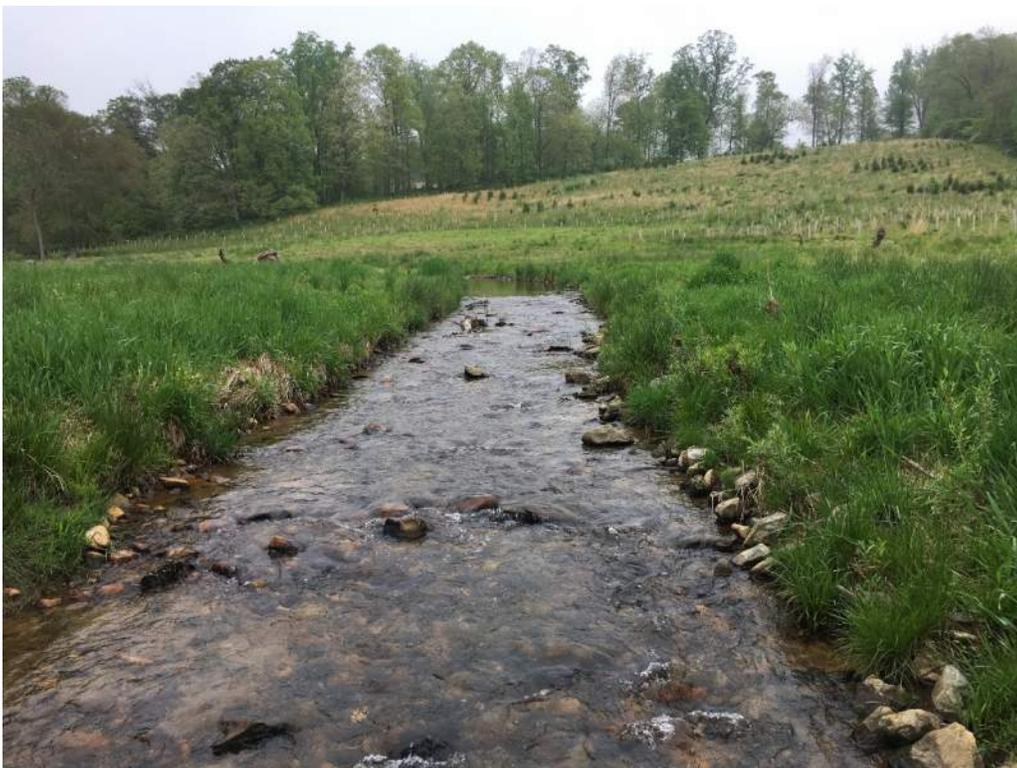
Photo 4: View of riffle crest at station 9+35.

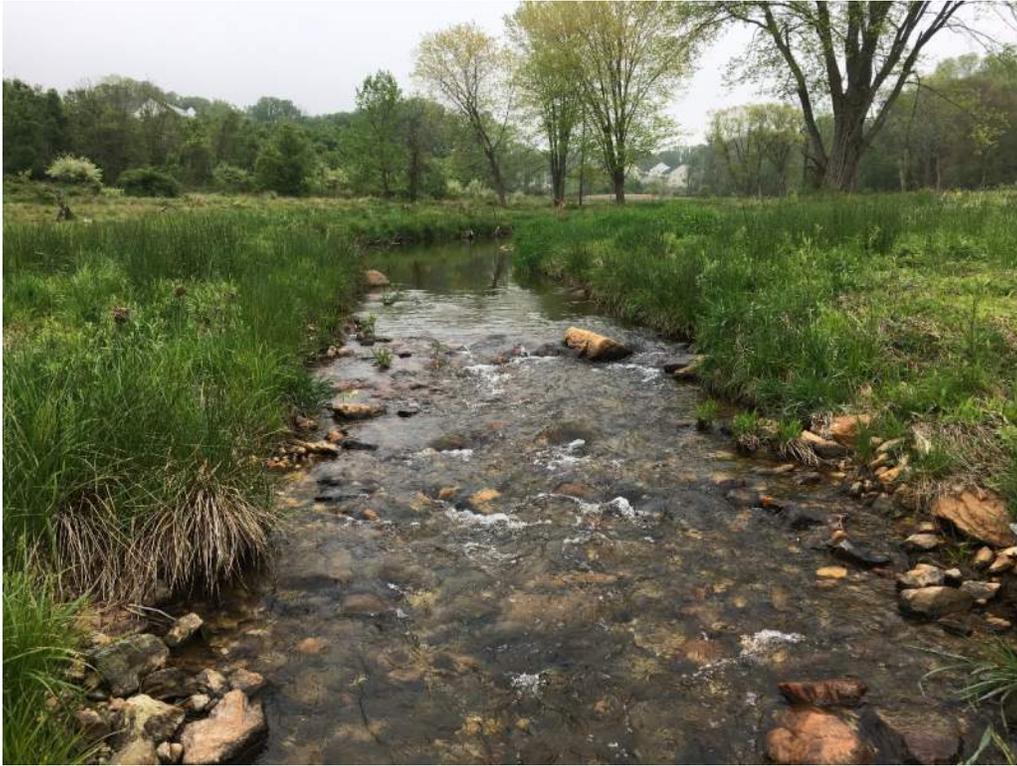
Photo 5: View of riffle crest at station 11+60.

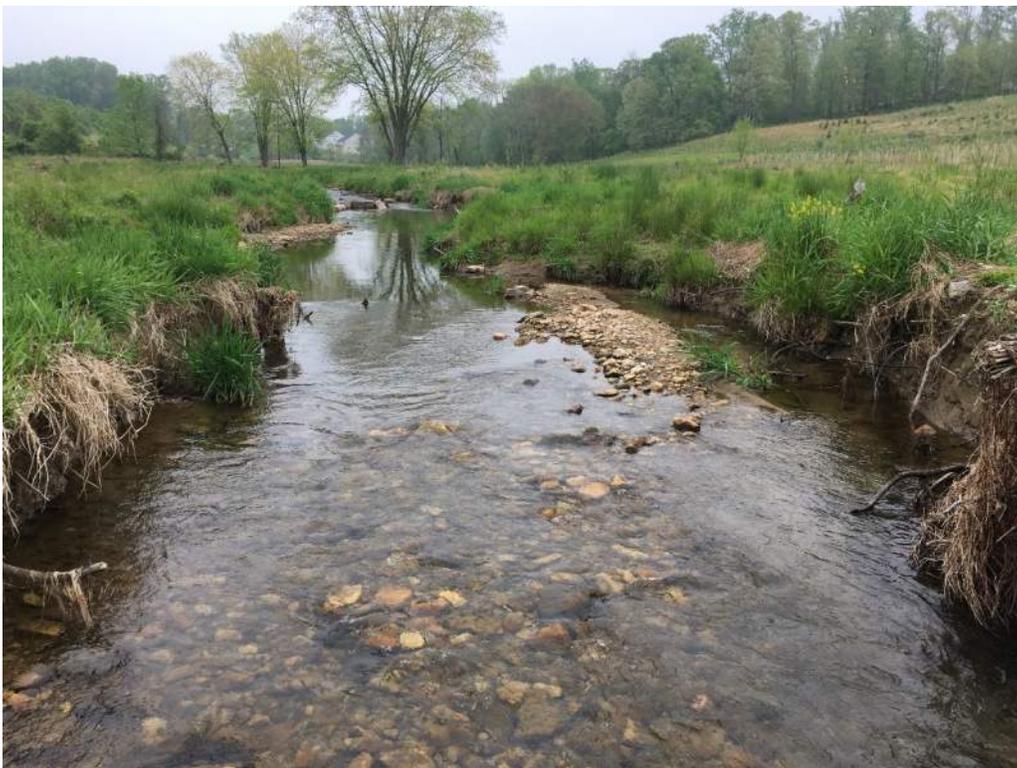
Photo 6: View of riffle crest at station 13+24.

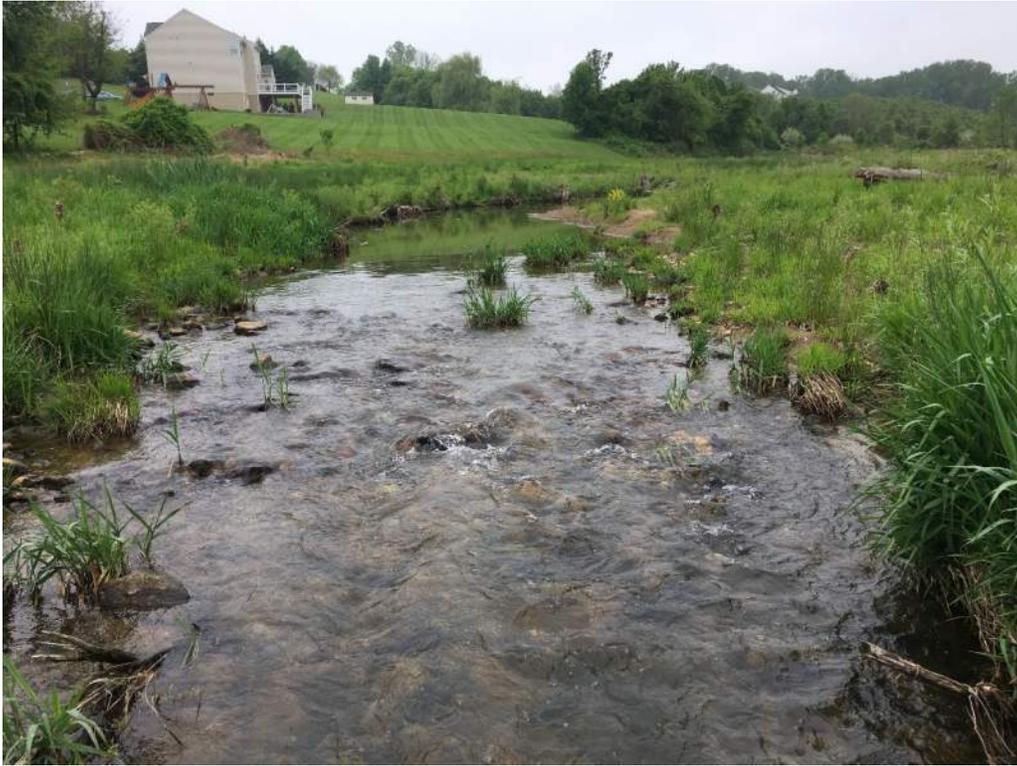
Photo 7: View of riffle crest at station 15+40.

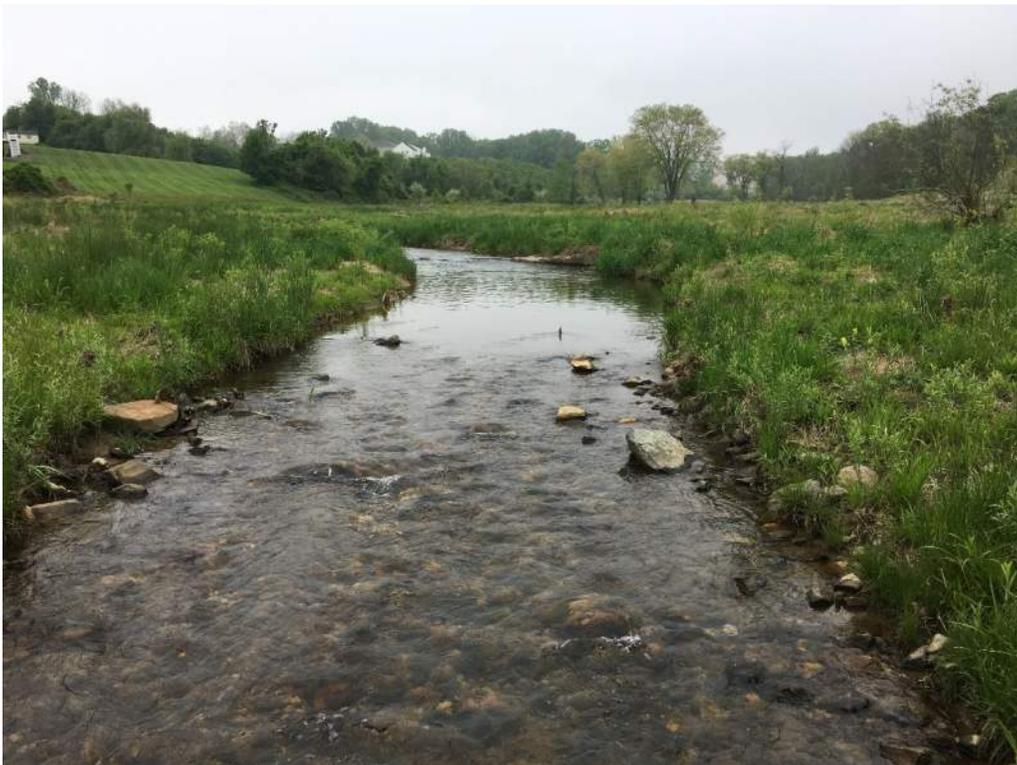
Photo 8: View of riffle crest at station 16+94.

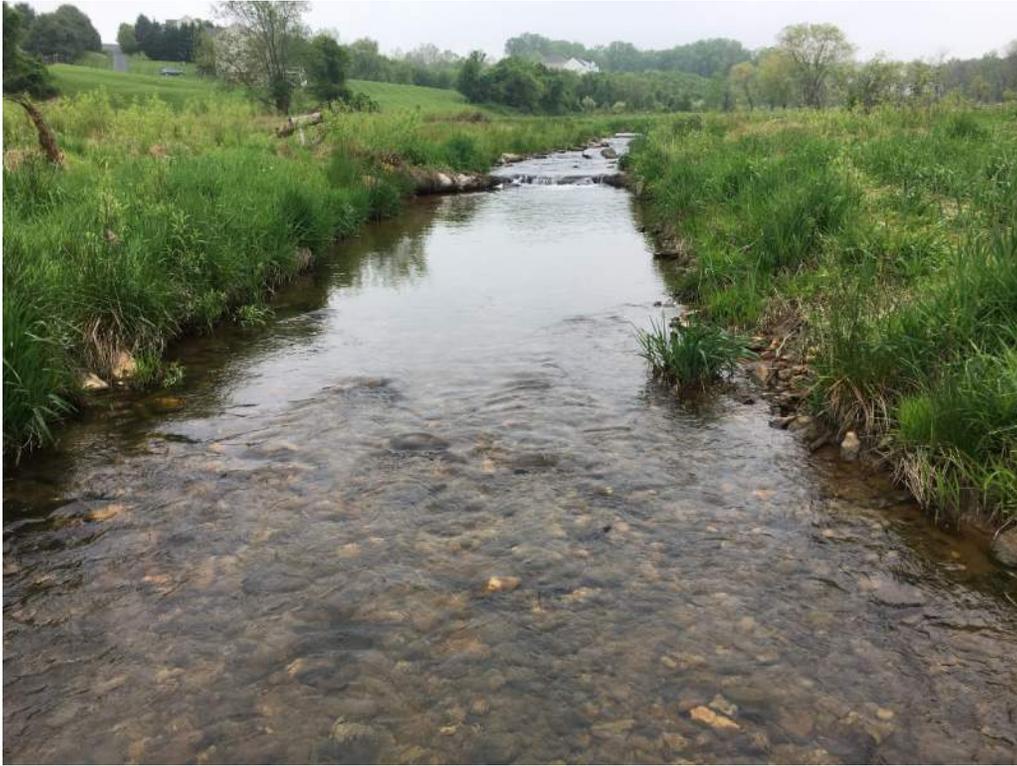
Photo 9: View of riffle crest at station 18+56.

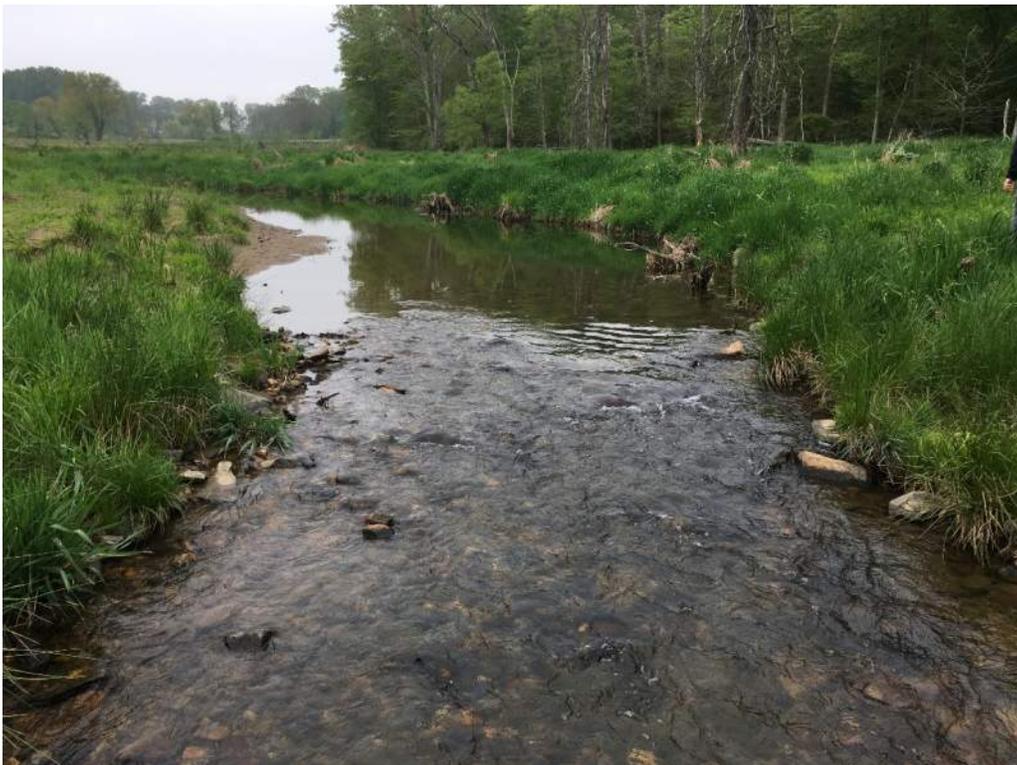
Photo 10: View of riffle crest at station 20+77.

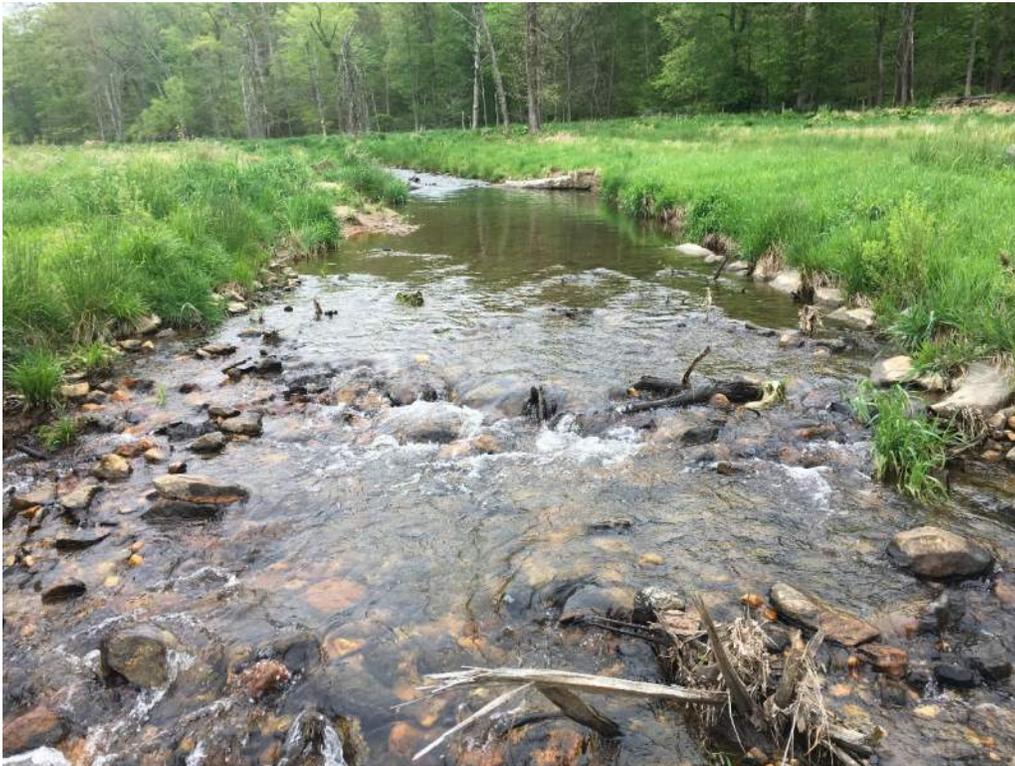
Photo 11: View of riffle crest at station 22+12.

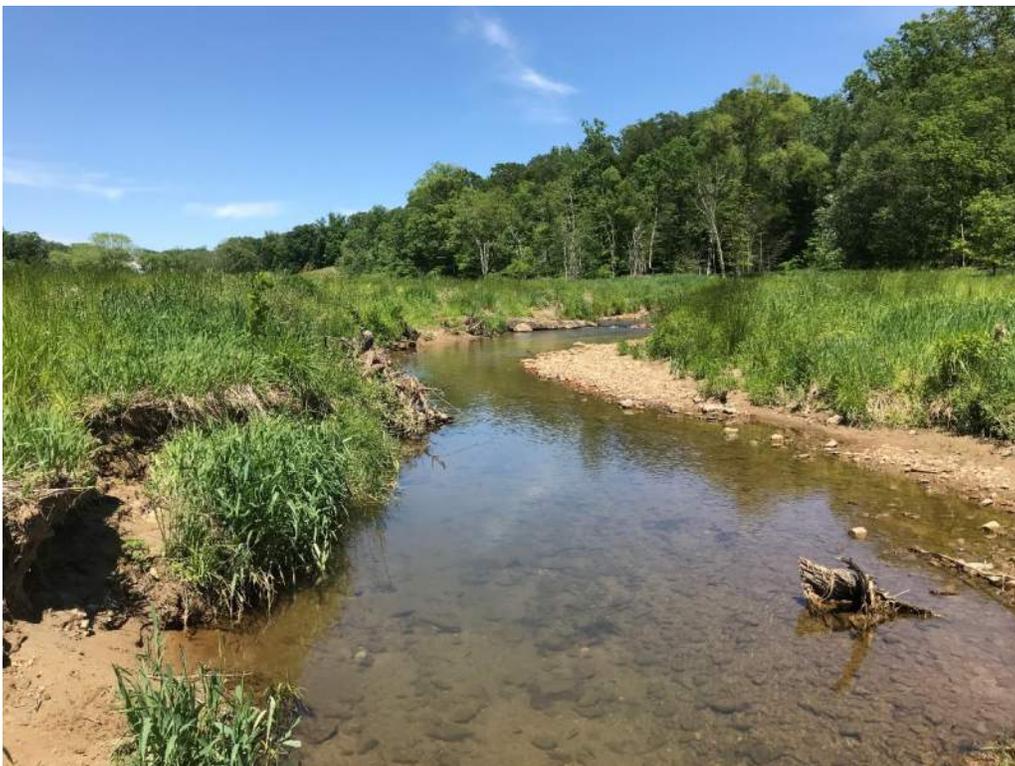
Photo 12: View of riffle crest at station 23+43.

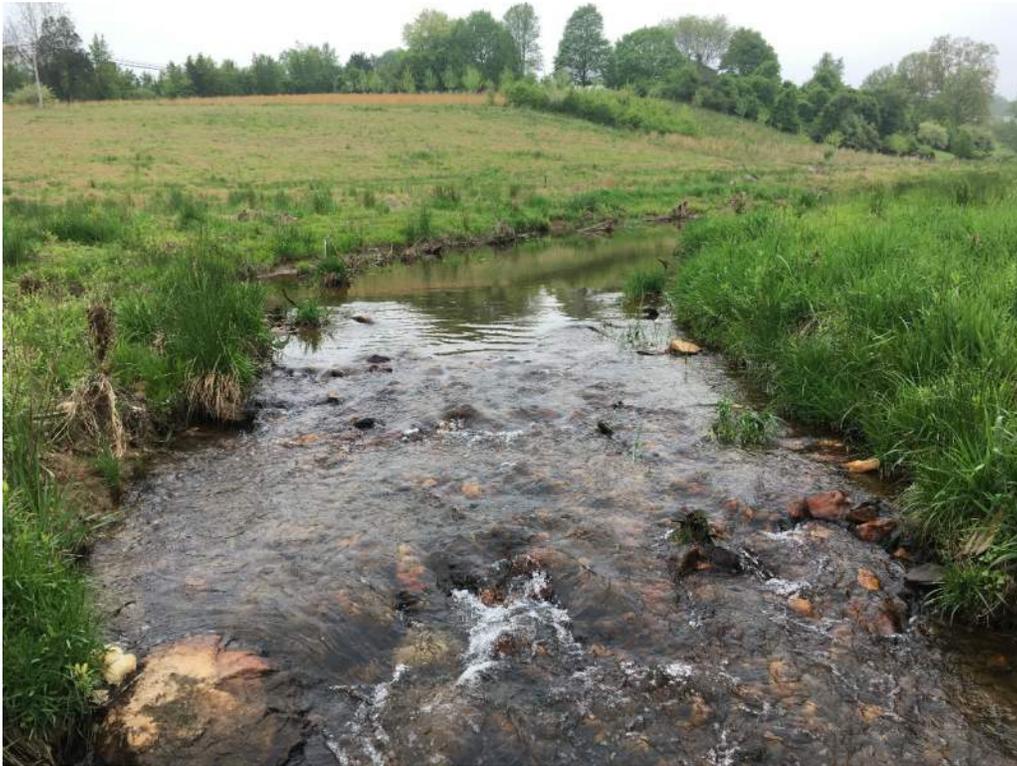
Photo 13: View of riffle crest at station 25+05.

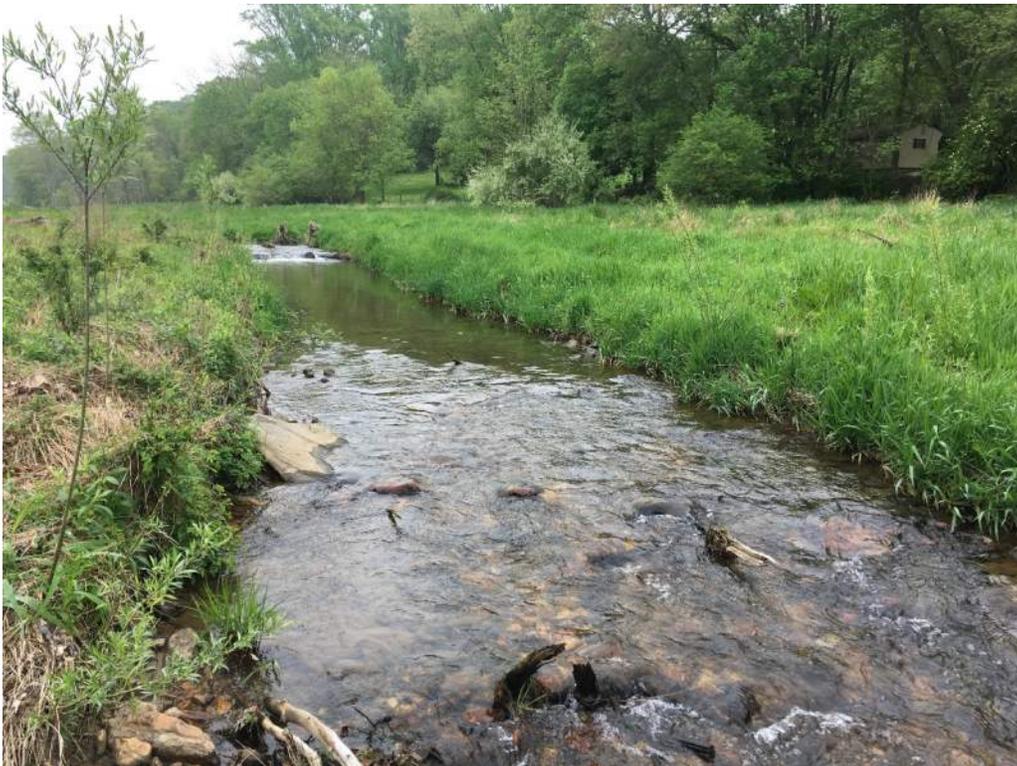
Photo 14: View of riffle crest at station 27+38.

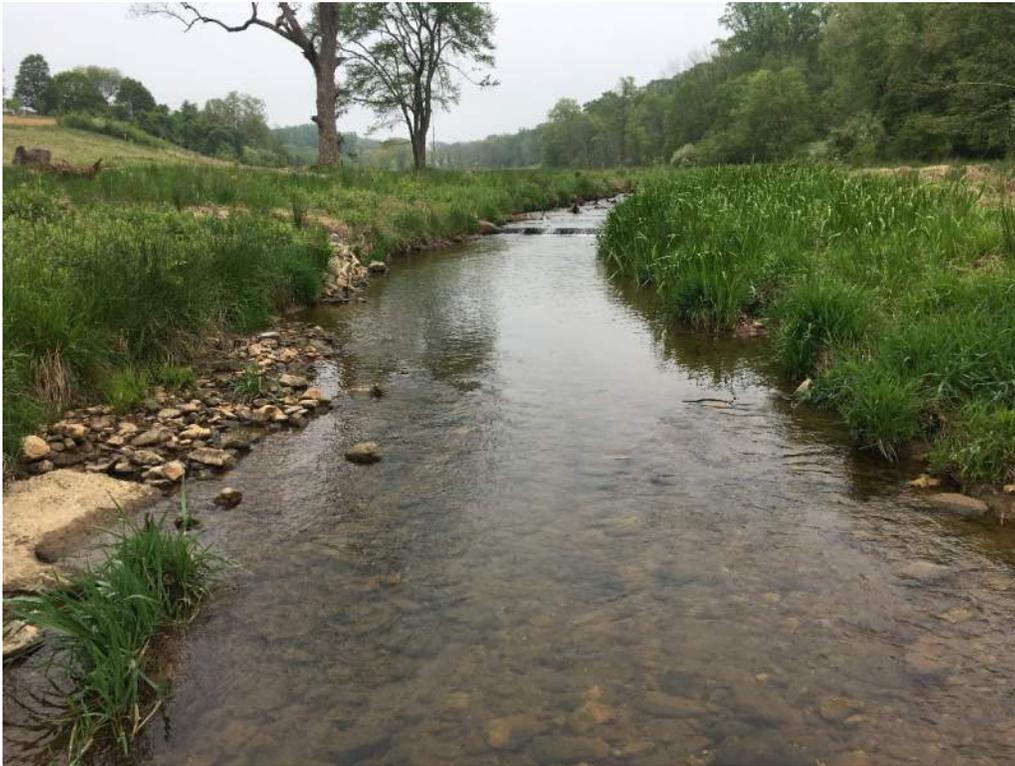
Photo 15: View of riffle crest at station 29+10.

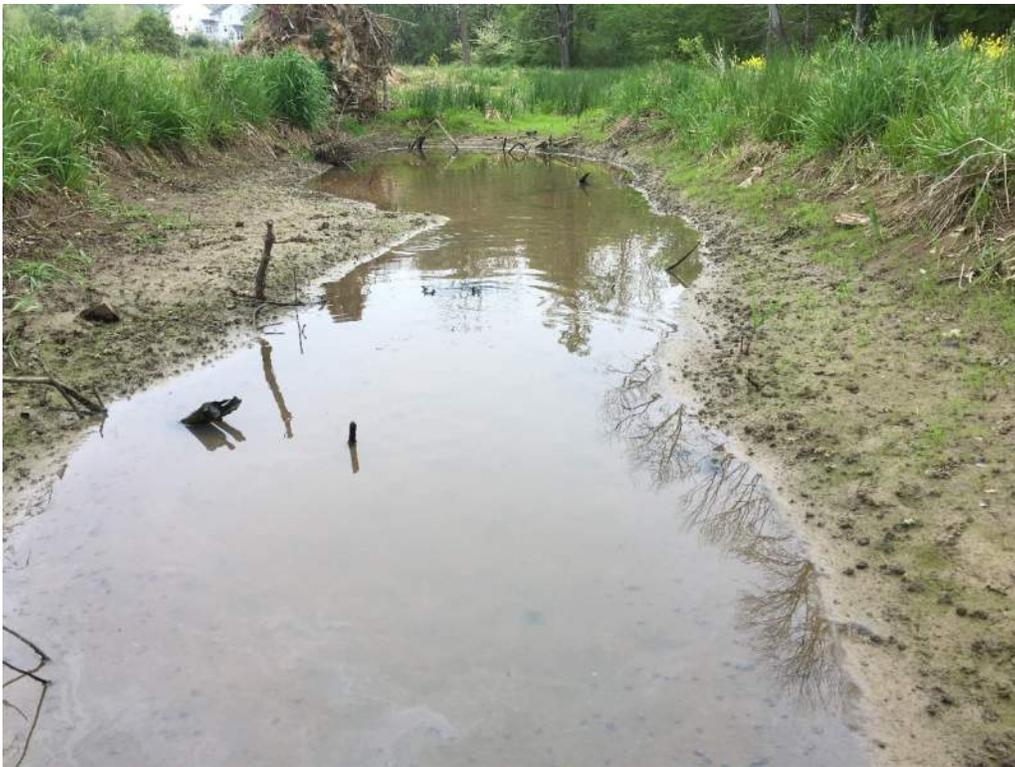
Photo 16: View of oxbow wetland adjacent to approximate stations 1+50-3+00.

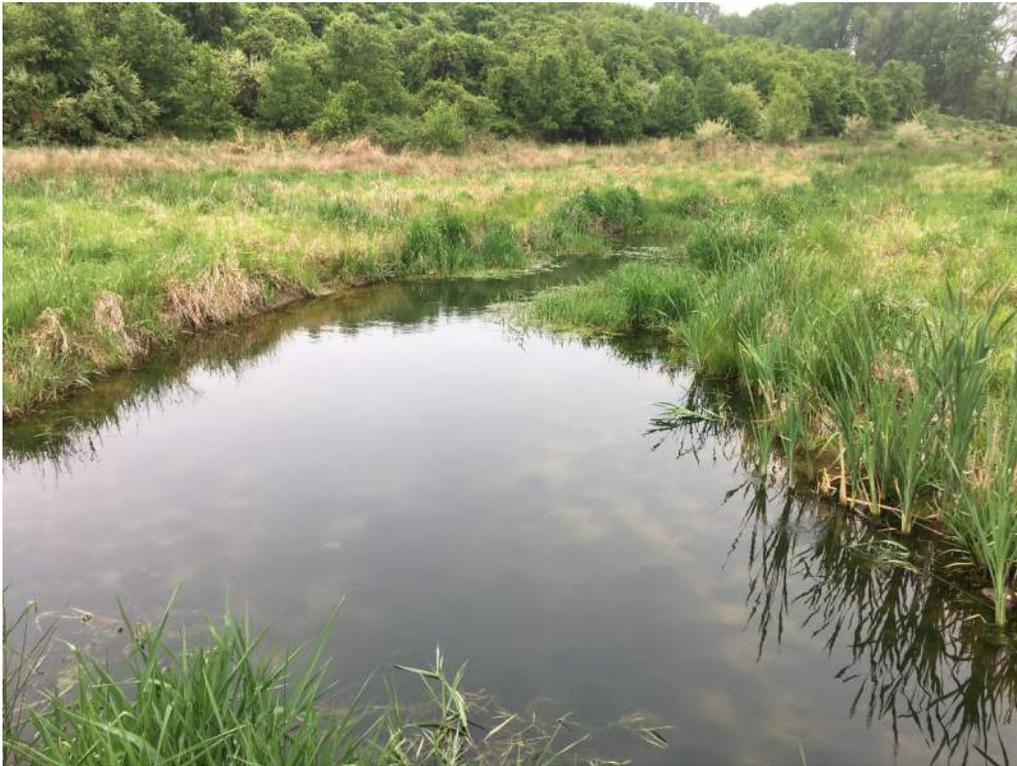
Photo 17: View of oxbow wetland adjacent to approximate stations 5+25-6+25.

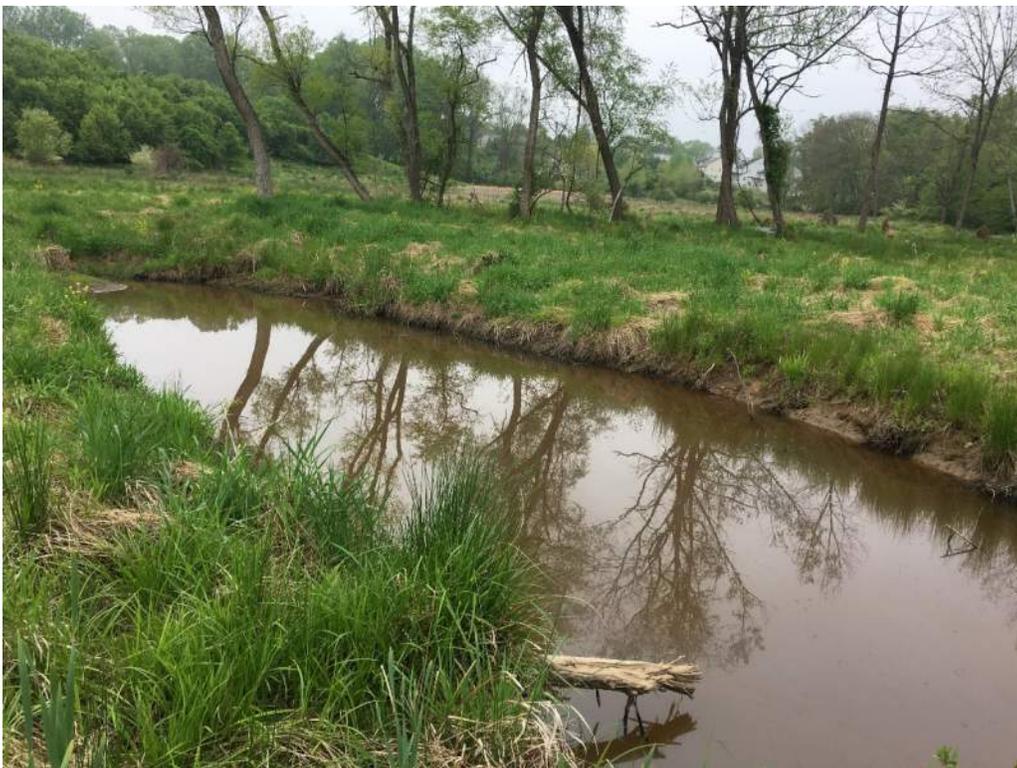
Photo 18: View of oxbow wetland adjacent to approximate stations 6+25-7+00.

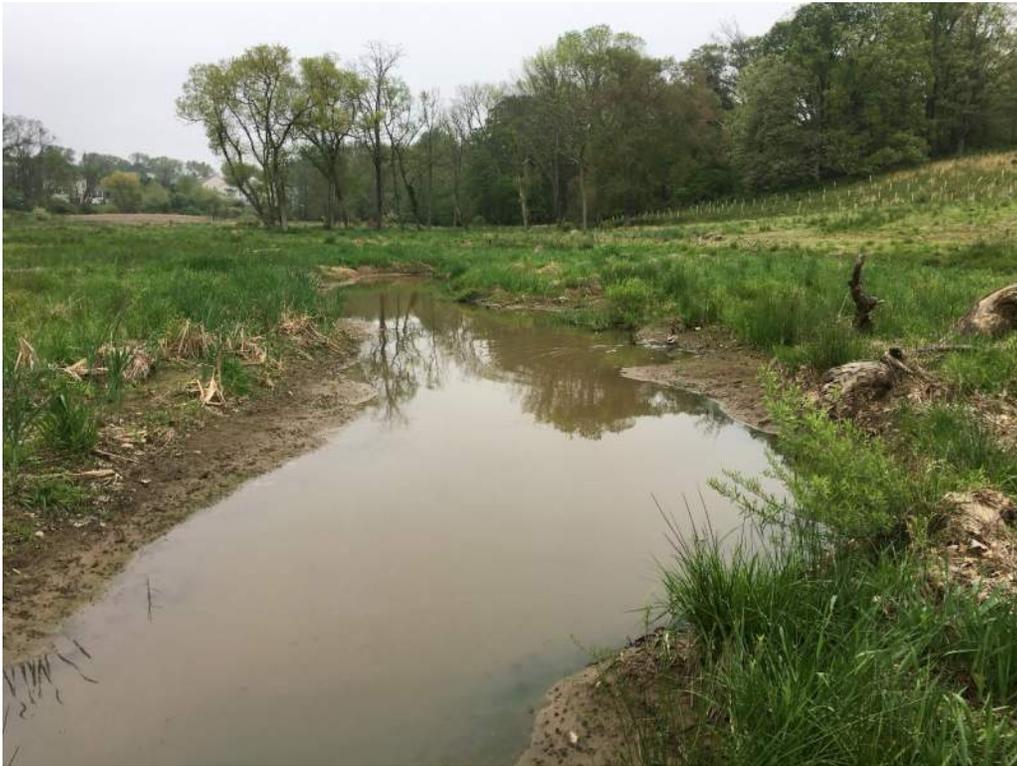
Photo 19: View of oxbow wetland adjacent to approximate stations 7+00-9+25.

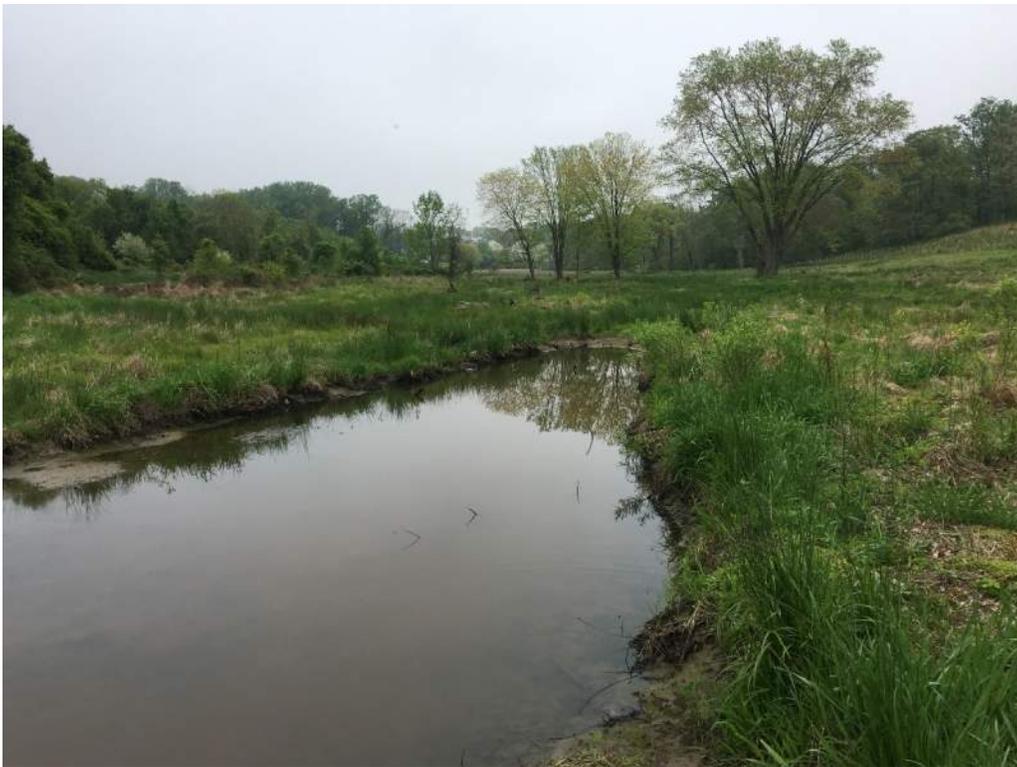
Photo 20: View of oxbow wetland adjacent to approximate stations 12+00-13+75.

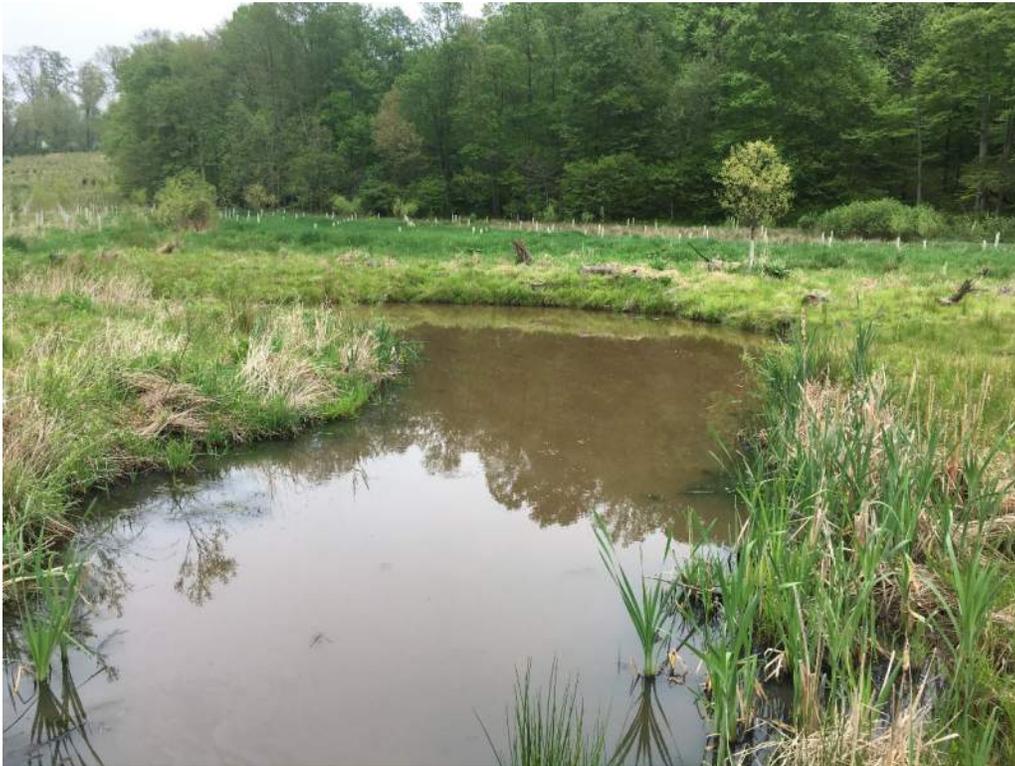
Photo 21: View of oxbow wetland adjacent to approximate stations 13+25-15+25.

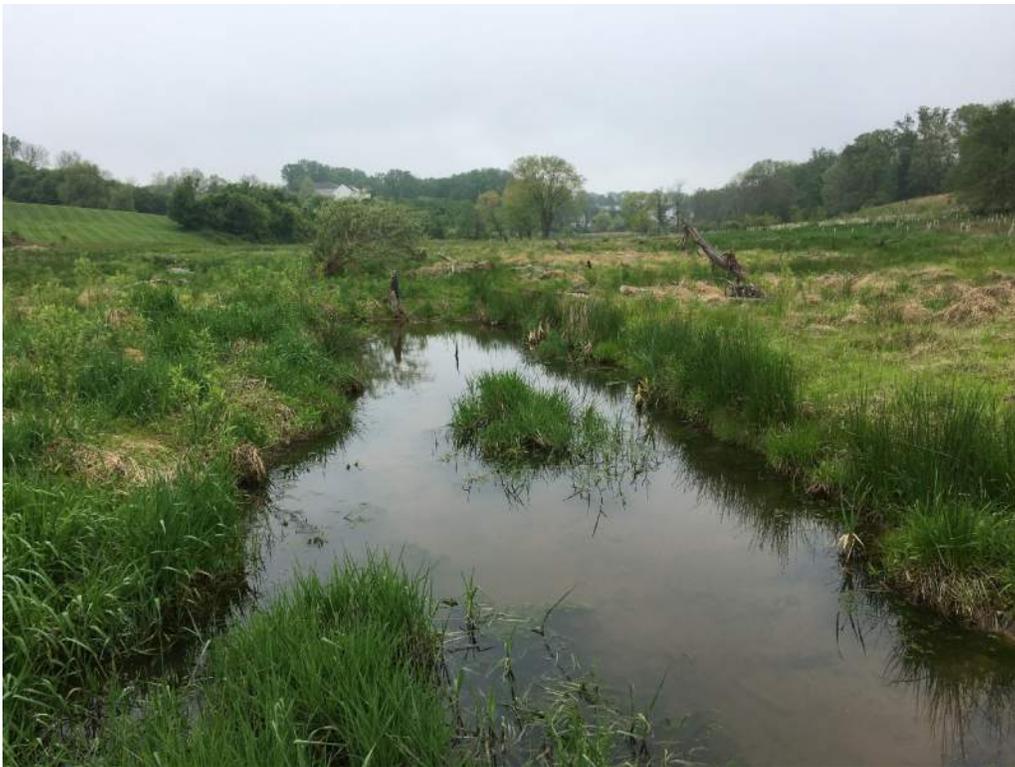
Photo 22: View of oxbow wetland adjacent to approximate stations 17+00-18+50.

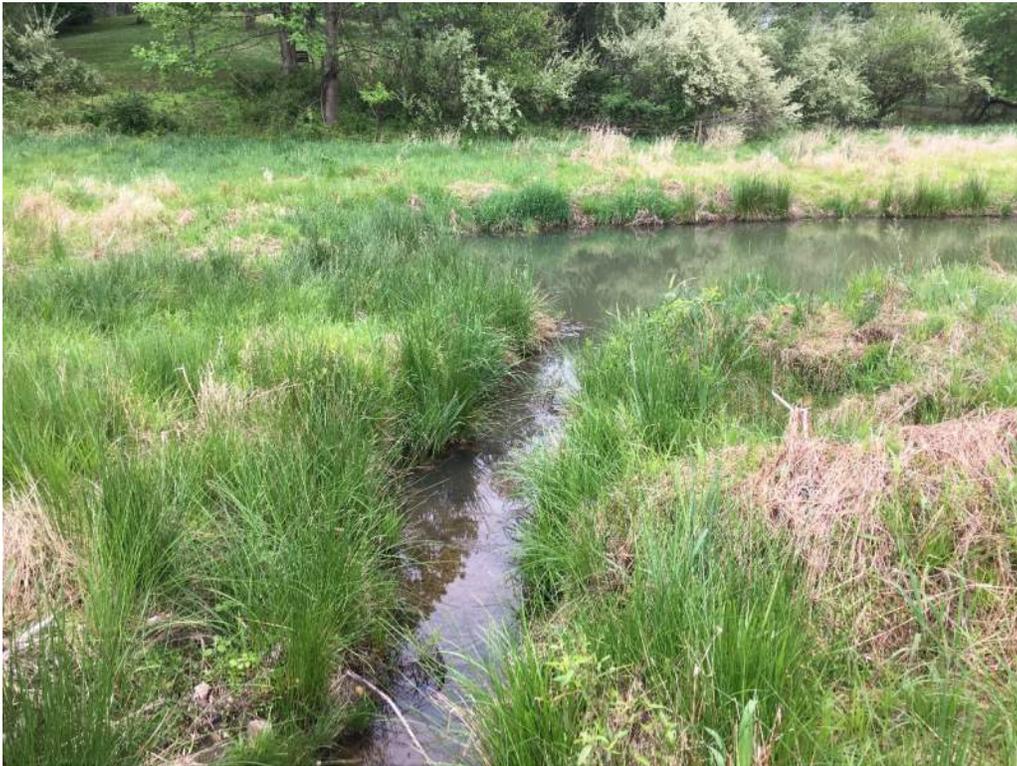
Photo 23: View of oxbow wetland adjacent to approximate stations 19+00-22+50.

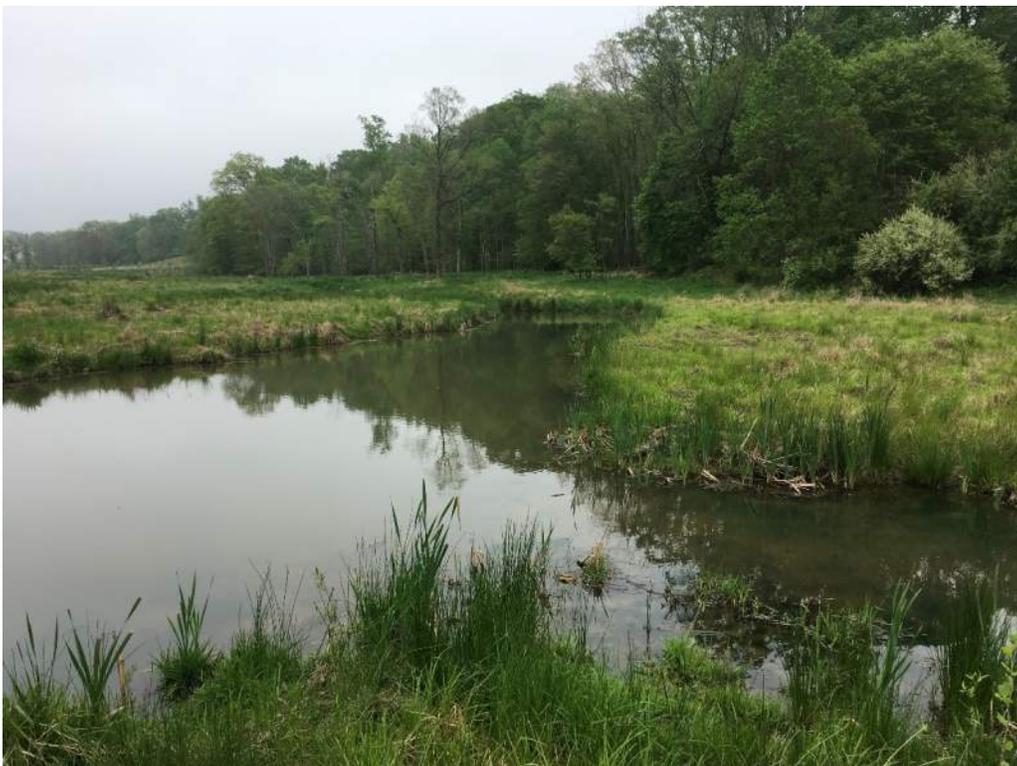
Photo 24: View of oxbow wetland adjacent to approximate stations 22+00-24+00.
