Appendix E2. a – Restoration Plans and TMDLs (Impervious Area Assessment)

Impervious Area Assessment

Harford County, MD Department of Public Works
 Watershed Protection and Restoration
 Watershed Restoration Status (MS4 Permit 11-DP-3310)

Stormwater and stream restoration - inspections FY2020

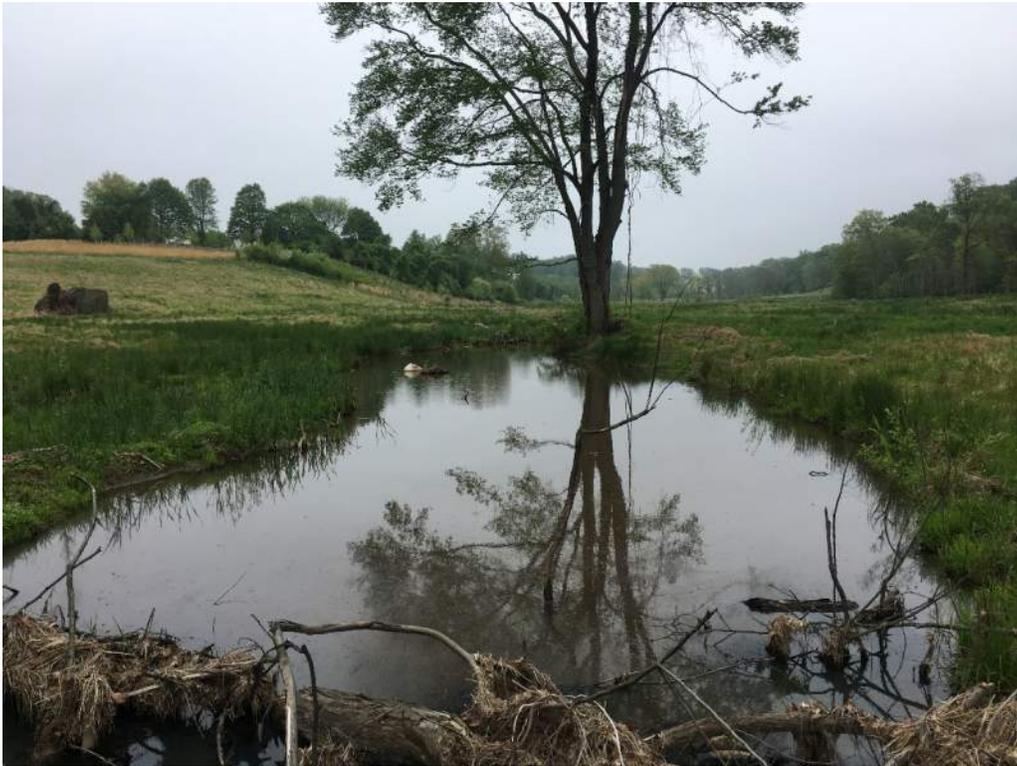
Photo 25: View of oxbow wetland adjacent to approximate stations 25+50-27+50.

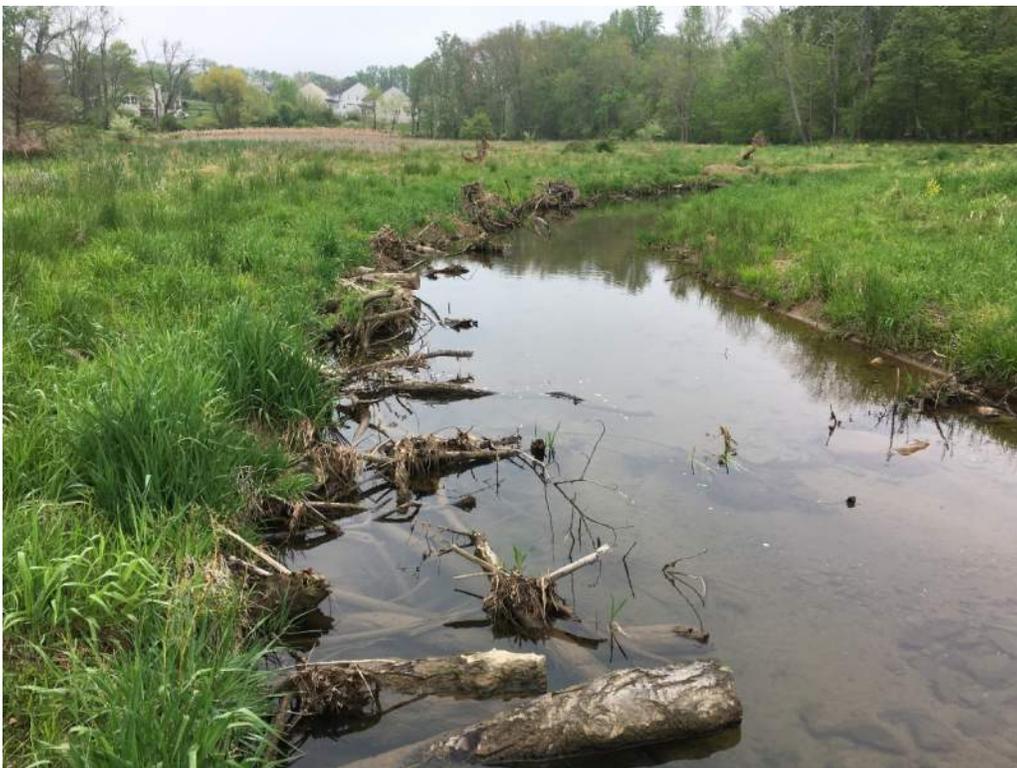
Photo 26: View of toe wood providing bank stability and habitat.

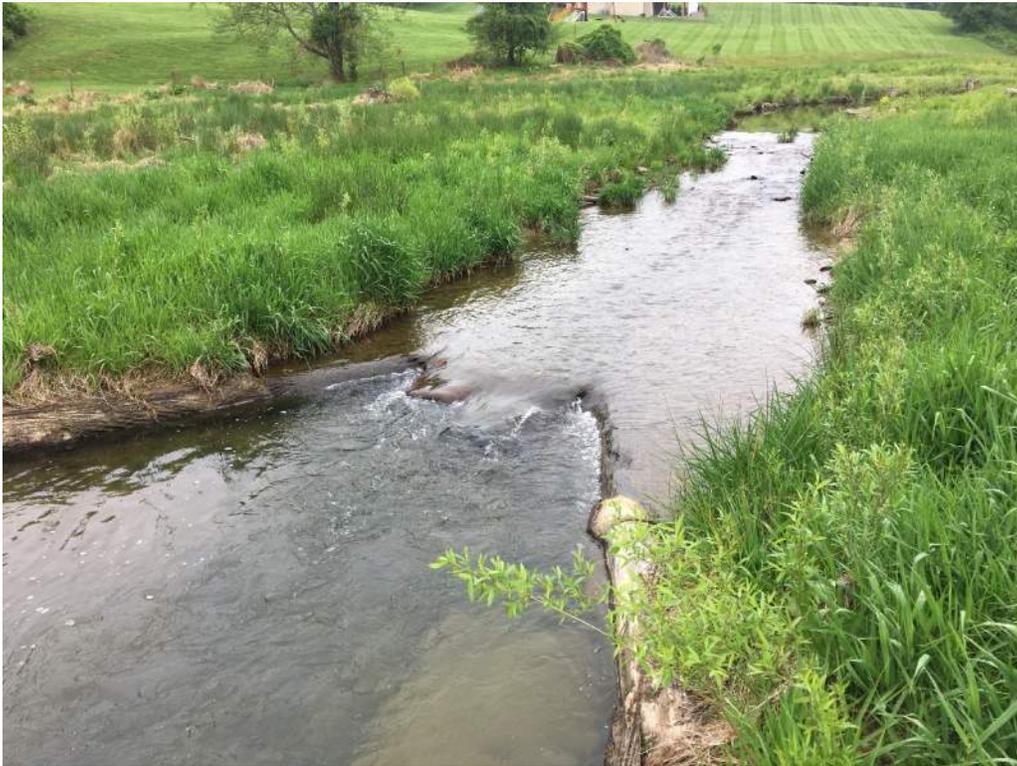
Photo 27: View of log vane at station 16+20.

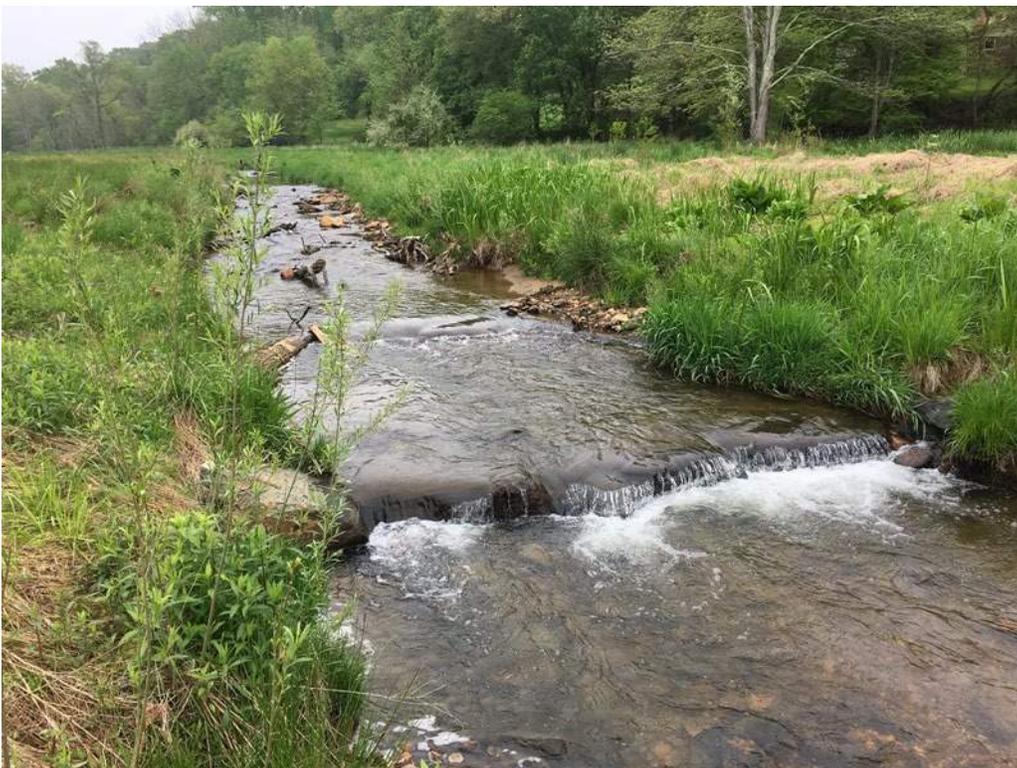
Photo 28: View of log vane with rock sill at station 28+40.

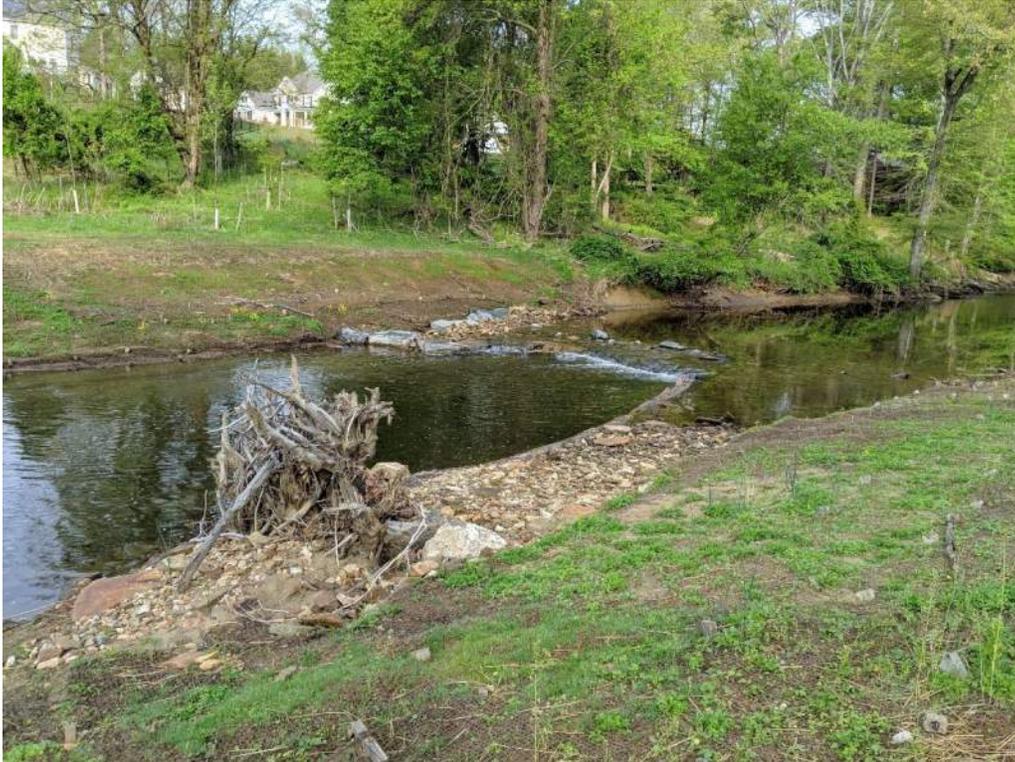
Photo 1: Top of riffle at station 7+75. J-hook #1 at station 8+00.

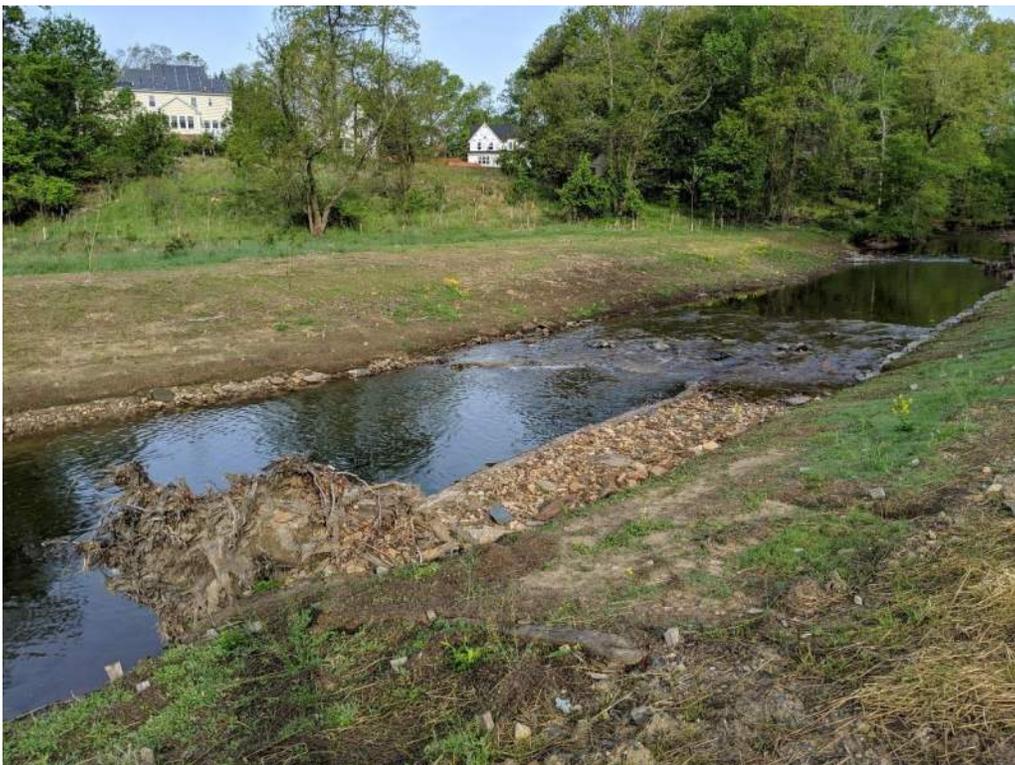
Photo 2: Top of riffle at station 9+10. J-hook #2 at station 9+50.

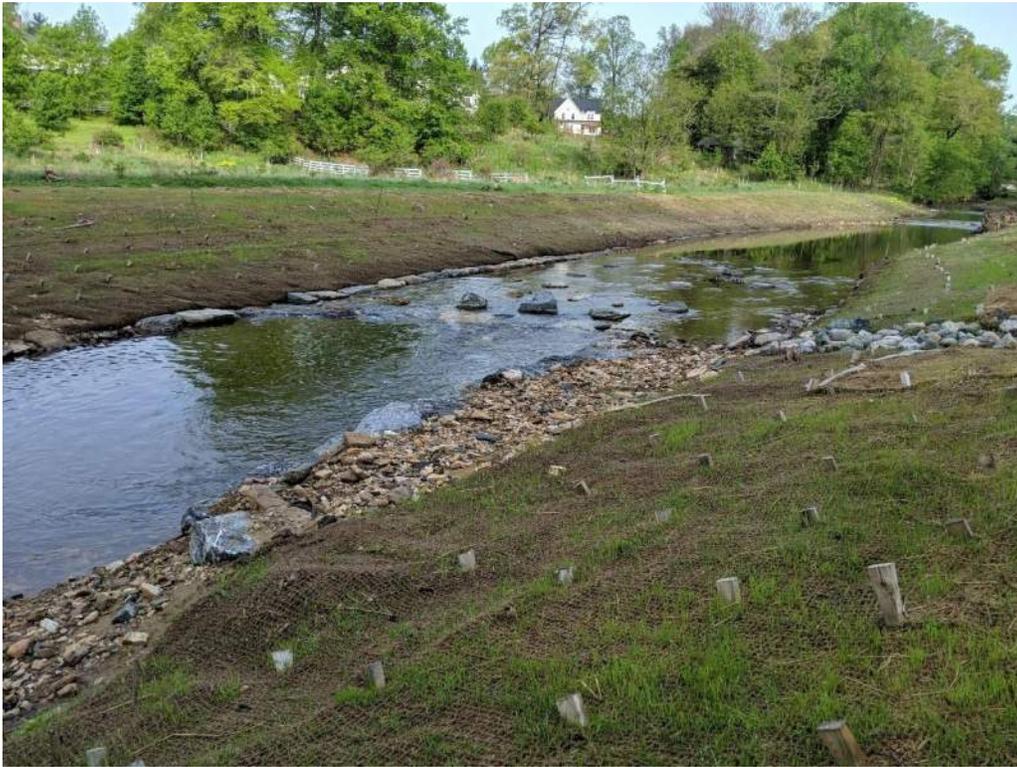
Photo 3: Top of riffle at station 11+10. J-hook #3 at station 11+60

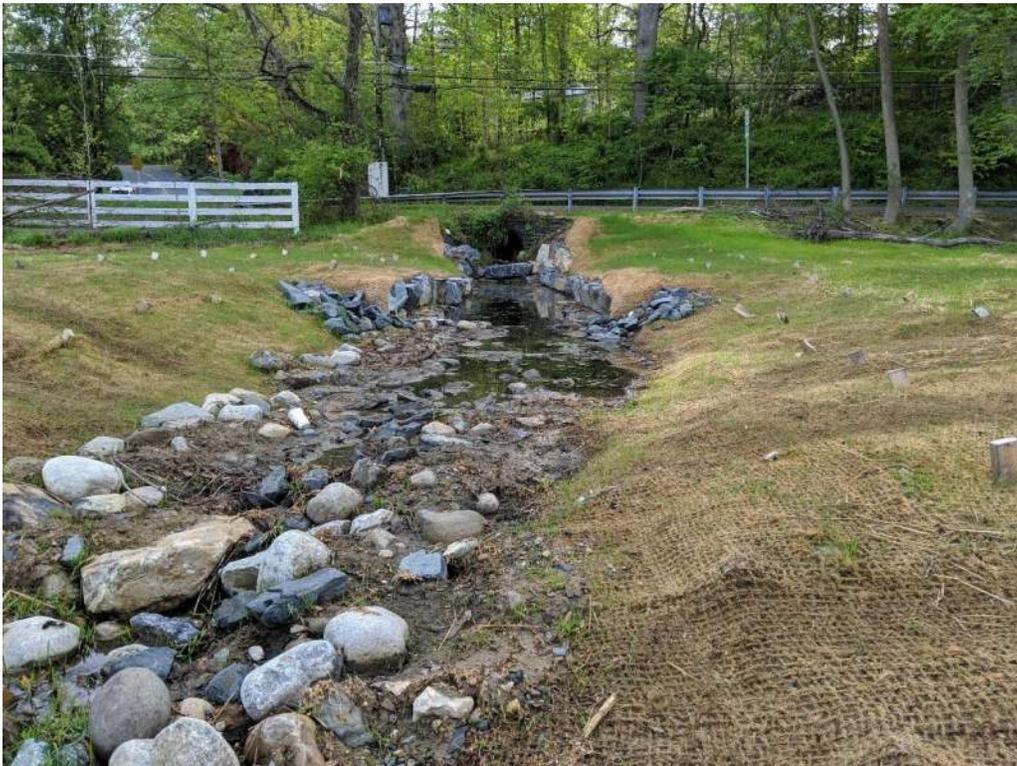
Photo 4: Looking upstream at Tributary #3.

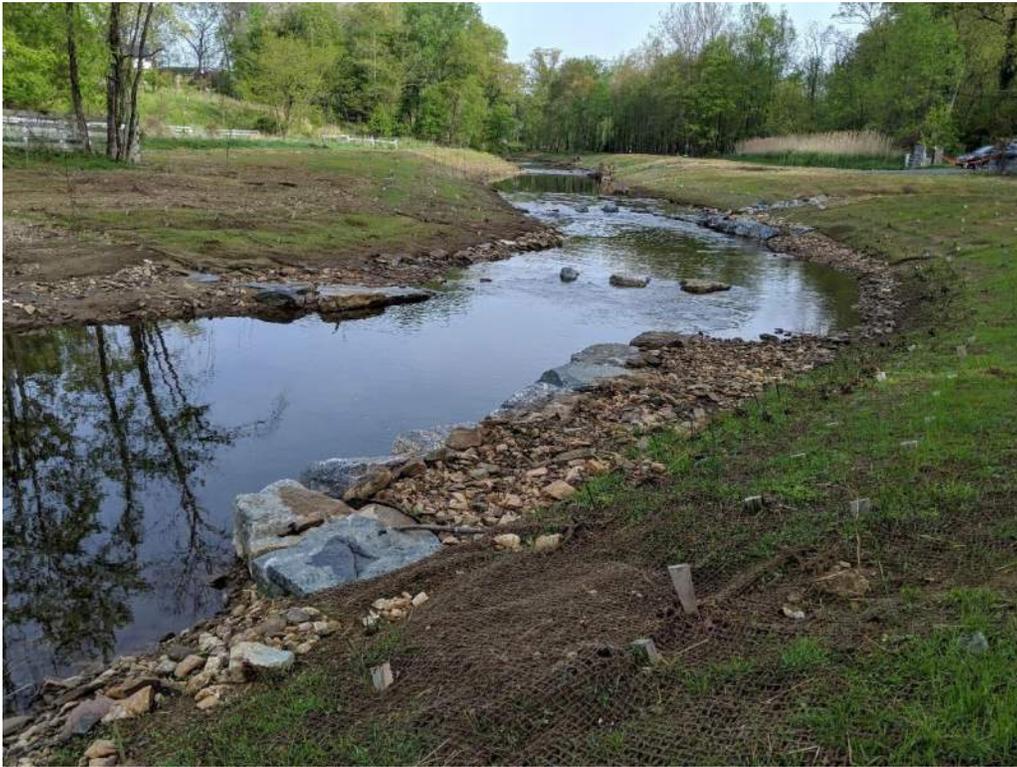
Photo 5: J-hook #4 at station 12+28.

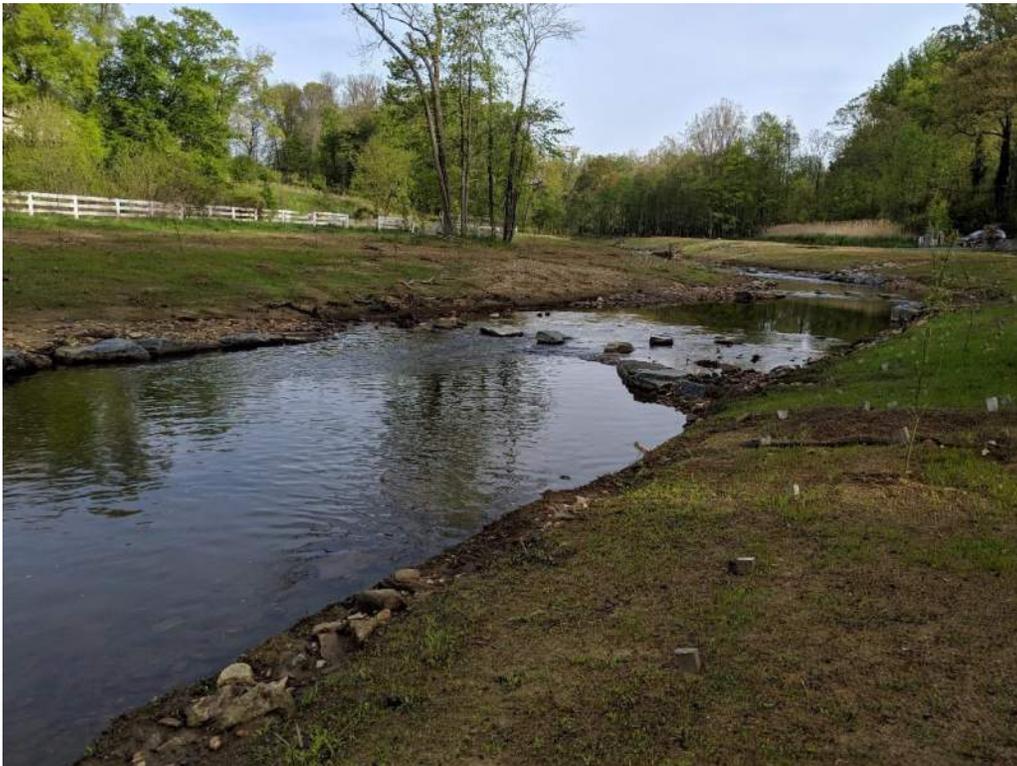
Photo 6: Top of riffle at station 12+83. J-hook #5 at station 13+08.

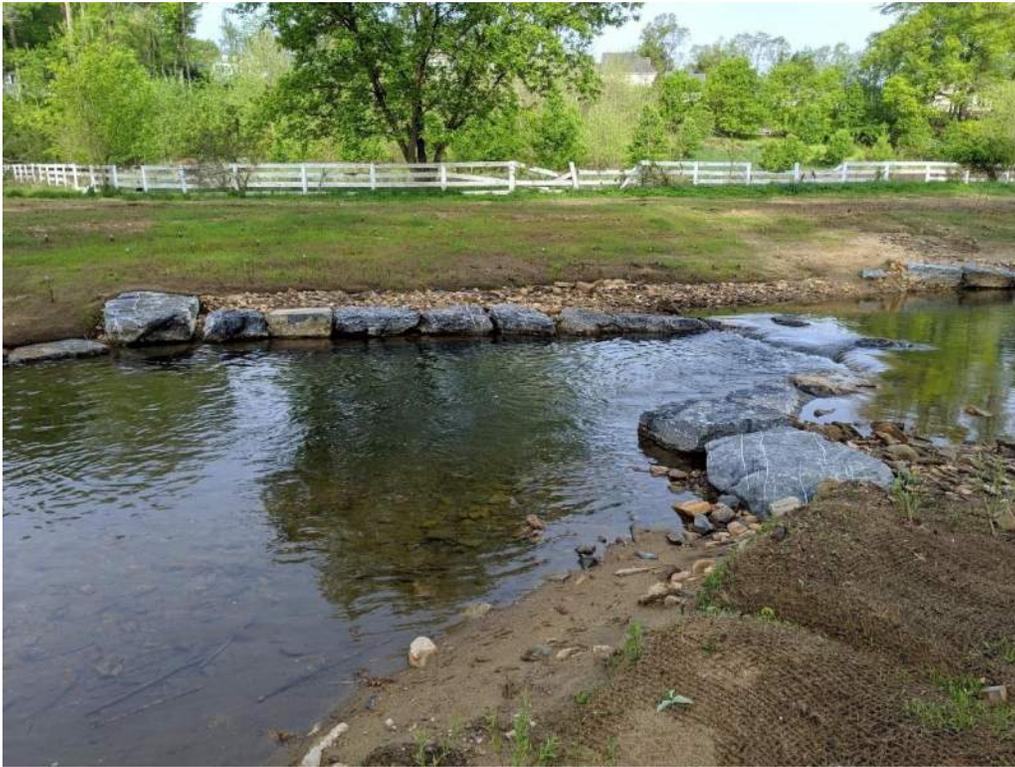
Photo 7: J-hook #6 at station 13+70.

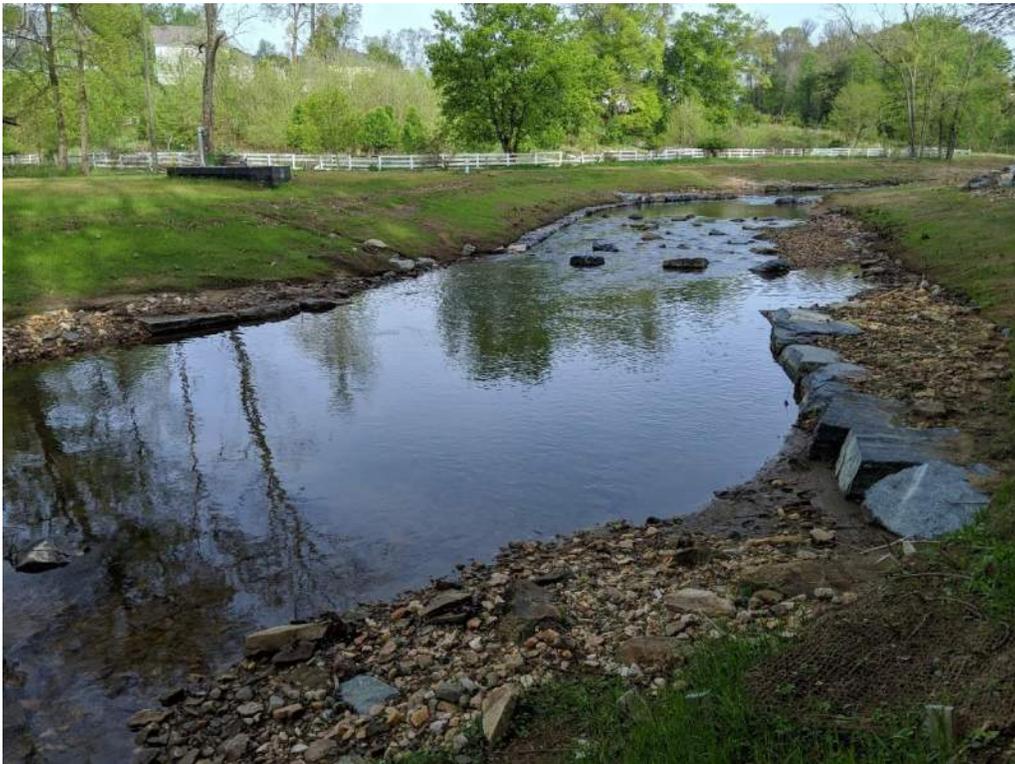
Photo 8: Top of riffle at station 14+25. Cross vane #1 at station 14+75.

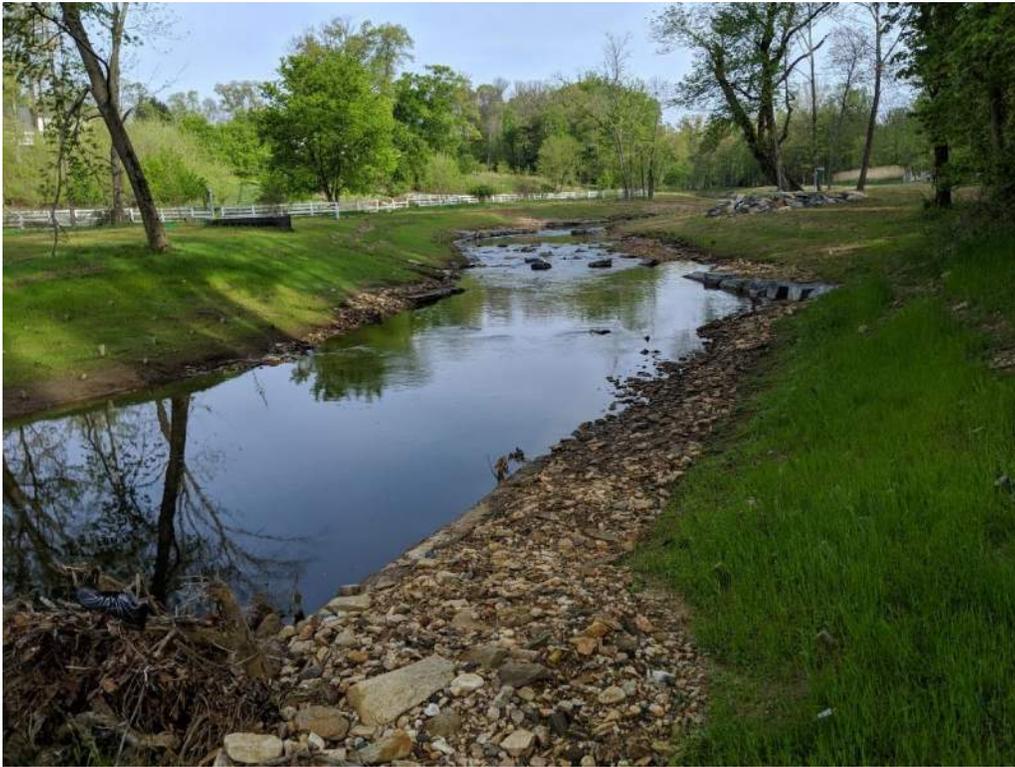
Photo 9: J-hook #7 at station 15+30.

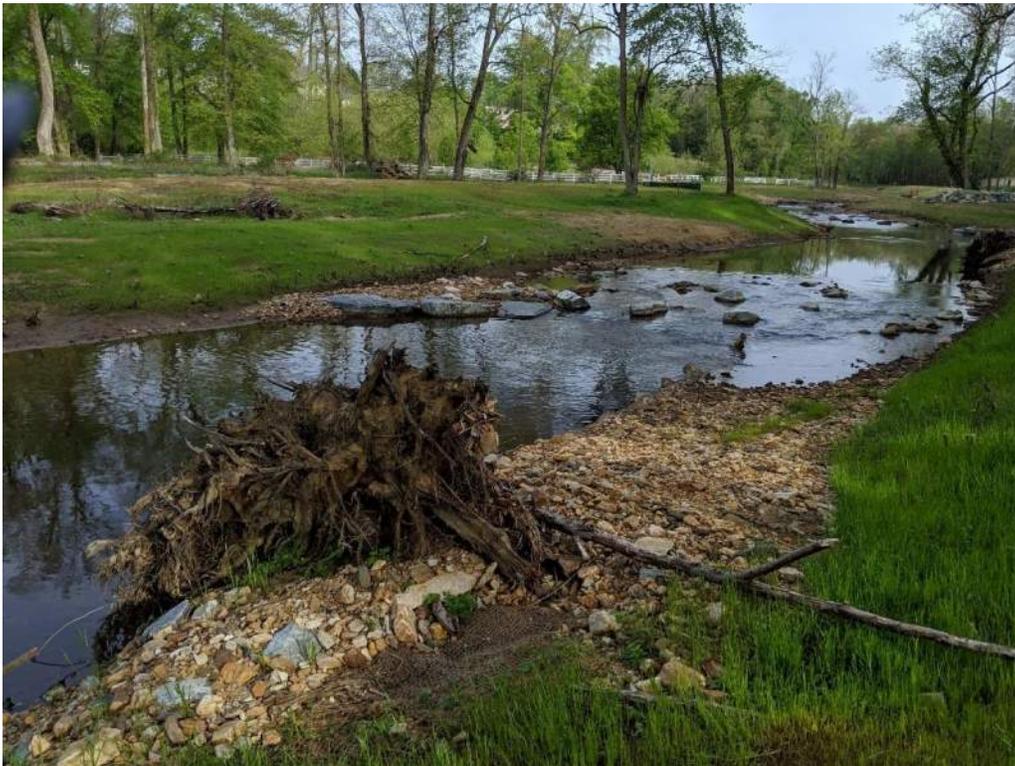
Photo 10: Top of riffle at station 16+05. J-hook #8 at station 16+35.

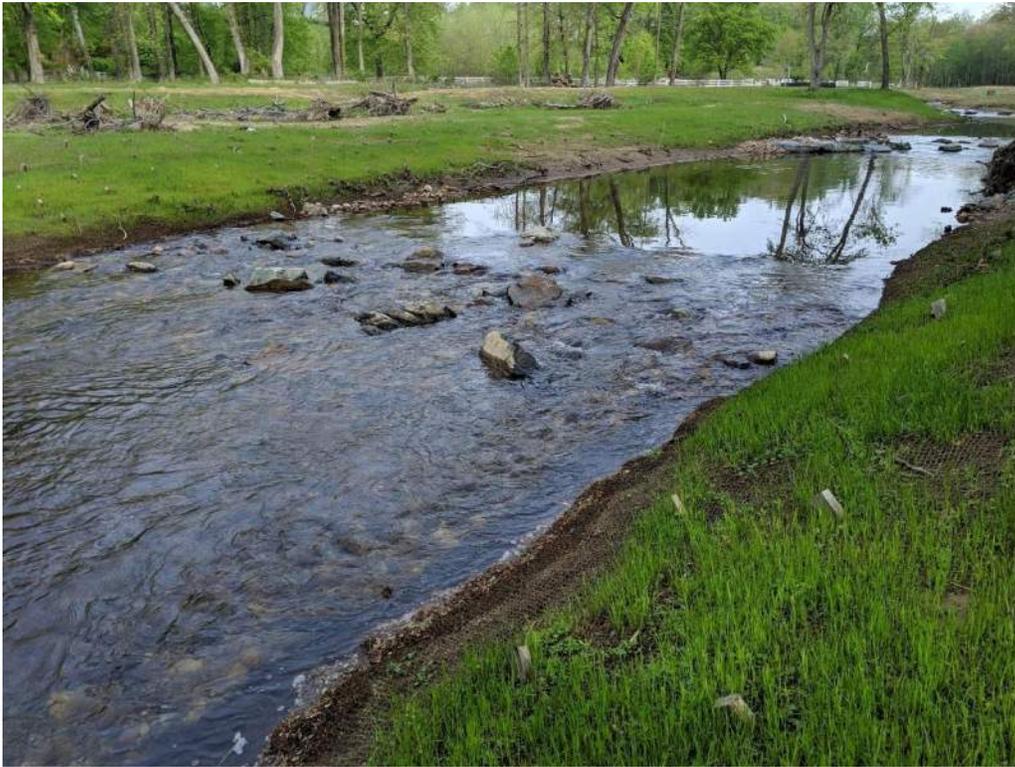
Photo 11: Top of riffle at station 17+00.

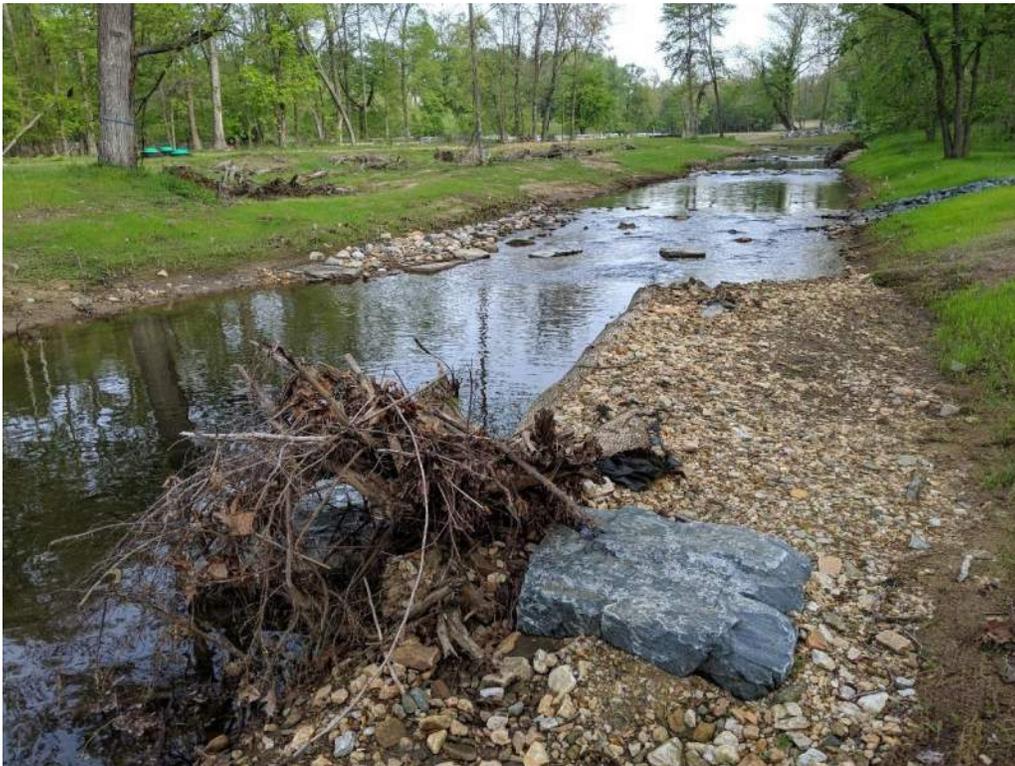
Photo 12: Top of riffle at station 17+90. J-hook #9 at station 18+20.

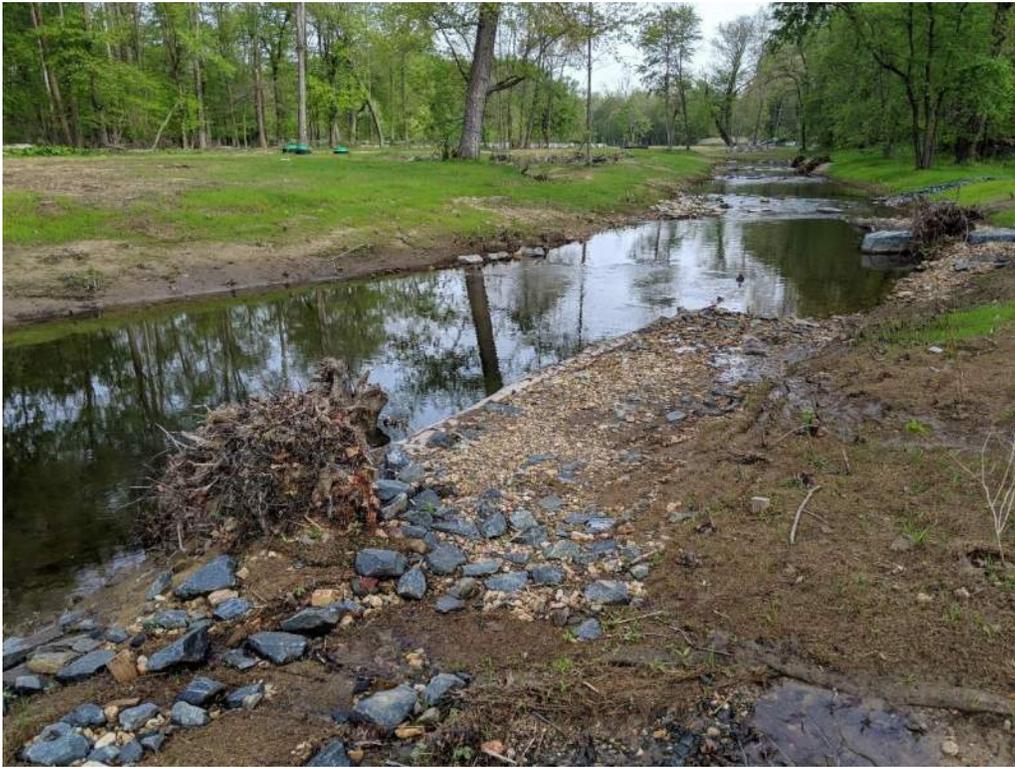
Photo 13: J-hook #10 at station 18+77.

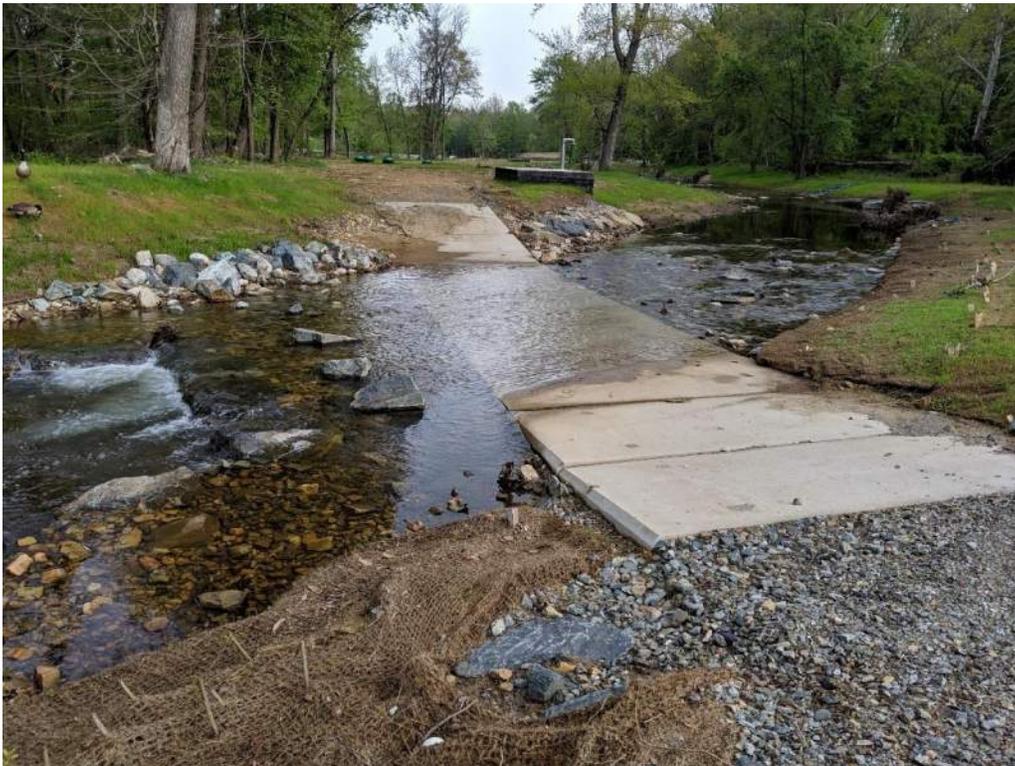
Photo 14: Top of riffle at station 19+63 and concrete ford crossing.

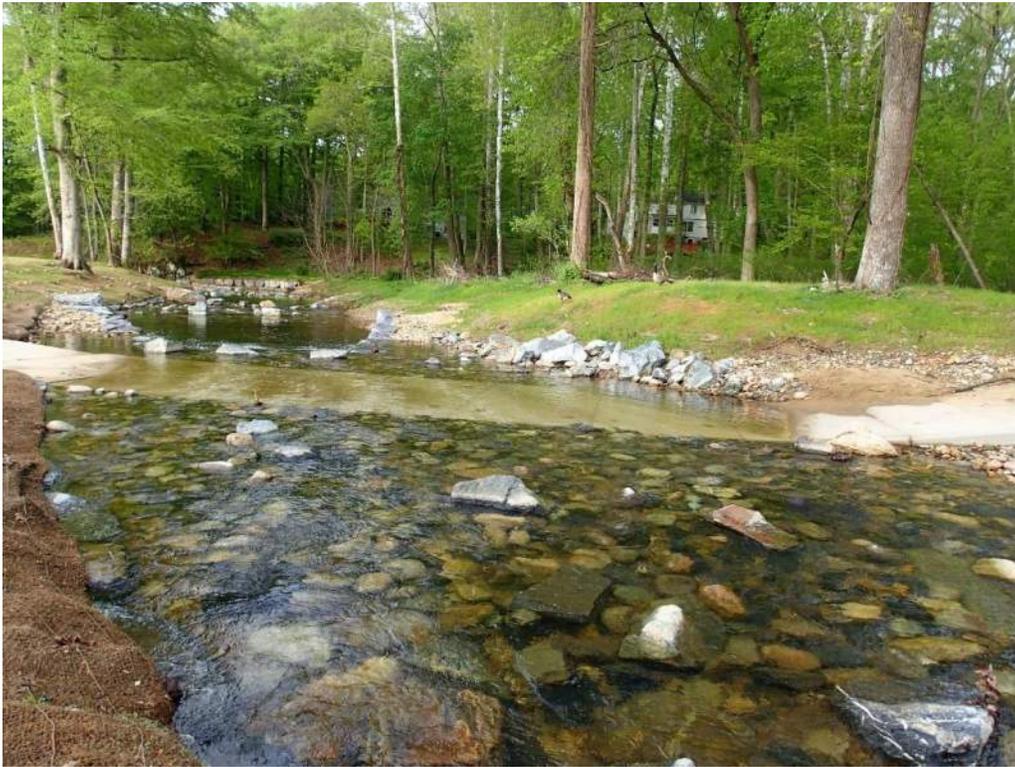
Photo 15: Downstream view of cross vane #2 at 20+26 after concrete ford crossing.

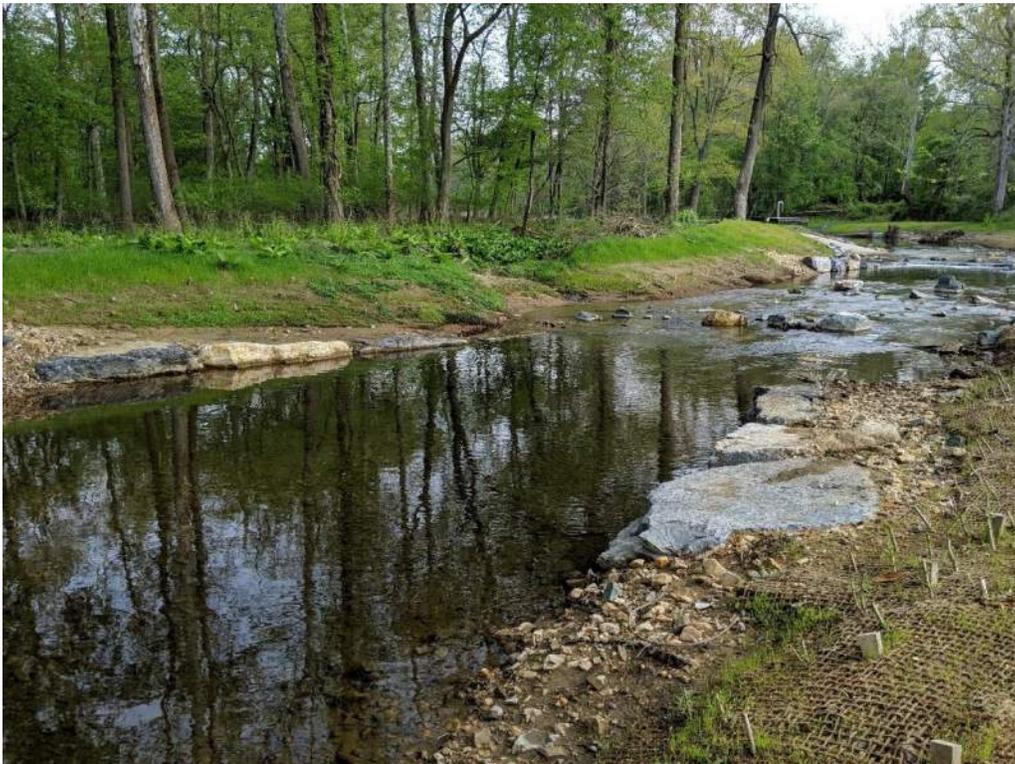
Photo 16: Top of riffle at station 20+81. Cross vane #3 at station 21+20.

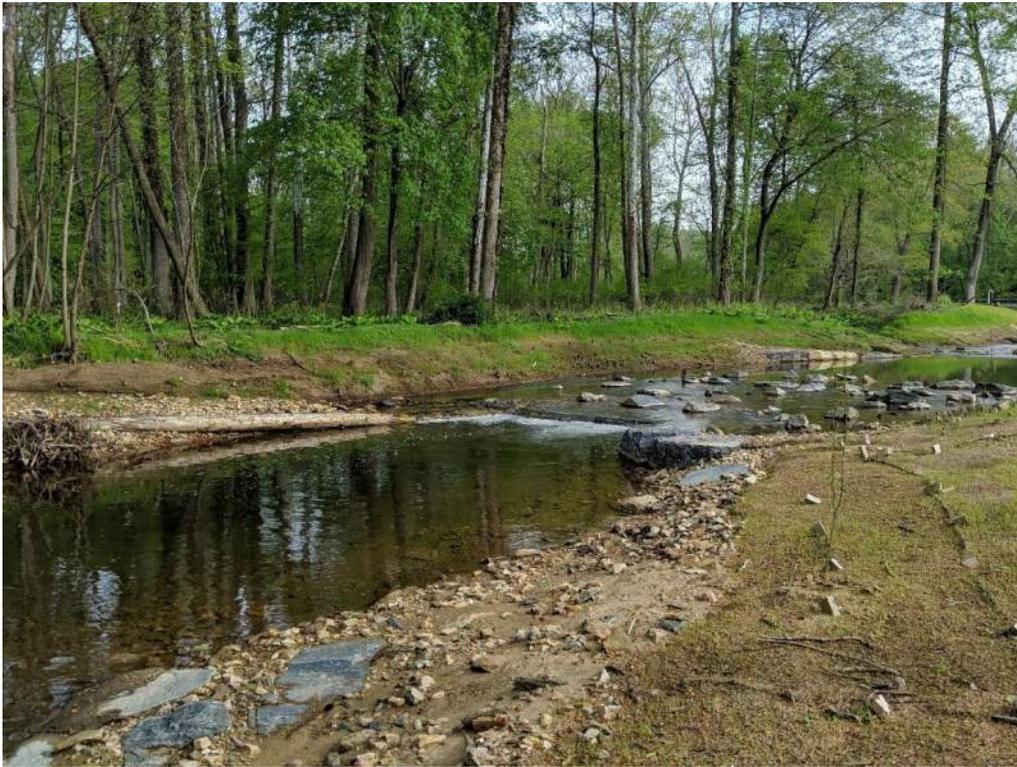
Photo 17: Top of riffle at station 21+75. J-hook #11 at station 22+05.

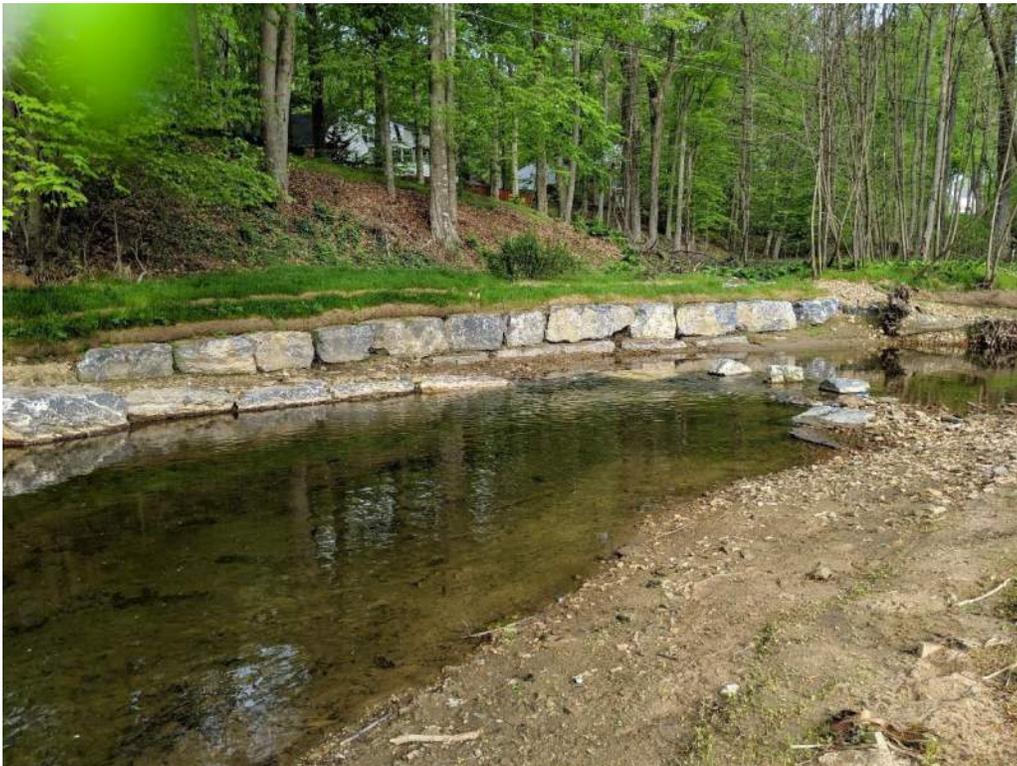
Photo 18: J-hook #12 at station 22+67.

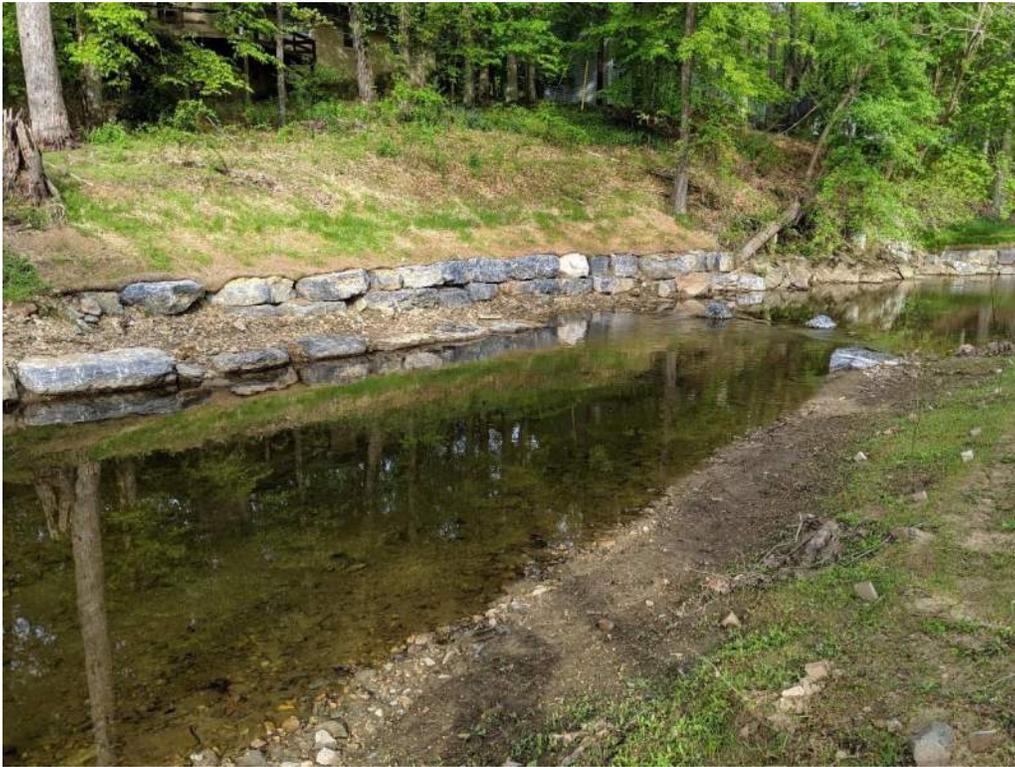
Photo 19: J-hook #13 at station 23+71.

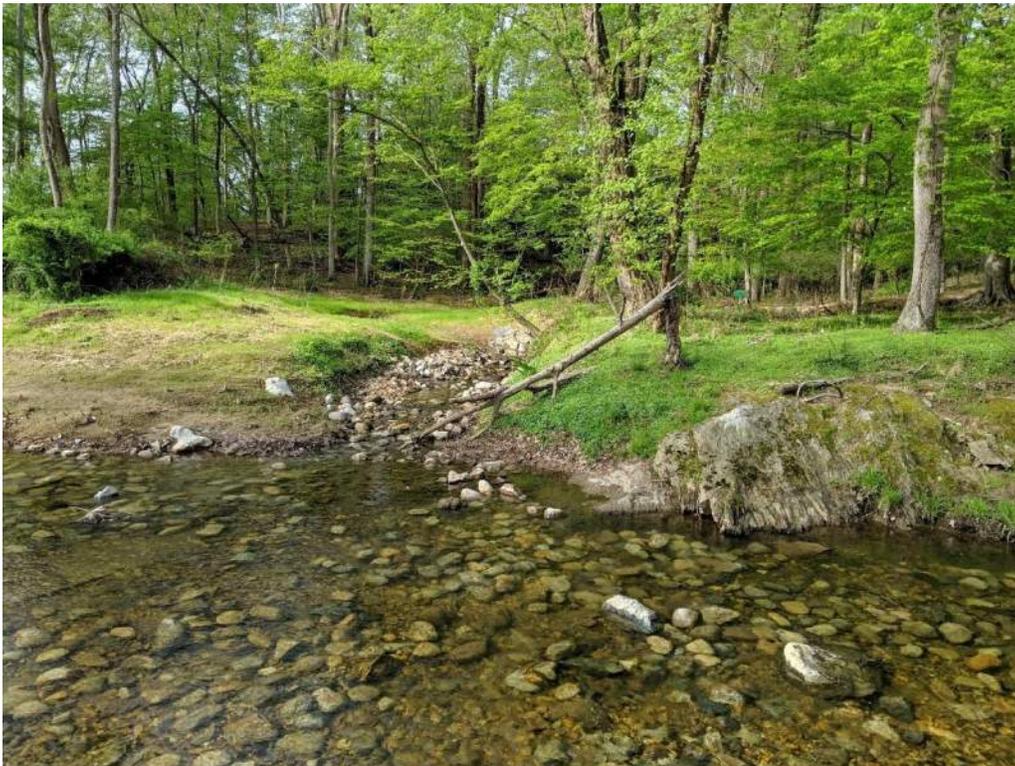
Photo 20: Upstream view of Tributary #4 from confluence.

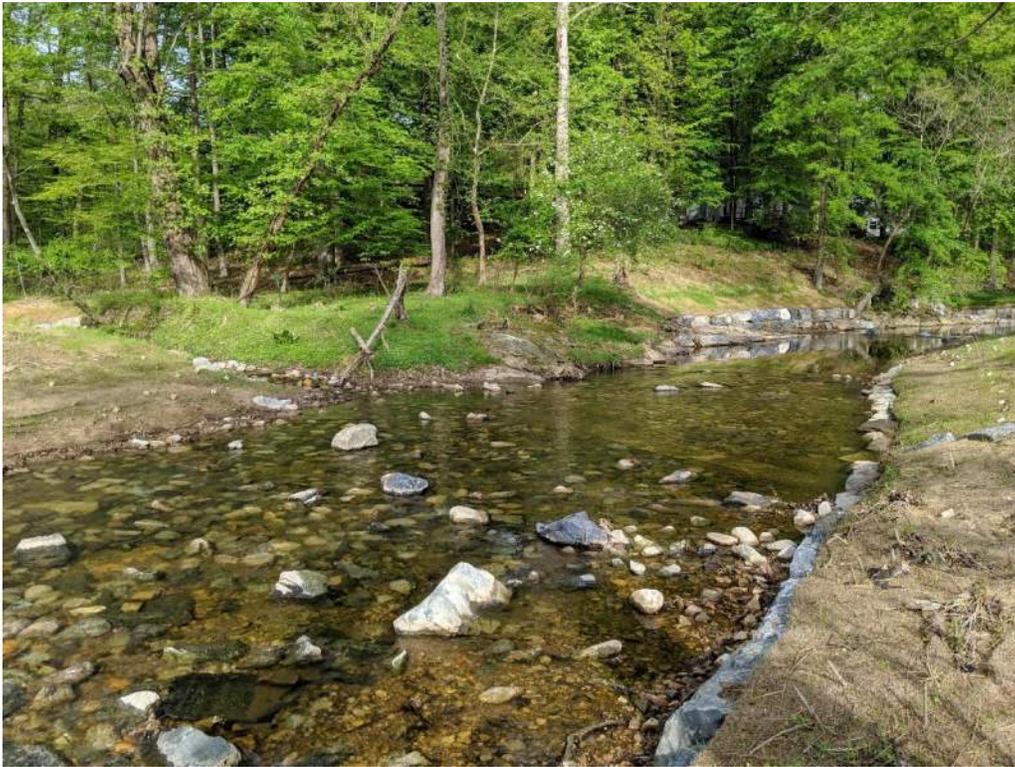
Photo 21: Top of riffle at station 24+50.

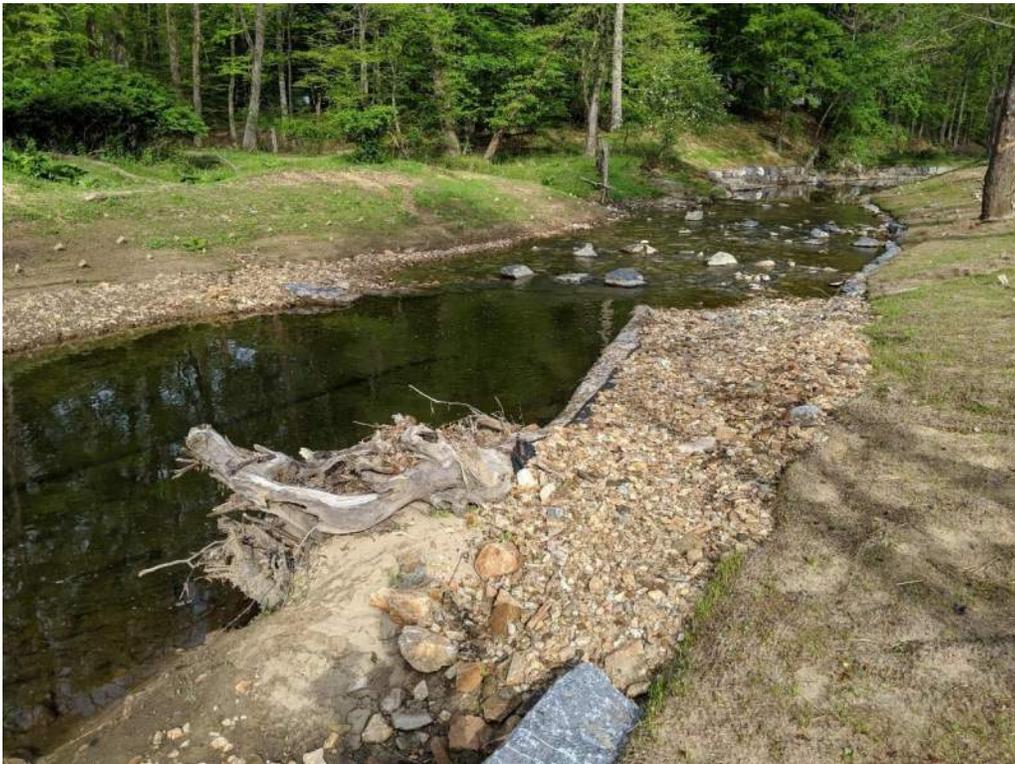
Photo 22: J-hook #14 at station 25+50.

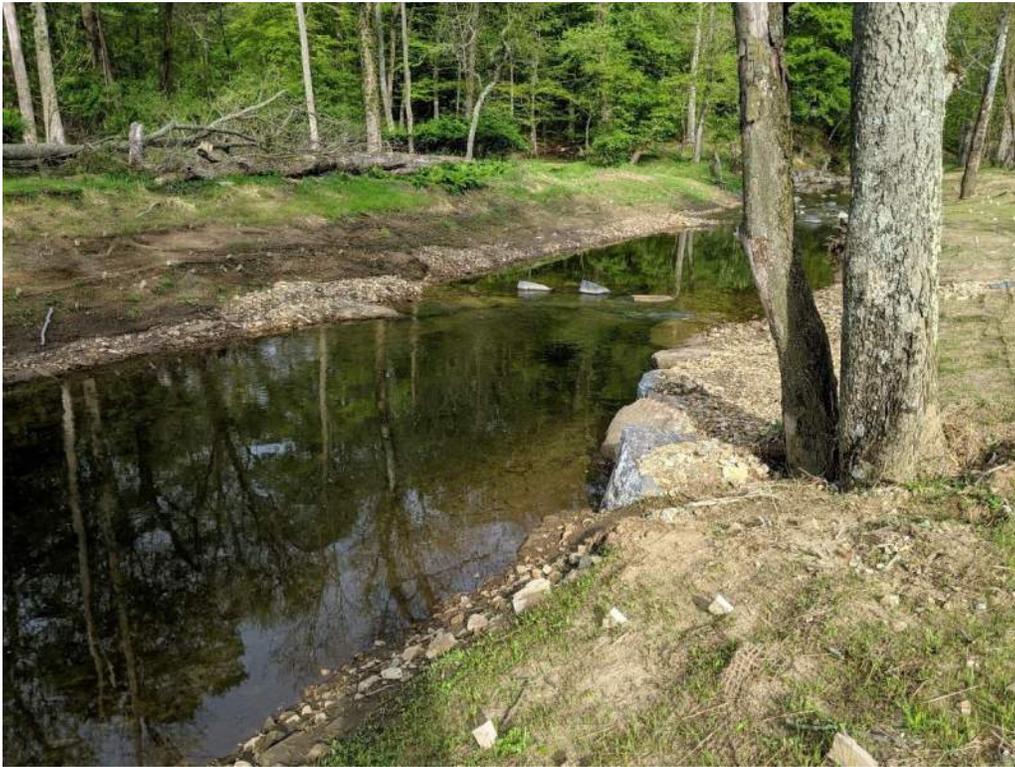
Photo 23: J-hook #15 at station 26+30.

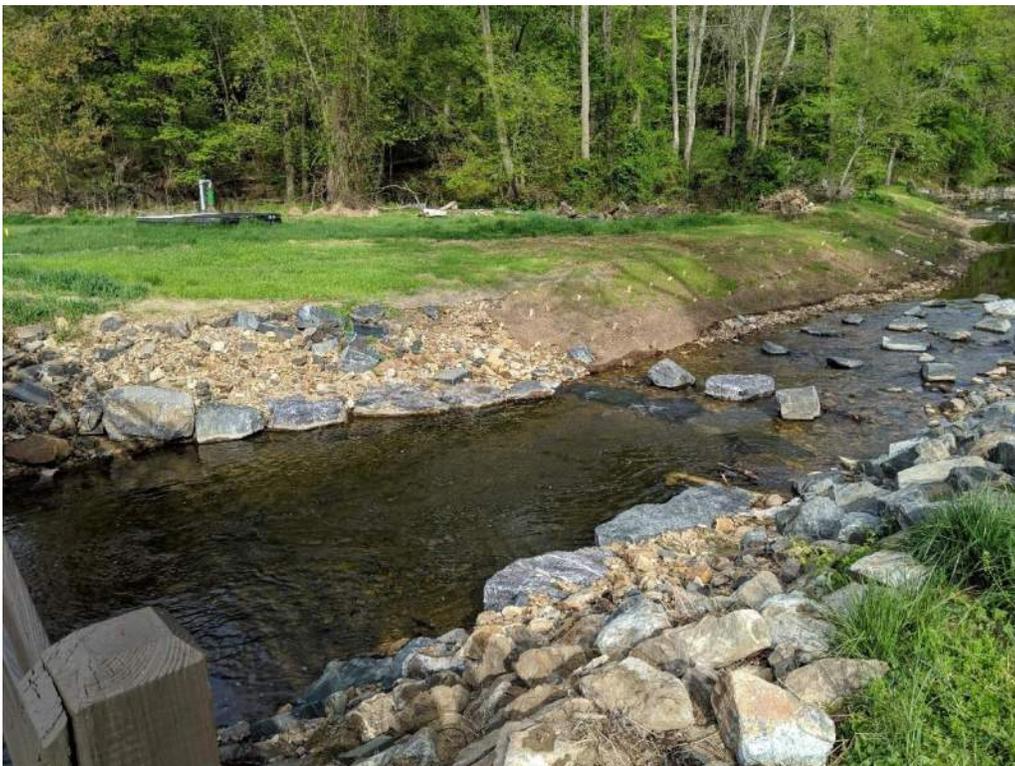
Photo 24: Top of riffle at station 27+05. Cross vane #4 at station 27+42.

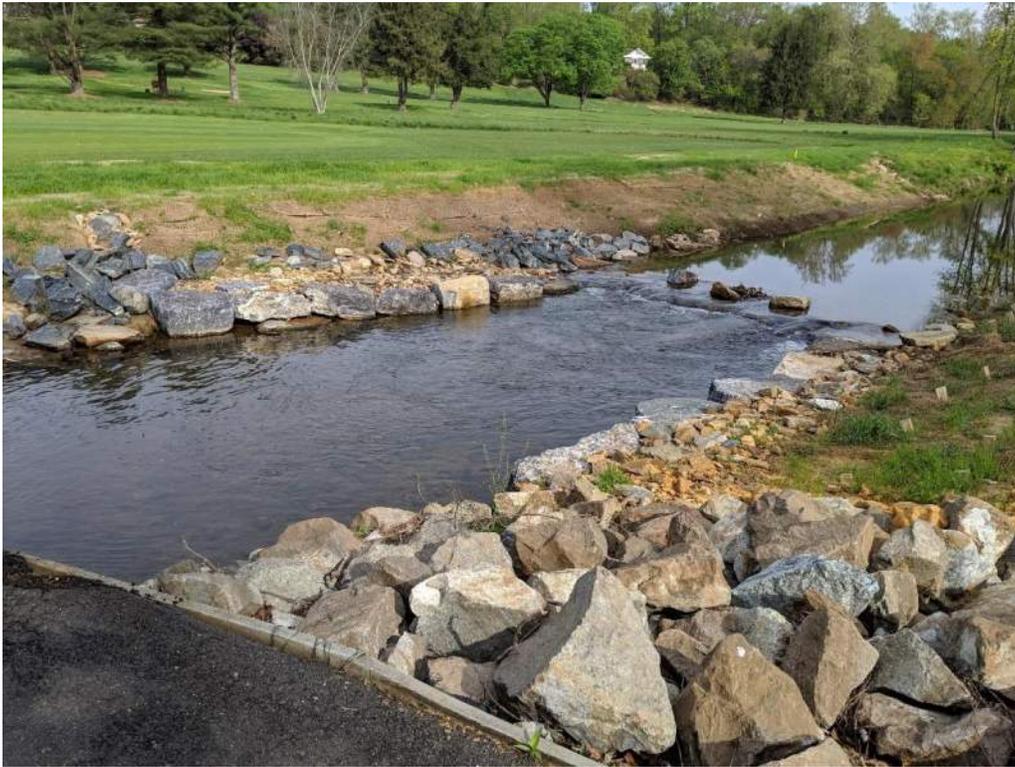
Photo 25: Cross vane #5 at cart crossing station 0+88.5.
