Appendix E2. a – Restoration Plans and TMDLs (Impervious Area Assessment)

Impervious Area Assessment

Harford County, MD Department of Public Works
 Watershed Protection and Restoration
 Watershed Restoration Status (MS4 Permit 11-DP-3310)

Stormwater and stream restoration - inspections FY2020

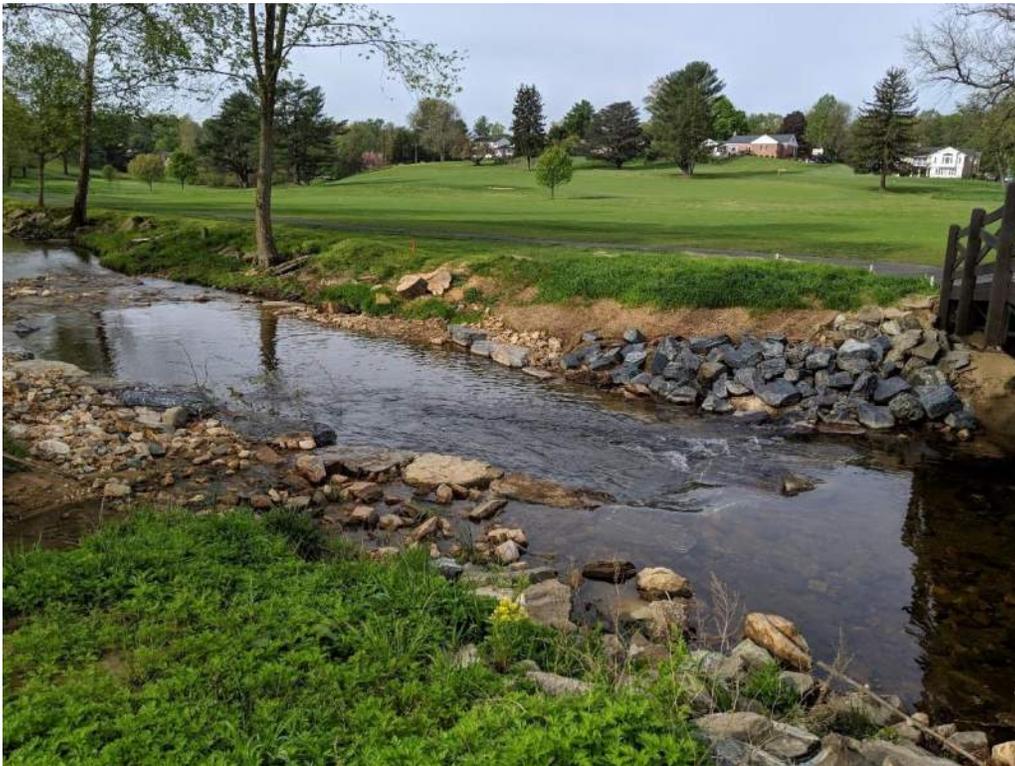
Photo 26: Cross vane #6 at cart crossing station 1+44.5 and confluence with Tributary #5.
