Upper Bynum Run Watershed Assessment Report

This report is a summary of the Upper Bynum Run Watershed. This report meets all the requirements of the 319 Grant application.

December 14, 2018

Stantec Consulting Services, Inc
810 Gleneagles Court, Suite 300
Baltimore, MD 21286

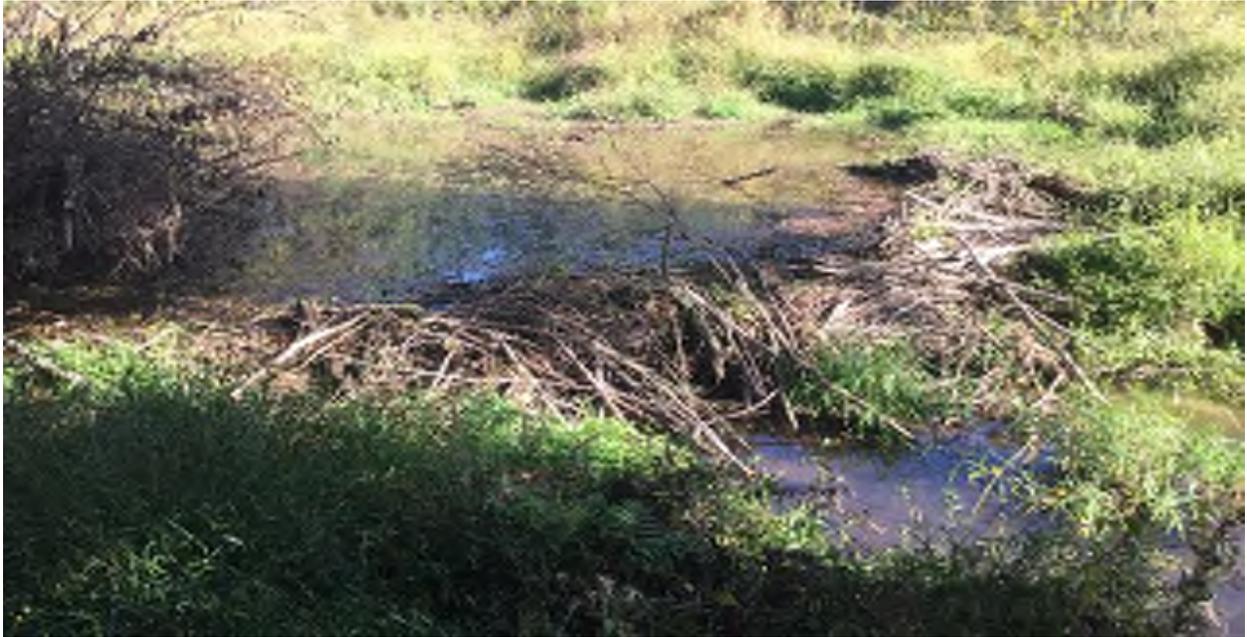
Photo 1 - Beaver dam at stream assessment Point 43 at downstream end of sub area 5

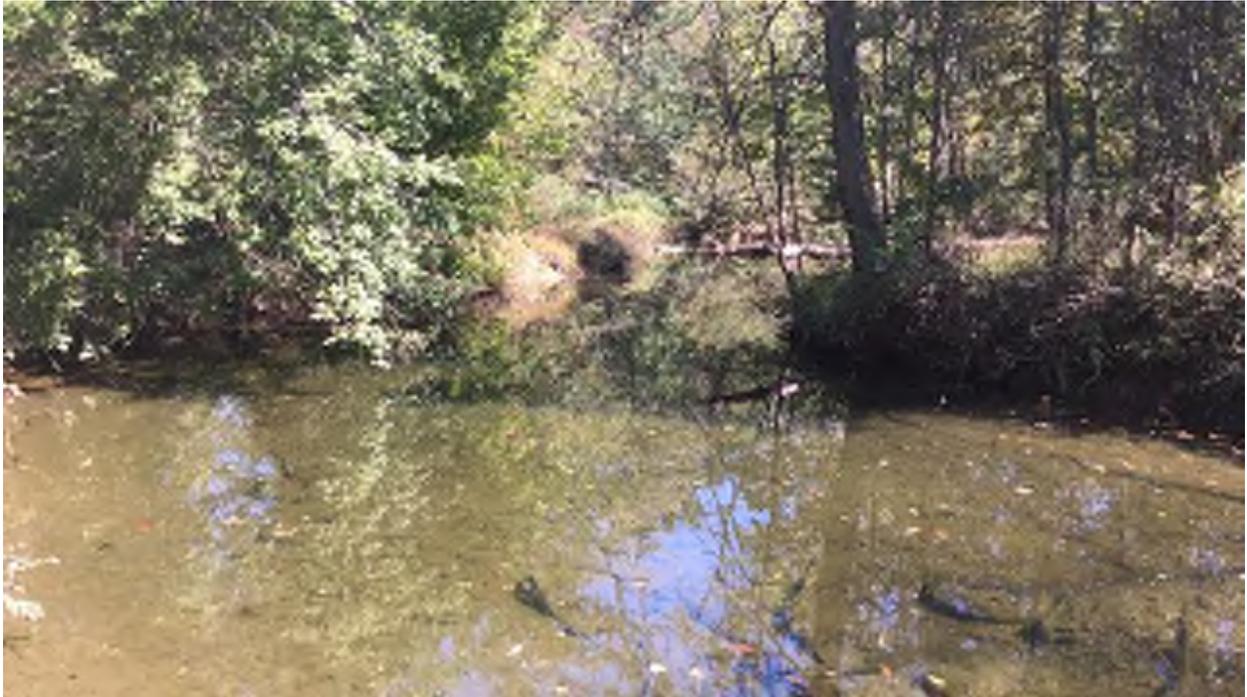
Photo 3- Backwater pool at stream assessment Point 118 created by downstream Mill Dam

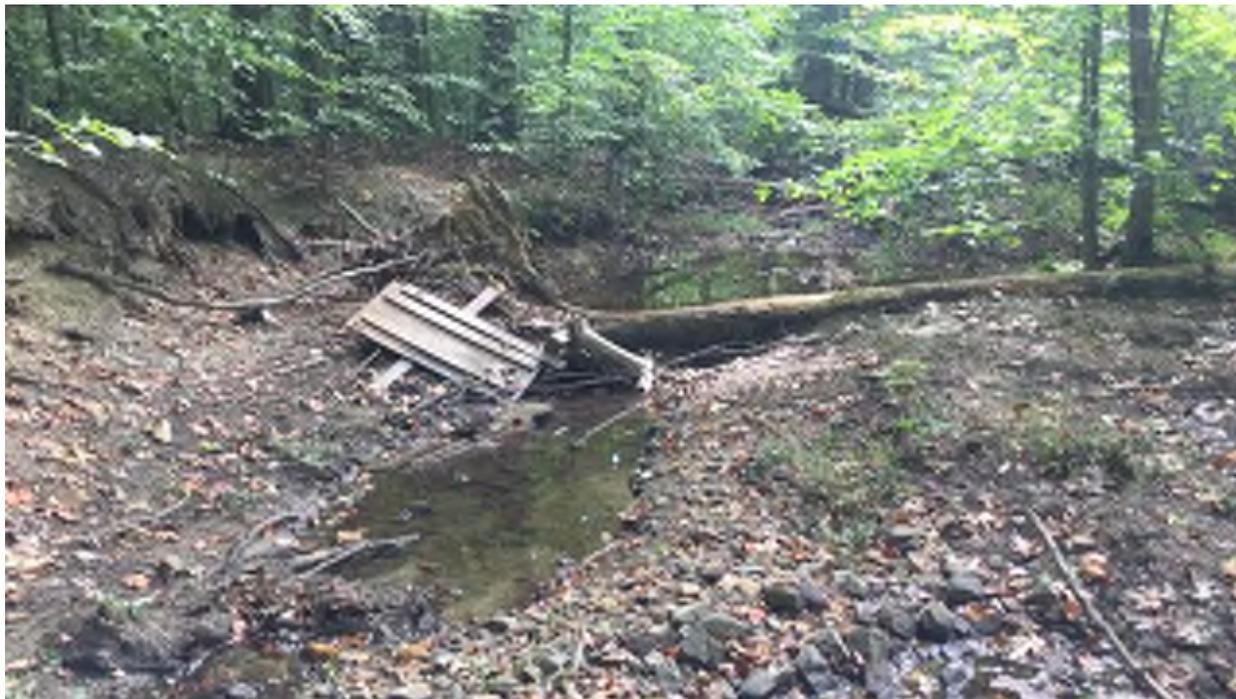
Photo 9 - Stream assessment Point 181 shows debris in the stream channel

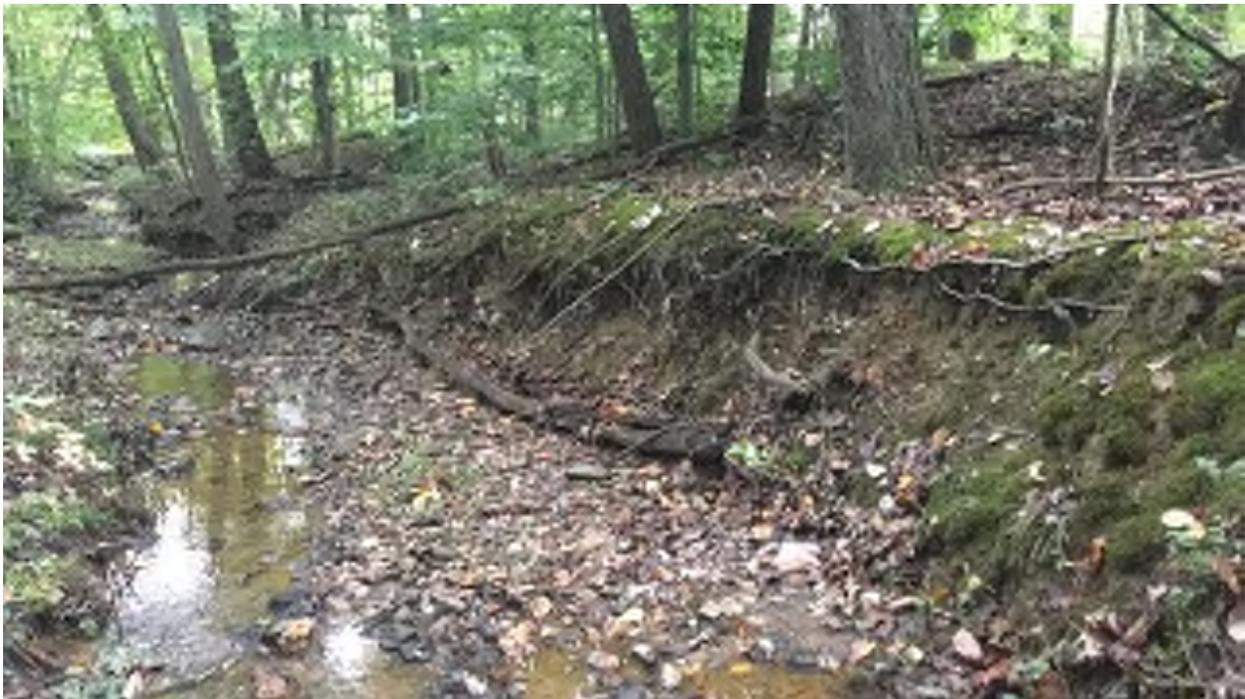
Photo 14 - Stream assessment Point 271 in subarea 3 - moderate bank erosion

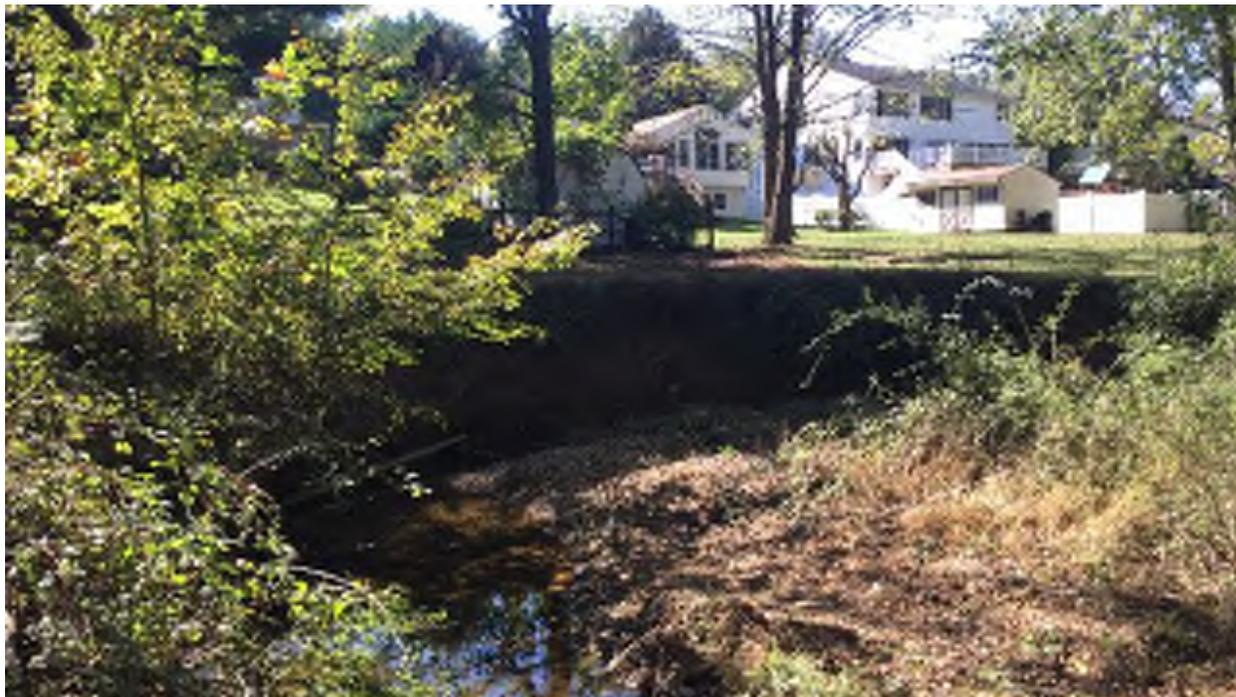
Photo 15 - Severe bank erosion at outside meander bend in subarea S1 at stream assessment Point 330

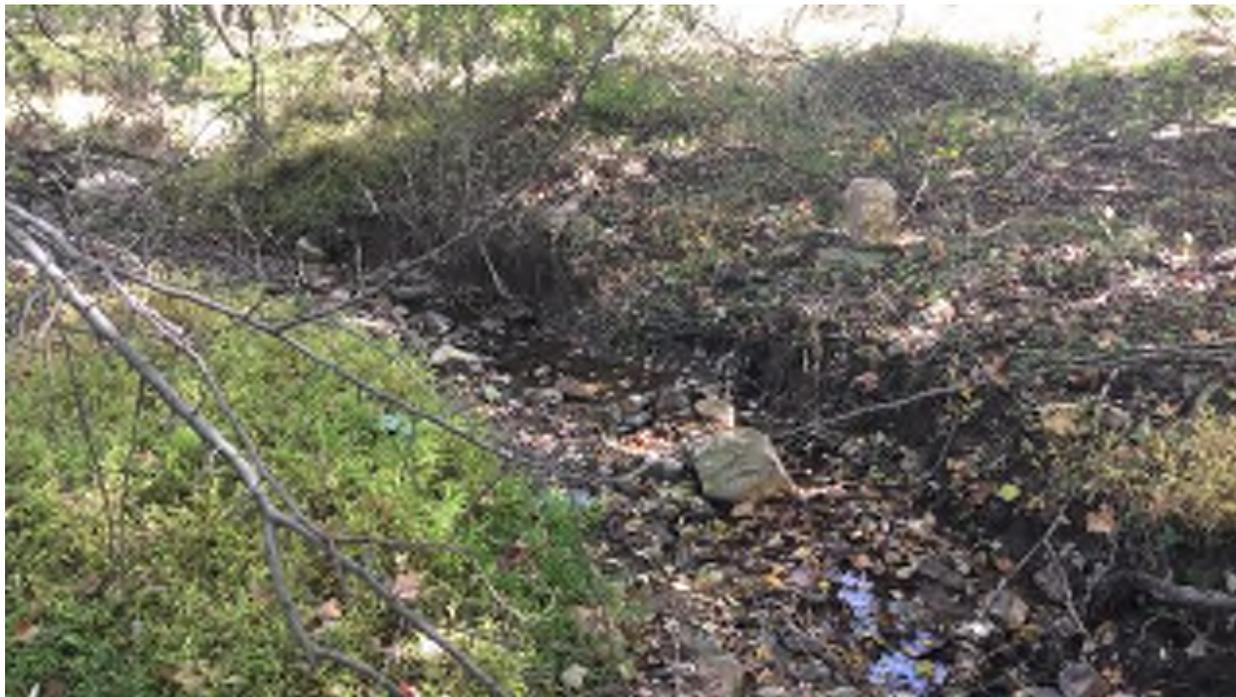
Photo 17 - Stream channel at assessment Point 370 in subarea S1 - moderate erosion

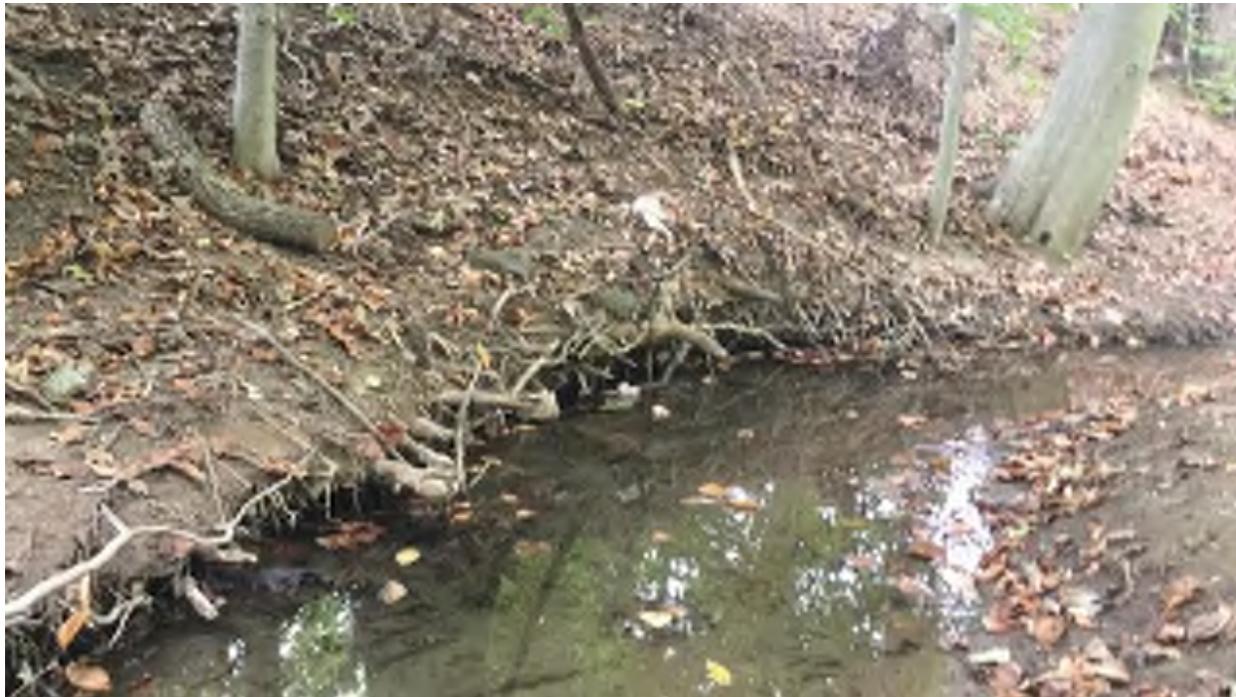
Photo 18 - Undercutting of banks on outside of meander bend at assessment Point 413 in subarea N2

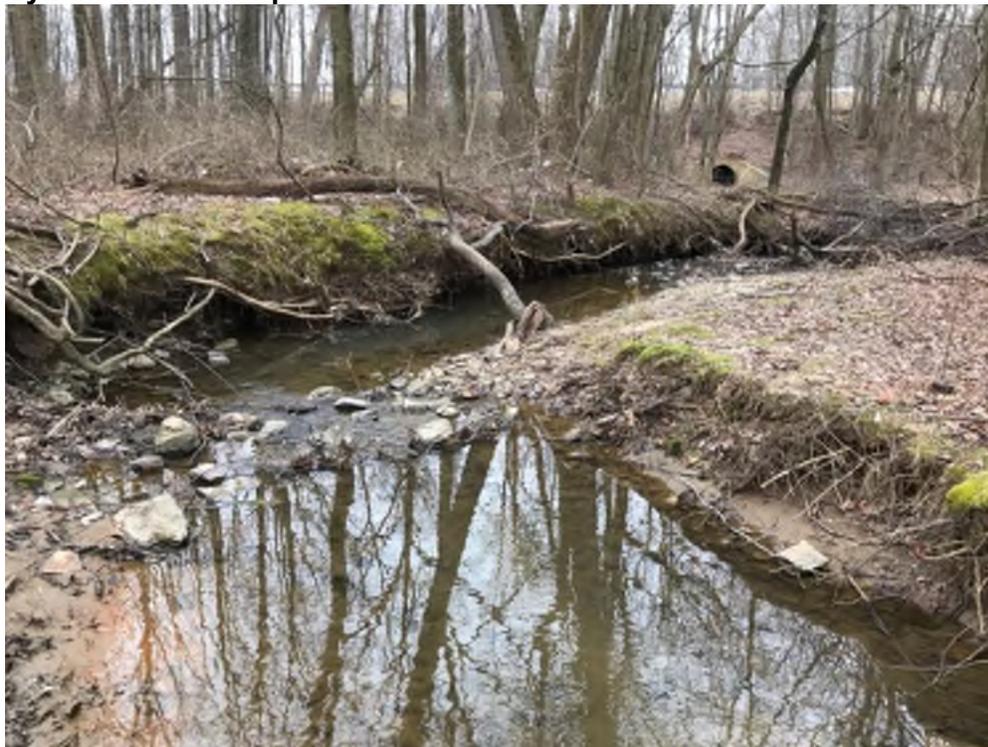
Bynum Run at Newport Drive

Photo 1: Outside bend with an undercut bank in wooded area upstream of culvert.

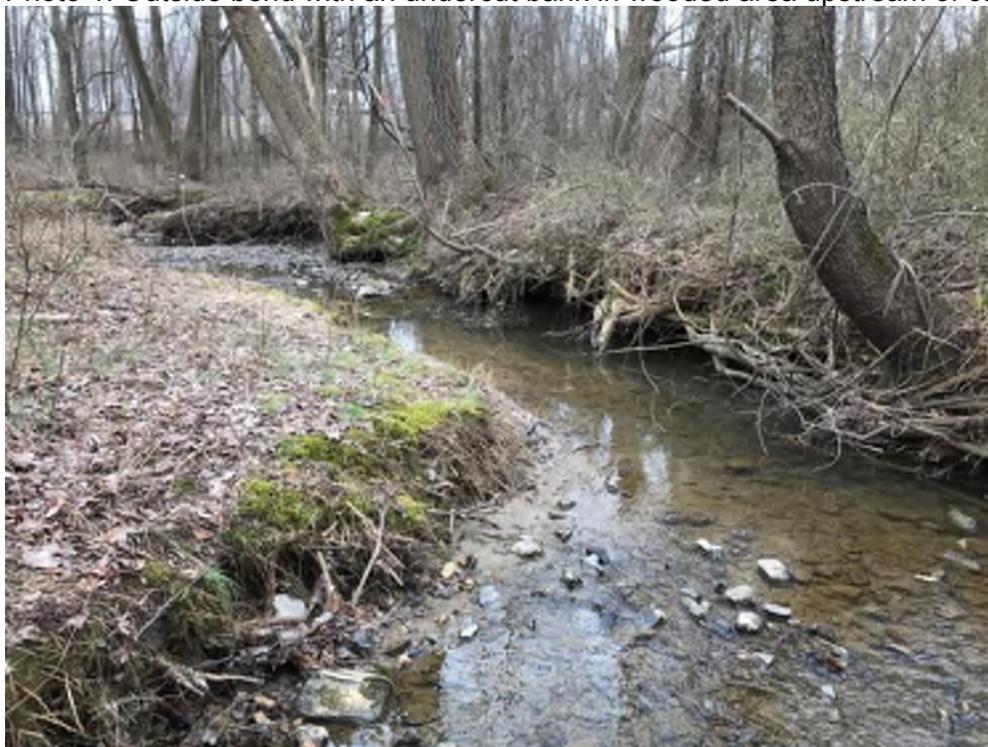
Photo 2: Undercut bank downstream of a bend in a wooded area.

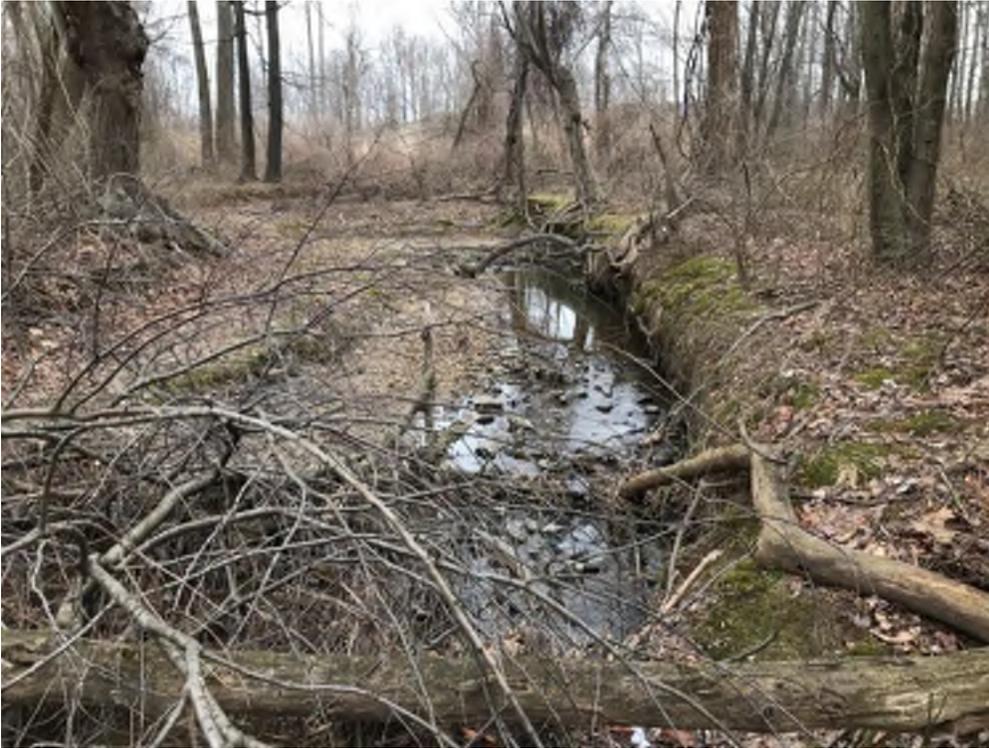
Photo 3: Outside bend with a steep undercut bank.

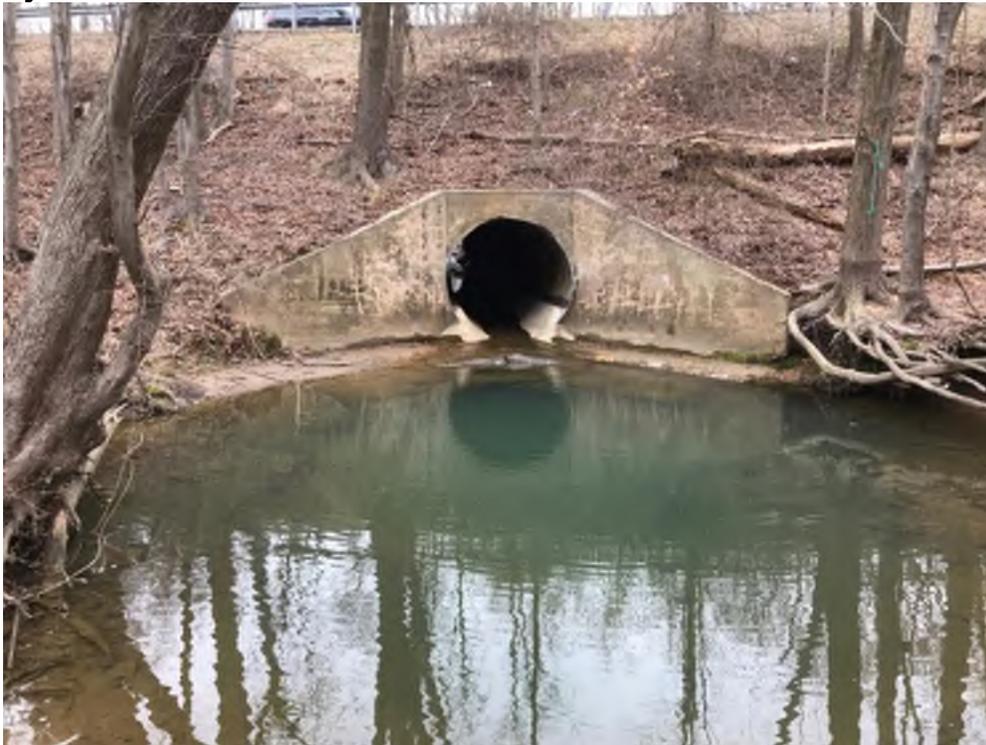
Bynum Run at MD-23

Photo 4: Scoured plunge pool at culvert outfall.

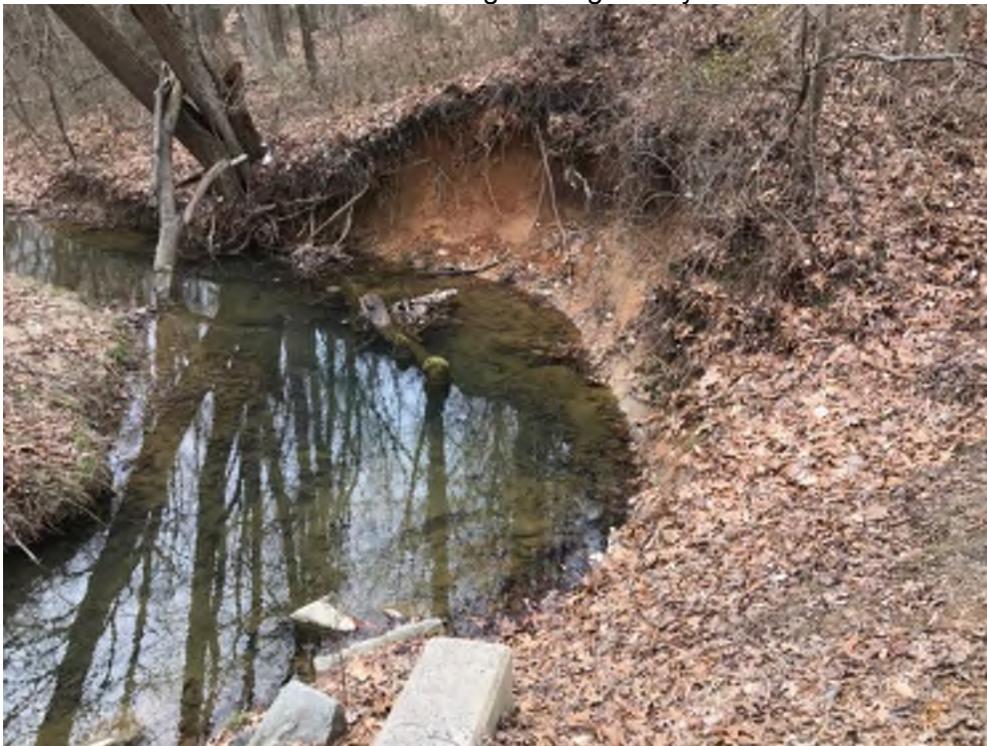
Photo 7: Outside bend tall vertical bank showing active signs of erosion.

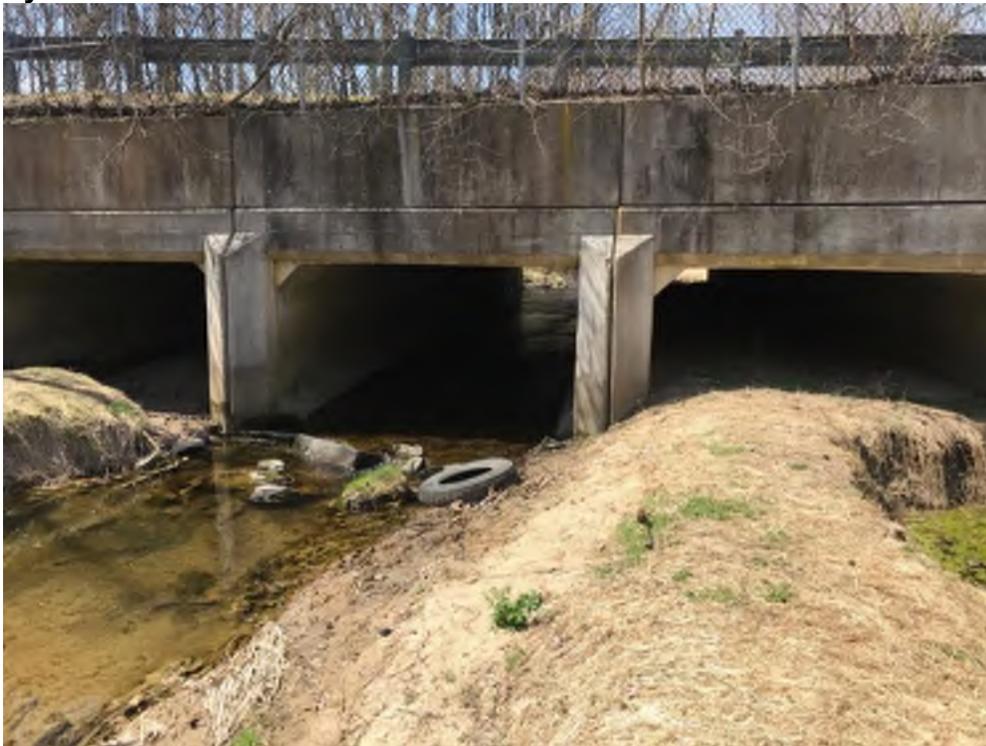
Bynum Run at Blake's Venture Park

Photo 8: Excessive aggradation located at the downstream side of a road crossing.

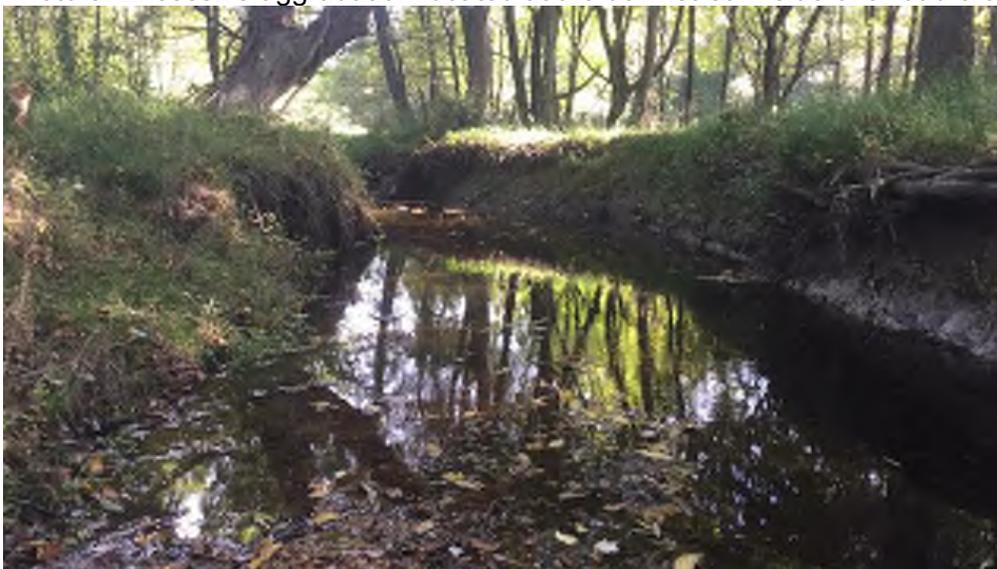
Photo 9: Incised channel cut off from its forested floodplain.

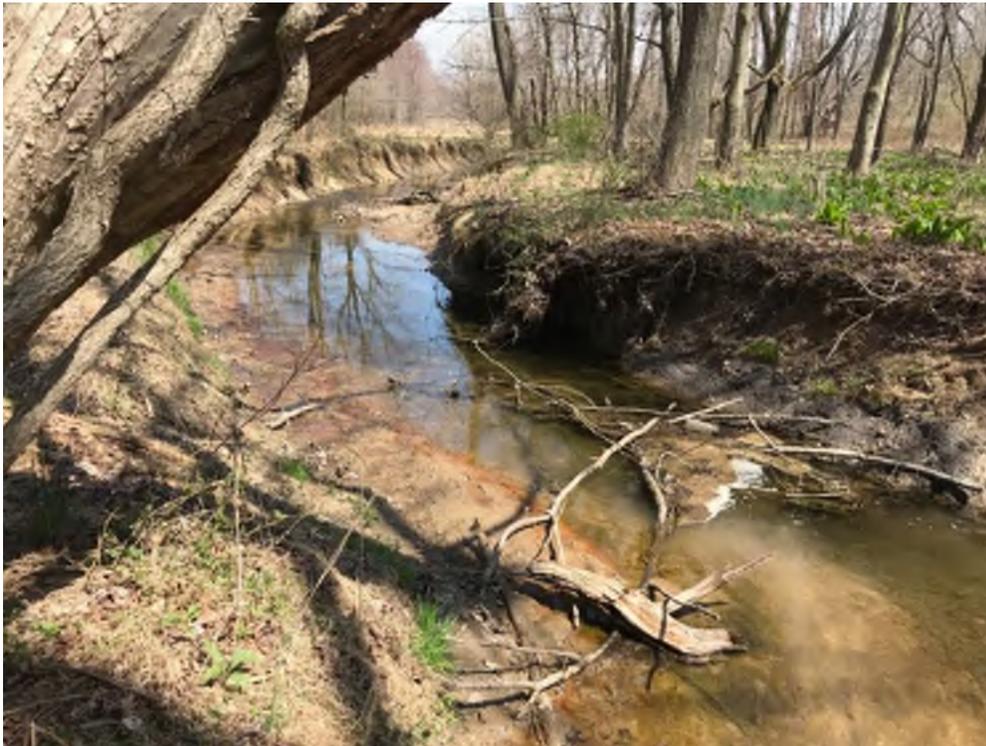
Photo 10: Incised channel with actively eroding banks on bends and straightaways.

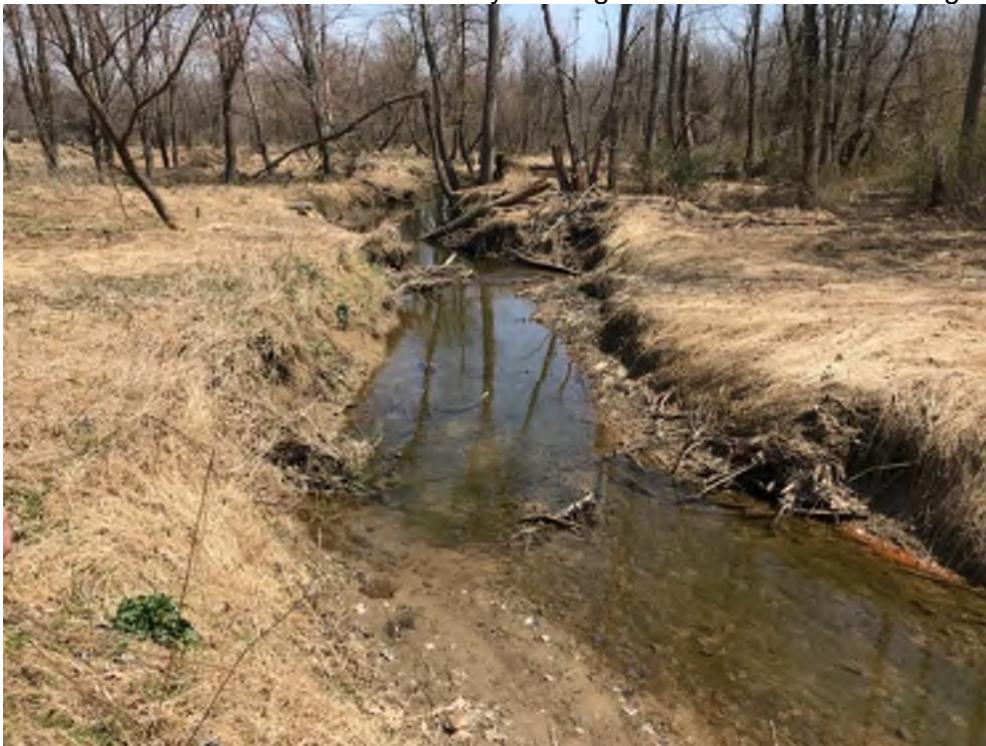
Photo 11: Previous beaver dam site. Headcut beginning to develop before bend.

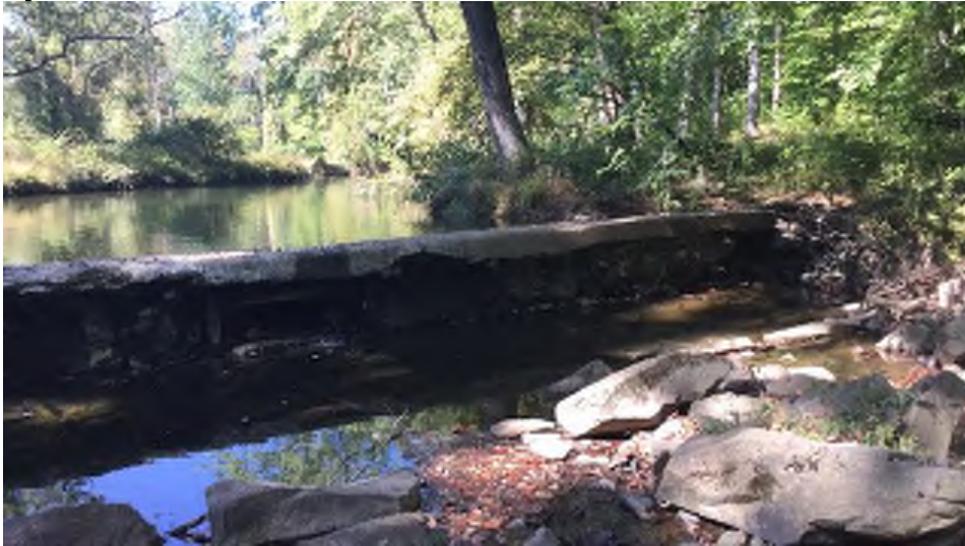
Bynum Run at Moores Mill Road

Photo 12: Looking upstream at inactive low head dam.

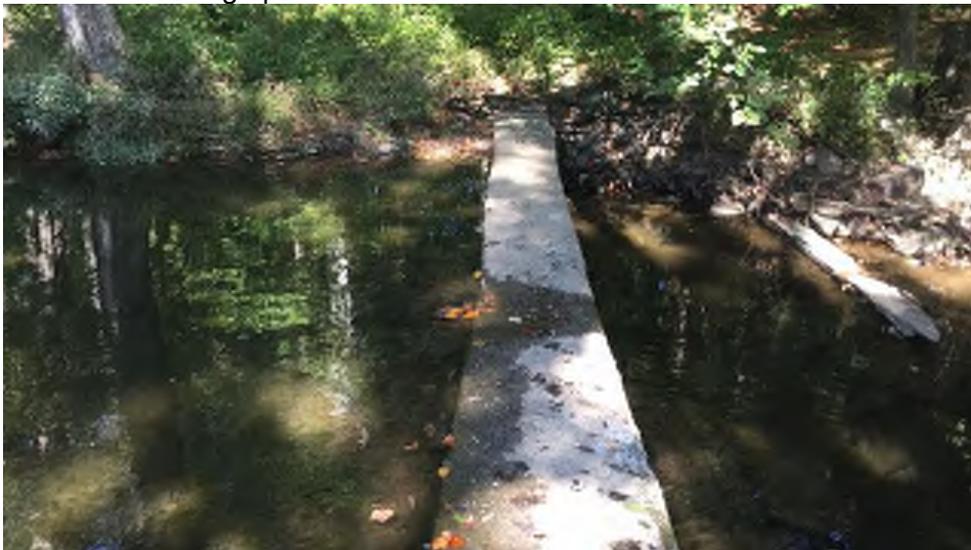
Photo 13: Low head dam from right bank showing a slight lean and aggradation upstream.

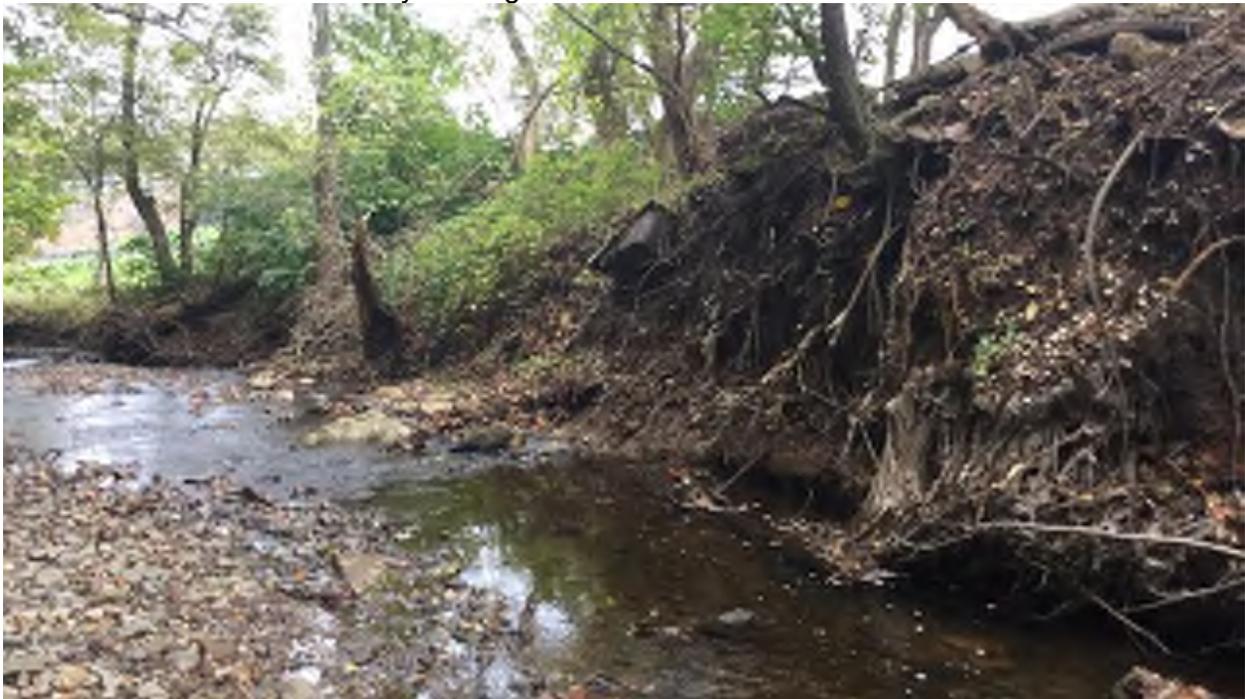
Photo 16: Steep bank showing signs of active erosion.

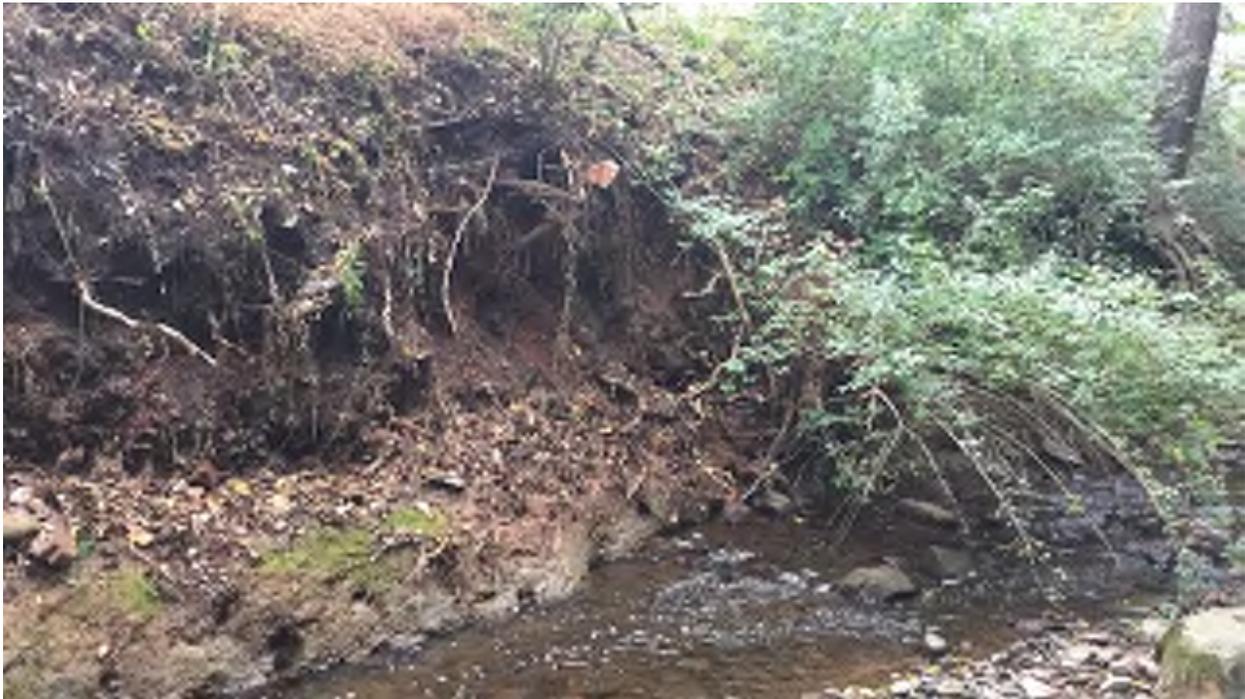
Photo 17: Steep stratified bank displaying erosion at riffle section.

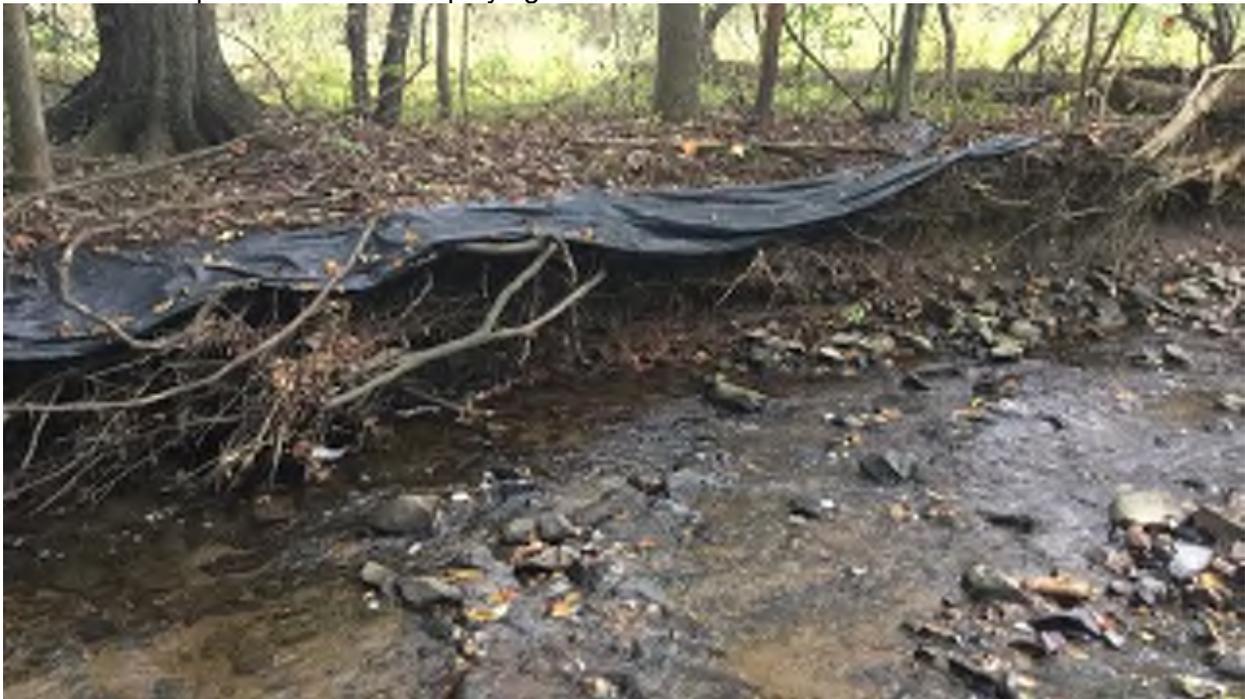
Photo 18: Steep eroding streambank exposing previous erosion protection attempts.

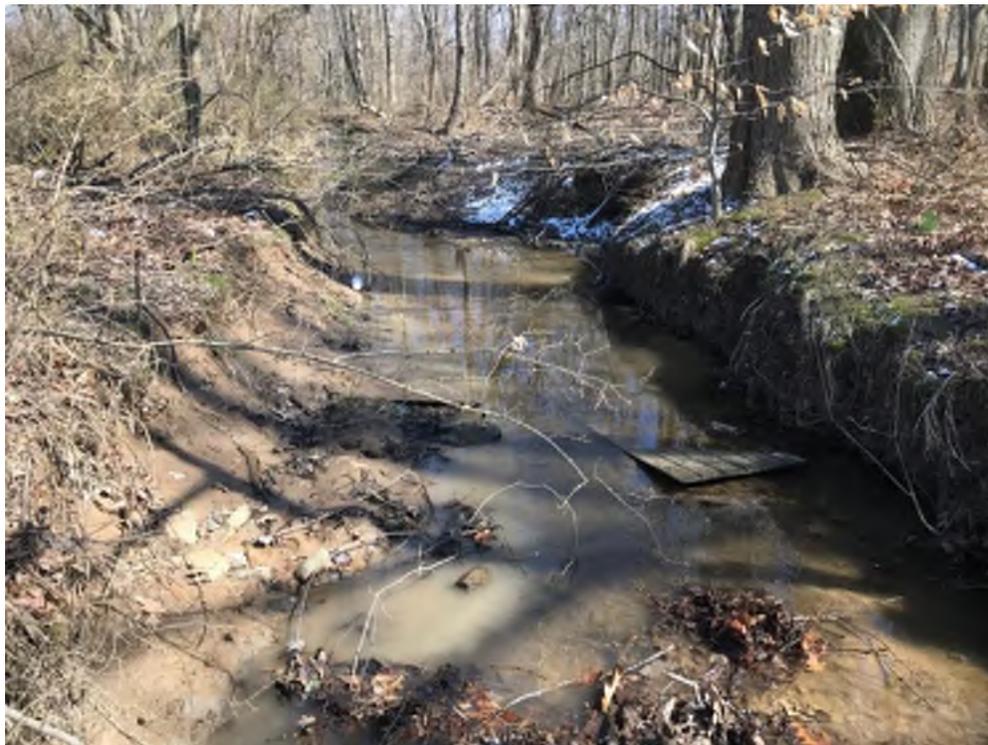
UNT at Melrose Lane

Photo 19: Incised channel with fine sediment deposition on streambed.

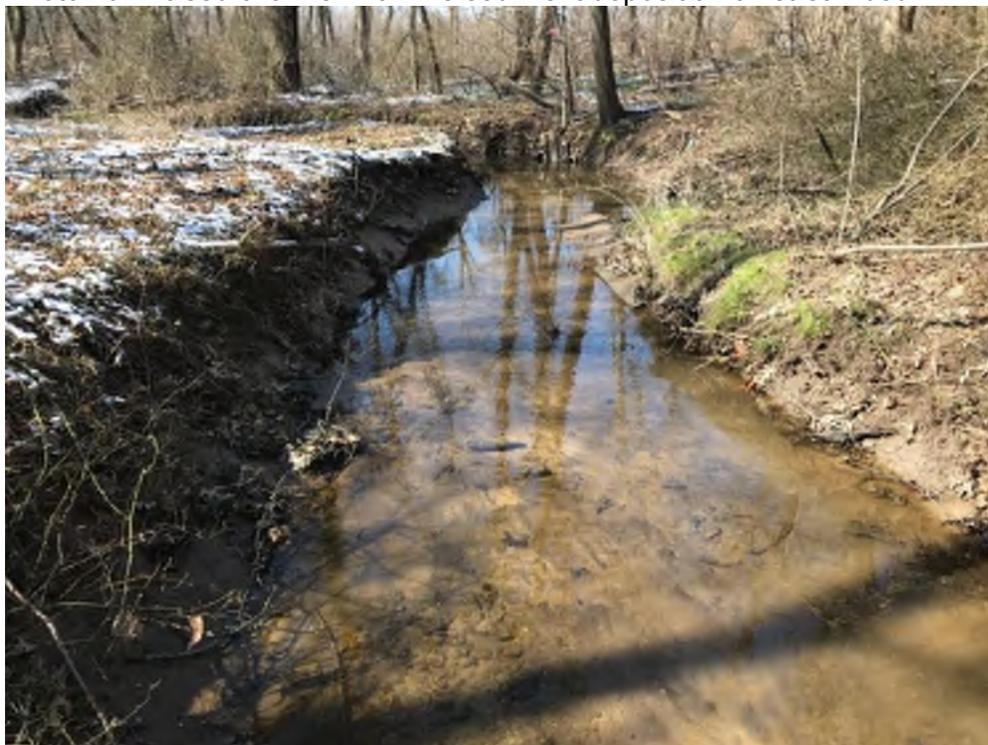
Photo 20: Incised channel with fine sediment deposition on streambed.

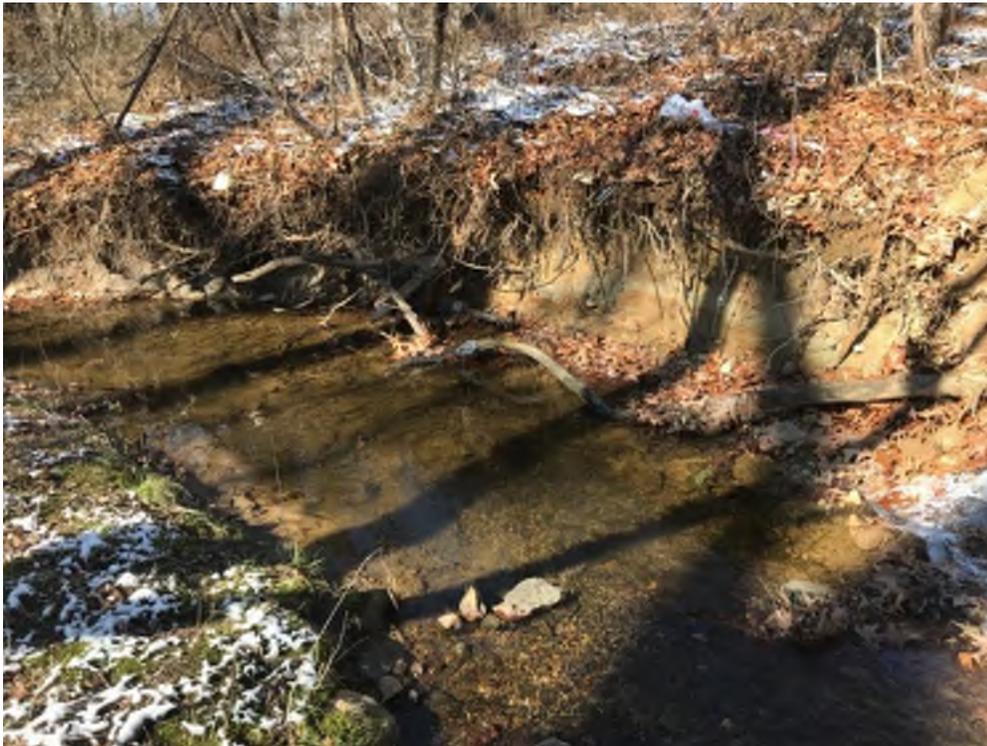
Photo 21: Stratified outside bend bank erosion.

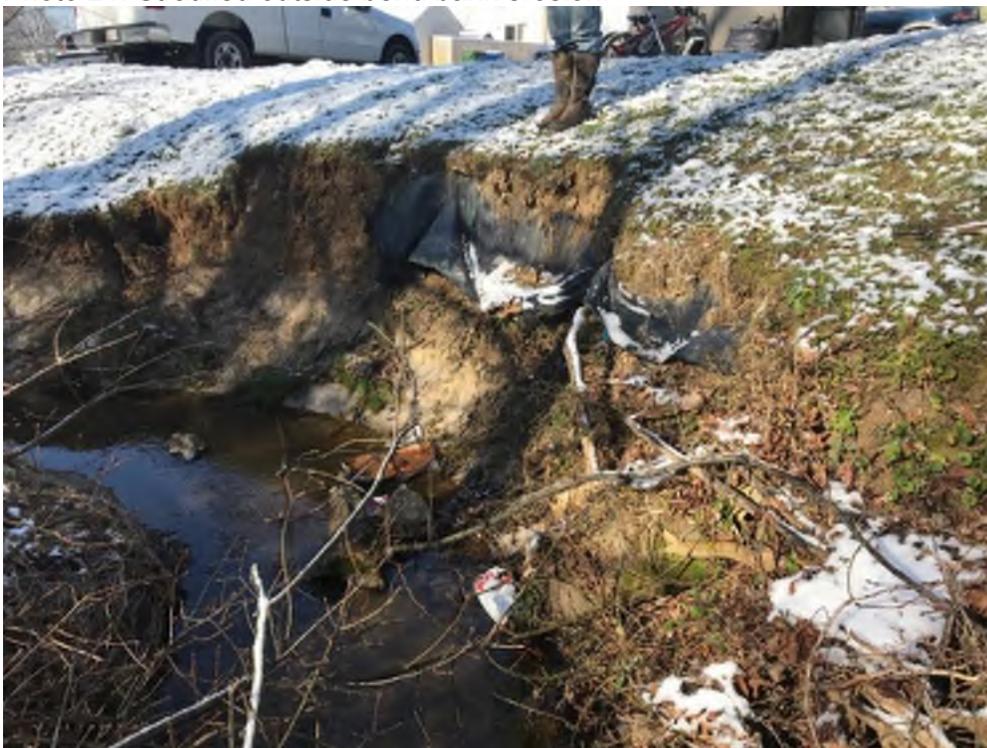
Photo 22: Outside bend erosion encroaching on neighboring property.

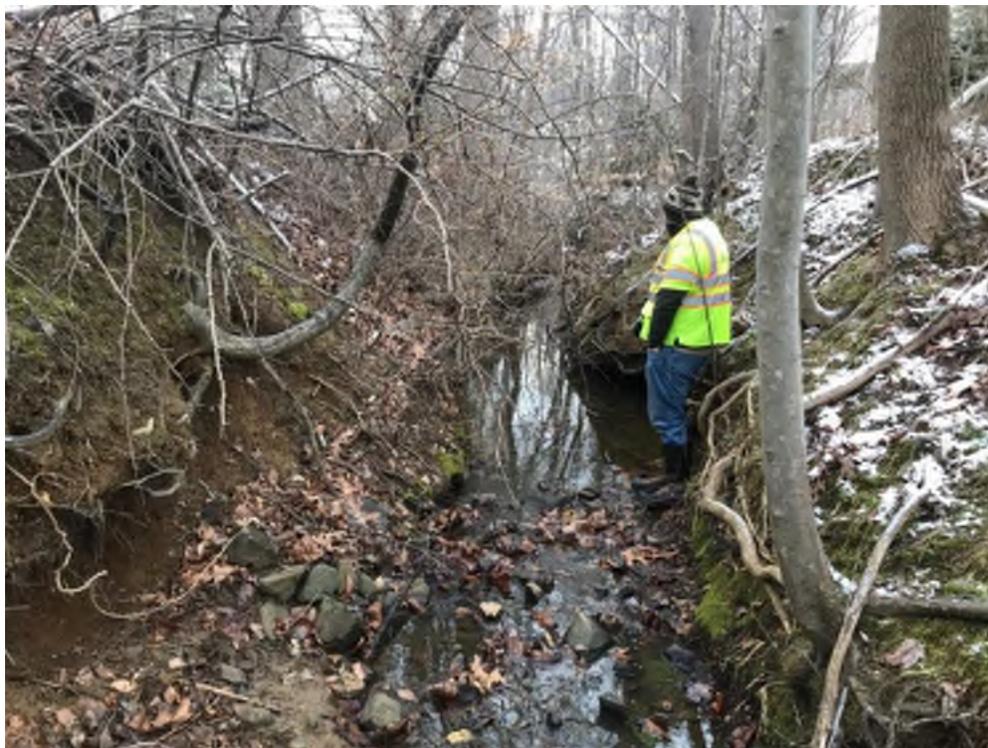
UNT at Switchman Drive

Photo 23: Deeply incised channel with eroding bank toe.

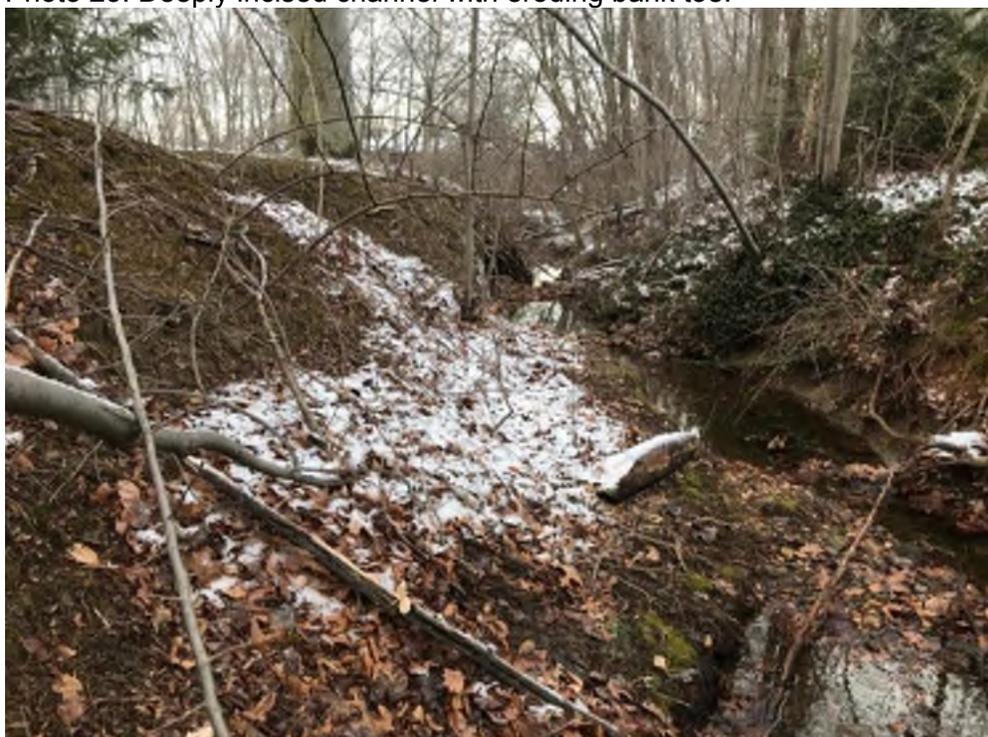
Photo 24: Deeply incised channel with slightly vegetated banks.

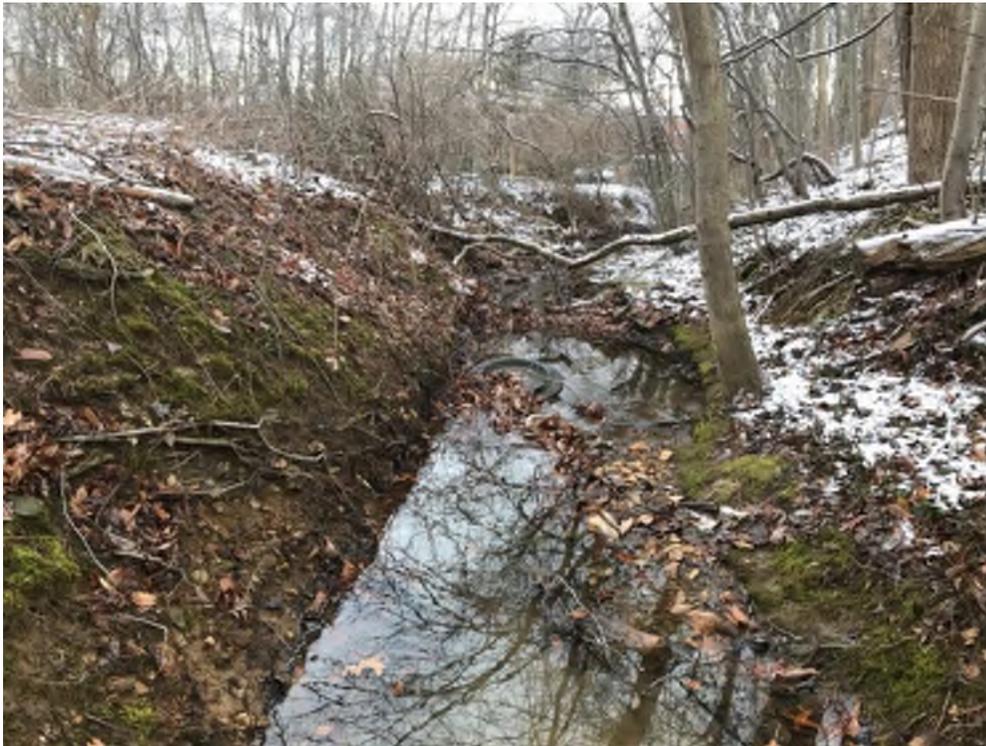
Photo 25: Deeply incised channel.

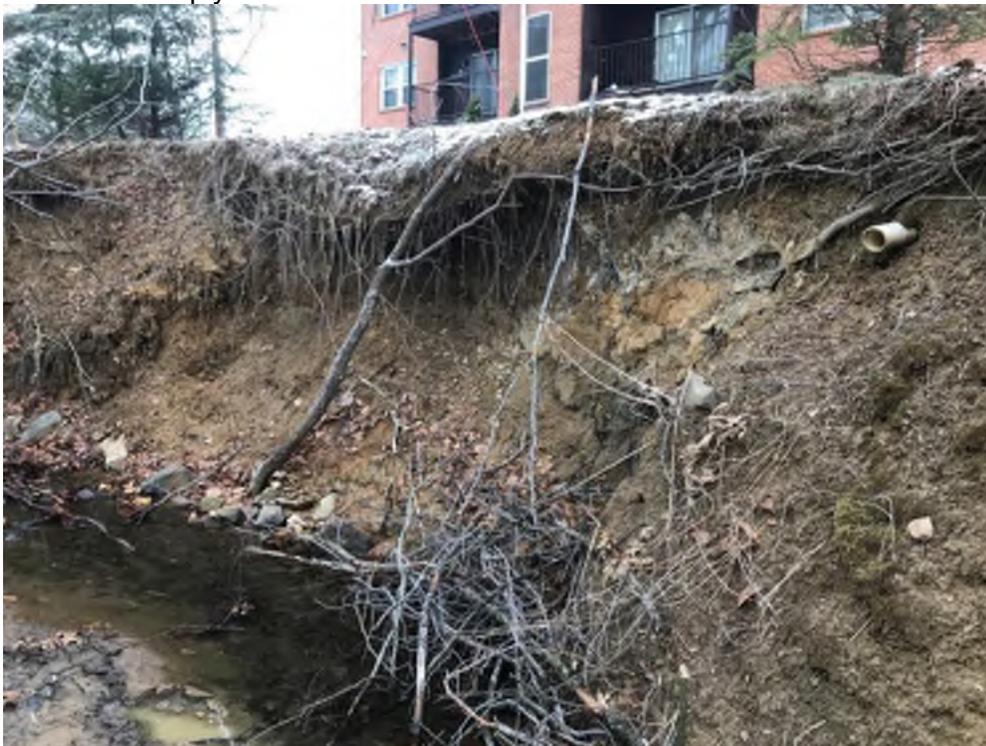
Photo 26: Outside bank erosion exposing roof drain and encroaching on neighboring property.
