Upper Bynum Run Watershed Assessment Report

This report is a summary of the Upper Bynum Run Watershed. This report meets all the requirements of the 319 Grant application.

December 14, 2018

Stantec Consulting Services, Inc
810 Gleneagles Court, Suite 300
Baltimore, MD 21286

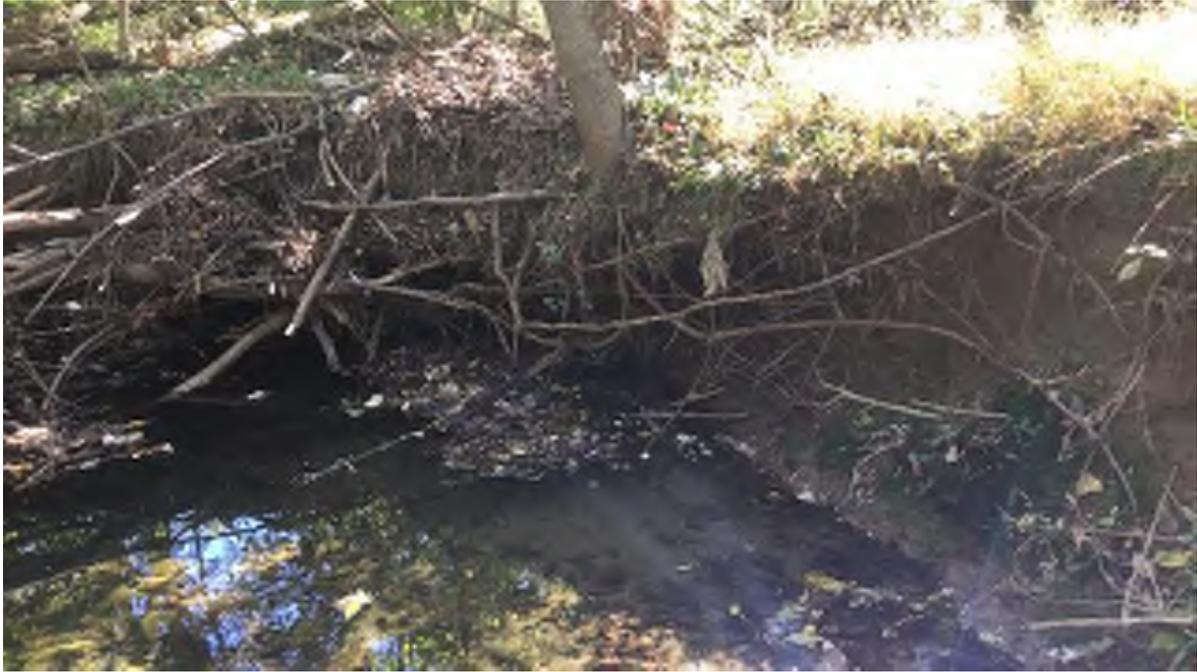
Photo 27: Steep outside bend erosion undercutting existing vegetation.

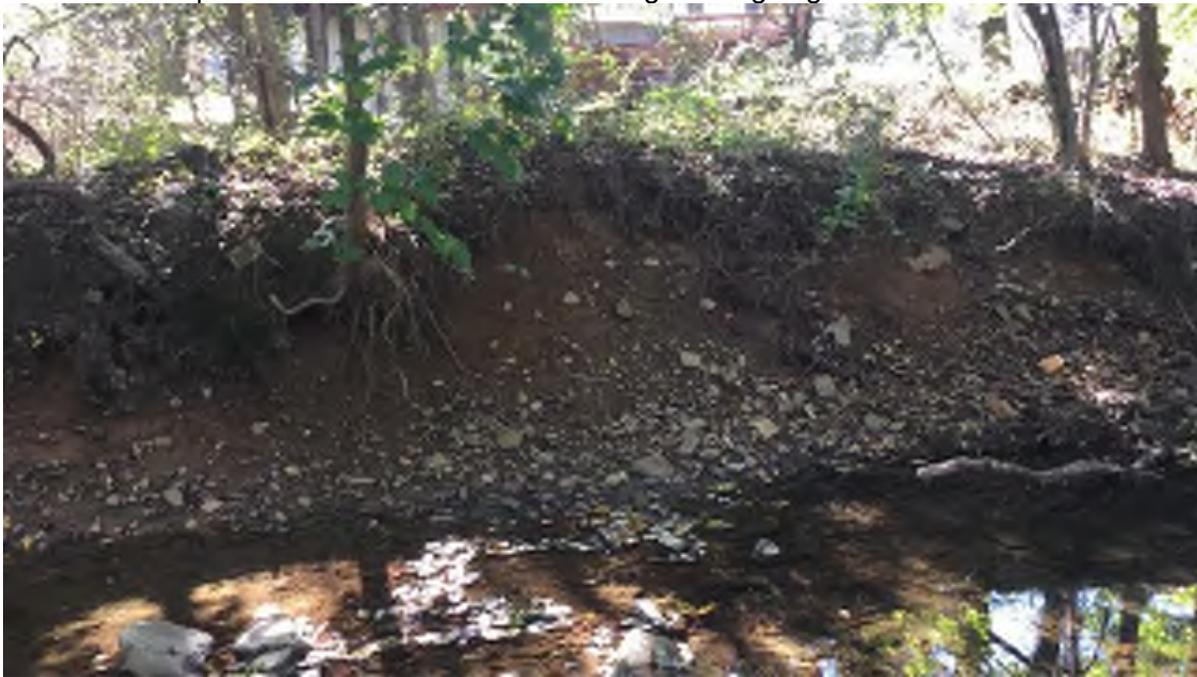
Photo 28: High, exposed, eroding bank.

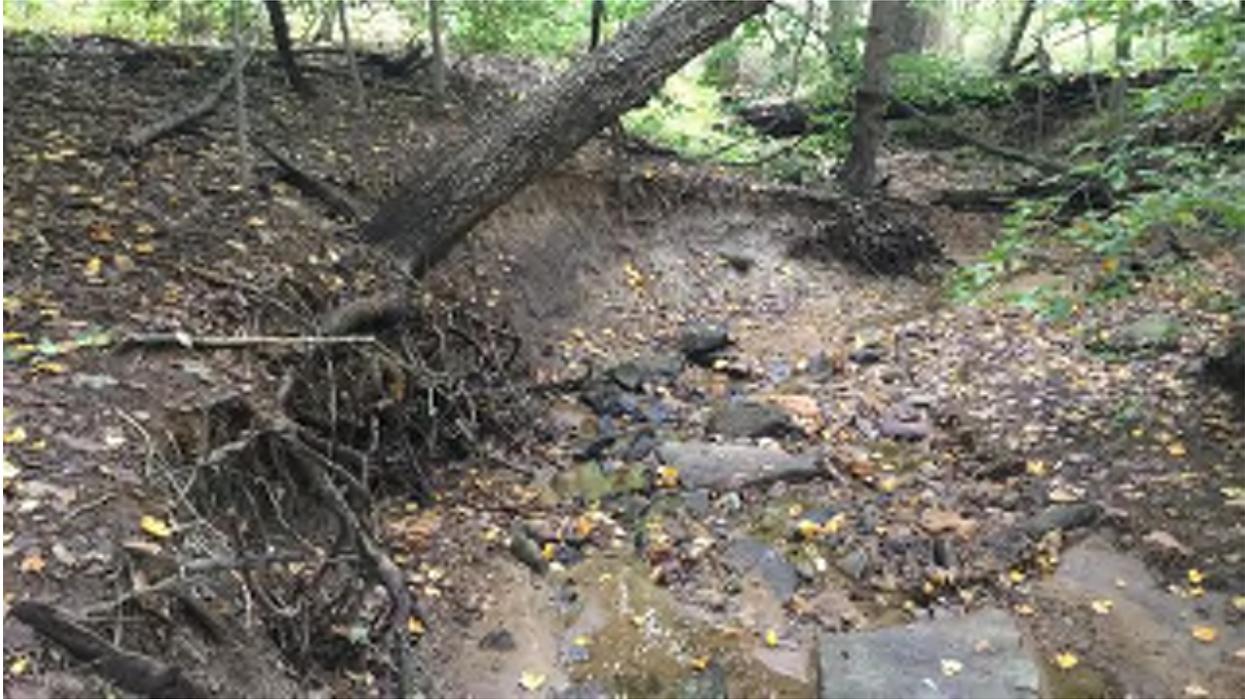
Photo 30: High exposed eroding bank.

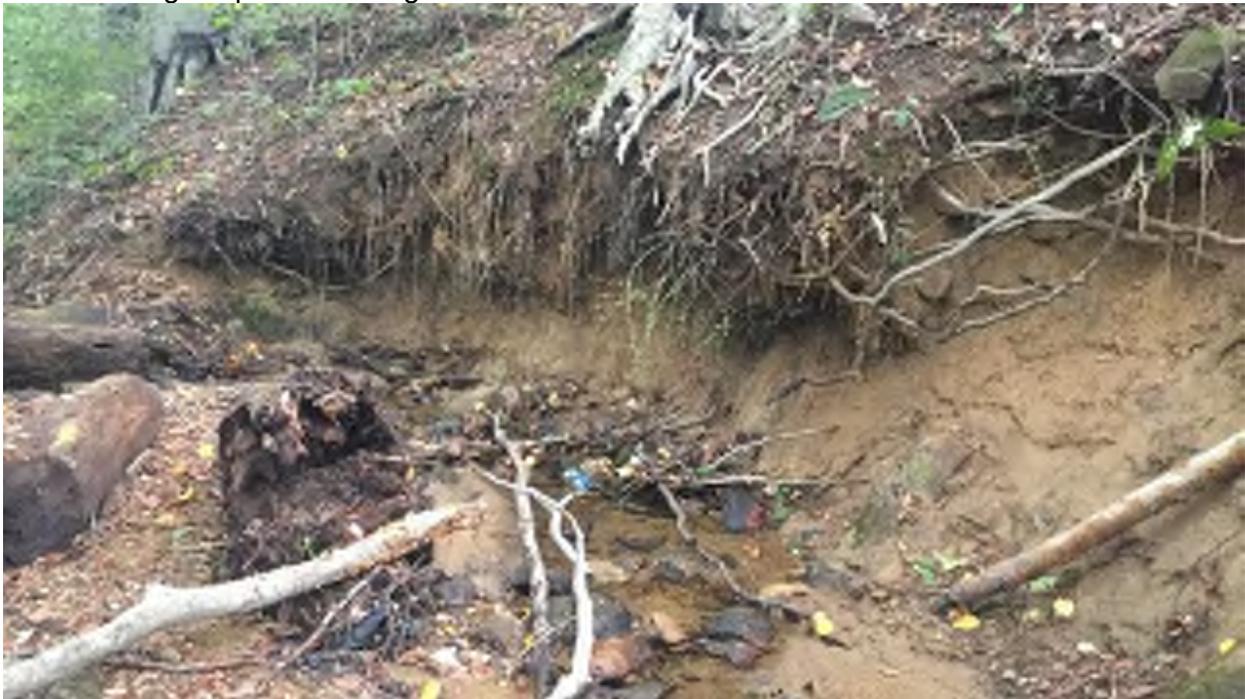
Photo 31: Hillside toe erosion.

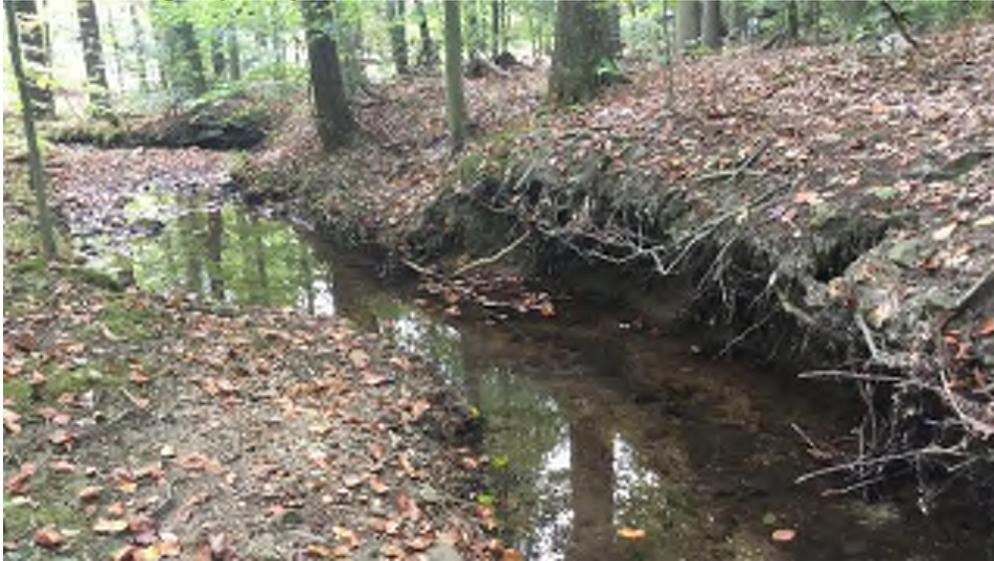
Photo 33: Undercut bank in forested area.

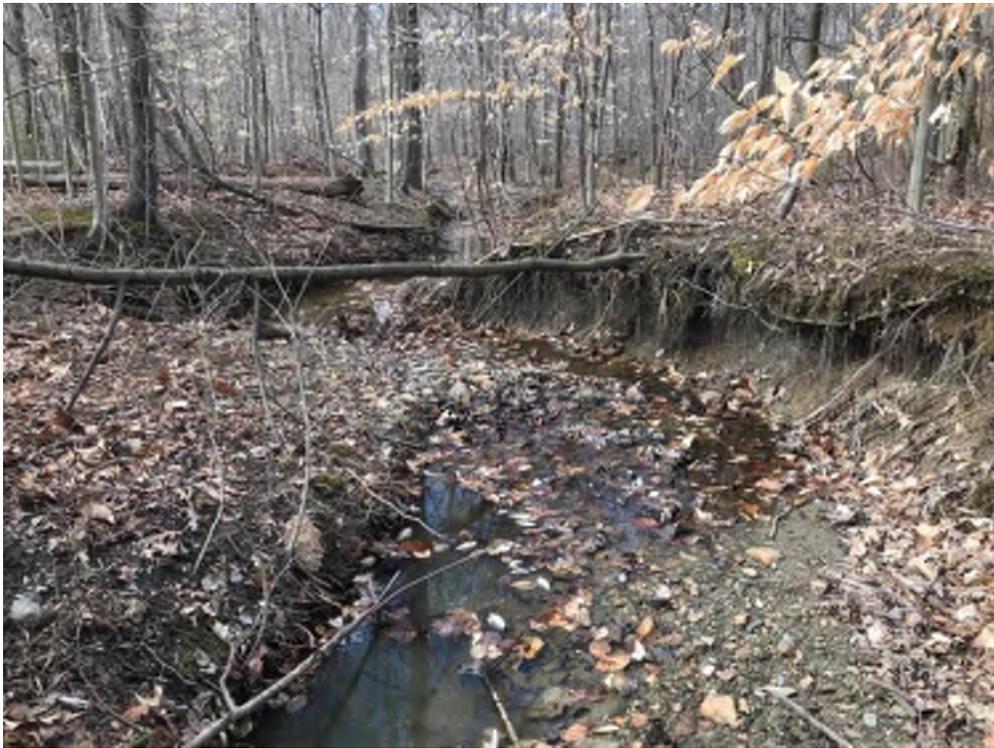
Photo 34: Outside bend bank erosion along torturous meanders.

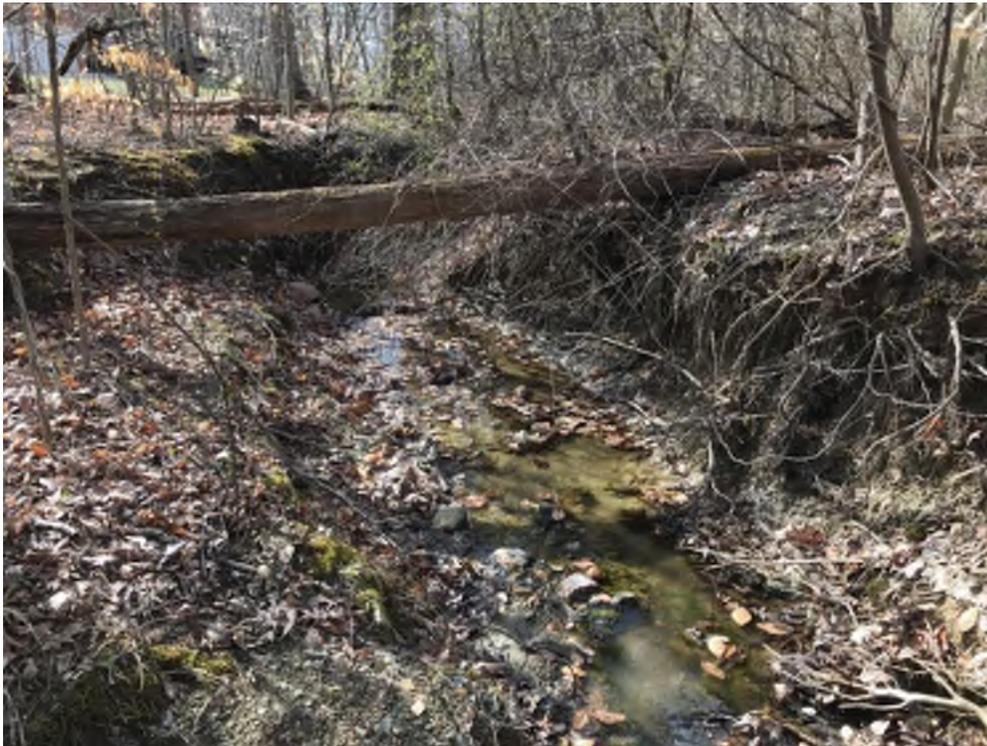
Photo 35: Deeply incised channel with exposed banks.

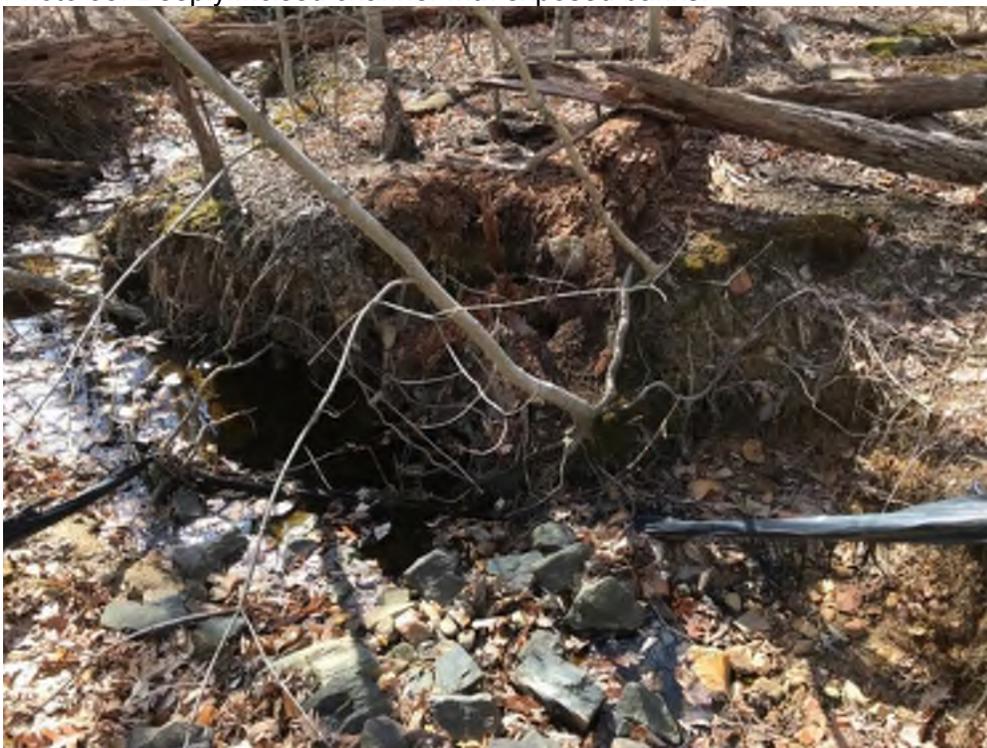
Photo 36: Steep inside bank indicating heavily incised channel.

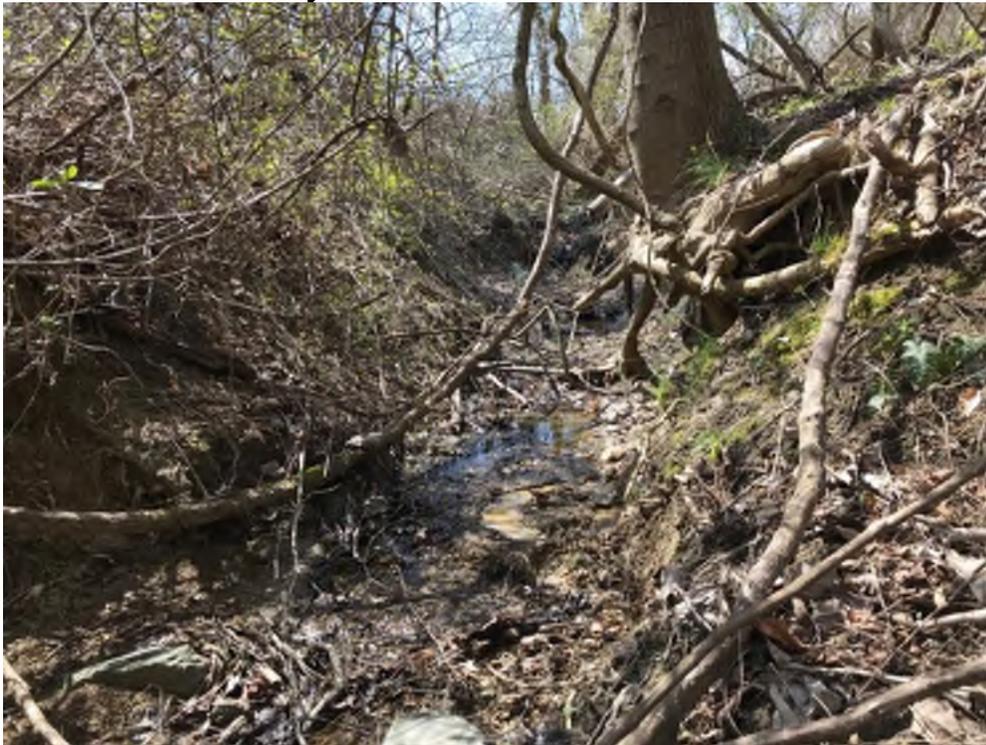
Photo 37: Deeply incised channel with vegetated banks.

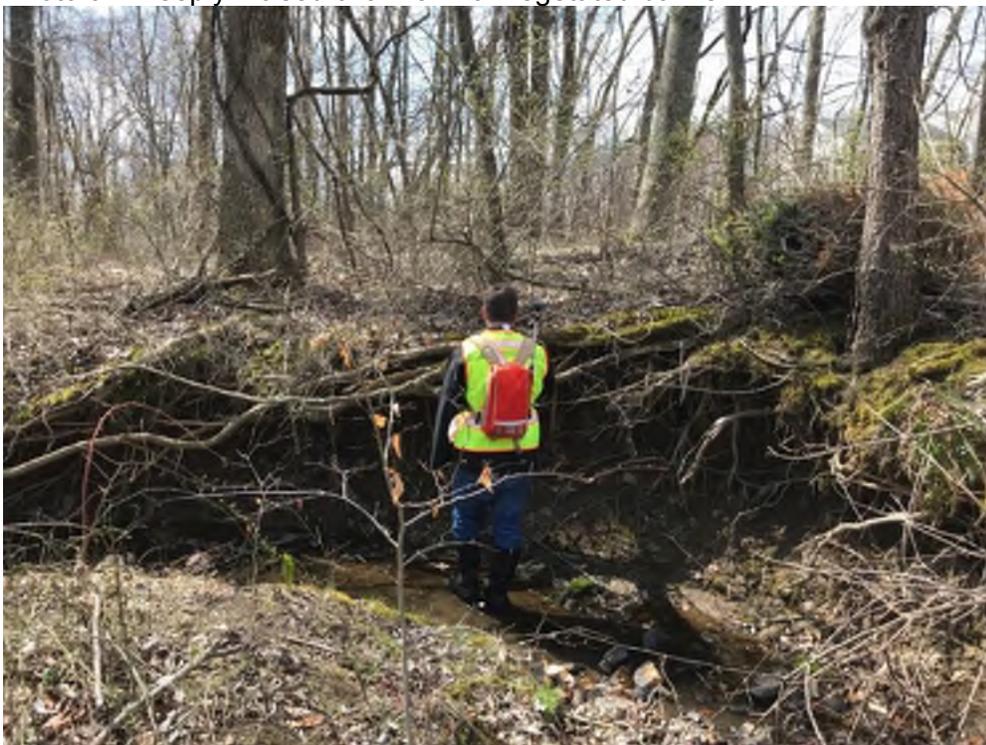
Photo 38: Outside bank erosion with exposed tree roots.

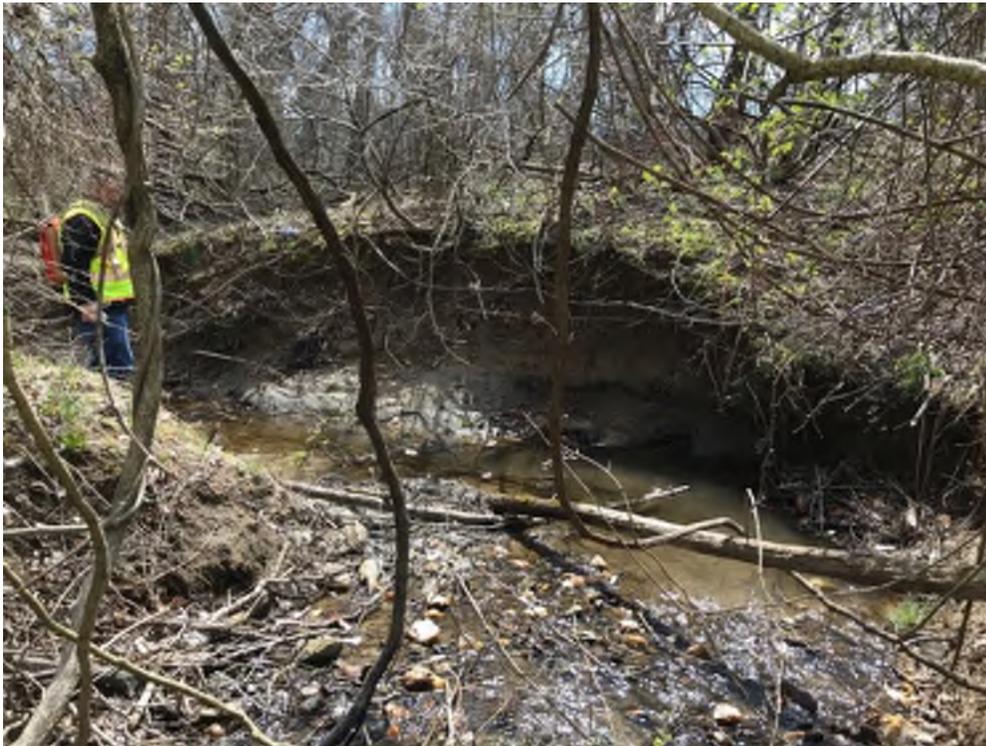
Photo 39: Exposed outside bank showing signs of severe erosion.

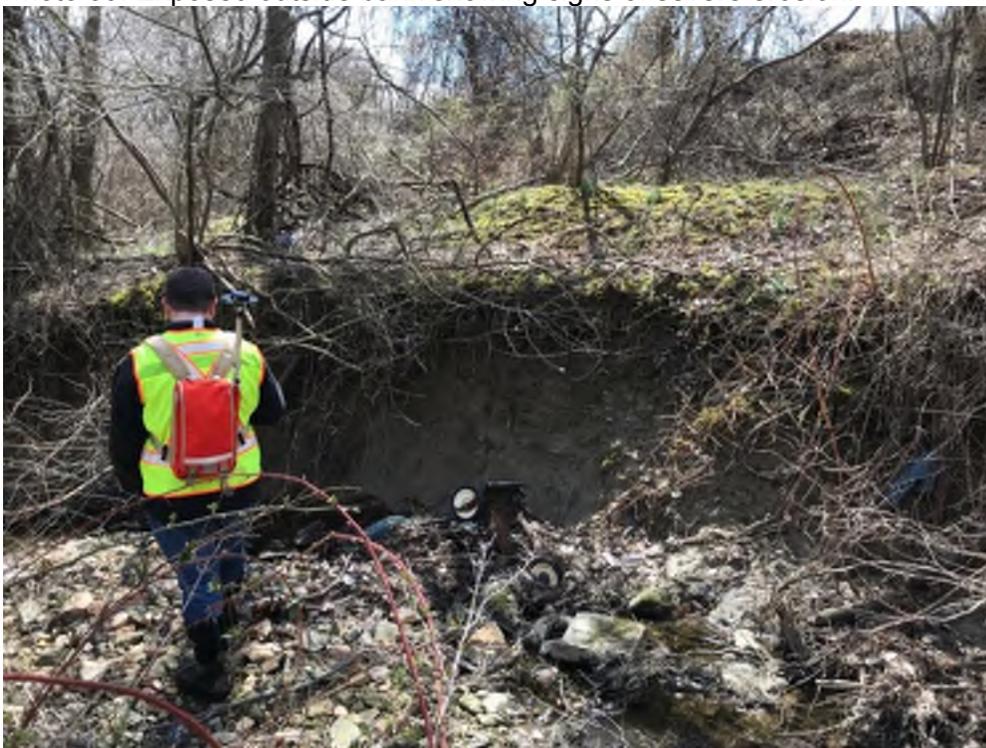
Photo 40: Exposed outside bank displaying signs of severe erosion.

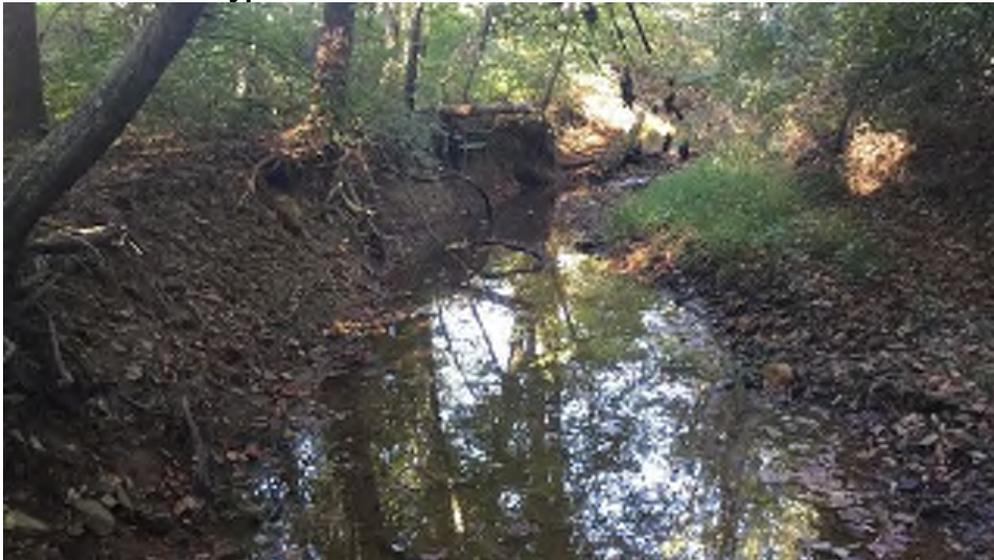
Photo 41: High exposed bank displaying signs of erosion.

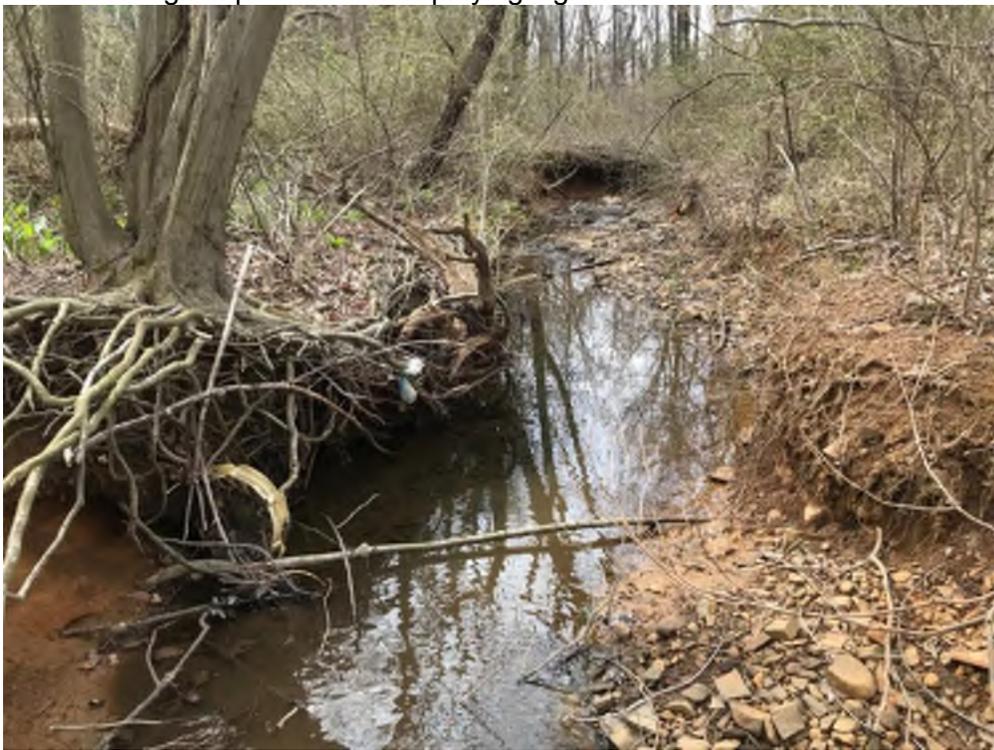
Photo 42: Incised channel with undercut bank.

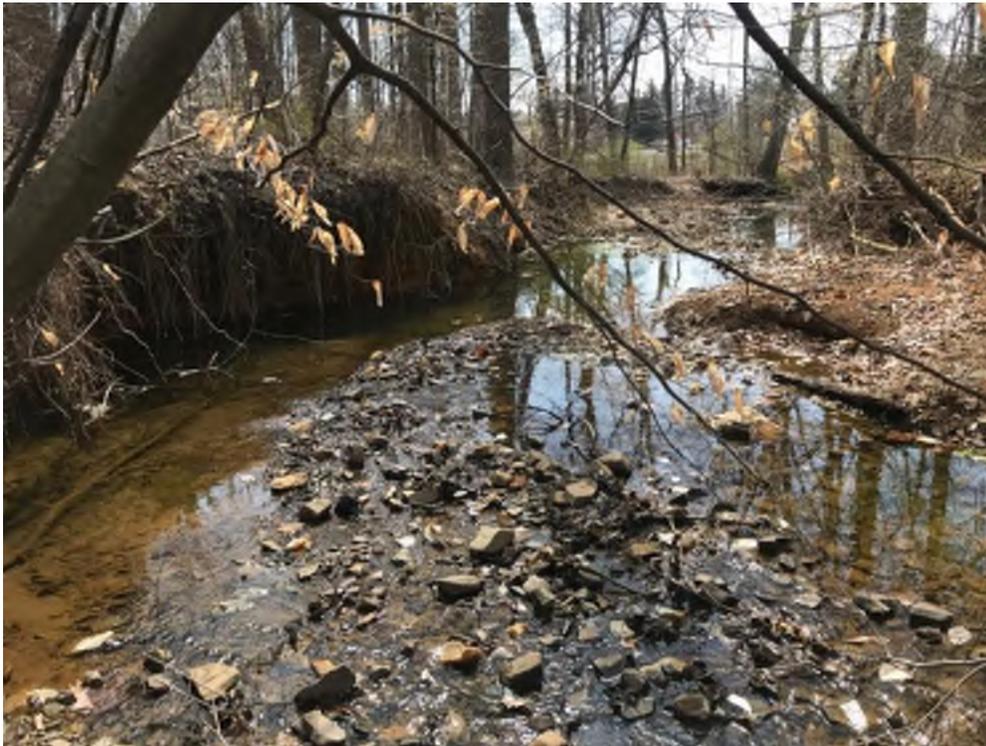
Photo 43: Transverse bar creating an undercut bank.

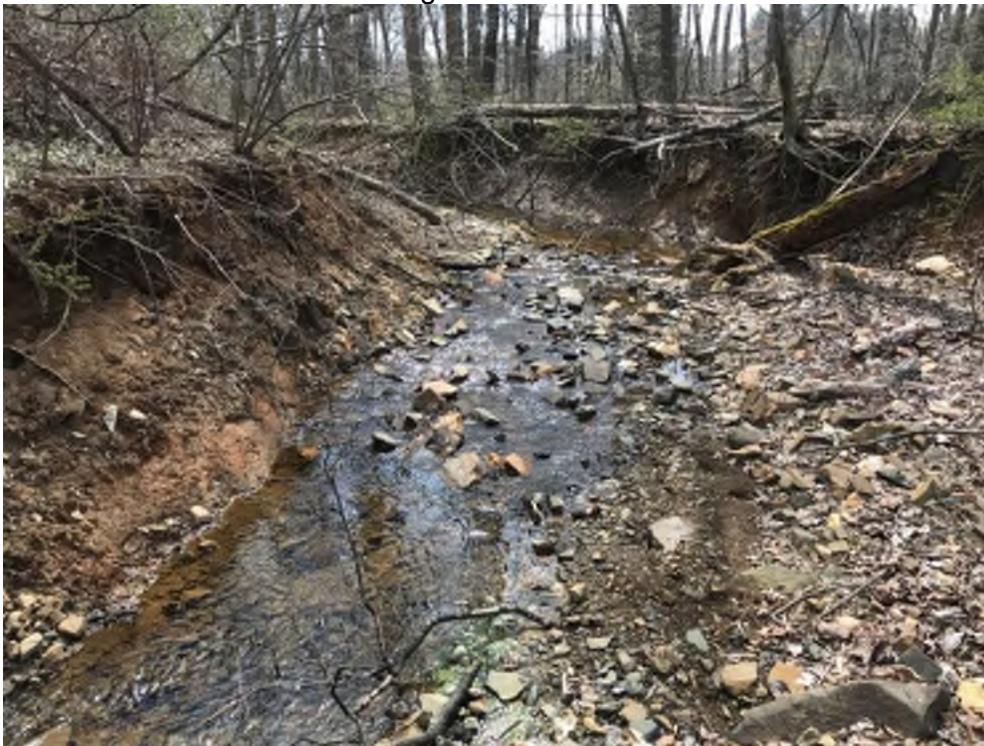
Photo 44: Incised and widened channel cut off from its forested floodplain.

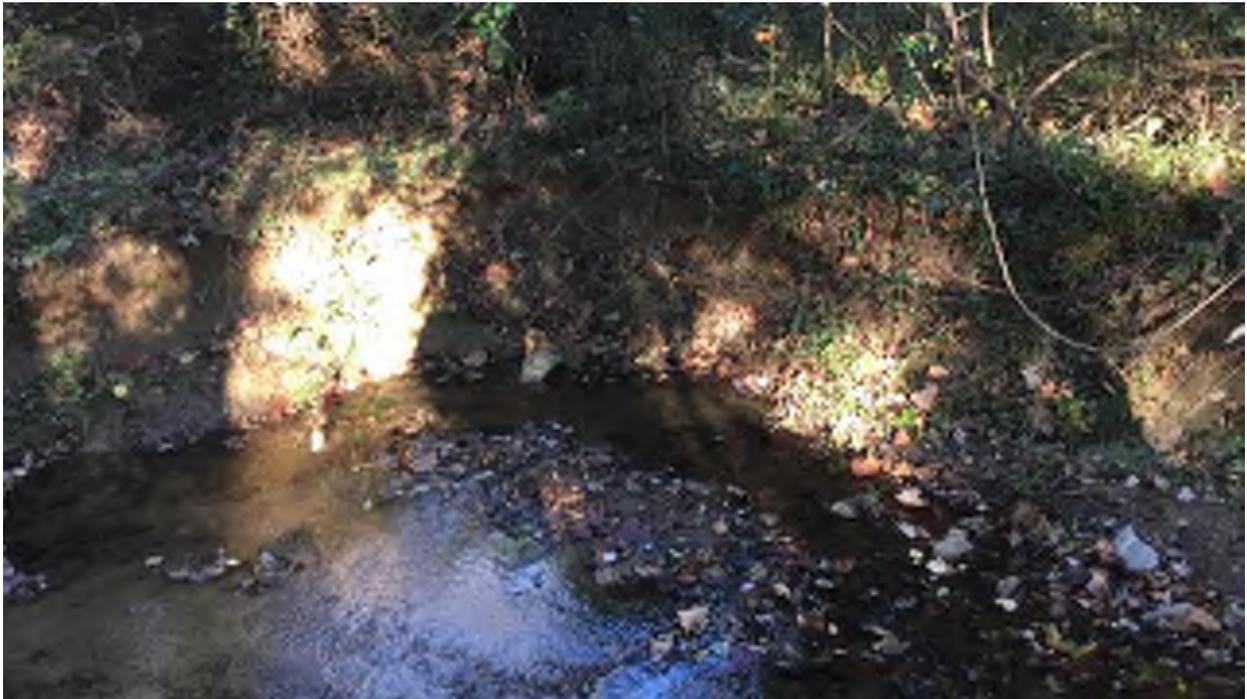
Photo 45: Slightly vegetated outside bend displaying moderate erosion.

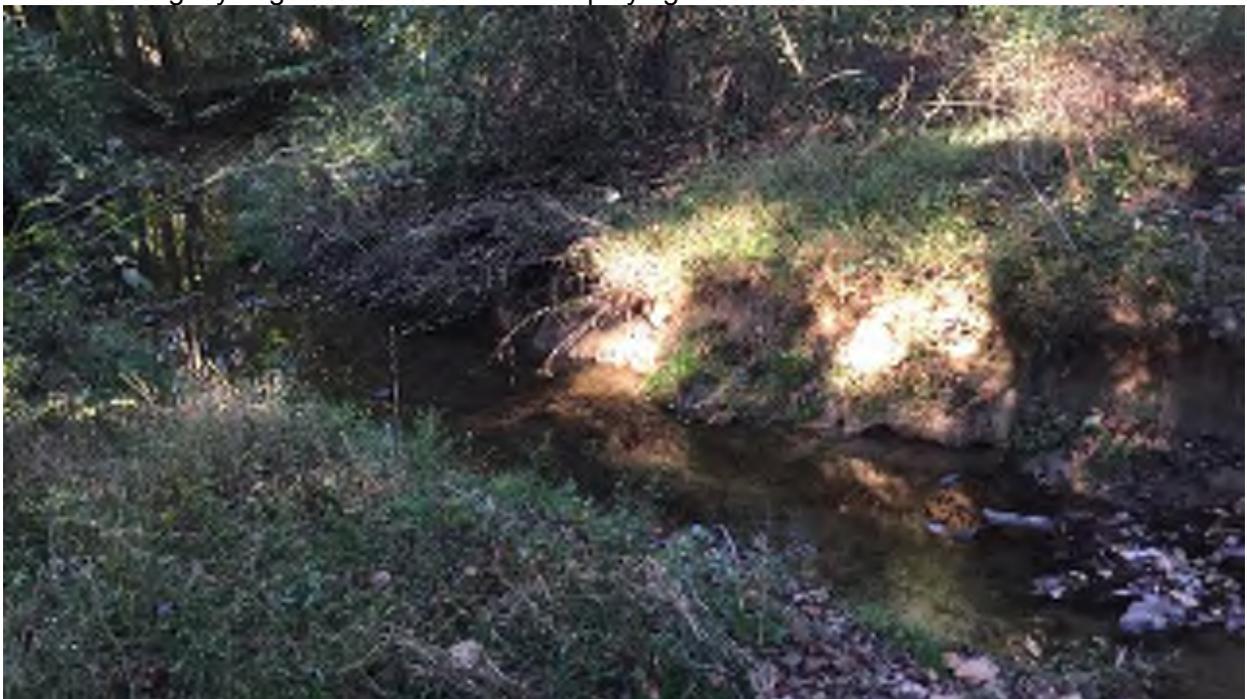
Photo 46: Steep bank downstream of bend showing signs of erosion.

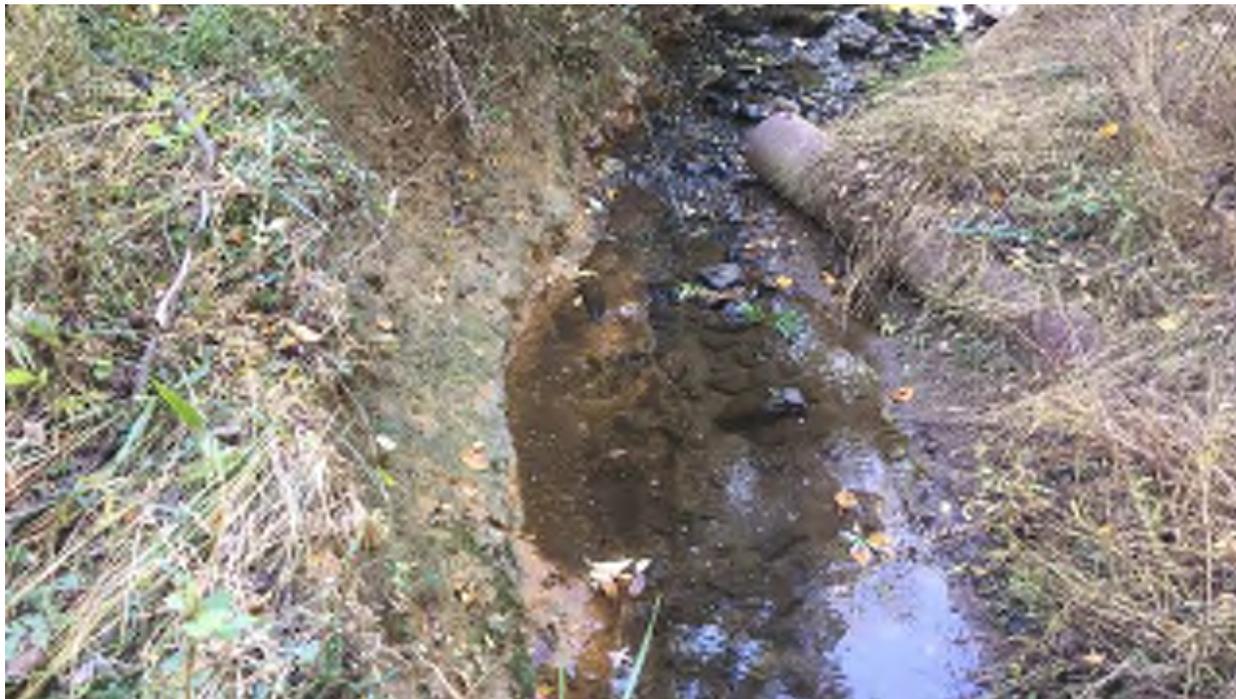
Photo 47: Unvegetated outside bank displaying erosion with a displaced pipe partially exposed.

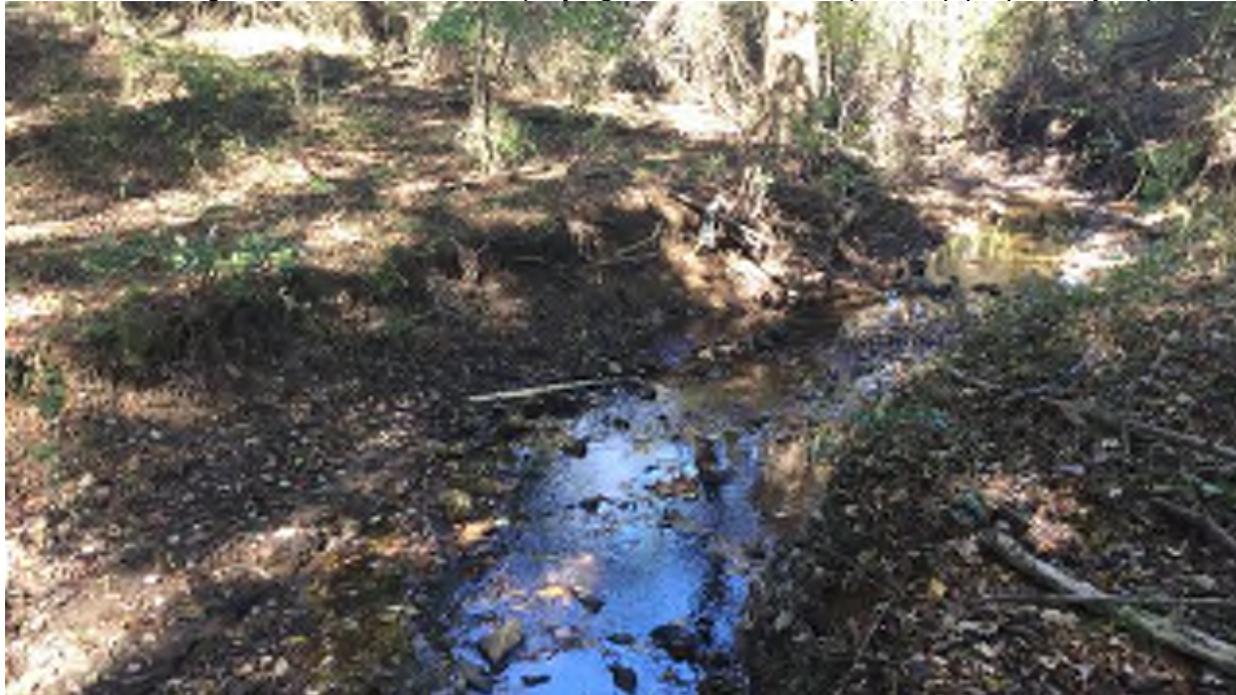
Photo 48: Both inside and outside stream banks showing signs of erosion at downstream bend.

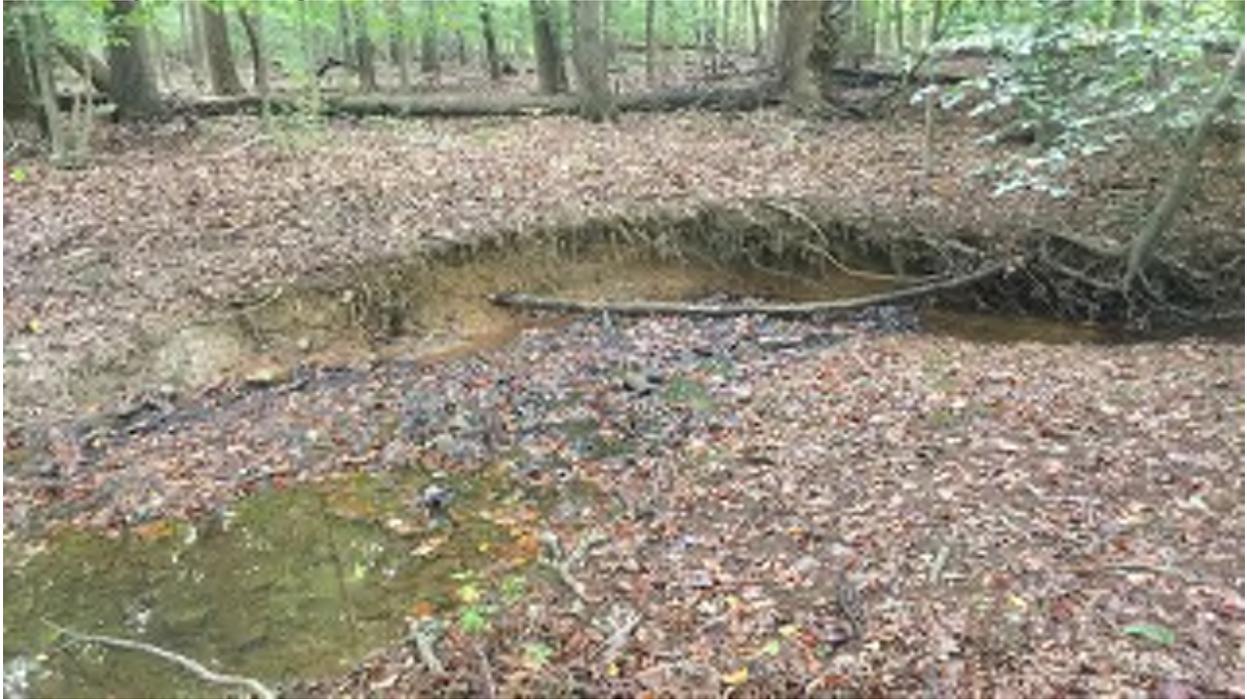
Photo 49: Outside bend displaying erosion.
