# Sam's Branch Tributary Watershed Assessment and Baseline Stream Monitoring

*Final Report*

*August 2012*

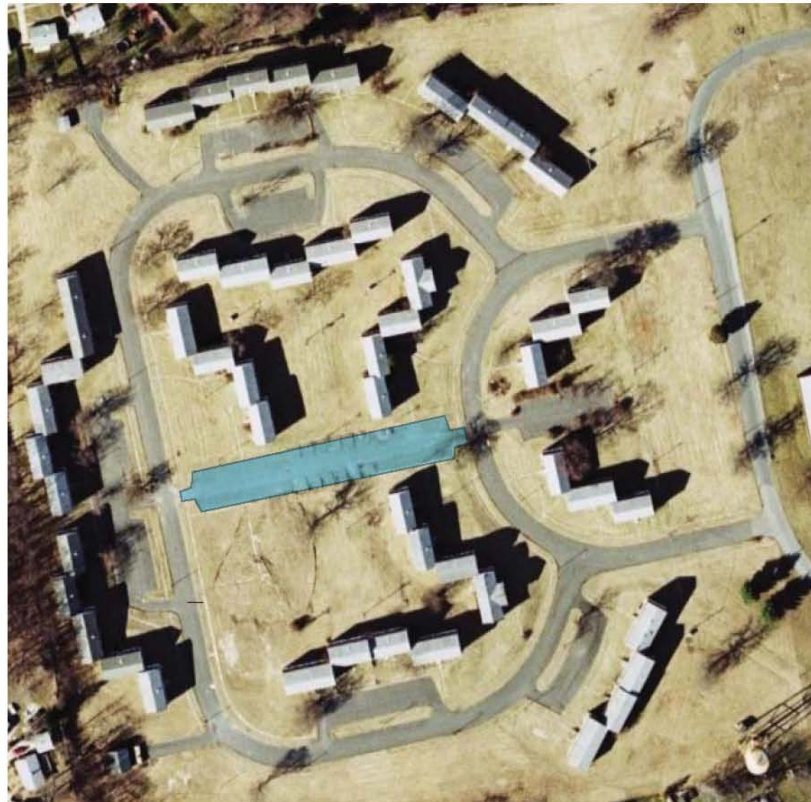
**Figure 3-3. SBB – Hawthorne Drive - abandoned high density residential**

Remove Impervious Surfaces - SBB - Hawthorne Drive

Proposed Impervious Surface Removal  
Area: 24,630 sq. ft.

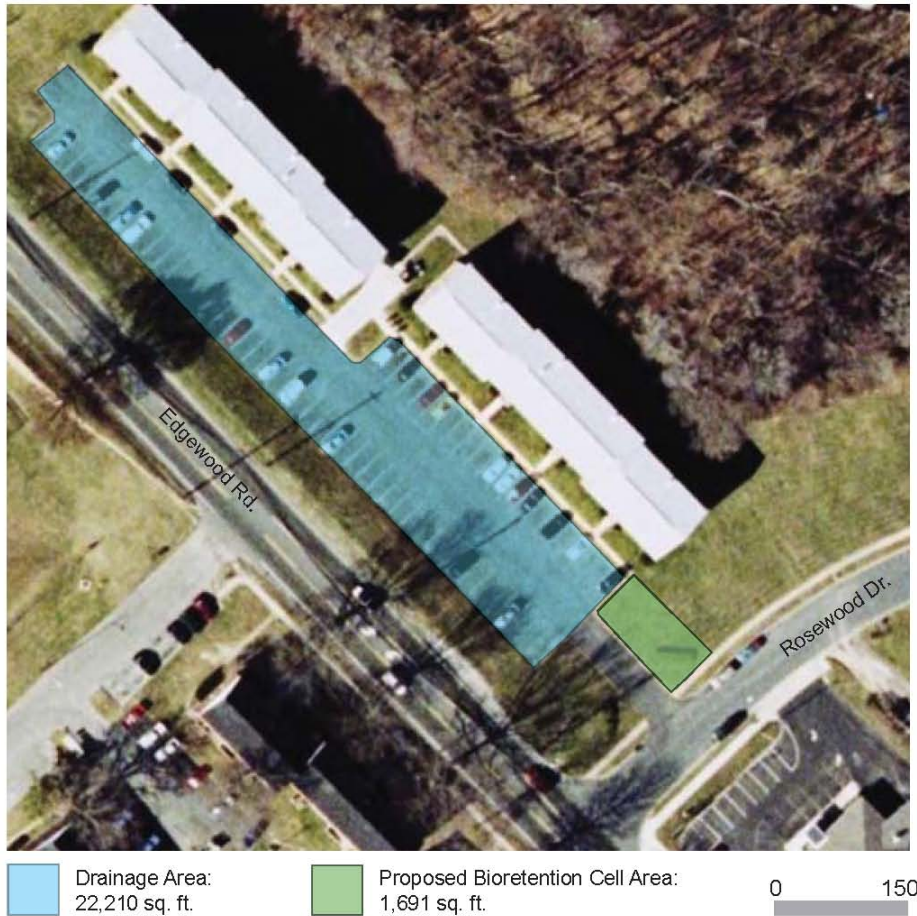
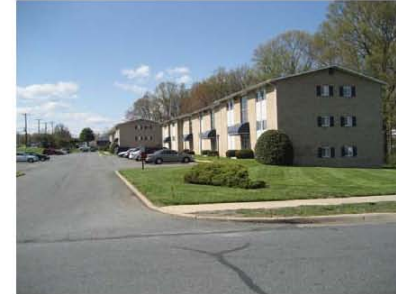
**Figure 3-12. SBK - Biorention**

*Proposed bioretention location*

Bioretention - Residential - SBK

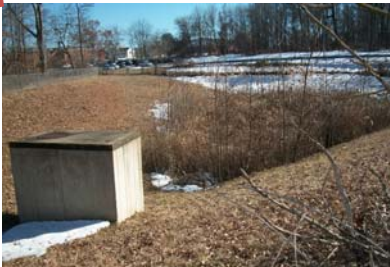
Severe Bank Erosion

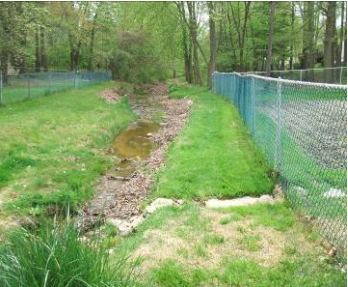
Poor Riparian Buffer

Proposed Enhanced Buffer:

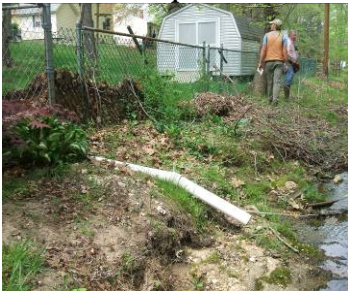
Direct Rooftop Connections

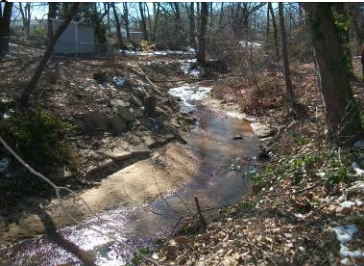
Homeowner concrete bank protection:

Many of the home-made bank protection and footbridge structures are failing and causing erosion. Bioengineered bank stabilization and riparian buffer enhancement is recommended. However, private land ownership would make this option difficult. Homeowner education to increase stream stewardship could be a lower cost alternative.

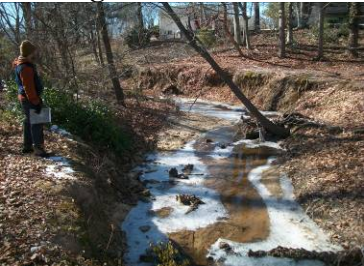
Existing bank erosion:

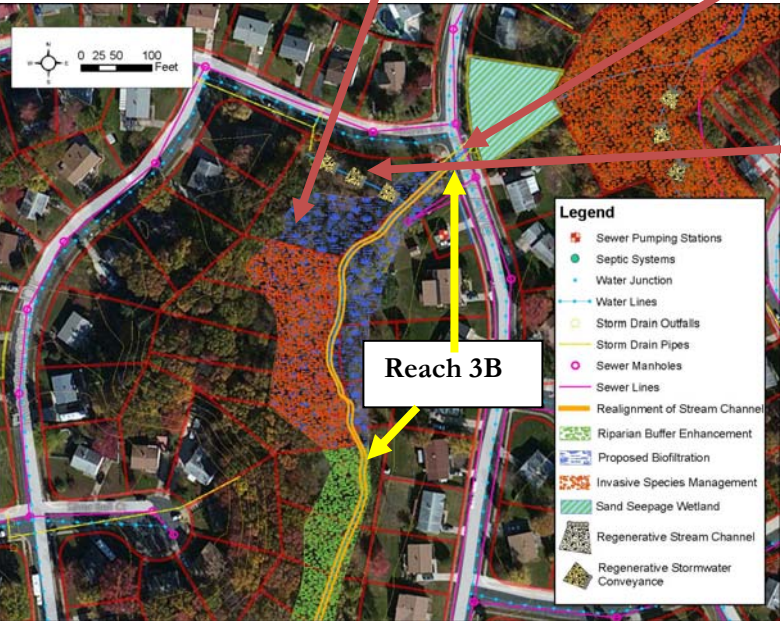
Poor Riparian Buffer and concrete swale at Perry Avenue

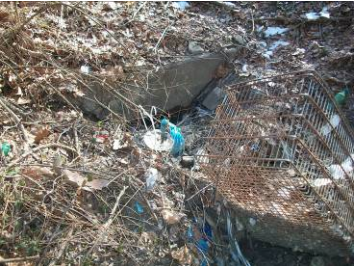
Clogged stormdrains.  
 Potential for stormwater treatment:

A regenerative stream channel including re-connection of baseflow with the floodplain would improve existing wetland quality and extent, while passively controlling the spread of invasive species. The stormwater outfalls in this reach were clogged with sediment and trash. The existing floodplain slough features offer a good opportunity for stormwater capture and attenuation via sand seepage wetlands. Management is necessary to control the spread of invasive species in the forested wetland.
